**MINERALS PROGRAM INSPECTION REPORT**  
**PHONE: (303) 866-3567**

| <b>MINE NAME:</b><br>Henderson Mine | <b>MINE/PROSPECTING ID#:</b><br>M-1977-342 | <b>MINERAL:</b><br>Molybdenum | <b>COUNTY:</b><br>Clear Creek, Grand |
| <b>INSPECTION TYPE:</b><br>Monitoring | <b>INSPECTOR(S):</b><br>Peter Hays | <b>INSP. DATE:</b><br>May 6, 2020 | <b>INSP. TIME:</b><br>10:00 |

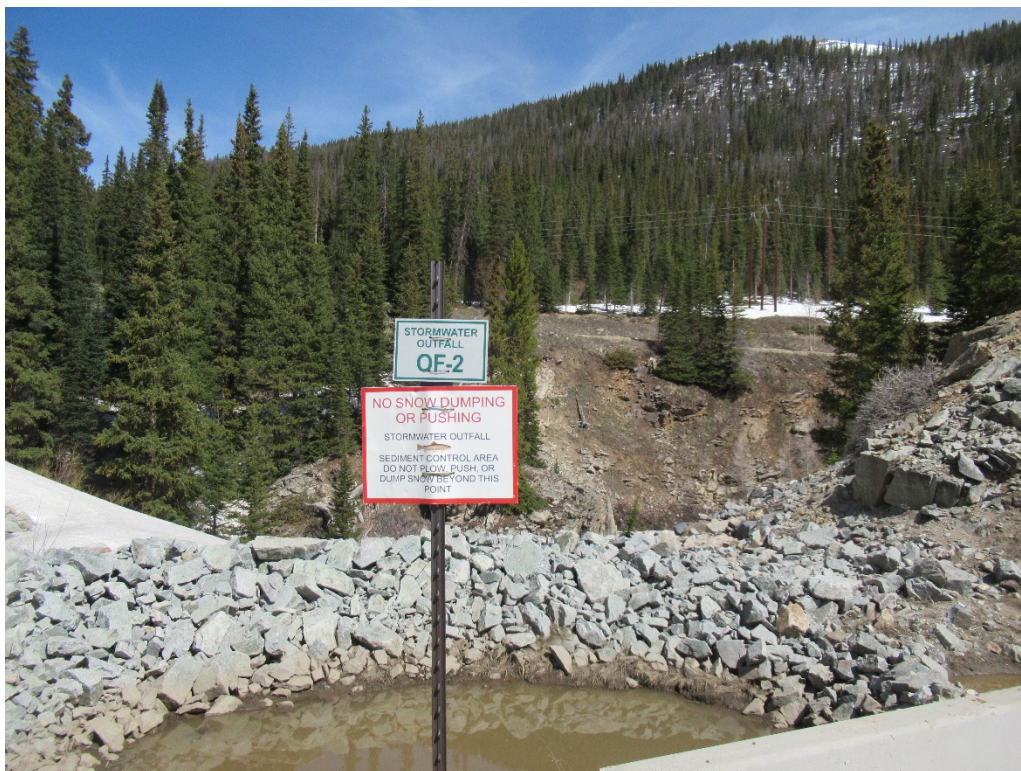
OF-2: BMP's at this outfall location consist of a series of rock check dams leading to a sedimentation pond above the rip-rap outfall. The sedimentation pond contained water above the outfall. The outfall appeared to be functioning properly.

View of OF-2

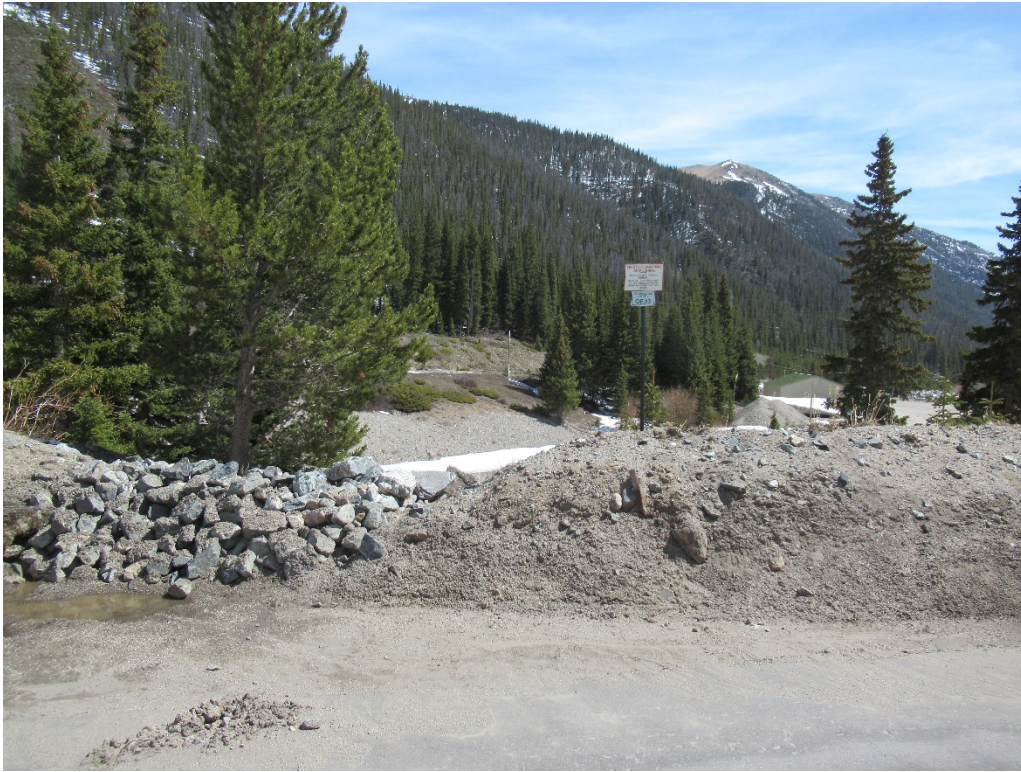
OF-13: BMP's at this outfall location consist of a rip-rap check dam. The sediment pond contained a small pool of water and the outfall was covered by snow.

View of OF-13

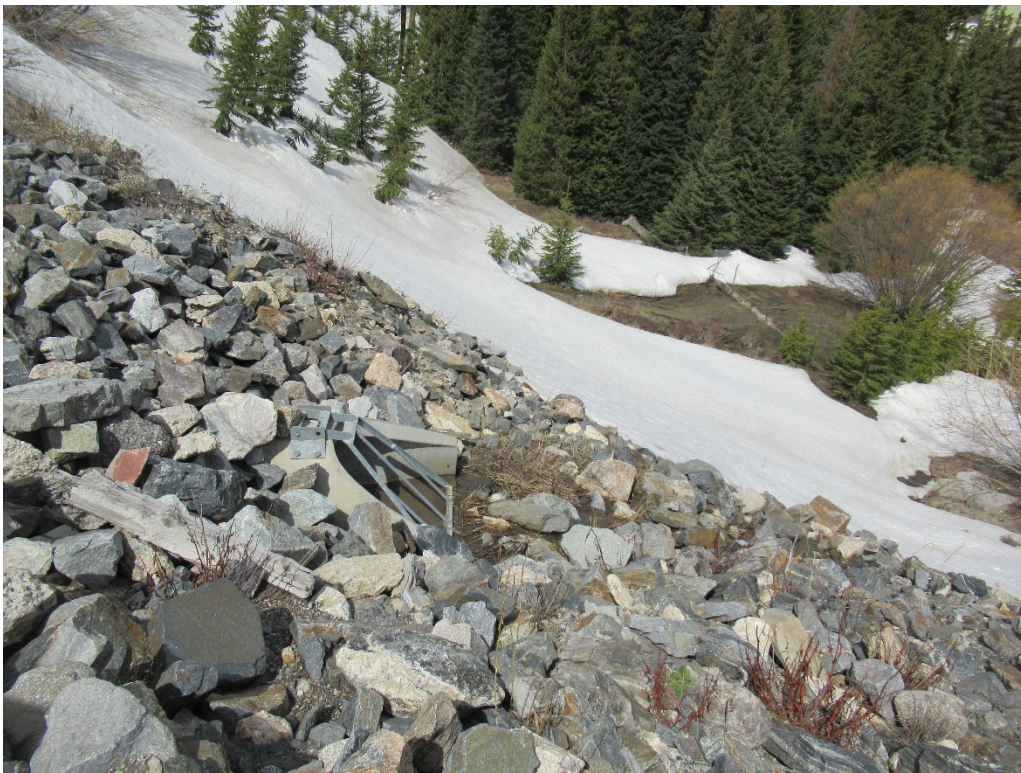
OF-9: BMP's at this outfall location consist of rip-rap and vegetation below the discharge pipe. The outfall was flowing water and appeared to be functioning properly.

View of OF-9

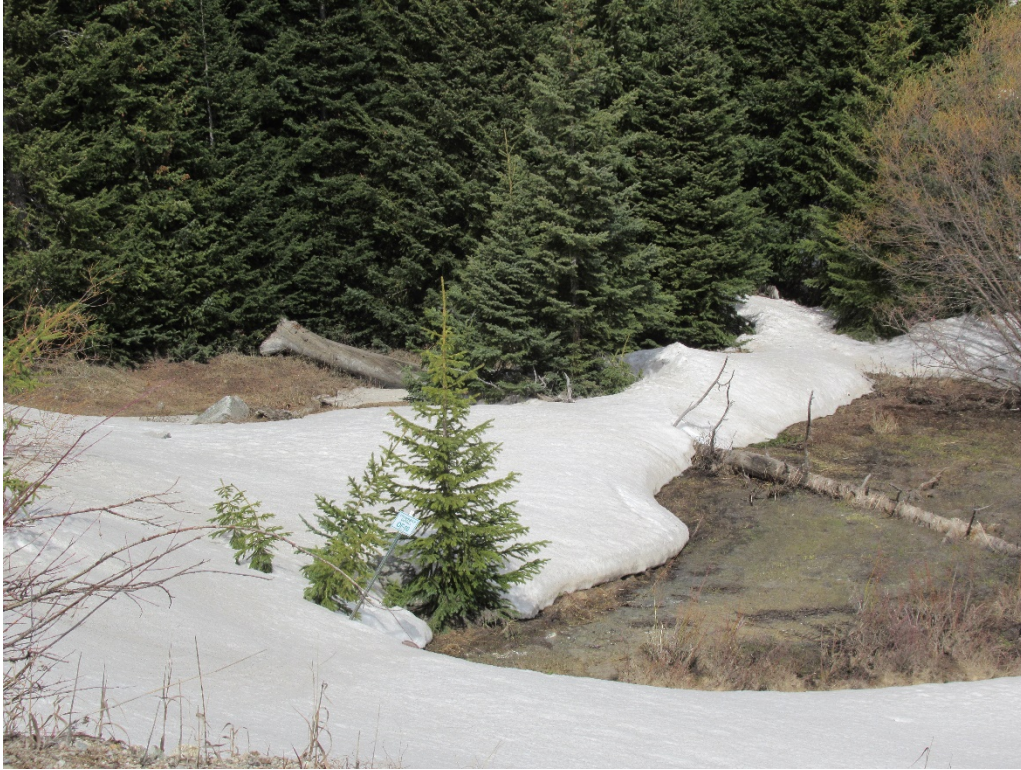
View of OF-16

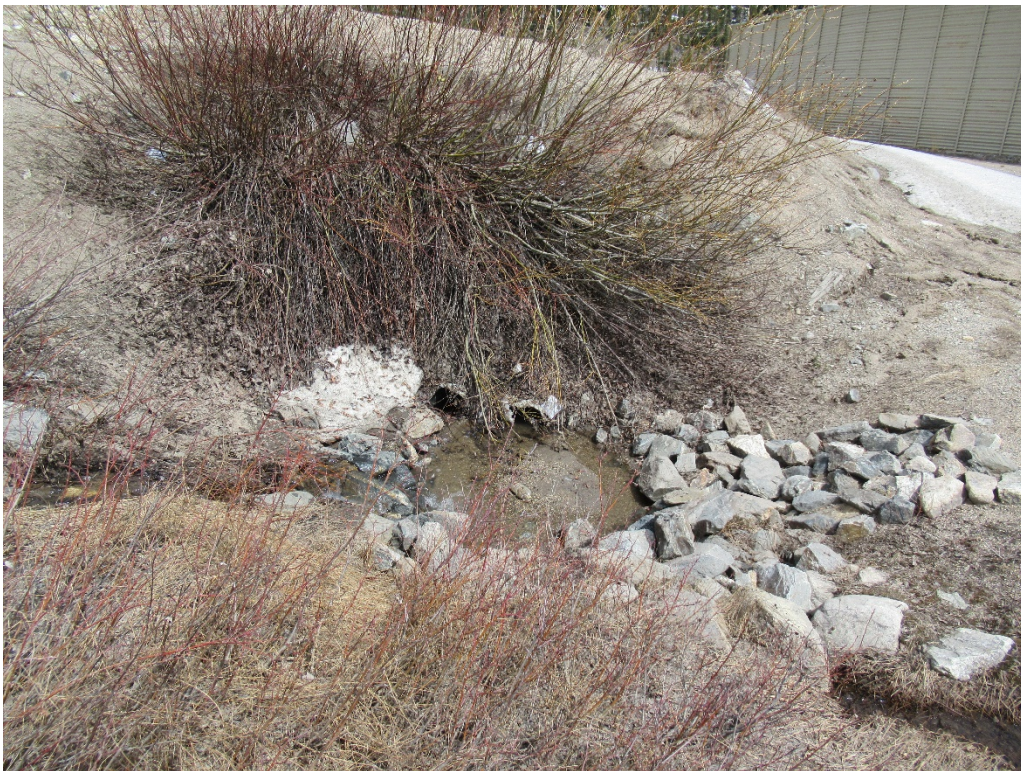
OF-16: BMP's at this outfall location consist of rip-rap and vegetation below the discharge pipe. The outfall was covered by a snow drift. The inlet of the culverts above the outfall were partially filled with sediment. The Division recommends the culverts are cleaned out to maintain the flow of water through the culverts.

View of partially filled culverts above OF-16

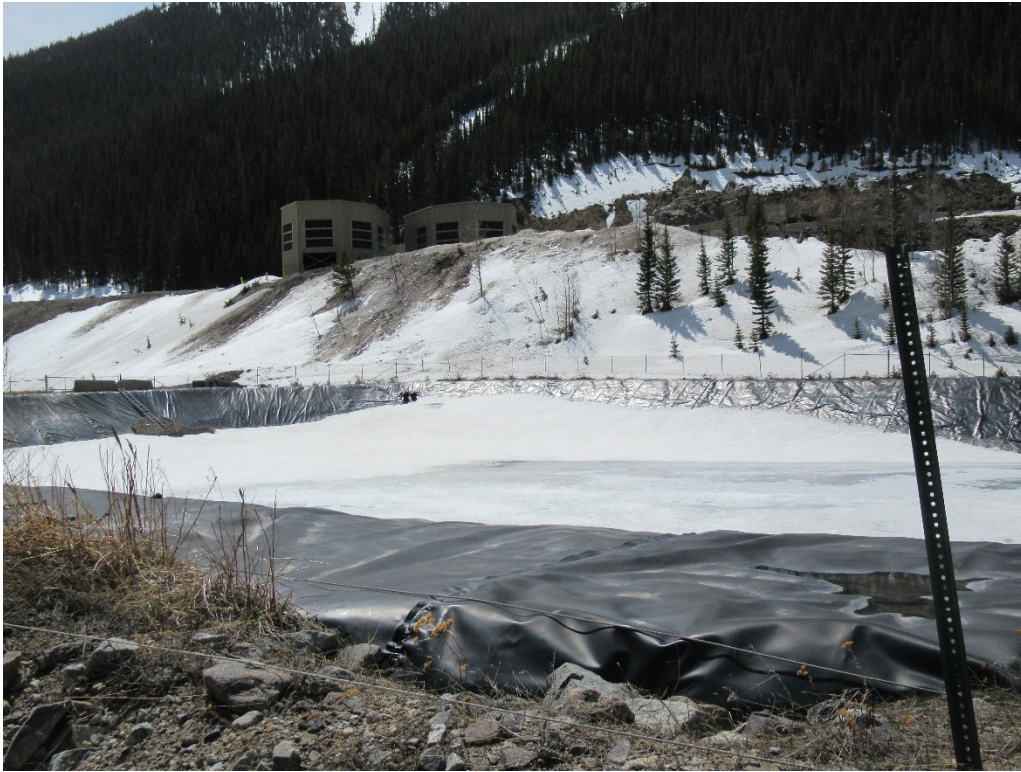
View of EPF 1.2

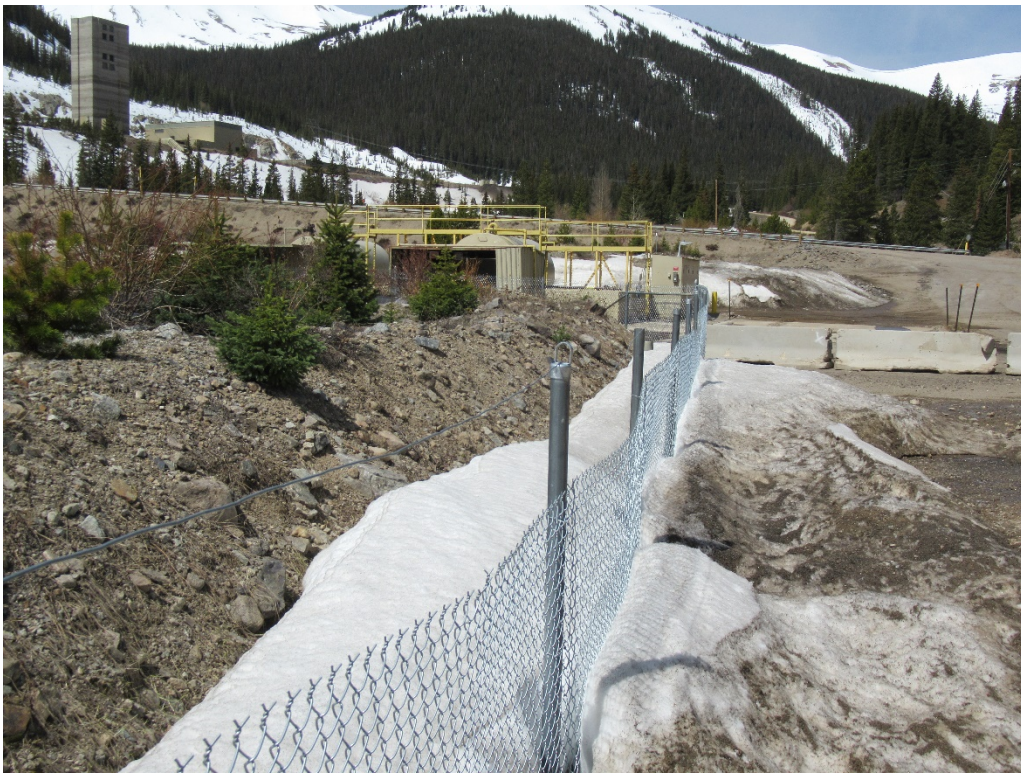
Mine EPF 1.2 is utilized for storm water control at the site. The Pond 1.2 liner was covered with snow. The liner and the inlet and outlet structures appeared to be working as designed and in accordance with the approved as-built drawings. The chain-link fence surrounding the pond was repaired in 2019. Sections of the fence were observed to be damaged by the snow load over the past winter. The Division recommends the damaged sections of fence are repaired by the Operator.

View of damaged fence around EPF 1.2

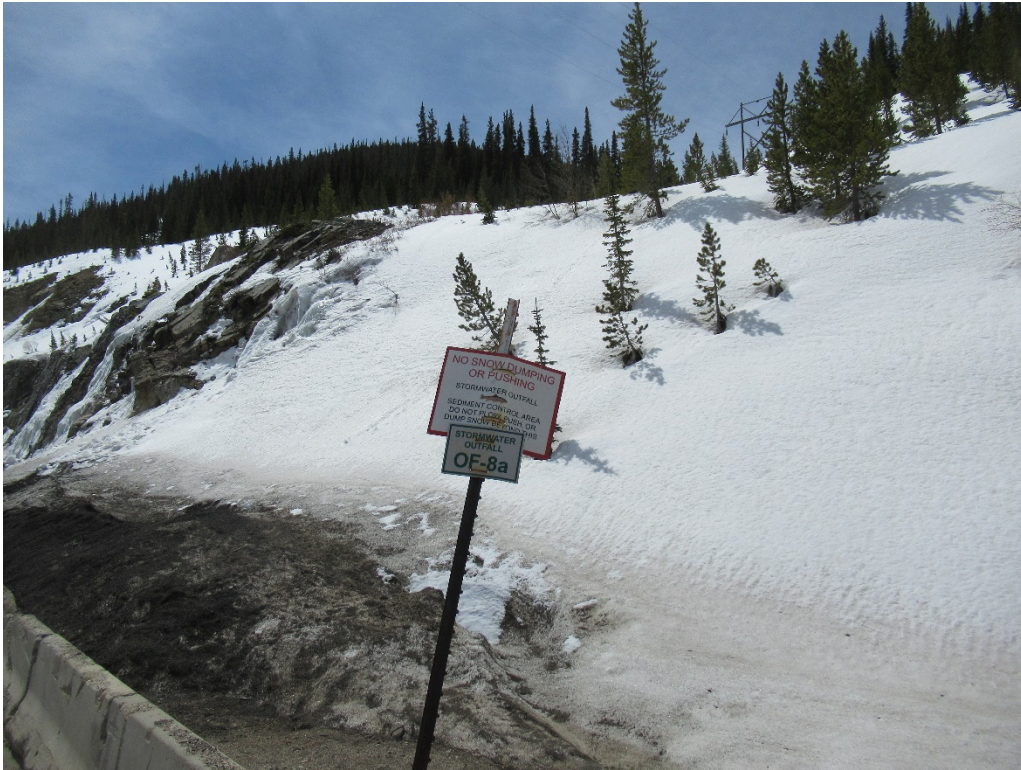
OF-8a: BMP's at this outfall location consist of ditch with a series of rock check dams leading to a sedimentation pond. The ditch and sedimentation pond were snow covered and could not be observed during the inspection.

View of OF-8a

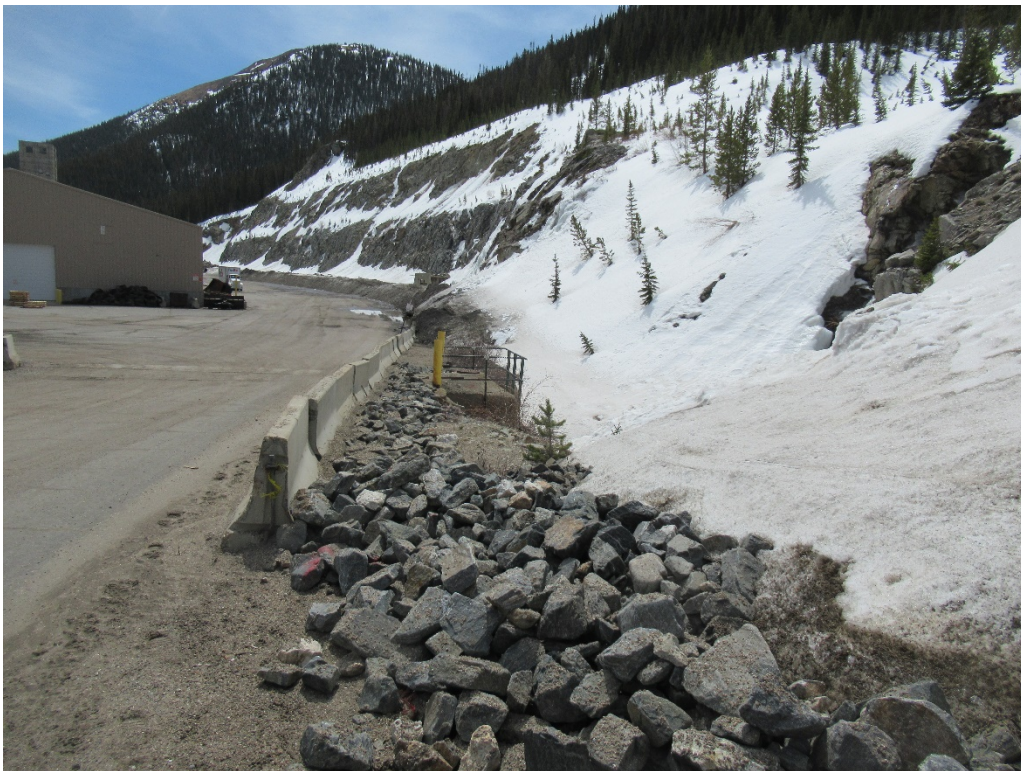
OF-8b: BMP's at this outfall location consist of a series of ditches and rock check dams leading to a rip-rap outfall. The ditch leading to the outfall was snow covered and could not be observed during the inspection.

View of OF-8b

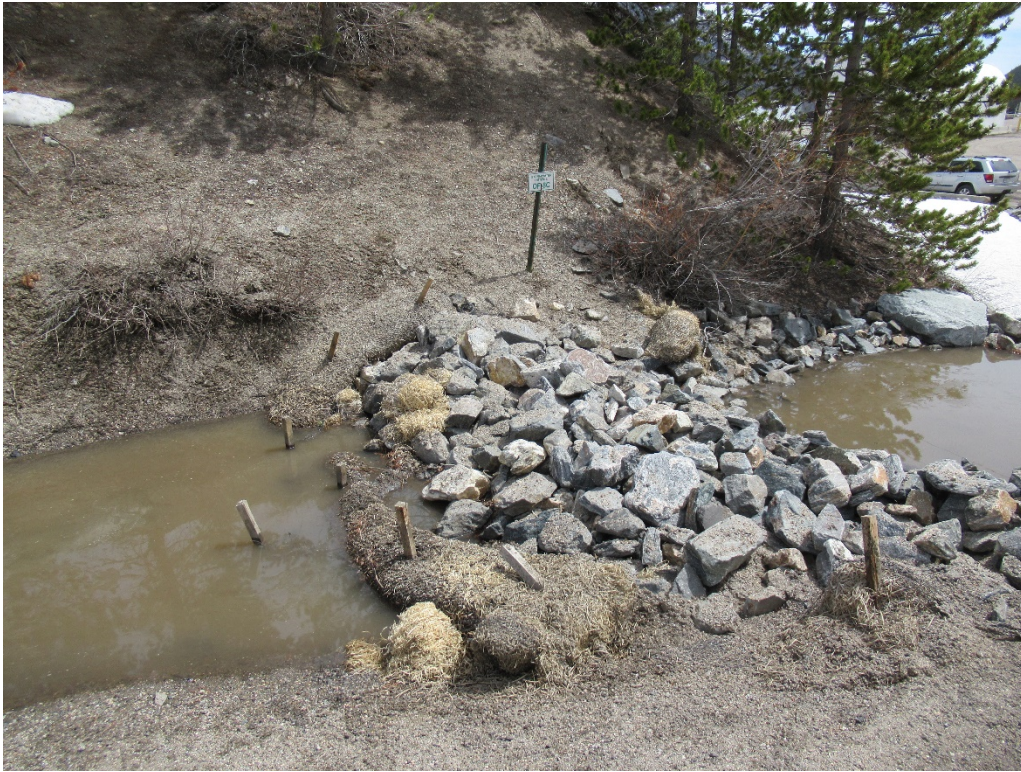
OF-8c: BMP's at this outfall location consist of a ditch with a series of rock check dams leading to a rip-rap outfall. The ditch and sediment pond contained water and the outfall was partially covered by snow, but appeared to be functioning properly.

View of OF-8c

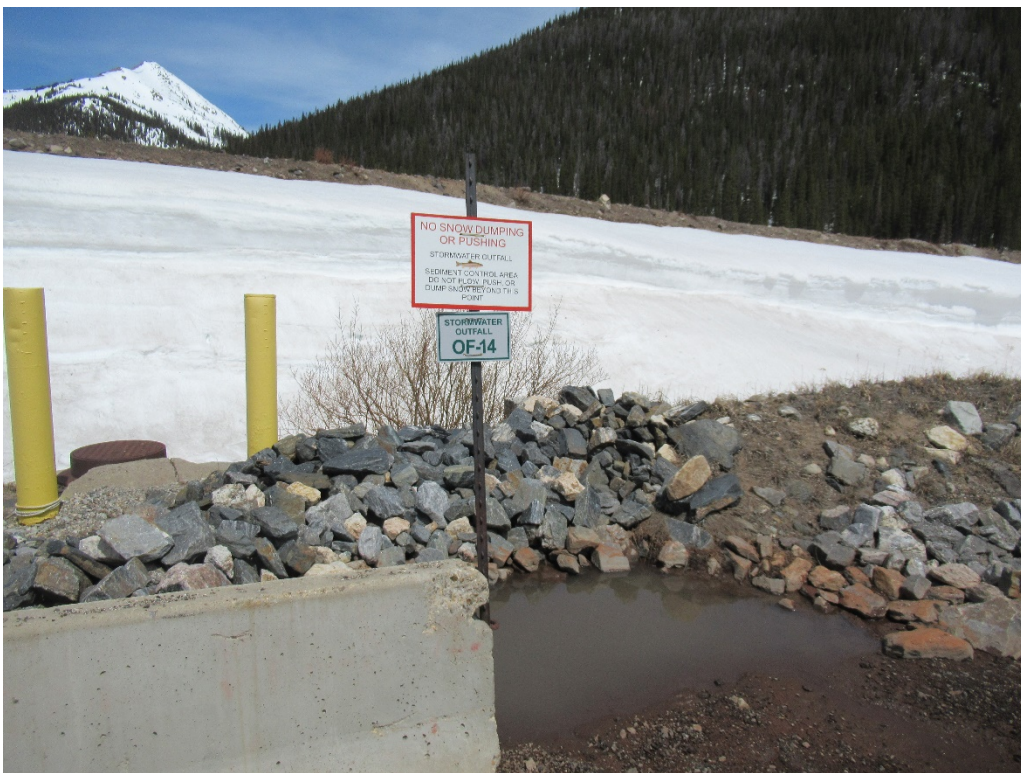
OF-14: BMP's at this outfall location consist of a ditch with a series of rock check dams leading to a rip-rap outfall. The sediment pond contained water and outfall was covered by snow.

View of OF-14

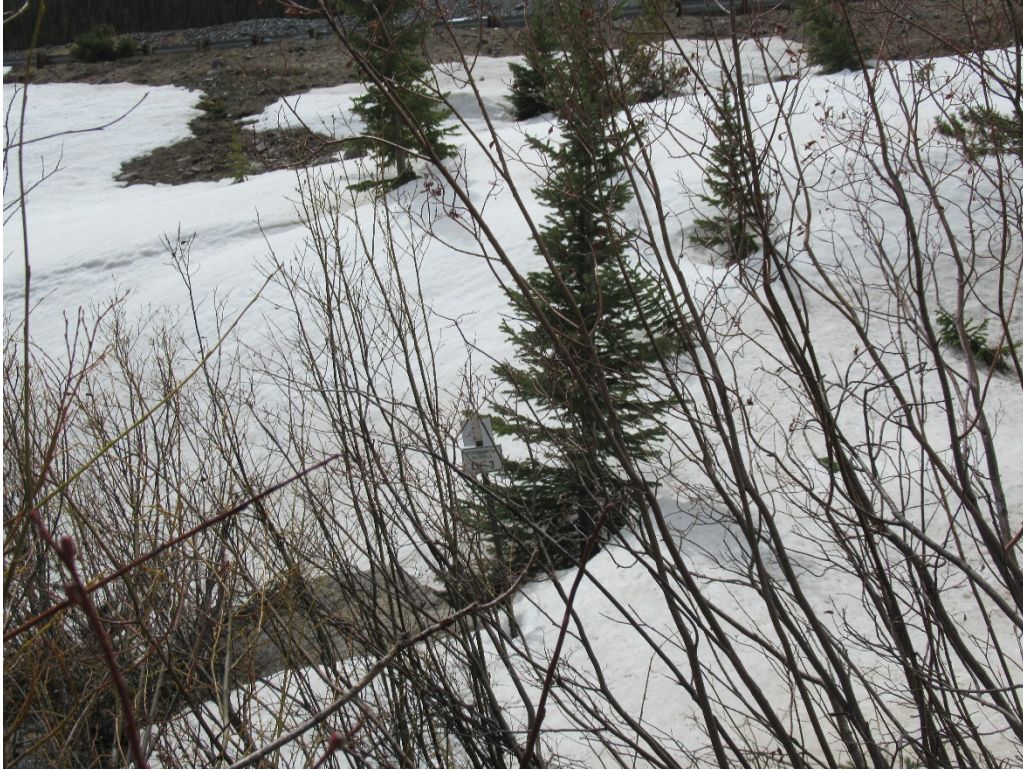
OF-3: BMP's at this outfall location consist of an engineered wetland and a sedimentation pond. The outfall was observed, however it was mostly covered by a snow drift.

View of OF-3
