MINERALS PROGRAM INSPECTION REPORT
PHONE: (303) 866-3567

MINE NAME: Cedarwood Clay Mine	MINE/PROSPECTING ID#: M-1977-317	MINERAL: Clay (general)	COUNTY: Pueblo
INSPECTION TYPE: Surety-Related Inspection	INSPECTOR(S): Patrick Lennberg	INSP. DATE: May 21, 2020	INSP. TIME: 11:00
OPERATOR: Seifert Enterprises, LLC	OPERATOR REPRESENTATIVE: None	TYPE OF OPERATION: 112c - Construction Regular Operation

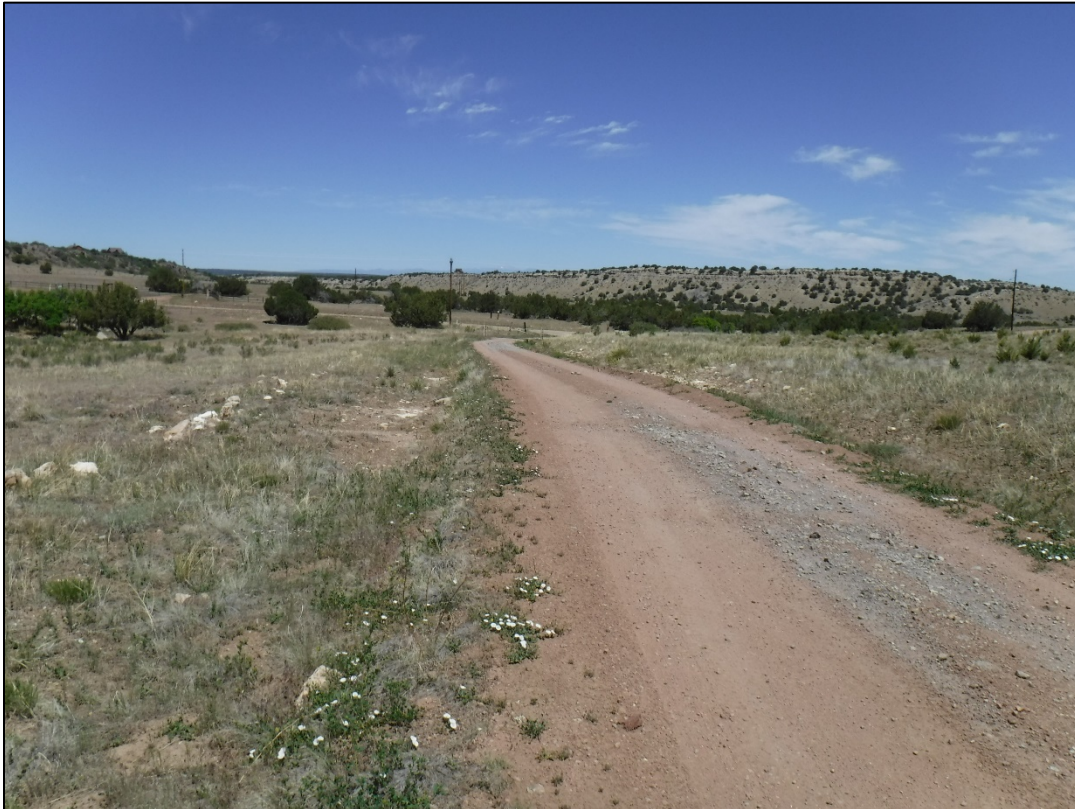
PROBLEM: The mine identification sign was not posted at the entrance of the mine site. This is a problem for failure to post a mine identification sign as required by Section 3.1.12(1) of the rule.

A mine sign was not observed at the entrance to the mine as required by Rule 3.1.12 and has been cited as a problem in this report. A few t-posts were located in the field but difficult to ascertain if they were permit boundary markers or relics from prior grazing operations. The lack of definitive permit boundary markers is being cited as a problem in this report pursuant to Rule 3.1.12(2).

Photo 1: Looking north along the entrance road towards Pickney Road

CORRECTIVE ACTIONS: The operator shall, at the entrance of the mine site, post a sign which shall be clearly visible from the access road with the following: the name of the operator, a statement that a reclamation permit for the operation has been issued by the Colorado Mined Land Reclamation Board; and the permit number. The operator shall submit photo documentation that a proper sign has been posted by the corrective action date.

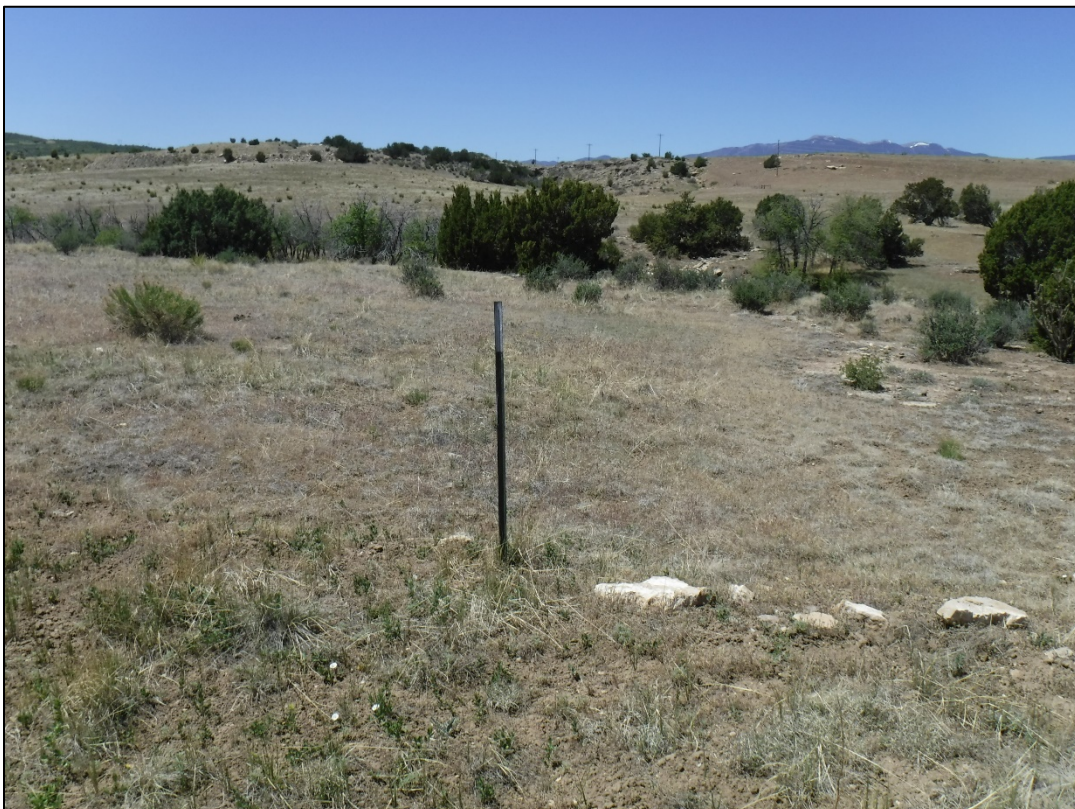
PROBLEM: The affected area boundary markers are missing or incorrectly placed. This is a problem for failure to maintain boundary markers around the affected area as required by Section 3.1.12(2) of the rule.

Photo 2: Possible boundary marker just west of the entrance road in Photo 1

CORRECTIVE ACTIONS: The operator shall conduct a survey and replace the boundary markers in the correct location(s). The Division recommends that the operator have independent survey contractor locate the missing boundary markers and verify the current marker locations. The operator shall provide proof to the Division that this has been done by the corrective action date.

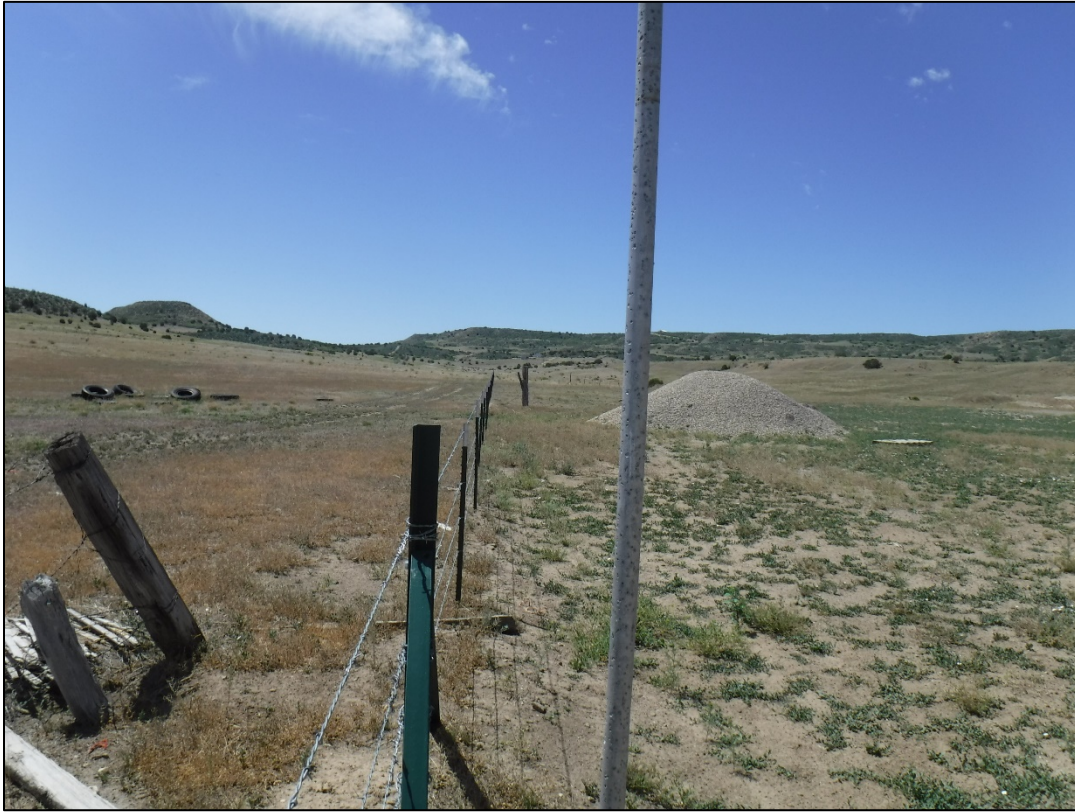
Photo 3: Possible boundary marker by stockpile area in Phase 2

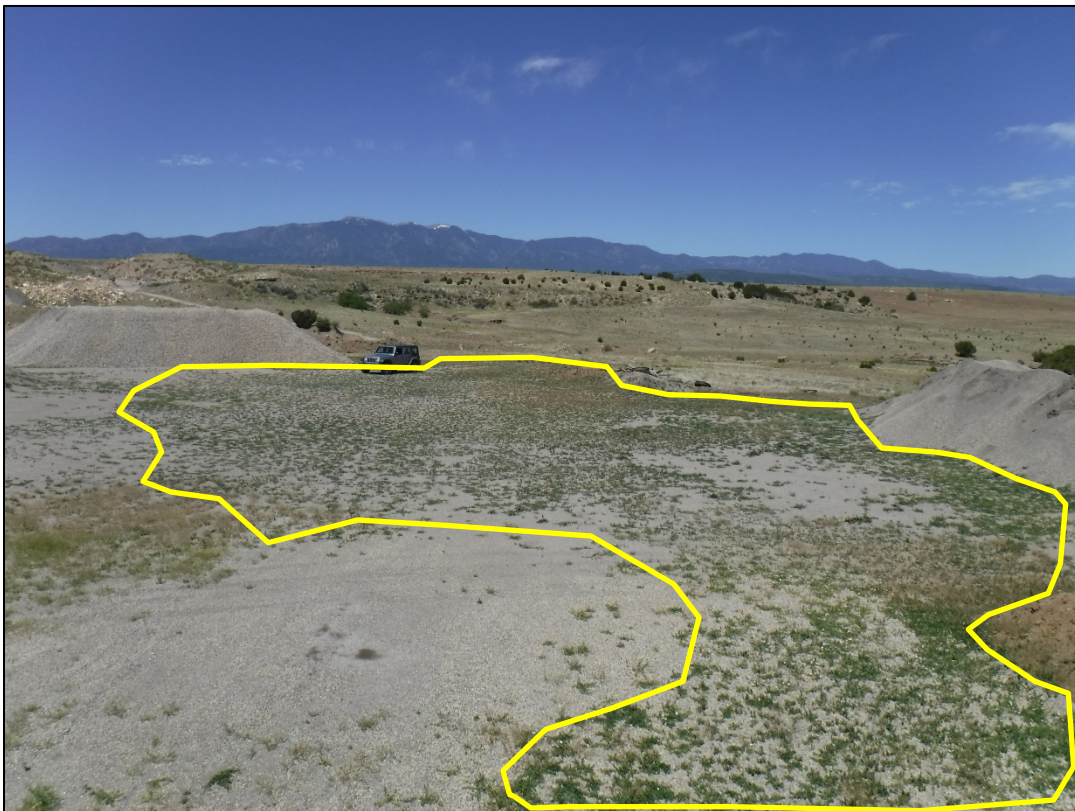
PROBLEM: There are state-listed noxious weeds present on site. This is a problem for failure to employ weed control methods for state listed noxious weed species within the permitted area, and to reduce the spread of weeds to nearby areas as required by Section 3.1.10 (6) of the rule.

At a staging area, near the road leading to the mining areas, a large patch of field bindweed was noted. Field bindweed is a List C noxious weed. The bindweed was also noted to be common throughout the permit area and was acting as a source to the surrounding area. Enclosed with this report is the fact sheet for field bindweed created by the Colorado Department of Agriculture. In addition to the bindweed some Common Mullein and a few Musk Thistles were noted. Failure to control noxious weeds at the site is being cited as a problem in this report.

Photo 4: Stockpile area with Field Bindweed outlined in yellow, bindweed not confined to outlined area

CORRECTIVE ACTIONS: Implement approved weed control plan and provide proof to the Division that this has been done. If a weed control plan is not already in place, the operator shall develop a weed control and management plan in accordance with Section 3.1.10 (6) of the Rule. This plan should be developed in consultation with the county extension agency, or weed control district office and should include specific control measures to be applied, a schedule for when control measures will be applied and a post-treatment monitoring plan. This weed control plan shall be submitted to the Division as a Technical Revision to the approved plan with the appropriate Technical Revision fee of \$216.00 by the corrective action date.

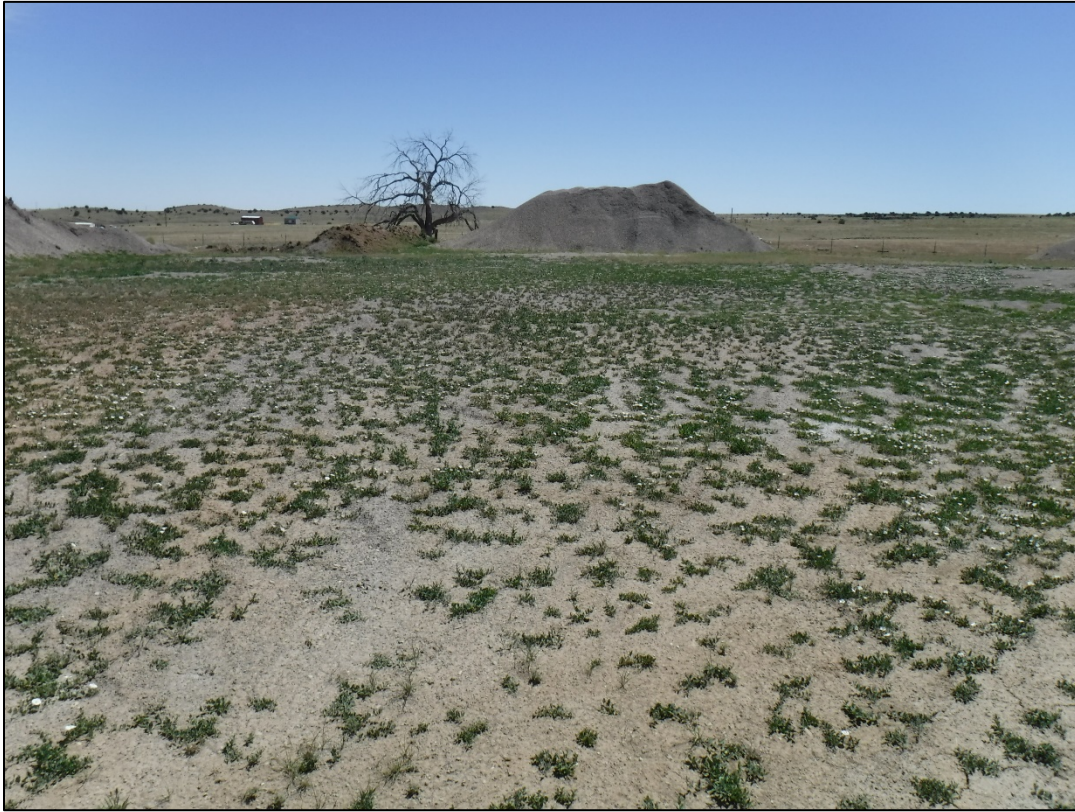
Photo 5: Field Bindweed near stockpile area

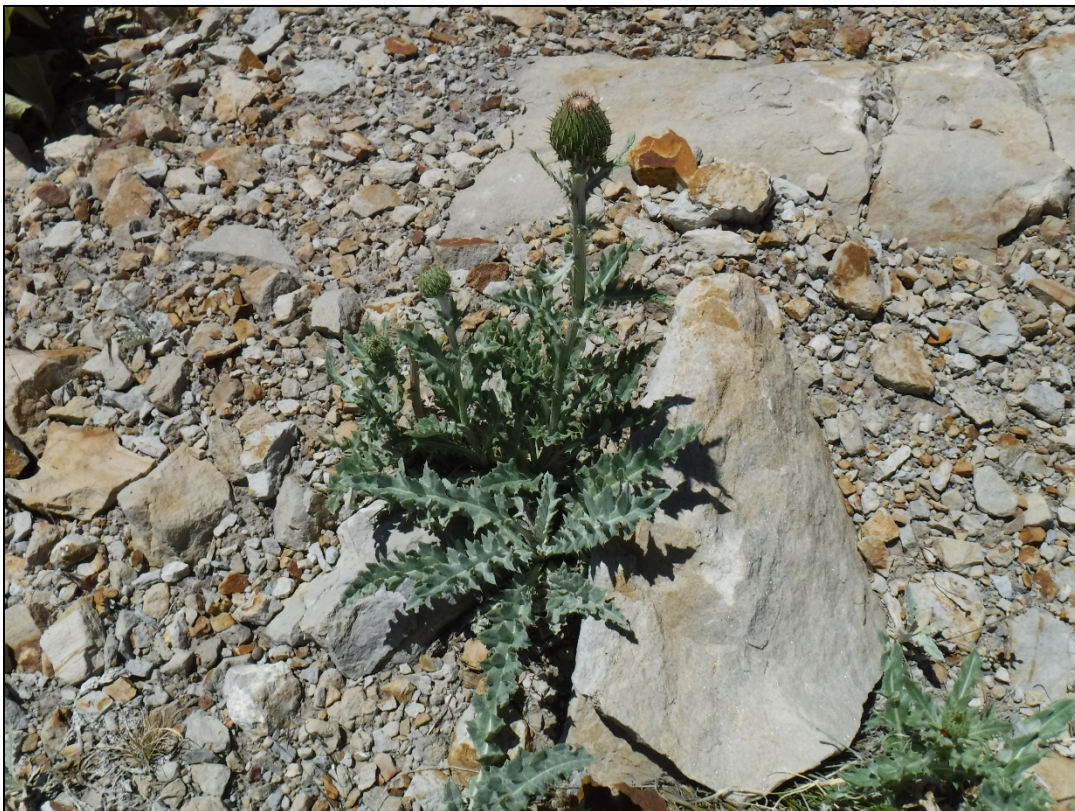
Photo 6: Possible musk thistle plant

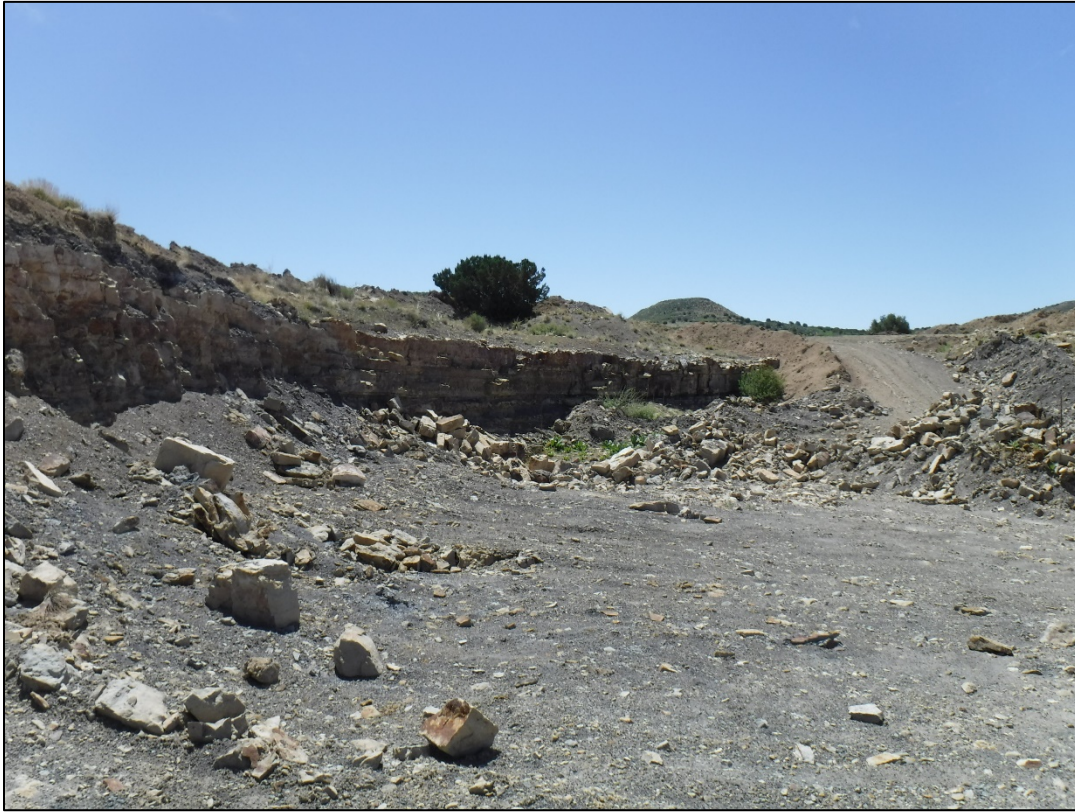
Photo 7: Typical highwall in the Phase 2 mining area, looking south

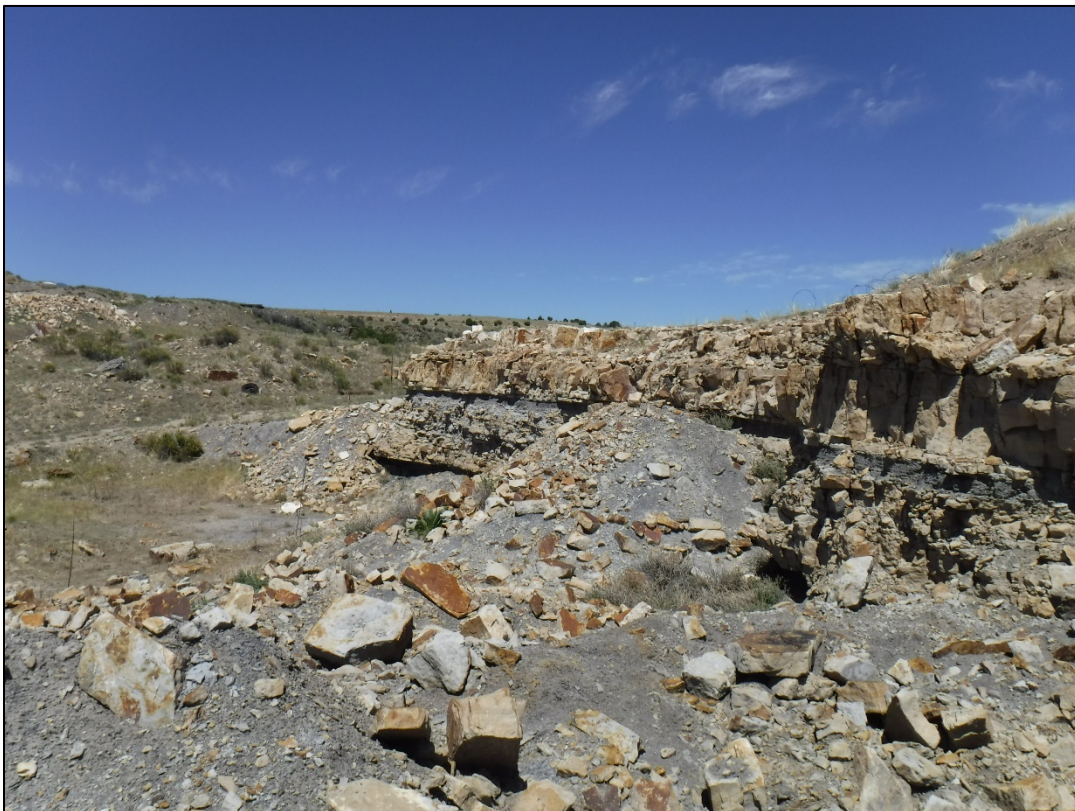
Photo 8: Typical highwall in the Phase 2 mining area, looking north

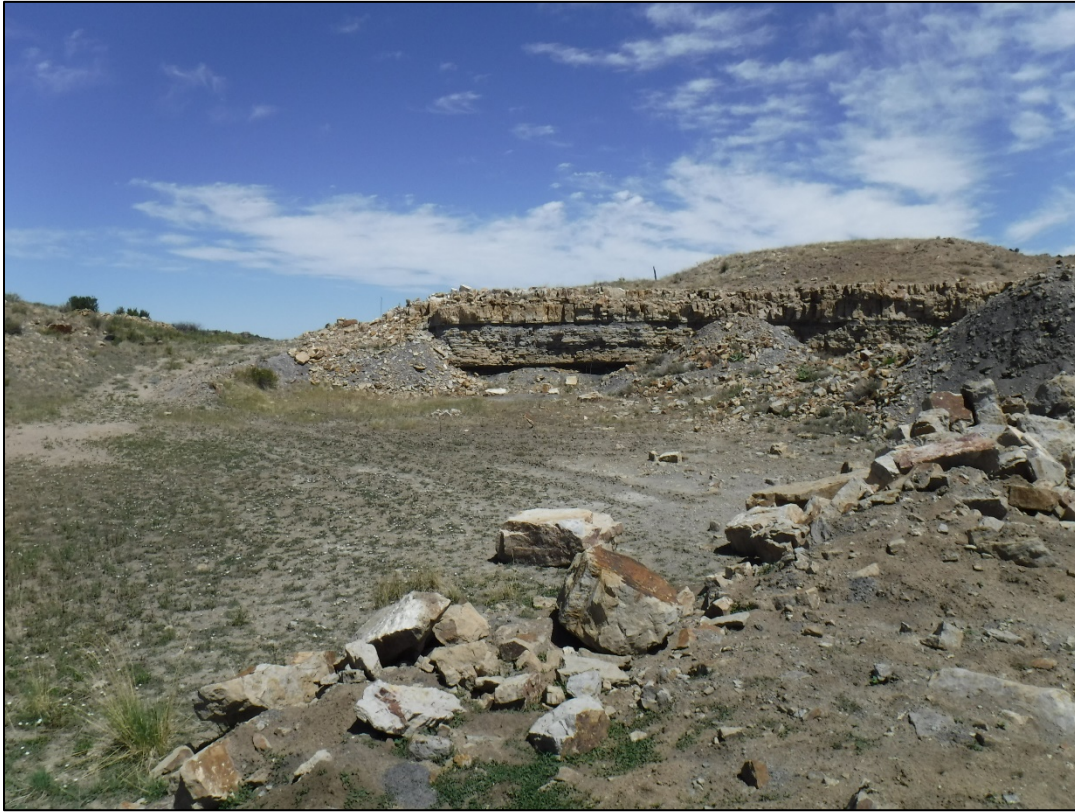
Photo 9: The highwall at the northend of Phase 2 mining area

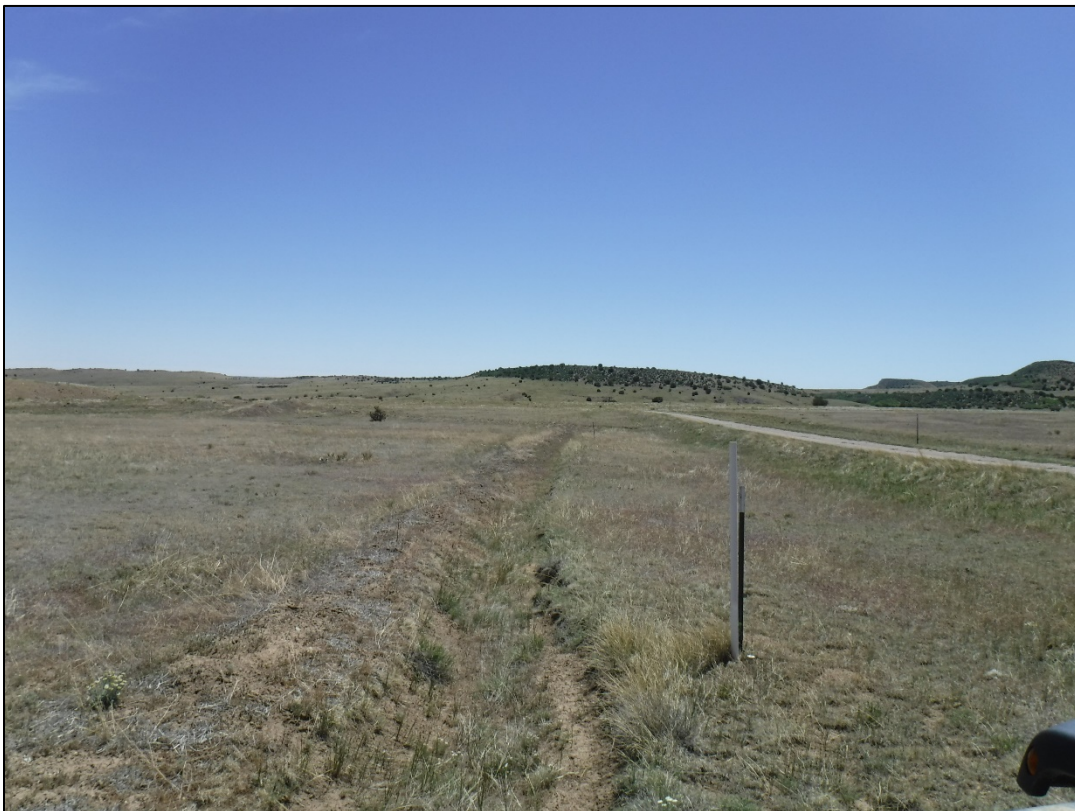
There is a road that borders the southern portion of the permit area that appears to lead to private

Photo 10: Southern permit boundary with residential road (center right of photo)

residences. The Division recommends the operator fence this portion of the permit area to prevent people from accidentally crossing into an active mining area.

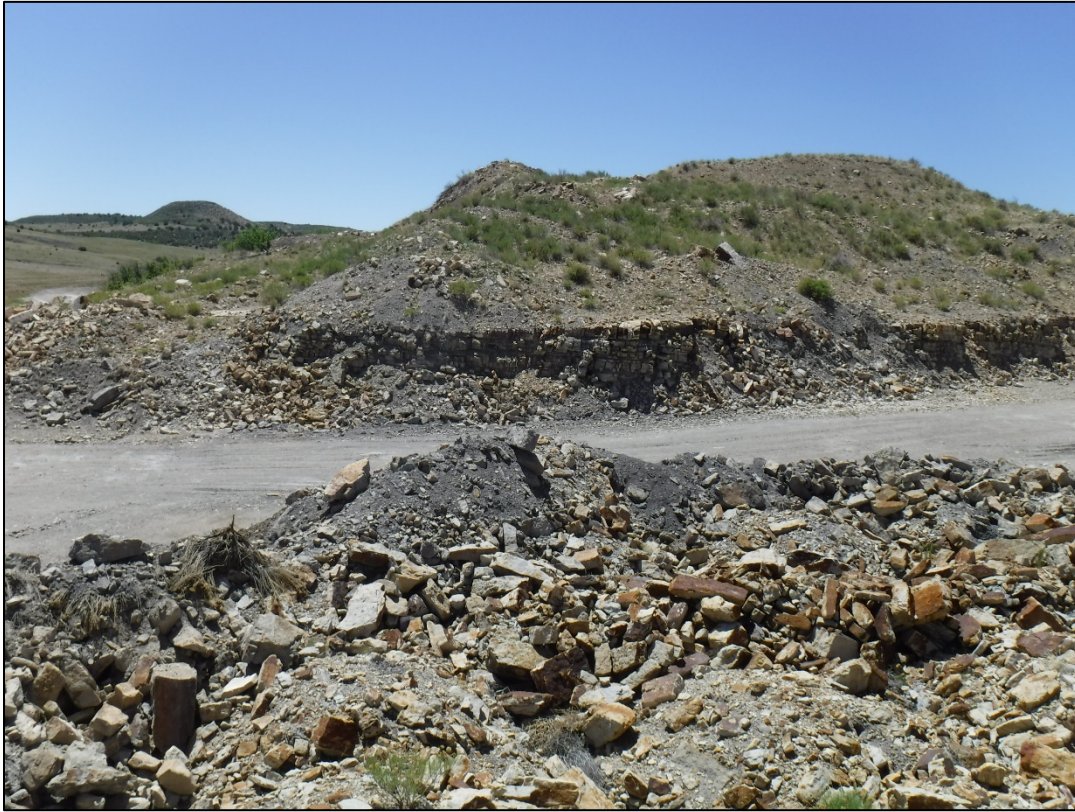
All the haul roads throughout the site were stable and there were no signs of excessive erosion from mining areas, roads or stockpiles. The arroyo that runs through the site from north to south along the eastern half of the permit area appeared stable and was not impacting any mining area nor did it appear that mining was affecting the arroyo.

Photo 11: Looking south at the haul road leading to the Phase 1 mining area

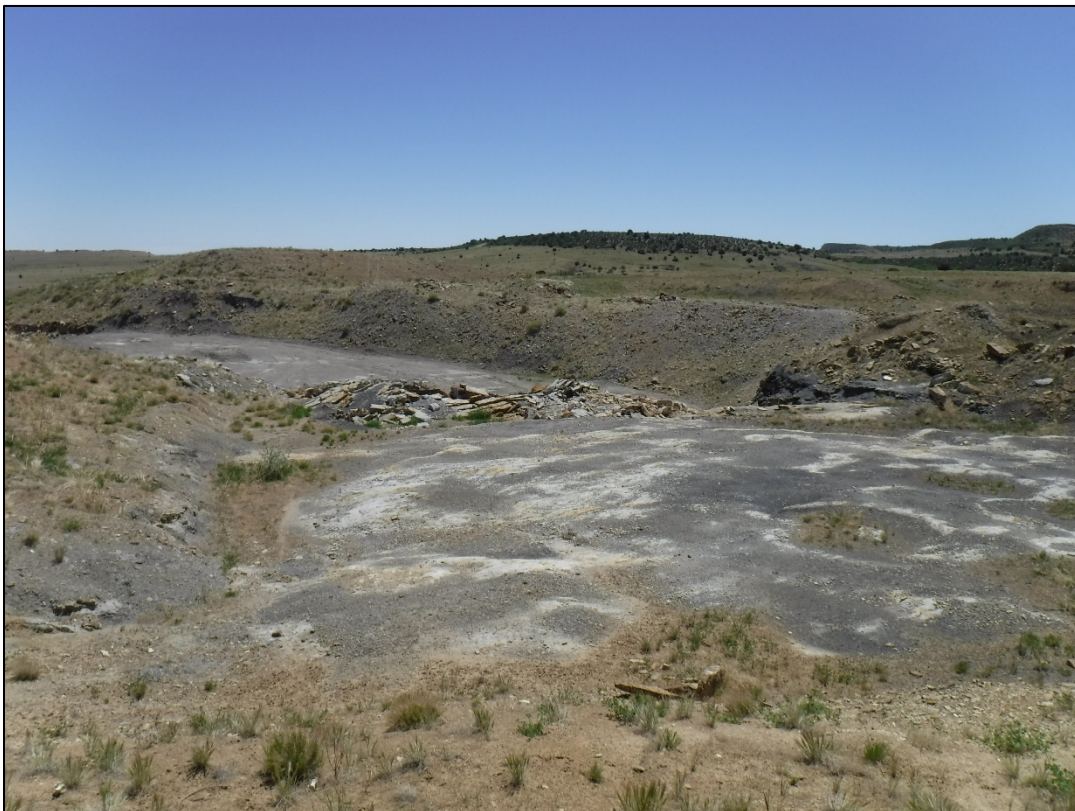
Photo 12: Looking down into the Phase 1 mining area

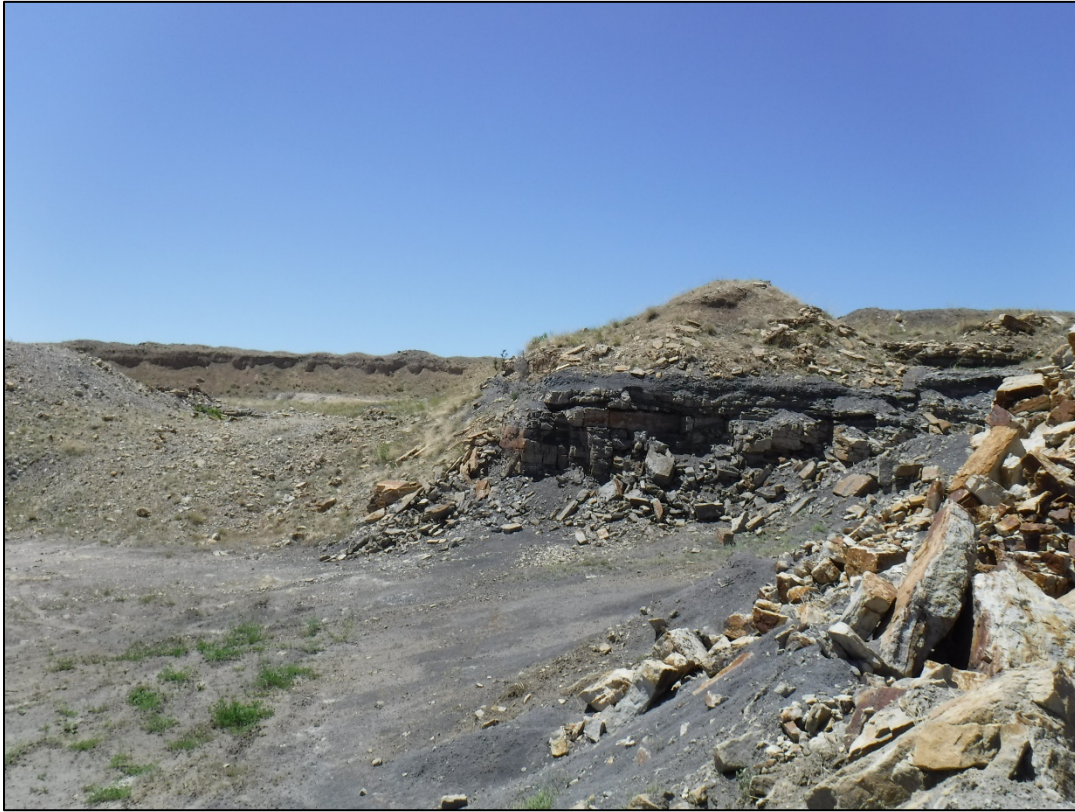
Photo 13: Highwall in Phase 1 mining area

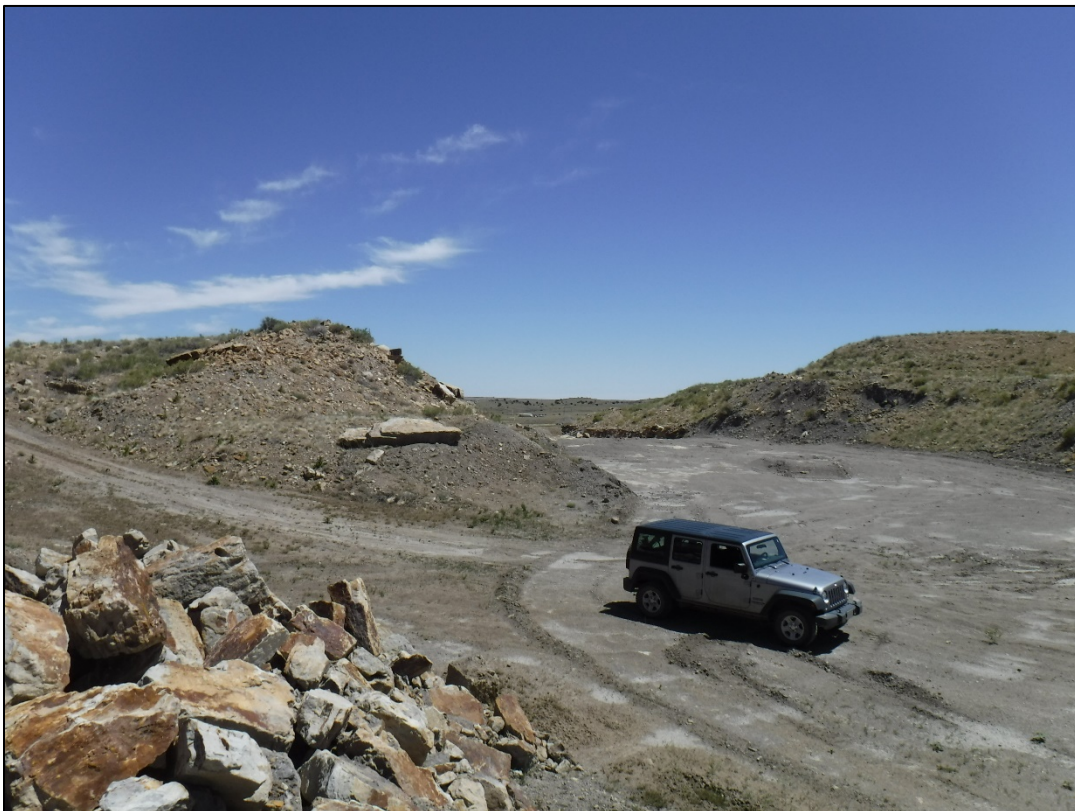
Photo 14: Phase 1 mining area
