MINERALS PROGRAM INSPECTION REPORT
PHONE: (303) 866-3567

MINE NAME: Fork Horn Mesa Subdivision	MINE/PROSPECTING ID#: M-2008-044	MINERAL: Gravel	COUNTY: La Plata
INSPECTION TYPE: Surety Release Inspection	INSPECTOR(S): Lucas West	INSP. DATE: May 19, 2020	INSP. TIME: 14:00
OPERATOR: Palmer Pipe & Construction, LLC	OPERATOR REPRESENTATIVE: None	TYPE OF OPERATION: 110c - Construction Limited Impact	
REASON FOR INSPECTION: Surety Release Requested	BOND CALCULATION TYPE: None	BOND AMOUNT: \$3,523.00	
DATE OF COMPLAINT: NA	POST INSP. CONTACTS: None	JOINT INSP. AGENCY: None	
WEATHER: Raining	INSPECTOR'S SIGNATURE:

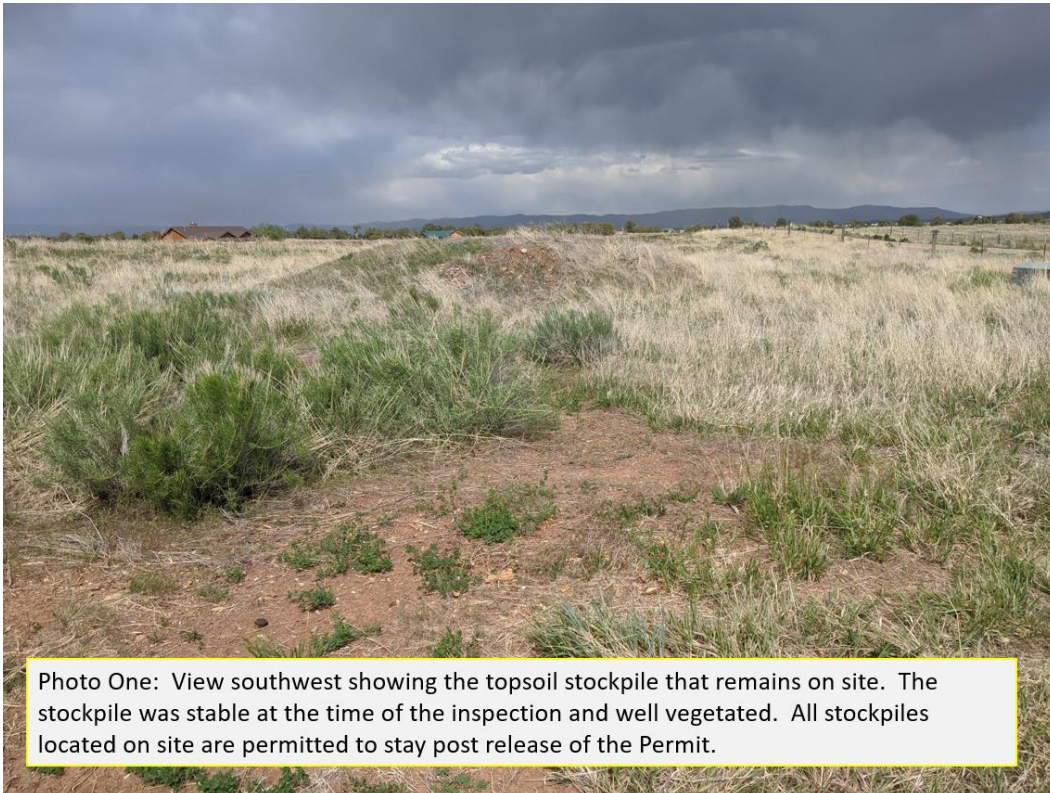
No mining or reclamation equipment was present on site. This area was not the actual site of excavation, the material was generated when an oil and gas well pad was constructed nearby. The material was stockpiled on site to be processed, used and sold. The affected lands consist of a small topsoil stockpile that was scraped back to create a location for the material to be stockpiled. A recent Technical Revision was approved to allow the remaining stockpiles to remain on site for landowner use. The stockpiles that remain on site are permitted to exist upon approval of the release. The topsoil stockpile is small, nearly knee high, and appears to be stable. It has been vegetated with volunteer species and shows no signs or significant erosion. The topsoil stockpile can be seen in Photo One.

Photo One: View southwest showing the topsoil stockpile that remains on site. The stockpile was stable at the time of the inspection and well vegetated. All stockpiles located on site are permitted to stay post release of the Permit.

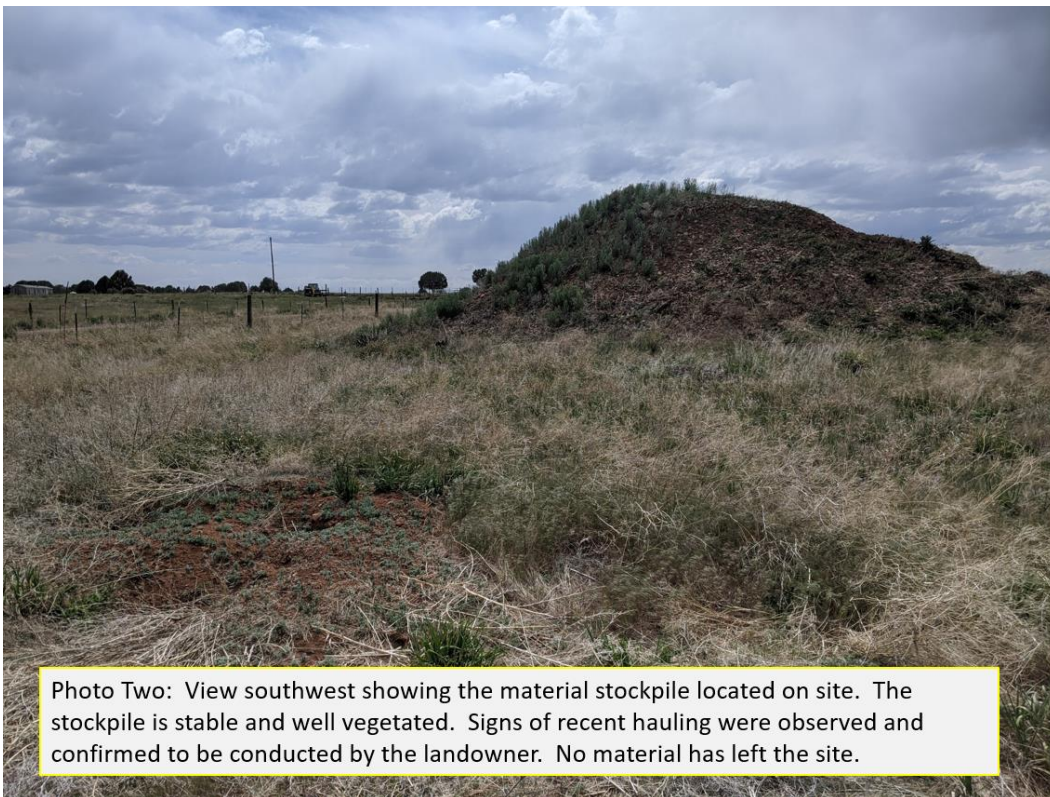
The material stockpile is one consolidated stockpile estimated at approximately 250 cubic yards. The stockpile appears to be stable and in good condition. No signs of settling, slumping or erosion was observed. Evidence of recent hauling activity was observed. Photo Two shows the stockpiled material. All areas around the stockpiles are well vegetated with volunteer species. No state listed noxious weeds were noted on site during the inspection.

Photo Two: View southwest showing the material stockpile located on site. The stockpile is stable and well vegetated. Signs of recent hauling were observed and confirmed to be conducted by the landowner. No material has left the site.
