**MINERALS PROGRAM INSPECTION REPORT**  
**PHONE: (303) 866-3567**

<b>MINE NAME:</b> Bennett Pit	<b>MINE/PROSPECTING ID#:</b> M-2016-085	<b>MINERAL:</b> Sand and gravel	<b>COUNTY:</b> Weld
<b>INSPECTION TYPE:</b> Multi Person Inspection	<b>INSPECTOR(S):</b> Peter Hays	<b>INSP. DATE:</b> May 21, 2020	<b>INSP. TIME:</b> 10:00
<b>OPERATOR:</b> Northern Colorado Constructors	<b>OPERATOR REPRESENTATIVE:</b> Chris Zadel, J.C. York	<b>TYPE OF OPERATION:</b> 112c - Construction Regular Operation

CT-1 Inspection Report  
May 21, 2020  
Overall Map

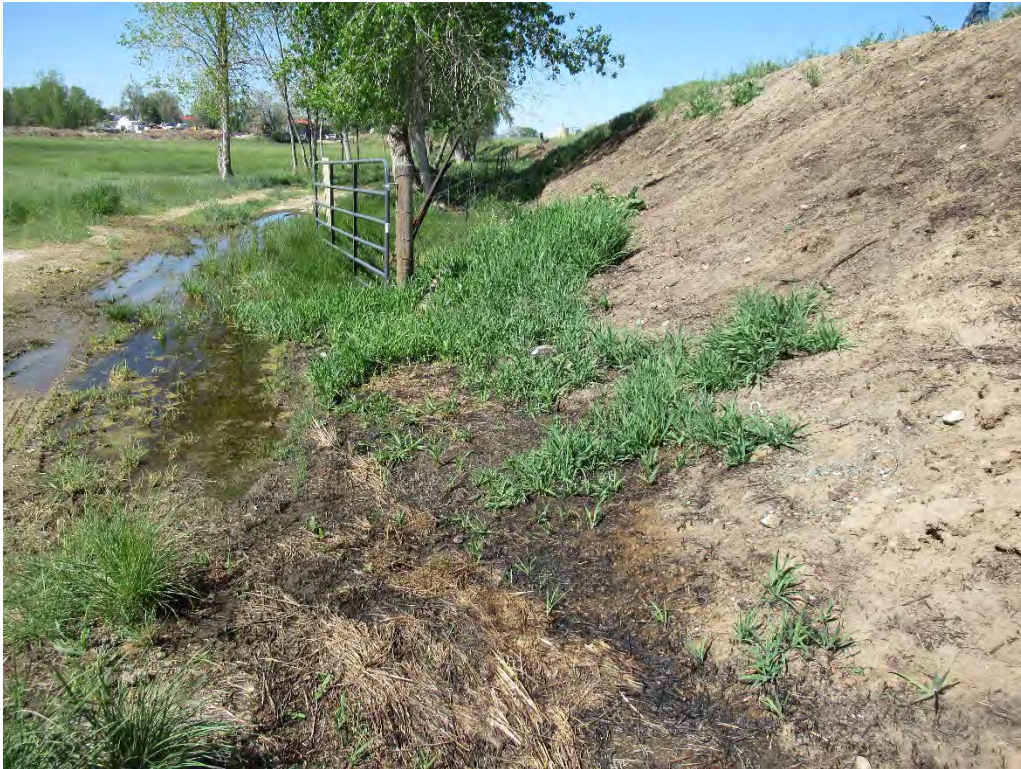
Water as observed seeping from the base of the ditch, approximately one (1) to two (2) feet from the ground elevation, along the south side of the ditch. Puddles of standing water were observed next to the ditch and adjacent to a dirt road. Mr. Lousberg stated the ditch has seeped water in the past, but not to this extent.

During the inspection, Mr. Vidal stated the ditch company was sending the maximum allowed flow of 17 CFS through the ditch. The Ditch Company typically runs the ditch at 10 CFS at this time of year.

Based on the observations from this inspection and information regarding additional water being sent through the ditch by the Ditch Company earlier than usual. The Division does not believe sufficient evidence exists to conclude the mining operation is causing the ditch water to seep out of the base of the ditch embankment.

View of seepage from ditch at curve in the ditch looking west

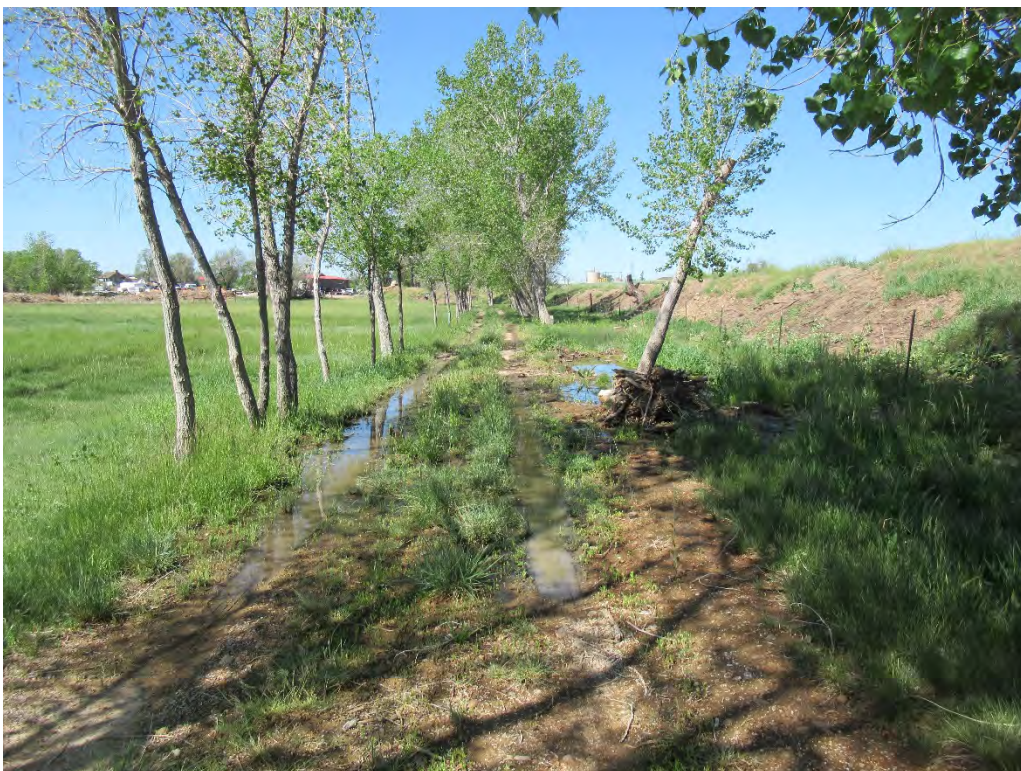
View of seepage from ditch looking west

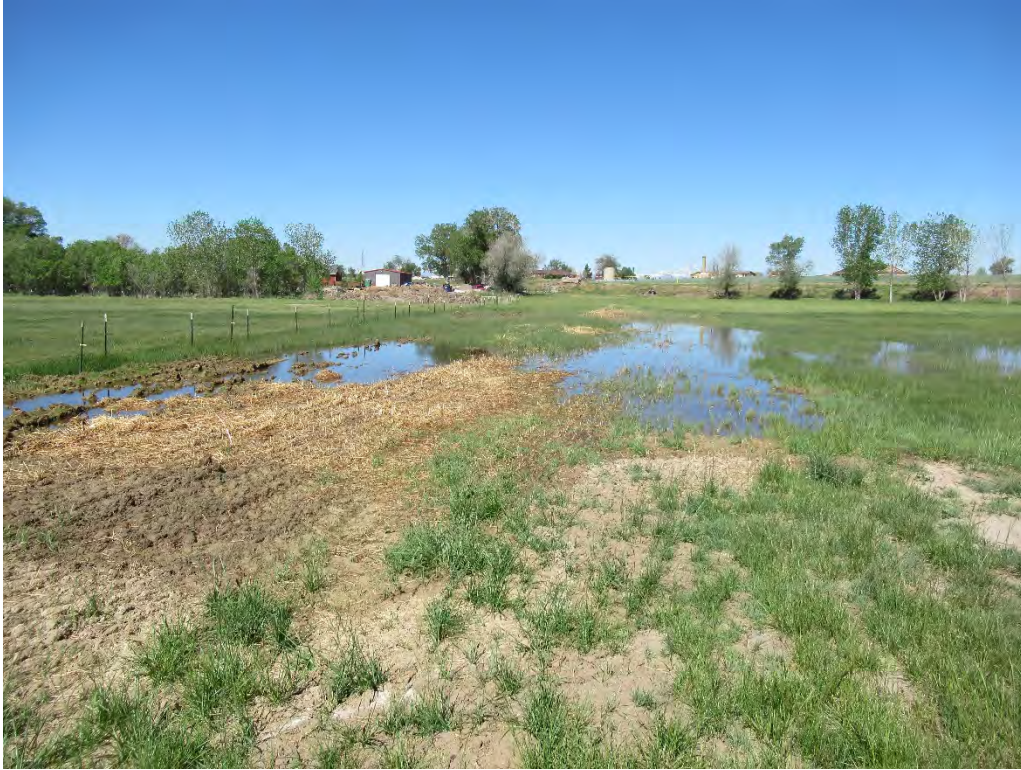
Water was observed in the southern portion of the south field during the inspection. A pond area containing several inches of water along with wetland vegetation, soft rushes, were observed during the inspection. Mr.

Lousberg stated the field ponds water in the summer, but not typically during this time of year.

The Division does not believe sufficient evidence exists to conclude the mining operation is causing the ponding water in the south field of the Lousberg property based on the landowner's comments, the presence of establish wetland vegetation in the field, the presence of the slough between the slurry wall and the Lousberg property to relieve the groundwater mounding effect and the Google Earth images of ponded/saturated conditions in the field historically. Additionally, the field located between the Lousberg south field and the slough was dry at the time of the inspection, which the Division would expect to be saturated if groundwater levels were higher than the typical seasonal elevations.

View of ponded water in Lousberg south field from the southeast corner of field looking west

The Division will continue to require the Operator to collect and report the groundwater elevation data to the Division with the annual report. During the inspection, the Operator stated a survey crew would be on-site in a few weeks to survey the slurry wall. The Division recommends the elevation of the Lousberg south field be surveyed to allow the groundwater data collected at MW-RS to be correlated with the field elevation.

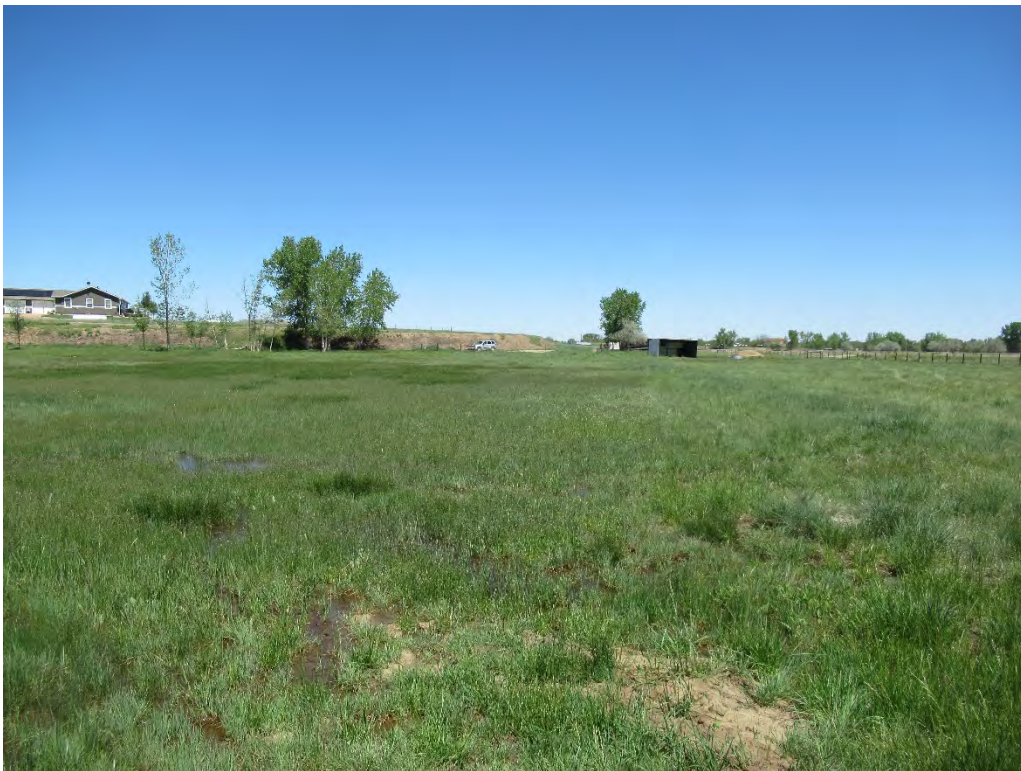
View of ponded water in Lousberg south field from the southeast corner of field looking north

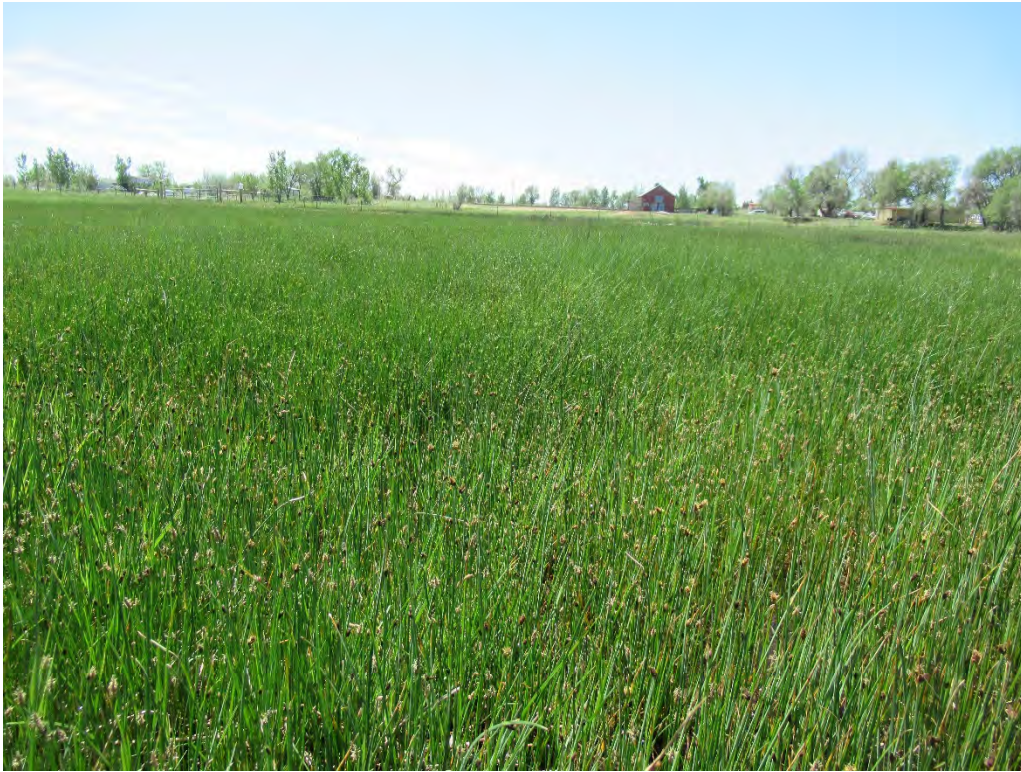
The presence of the wetland vegetation indicates the field has been saturated over the past few years, since the rush species would typically take several years to establish to the extent observed during the inspection.

View of wetland vegetation in Lousberg south field looking south

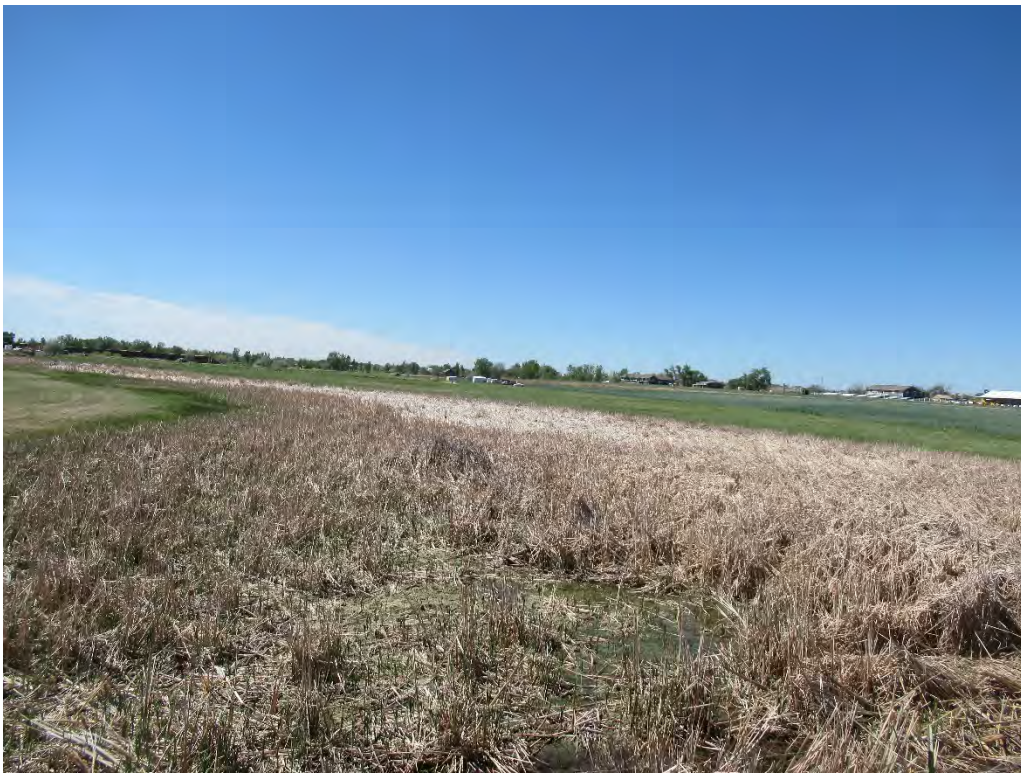
View of slough from the access road looking south

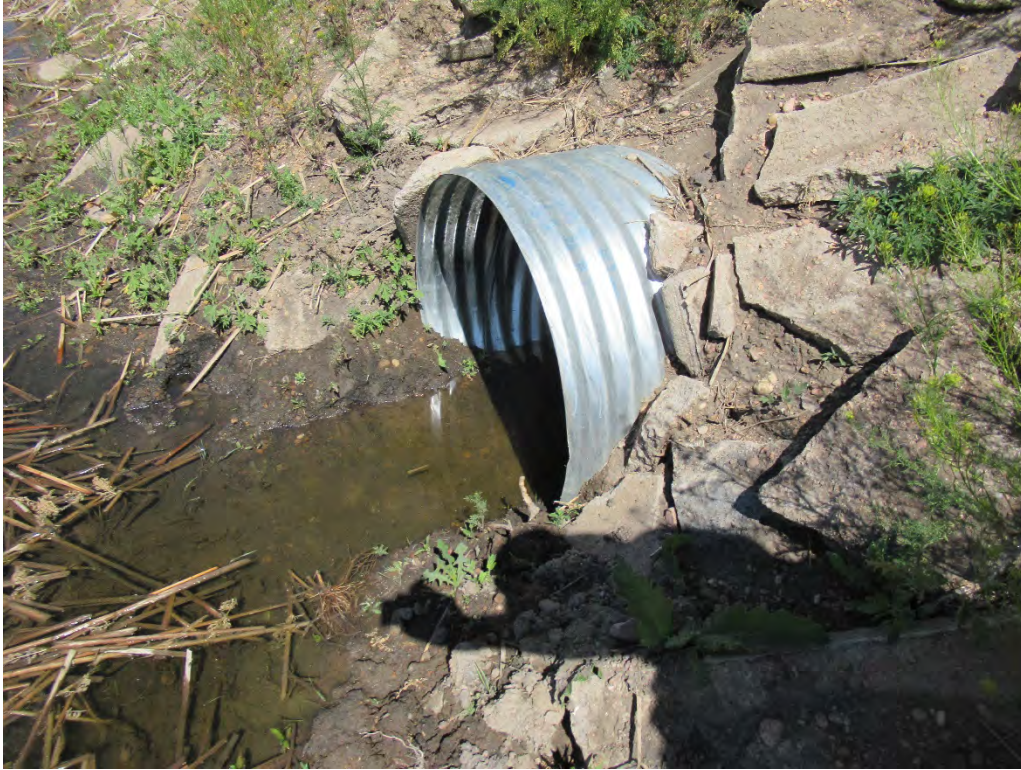
The culverts associated with the access road were observed during the inspection. One (1) thirty-six (36) inch diameter culvert was observed at approximately the middle of the slough under the access road. The culvert appeared to be functioning properly. The Operator has installed a ditch from the east side of the slough to the west end of the access road to allow water to flow to the west from the slough. Two (2) twenty (20) inch diameter HDPE pipes were observed at the end of the access road. Ponded water was observed on both sides of the culverts inlets and outlets. The culverts were estimated to be seventy-five (75) percent full and appeared to be undersized for the amount of water required to be conveyed under the west end of the access road.

View of the 36" diameter culvert inlet

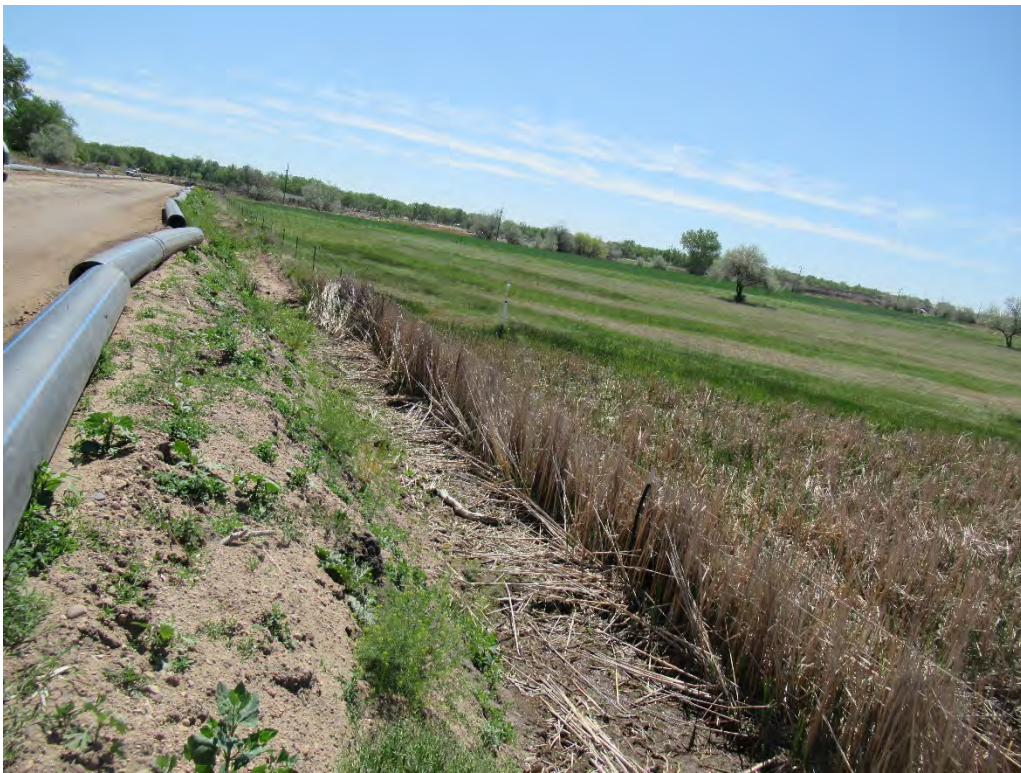
View of ditch along south side of access road from the 36" culvert looking east

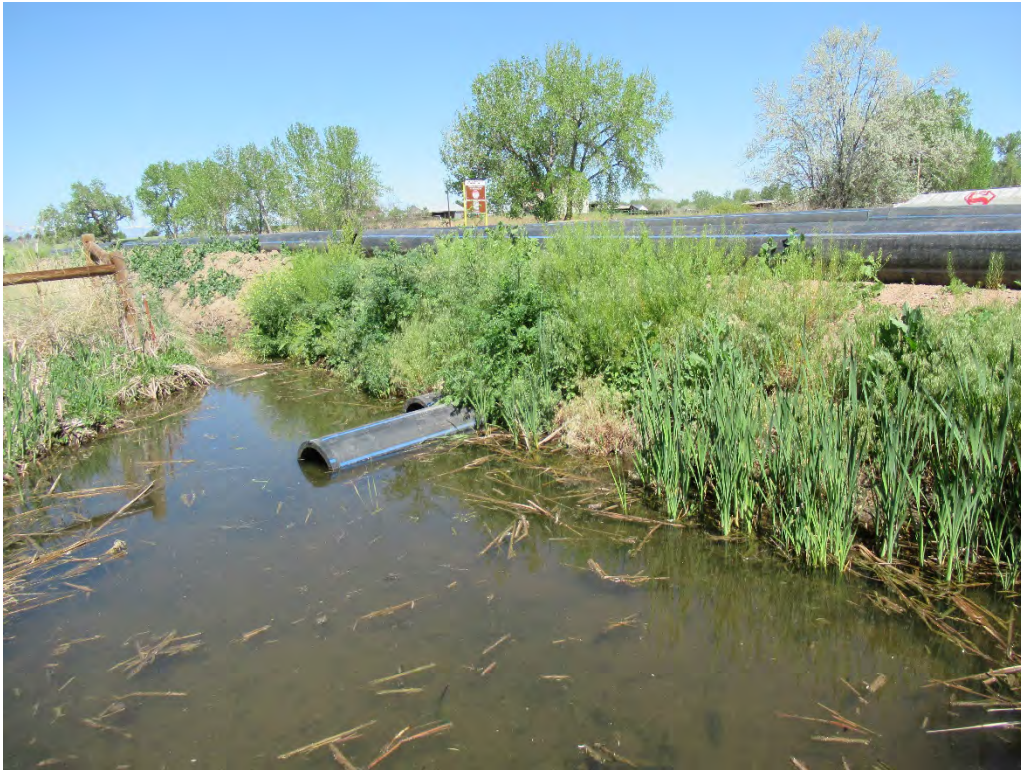
**PROBLEM:** The complainant is concerned the one (1) 36" CMP culvert in the middle of the access road and the two (2) 20" HDPE culverts are not adequately sized for a 100-year rainfall event.

View of the inlets for the 2-20" culverts

**CORRECTIVE ACTIONS:** Please provide a hydrologic analysis showing the 100-year, 24-hour storm rainfall-runoff results (including support for the selected storm depth and runoff parameter selection such as SCS curve numbers). The analysis must include pond routing, if appropriate, and culvert sizing analyses with the proper consideration given to tailwater conditions (especially for the two 20-inch culverts, but likely for the 36-inch culvert as well) for the access road from WCR 23 to the mining operation for Division review.

Additionally, the Division will require the Operator to provide a monitoring and maintenance plan for the culverts to prevent the potential build-up of sediment, vegetation and other debris.

As cited as a problem, the Division will require the Operator to provide a hydrologic analysis for the culverts by the corrective action date. Additionally, the Division will require the Operator to provide a monitoring and maintenance plan for the culverts to prevent the potential build-up of sediment, vegetation and other debris.

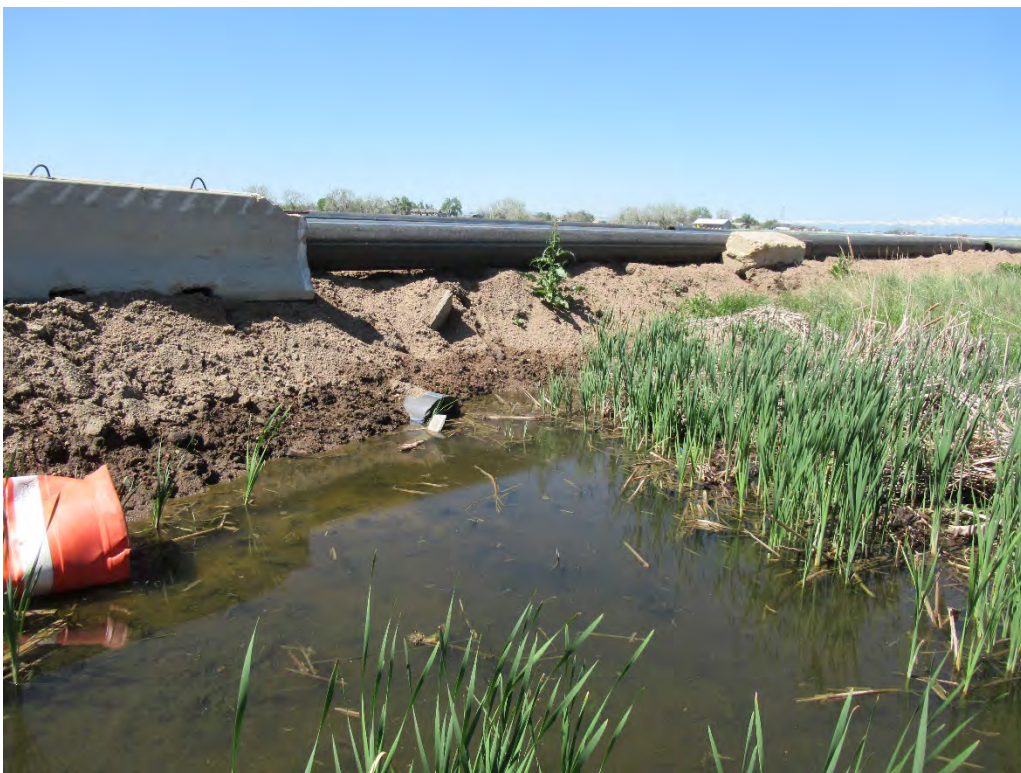
View of the outlets for the 2-20" culverts

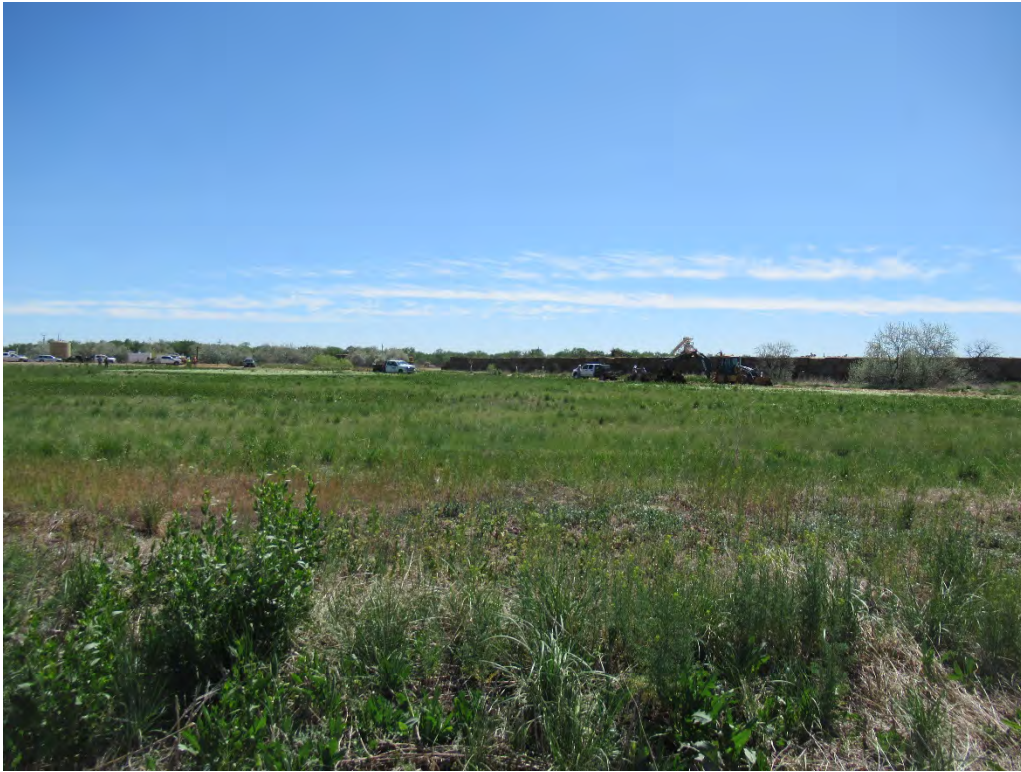
View of field (dry) between Lousberg south field and slough looking east from the fence line between the properties
