MINERALS PROGRAM INSPECTION REPORT

MINE NAME: 5550 Goldfield Rd./Big Johnson Reservoir	MINE/PROSPECTING ID#: M-2020-028	MINERAL: Silt/Sand	COUNTY: El Paso
INSPECTION TYPE: Illegal(Unpermitted Operation)	INSPECTOR(S): Timothy A. Cazier	INSP. DATE: May 29, 2020	INSP. TIME: 8:50
OPERATOR: Fountain Mutual Irrigation Co.	OPERATOR REPRESENTATIVE: Gary Steen	TYPE OF OPERATION: IM - Is it Mining	
REASON FOR INSPECTION: Citizen Complaint	BOND CALCULATION TYPE: None	BOND AMOUNT: No Bond Held	
DATE OF COMPLAINT: May 6, 2020	POST INSP. CONTACTS: None	JOINT INSP. AGENCY: None	
WEATHER: Clear	INSPECTOR'S SIGNATURE:

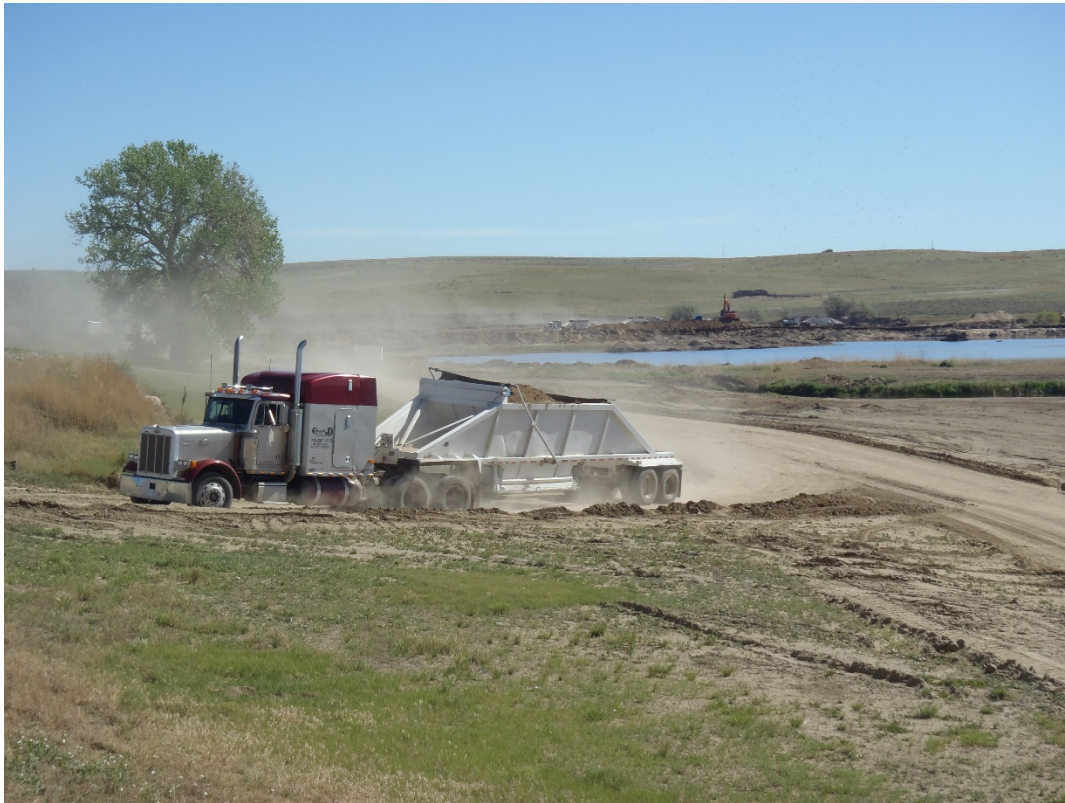
Photo 1. Typical contractor haul truck – leaving site (looking north).

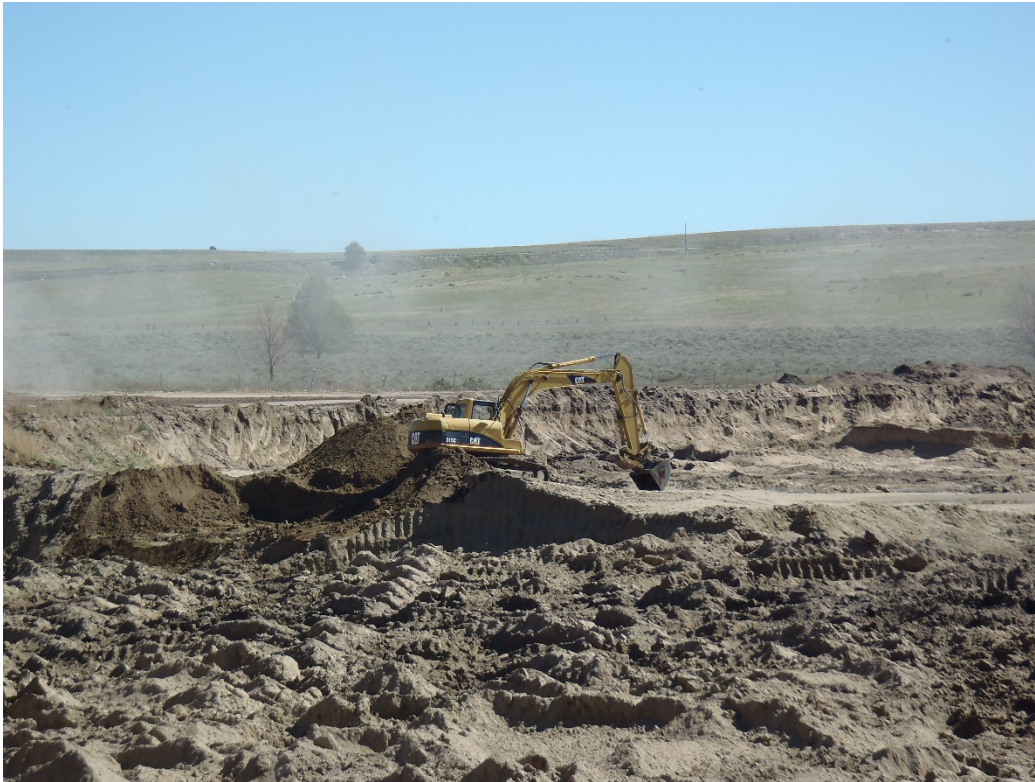
Photo 2. Contractor track hoe in excavation area (looking NE).

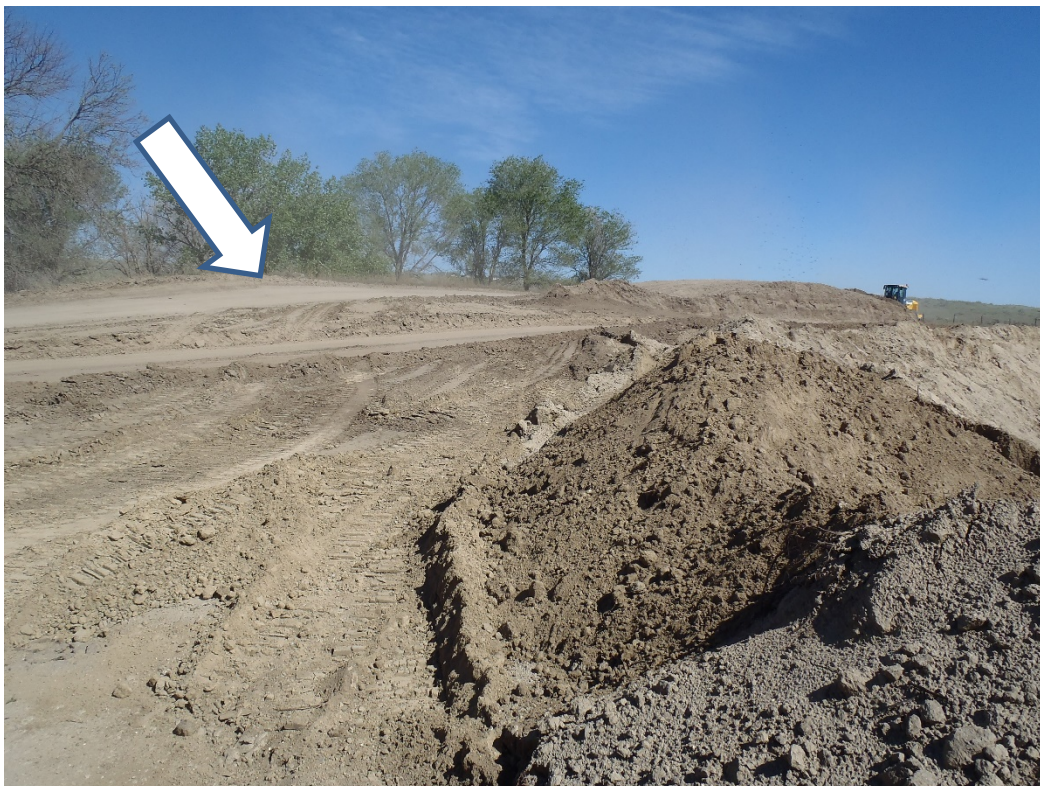
Photo 3. Topsoil stockpile (part of haul road, looking north).

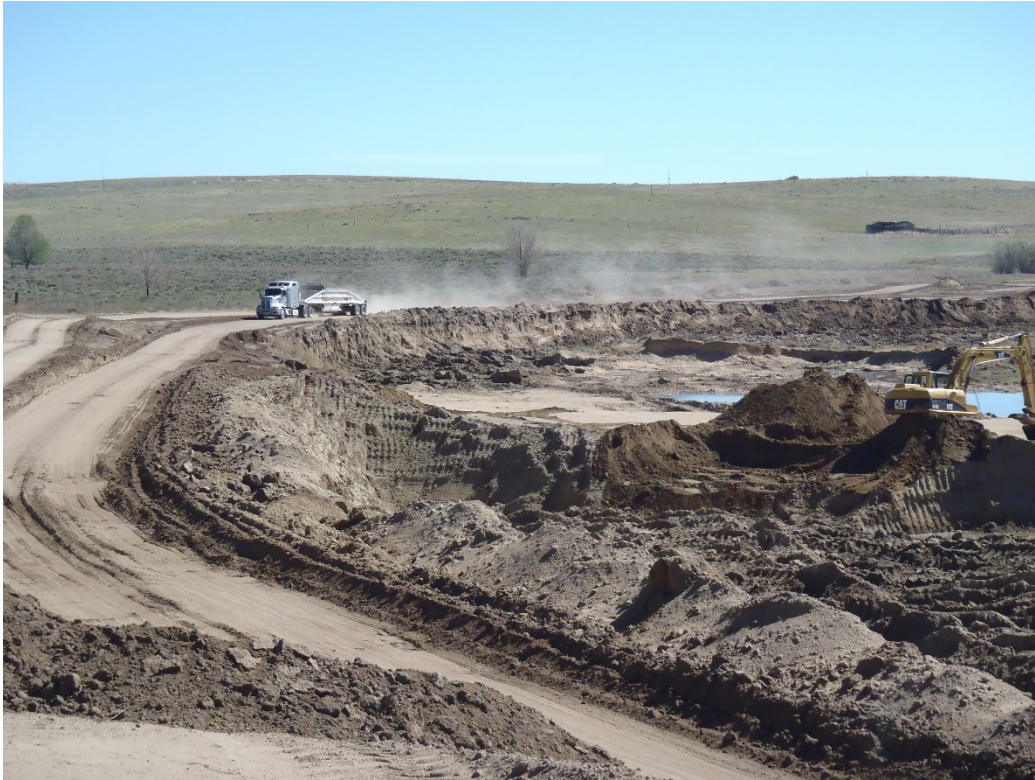
Given the haul truck traffic on the west (see **Photo 4**) and the reservoir being refilled on the east (see **Photo 5**), it was unsafe and impractical to use a GPS to determine the excavation area. Subsequent to the inspection, a more recent Google Earth image from 10/6/2019 became available (see **Post Inspection Map**). This image showed 18 acres had been affected as part of the excavation as of that date. Based on Mr. Steen's estimate of an average excavation depth of 8 feet and an excavated volume of 435,600 CY, the DRMS estimated 33.74 acres to have been affected.

Photo 4. Haul road on west side and typical excavation area – note reservoir water on right (looking NE).

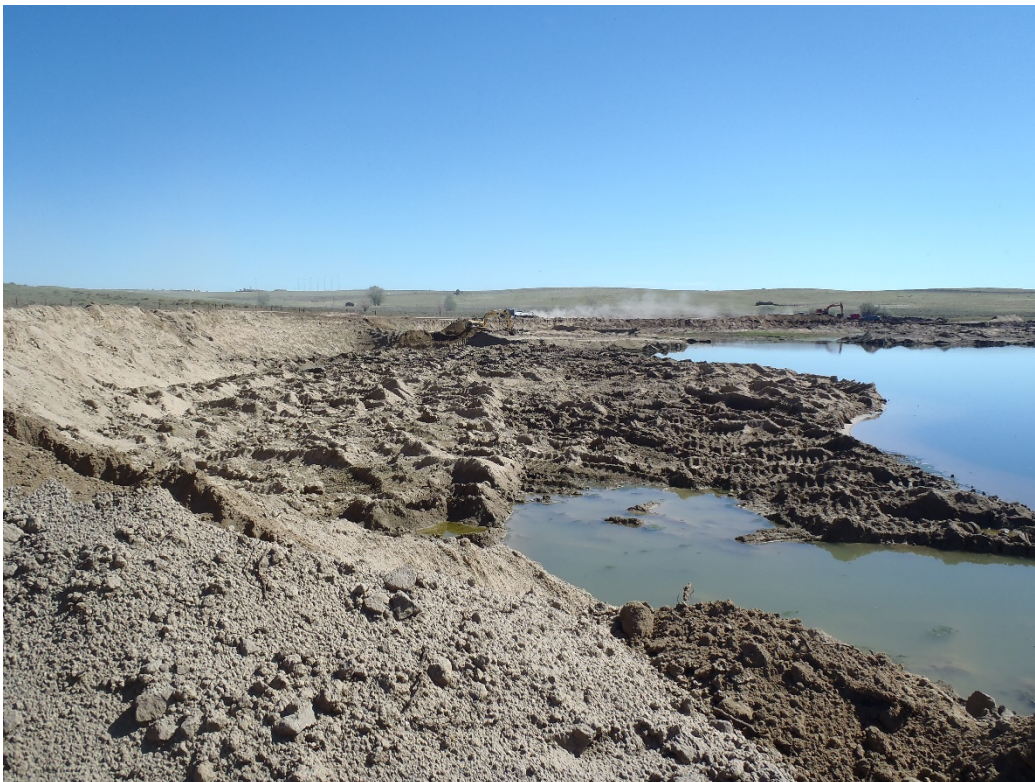
Photo 5. Reservoir beginning to flood excavation area (looking NE).
