## MINERALS PROGRAM INSPECTION REPORT

<b>MINE NAME:</b> Carrizo Stone South	<b>MINE/PROSPECTING ID#:</b> M-2006-024	<b>MINERAL:</b> Sandstone (silica, st quartzite)	<b>COUNTY:</b> Baca
<b>INSPECTION TYPE:</b> Monitoring	<b>INSPECTOR(S):</b> Daniel Cunningham	<b>INSP. DATE:</b> June 1, 2020	<b>INSP. TIME:</b> 12:00
<b>OPERATOR:</b> Carrizo Stone, LLC	<b>OPERATOR REPRESENTATIVE:</b> Ray Sikes	<b>TYPE OF OPERATION:</b> 110c - Construction Limited Impact	
<b>REASON FOR INSPECTION:</b> Normal I&E Program	<b>BOND CALCULATION TYPE:</b> Complete Bond	<b>BOND AMOUNT:</b> \$15,000.00	
<b>DATE OF COMPLAINT:</b> NA	<b>POST INSP. CONTACTS:</b> None	<b>JOINT INSP. AGENCY:</b> None	
<b>WEATHER:</b> Clear	<b>INSPECTOR'S SIGNATURE:</b>

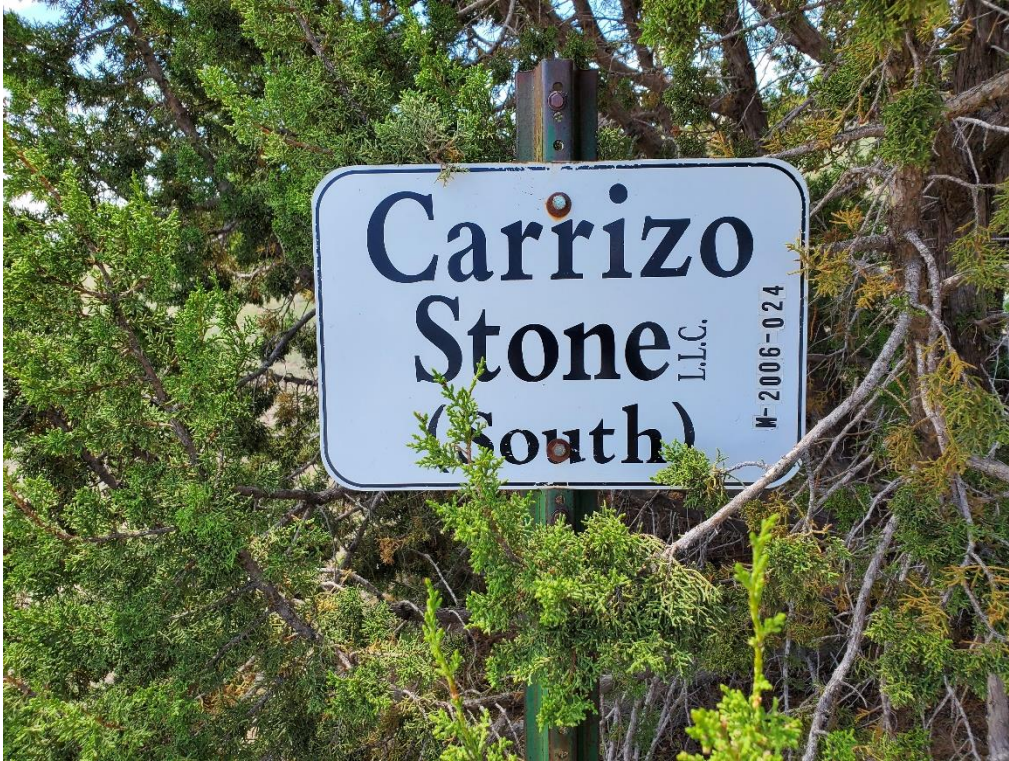
Photo 1; Entrance Sign

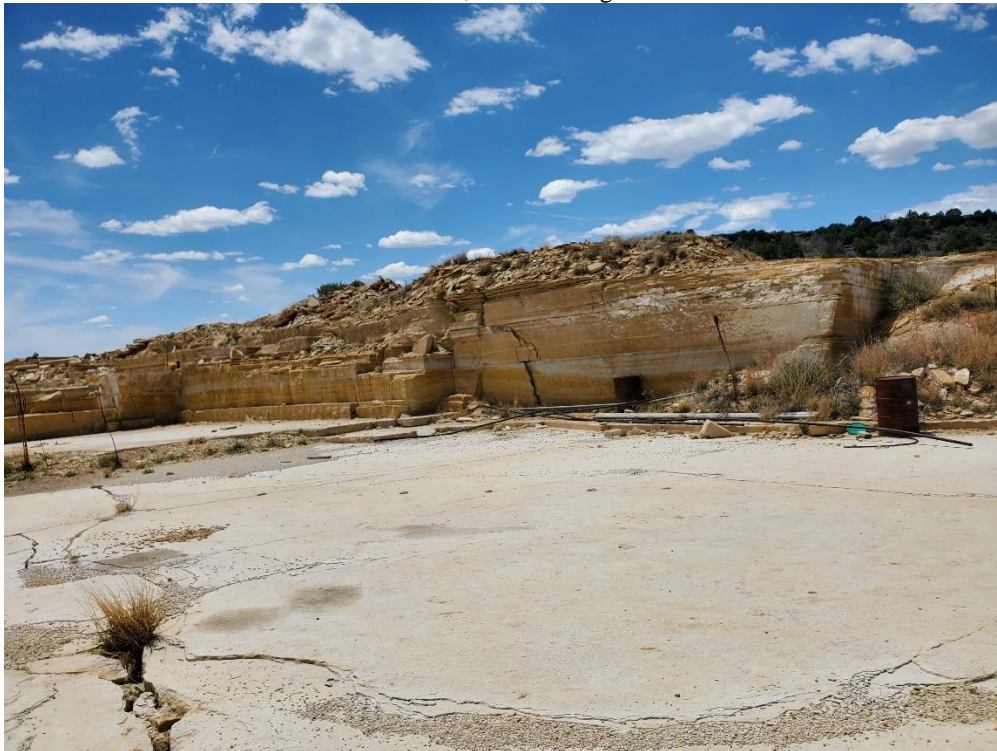
Photo 2; Highwall

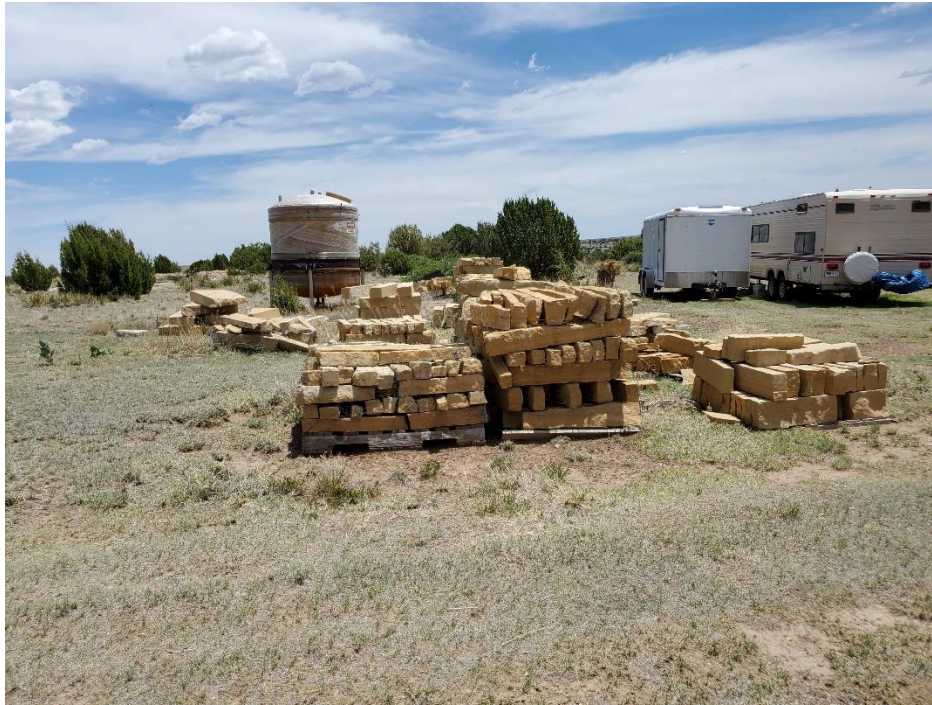
Photo 3: Stockpiles

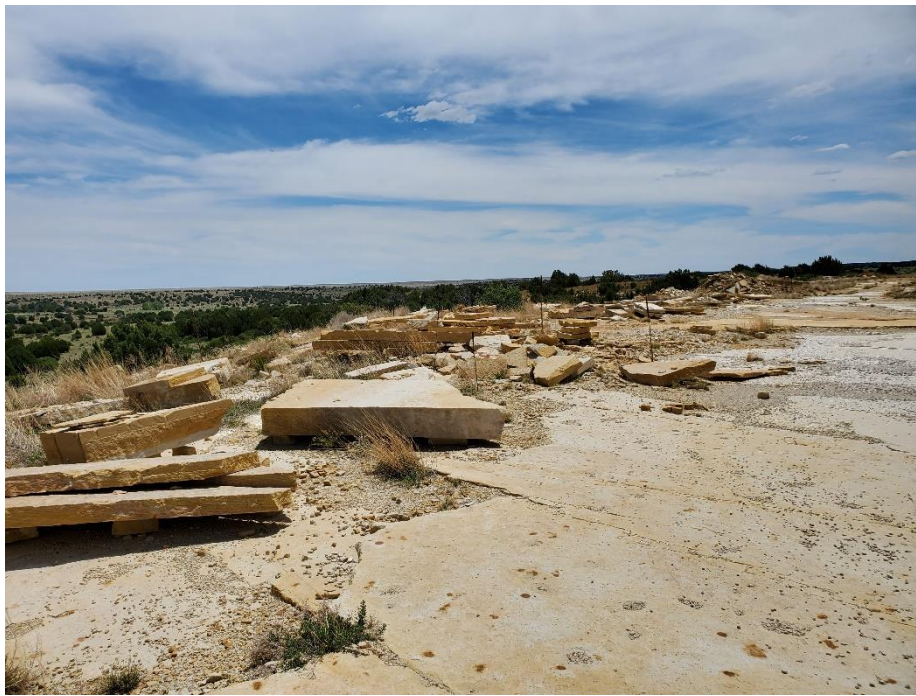
Photo 4; East side of Permit
