MINERALS PROGRAM INSPECTION REPORT

MINE NAME: Carrizo Stone North	MINE/PROSPECTING ID#: M-2005-067	MINERAL: Sandstone (silica, st quartzite)	COUNTY: Baca
INSPECTION TYPE: Monitoring	INSPECTOR(S): Daniel Cunningham	INSP. DATE: June 1, 2020	INSP. TIME: 13:00
OPERATOR: Carrizo Stone, LLC	OPERATOR REPRESENTATIVE: Ray Sikes	TYPE OF OPERATION: 112c - Construction Regular Operation	
REASON FOR INSPECTION: Normal I&E Program	BOND CALCULATION TYPE: Complete Bond	BOND AMOUNT: \$41,386.00	
DATE OF COMPLAINT: NA	POST INSP. CONTACTS: None	JOINT INSP. AGENCY: None	
WEATHER: Clear	INSPECTOR'S SIGNATURE:

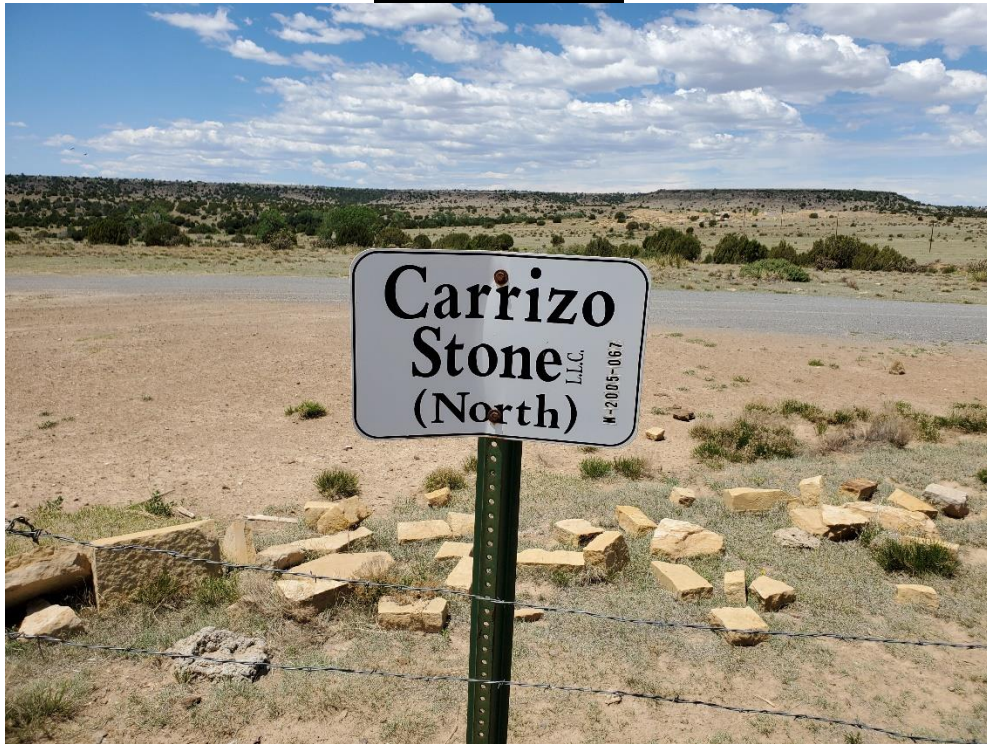
Photo 1: Entrance Sign

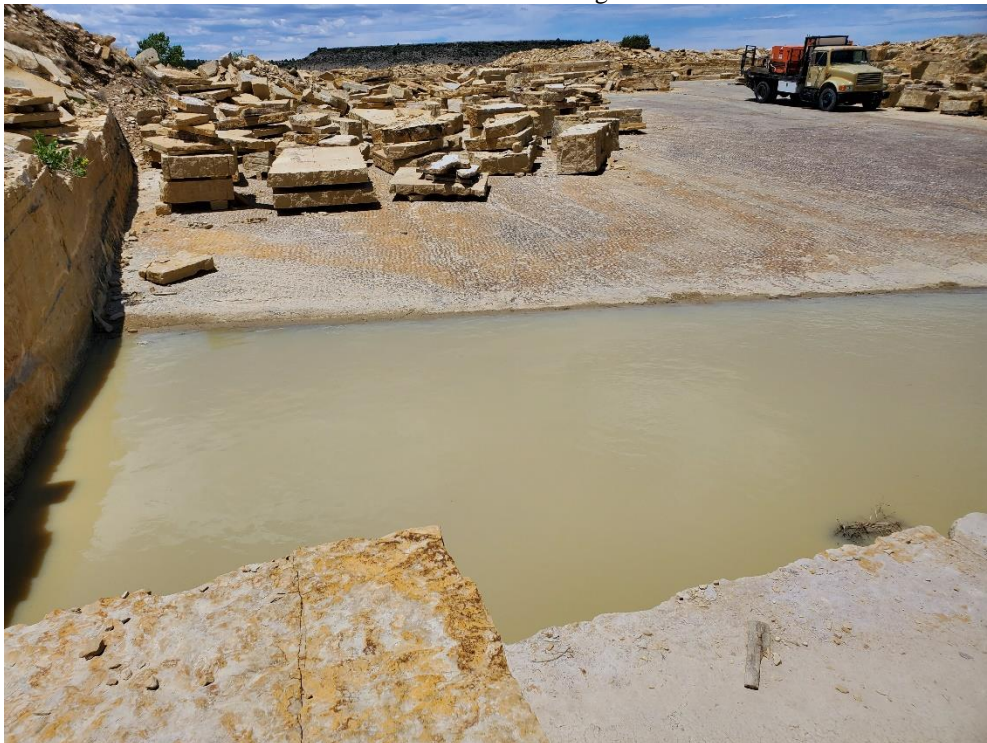
The site identification sign was posted at the mine entrance and the permit boundary were marked. No erosional issues were noted during the inspection. Topsoil was being stored on site. During the inspection, standing water was noted at the bottom of the mining area. Mr. Sikes stated that they have a pump on site to remove the water, however at this time it was down for maintenance. At this time the Division does not feel there is a problem with the standing water. However, if during the next inspection standing water is again seen on site, it will be noted as a possible problem or violation.

Photo 2: Standing Water

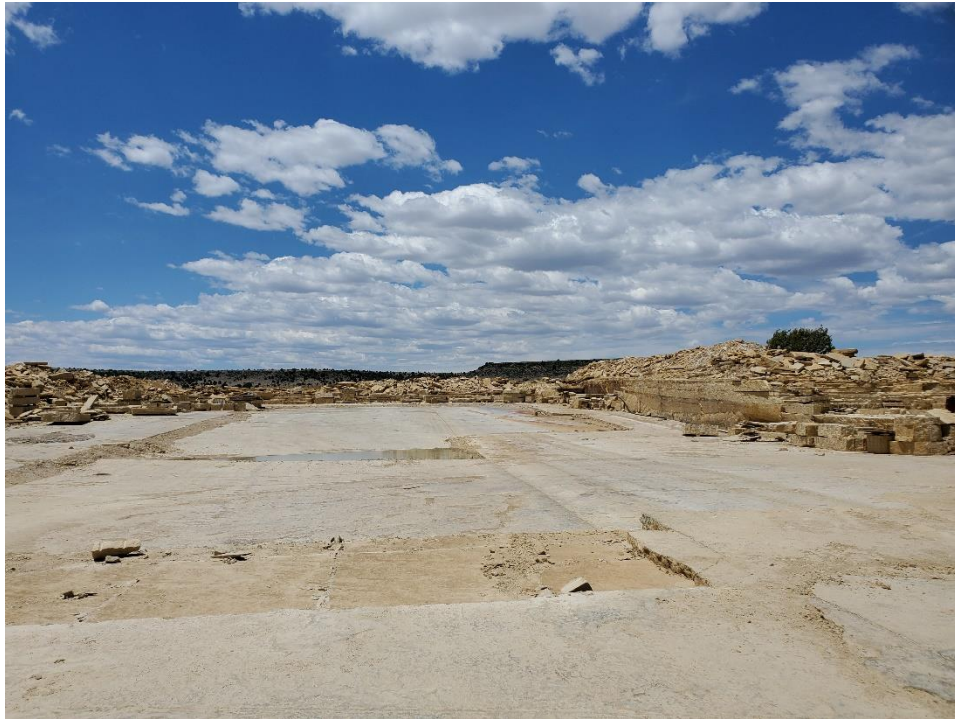
Photo 3: East side of pit floor

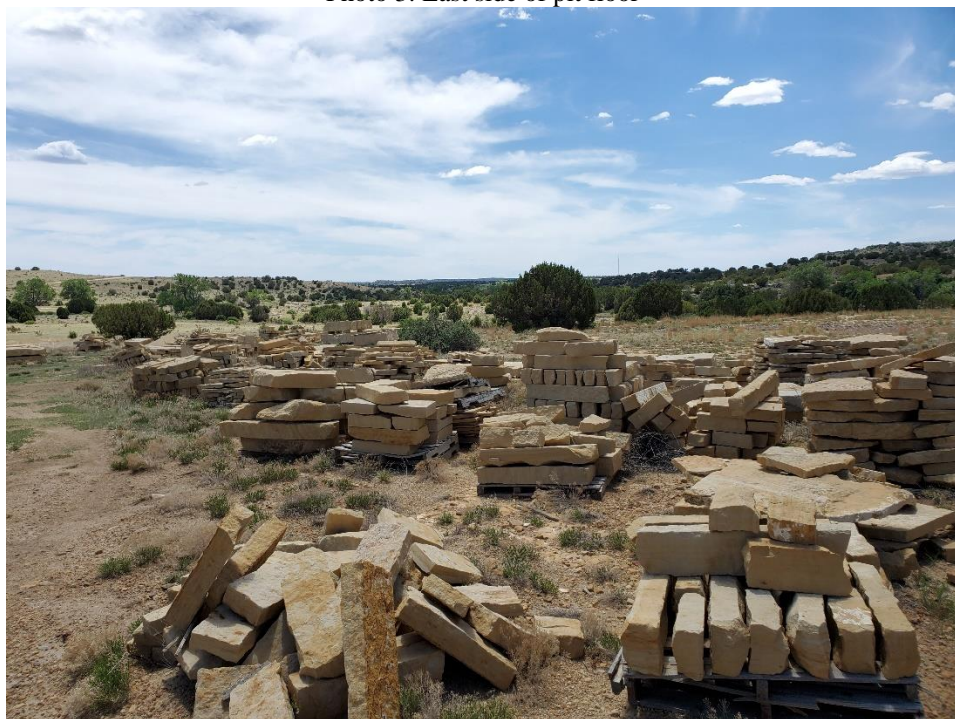
Photo 4: Stockpiles
