MINERALS PROGRAM INSPECTION REPORT

MINE NAME: CEMEX Sandstone Quarry	MINE/PROSPECTING ID#: M-1977-361	MINERAL: Sandstone (silica, stone, quartzite)	COUNTY: Boulder
INSPECTION TYPE: Monitoring	INSPECTOR(S): Amy Eschberger	INSP. DATE: June 3, 2020	INSP. TIME: 13:00
OPERATOR: CEMEX, Inc.	OPERATOR REPRESENTATIVE: Cita Cisse, Uwe Lubjuhn, Robin Bay	TYPE OF OPERATION: 110c - Construction Limited Impact

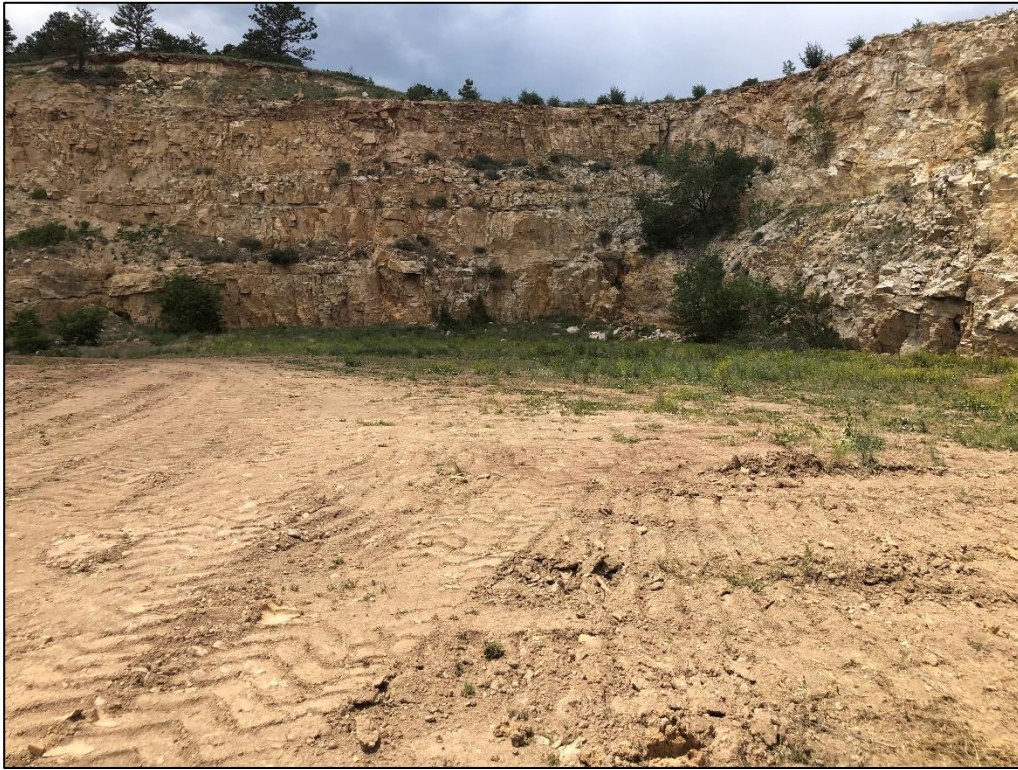
Photo 1. View looking west across top of backfilled northern portion of pit.

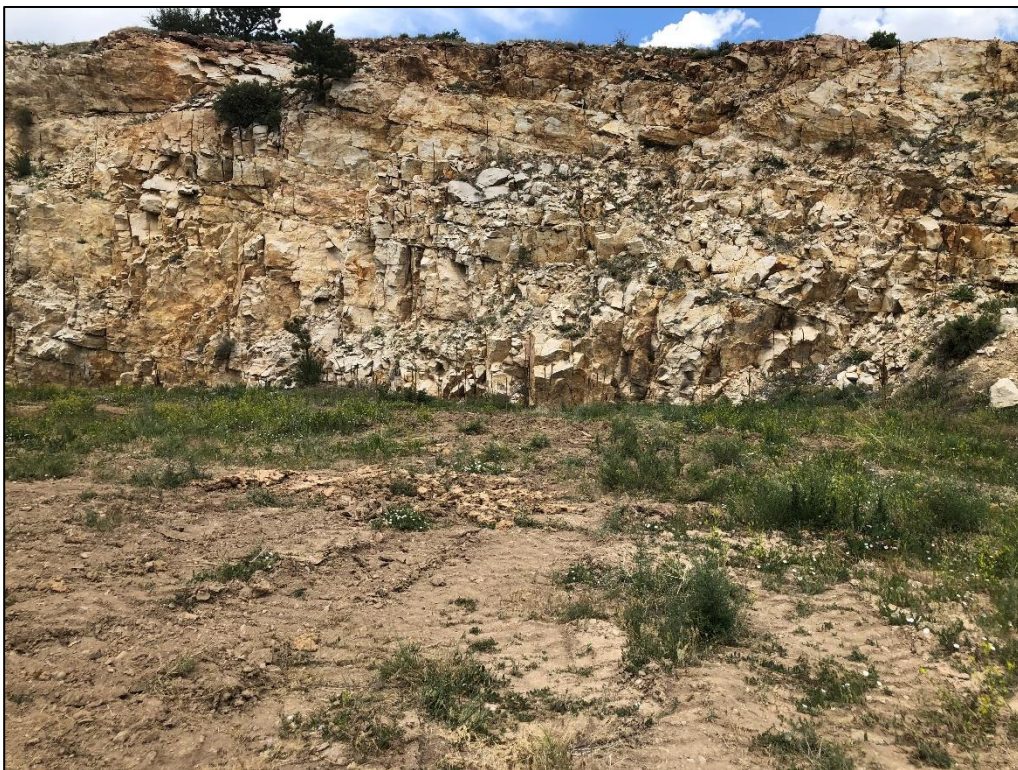
Photo 2. View looking north at northern pit wall with slopes of approximately 0.5H:1V.

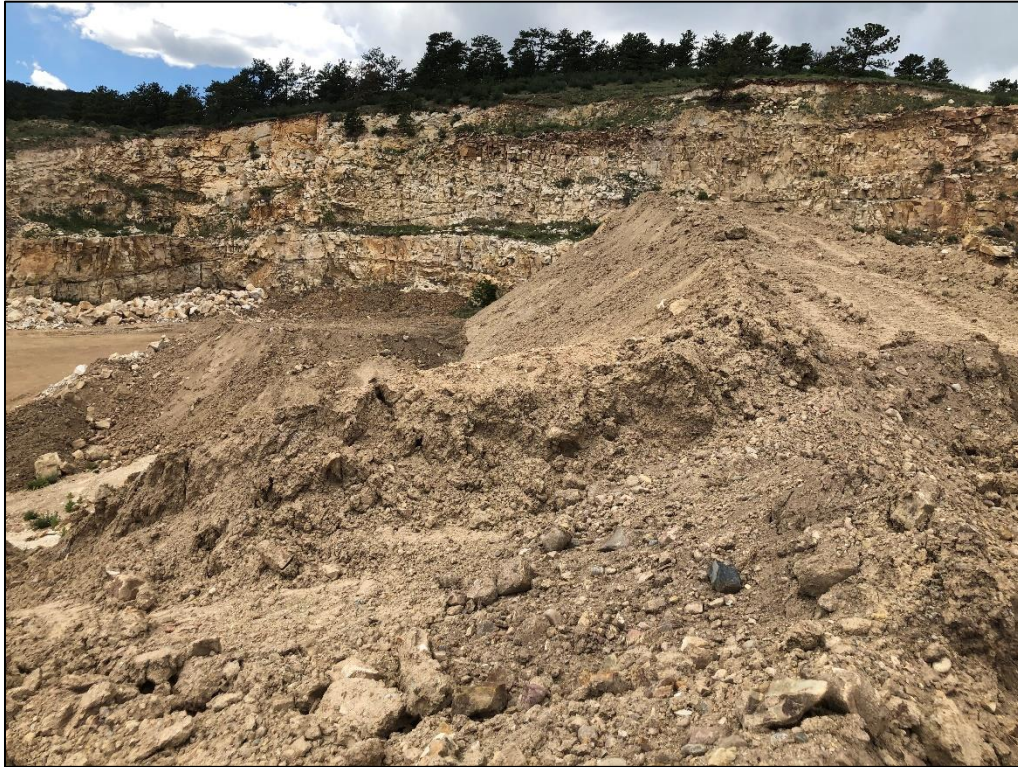
The Division observed the northern portion of the pit where imported backfill was placed in accordance with TR-2. This area has been graded nearly flat with a gentle southward slope. Additional backfill material has been placed at the southern edge of this area since the Division's last inspection. For final reclamation, this material will be pushed southward across the pit floor to create the approved final gradient to the southeast for positive drainage. The two existing topsoil stockpiles remain at the southwestern and southeastern edges of the pit, and have not yet been relocated to the northern backfilled portion of the pit per TR-4. These stockpiles are stable with good grass cover. The pit floor was dry during the inspection. No significant erosion issues were observed.

Photo 3. View looking west across northern portion of pit where additional backfill material has been placed since last inspection.

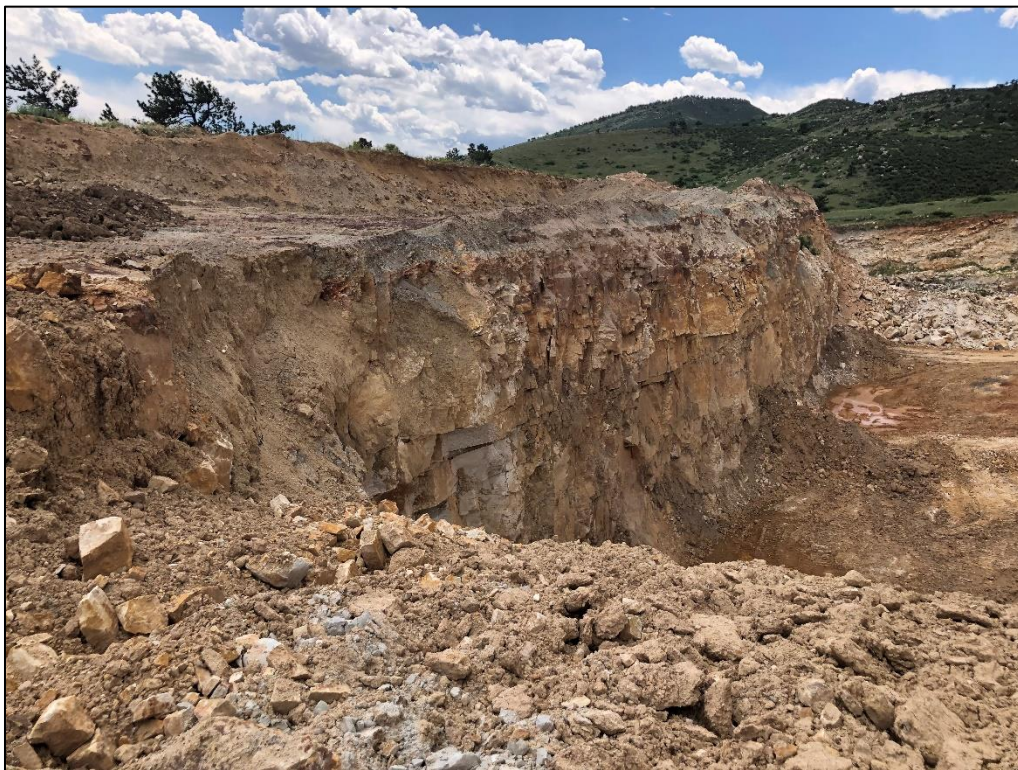
Photo 4. View looking south across eastern pit wall which is currently being mined.

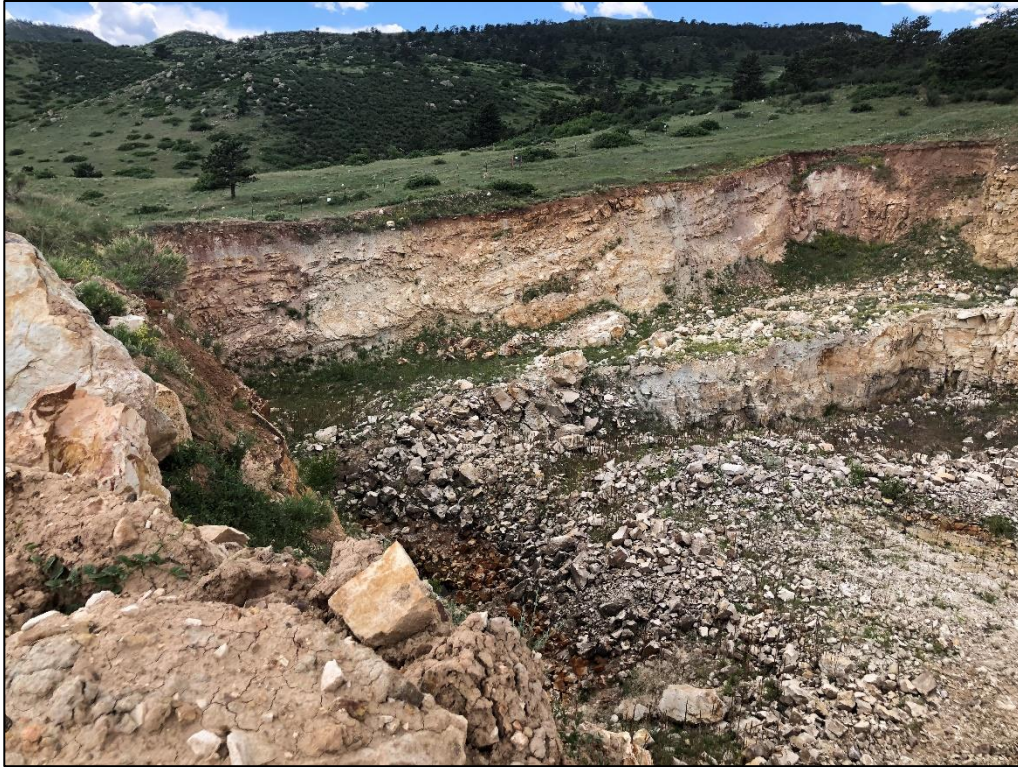
Photo 5. View looking south at southern pit wall with mostly 0.5H:1V slopes.

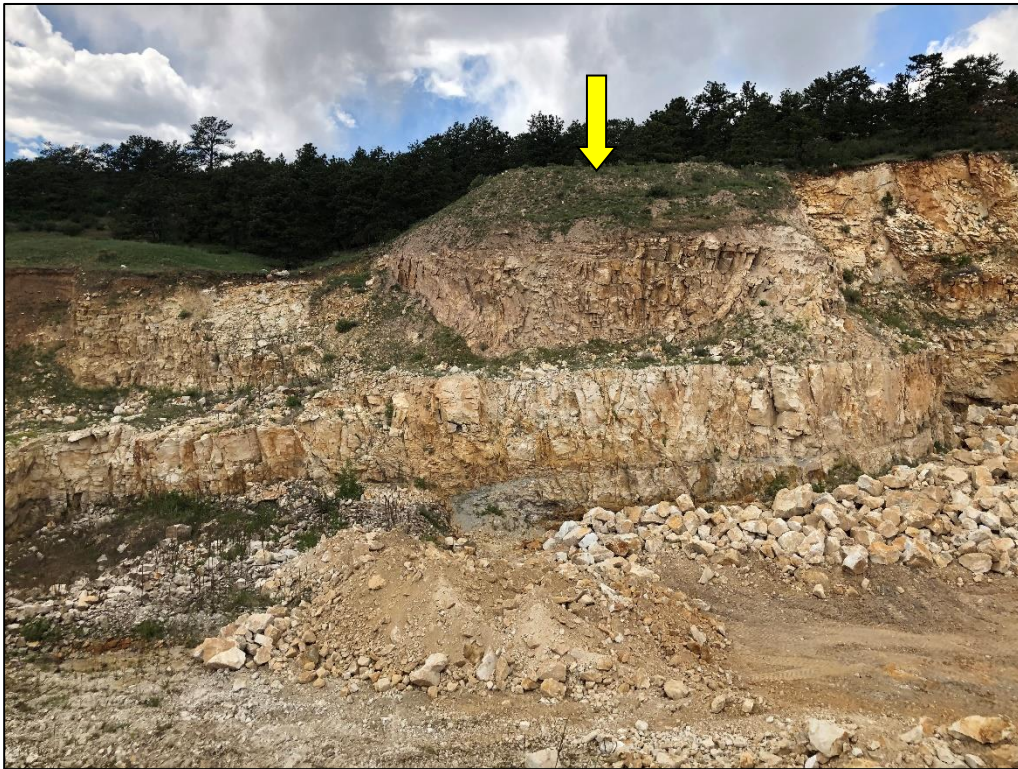
Photo 6. View looking west at western pit wall with mostly 0.5H:1V slopes. Note topsoil stockpile stored above highwall (indicated) stable with vegetative cover.

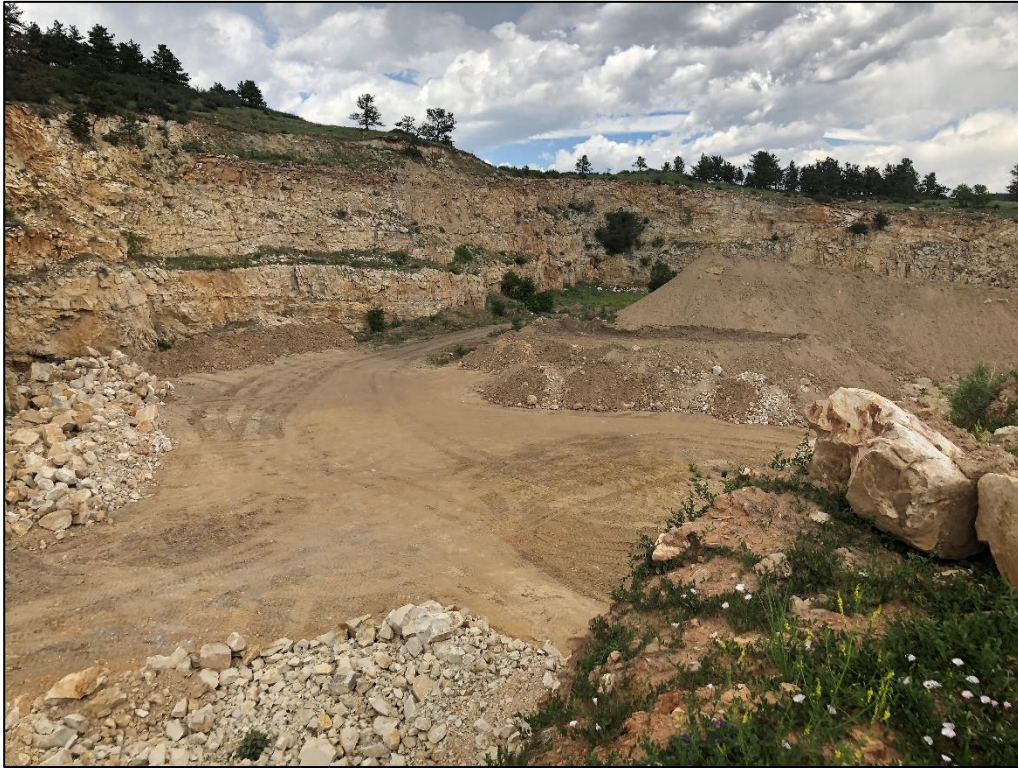
Photo 7. View looking northwest across pit from its southeastern corner. Note backfilled northern portion of pit (in background).

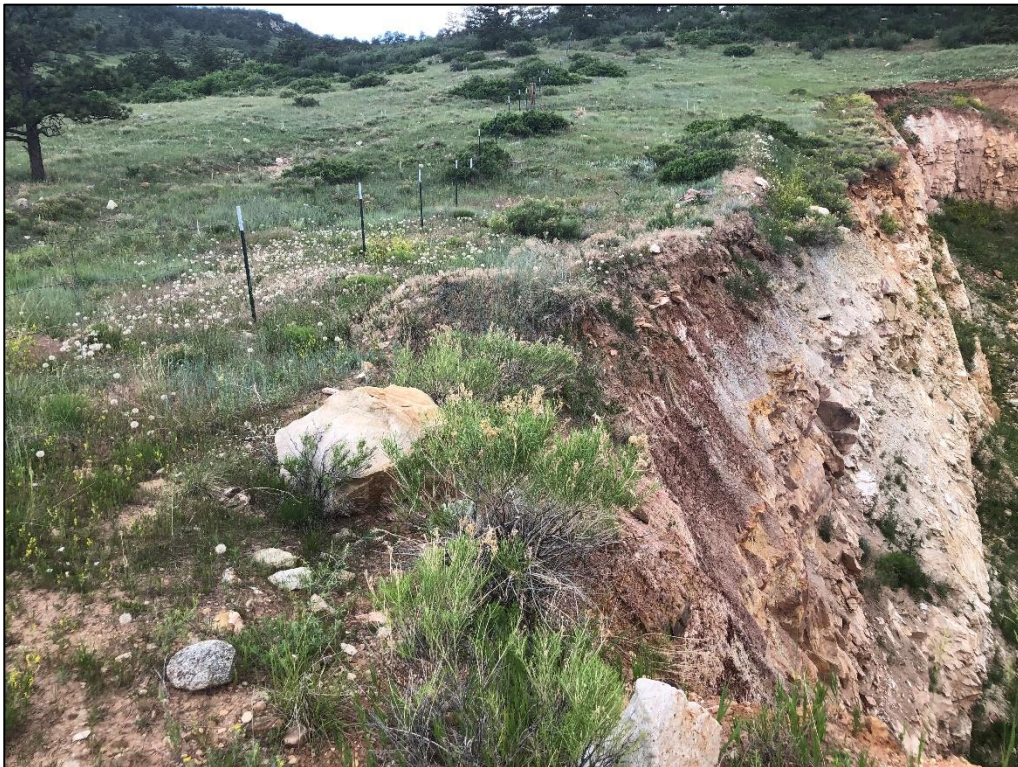
Photo 8. View looking west across southern pit wall (at right), showing barbed wire fence (at left) delineating southern permit boundary.

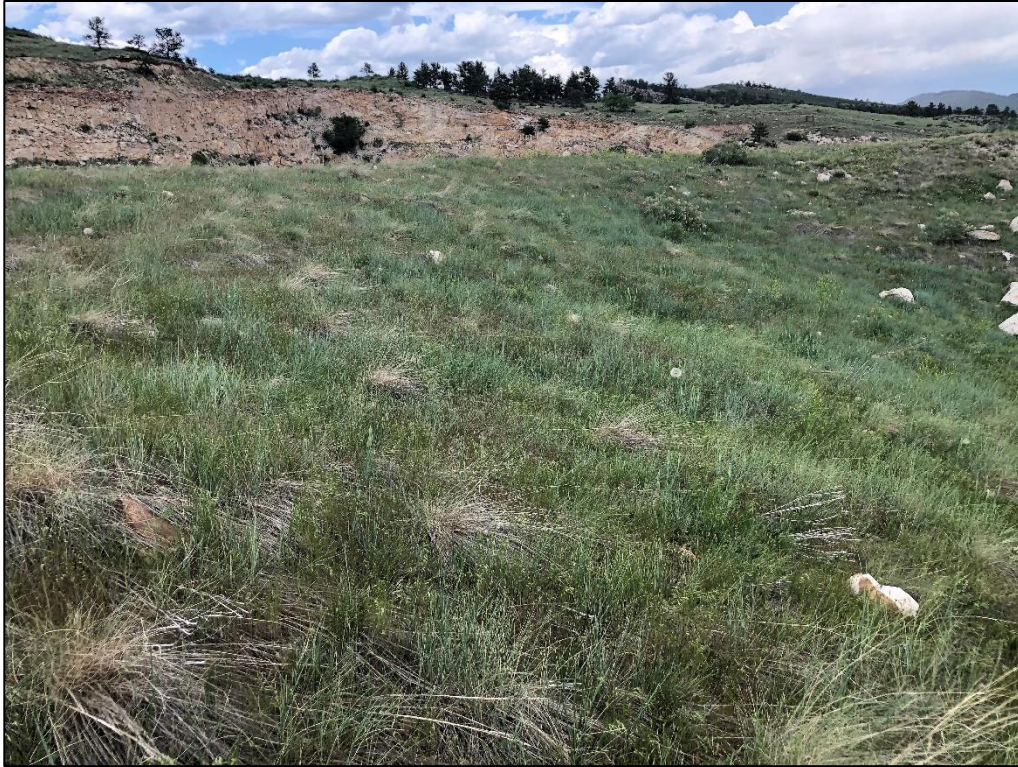
Photo 9. View looking northwest across side of large topsoil stockpile stored at southeastern edge of pit, stable with good grass cover.

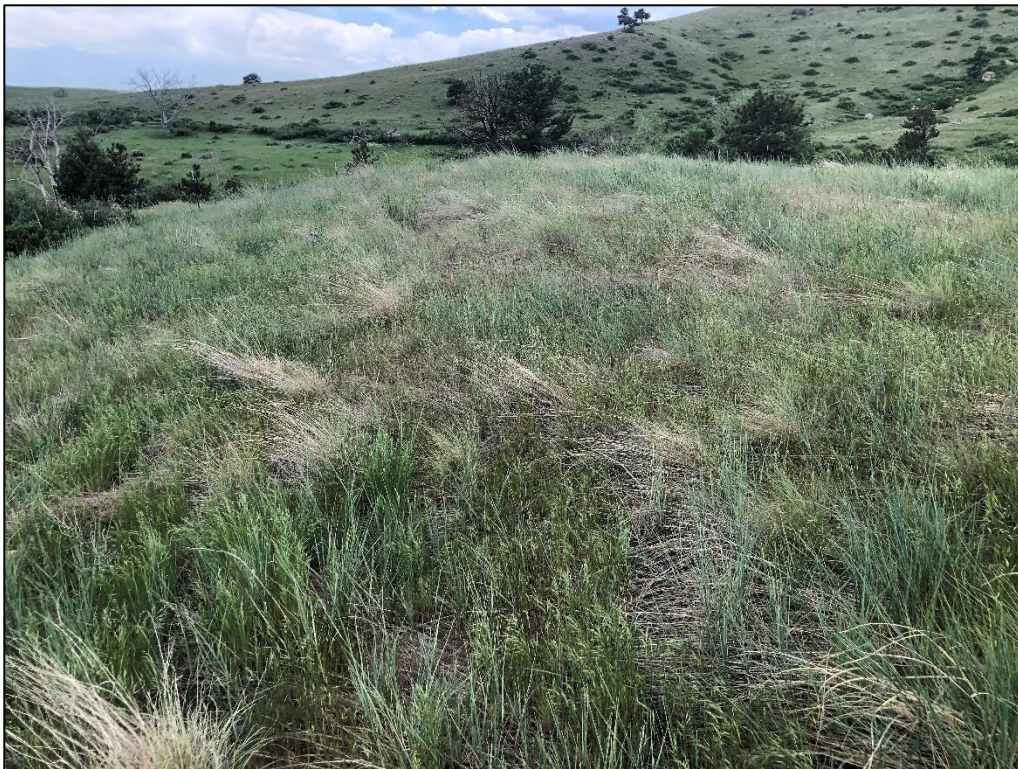
Photo 10. View looking southeast across top of large topsoil stockpile stored at southeastern edge of pit, stable with good grass cover.

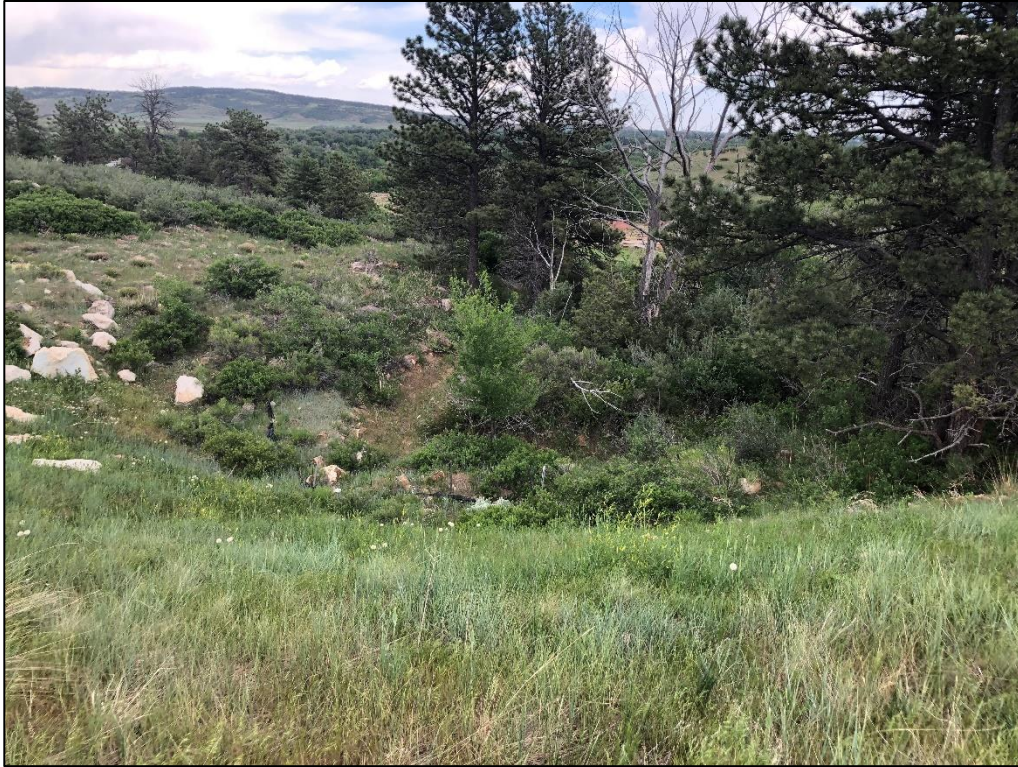
Photo 11. View looking east from top of large topsoil stockpile, showing southeastern portion of permit area where drainage will be constructed for final reclamation.

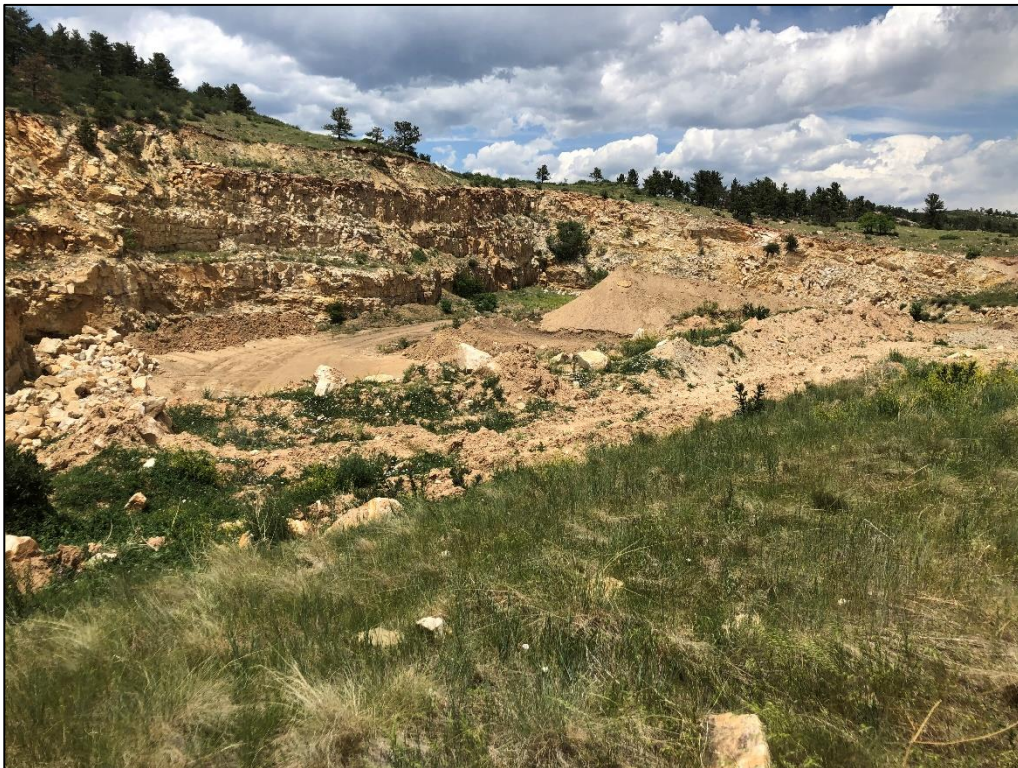
Photo 12. View looking northwest across pit from top of large topsoil stockpile.

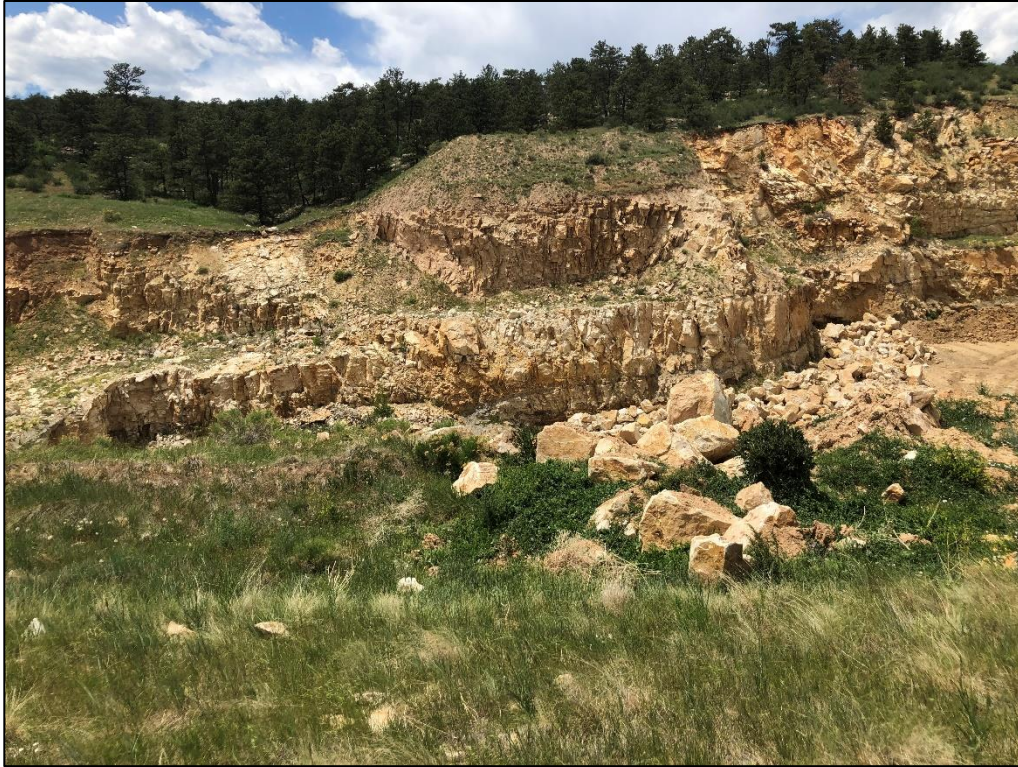
Photo 13. View looking west across pit from top of large topsoil stockpile.

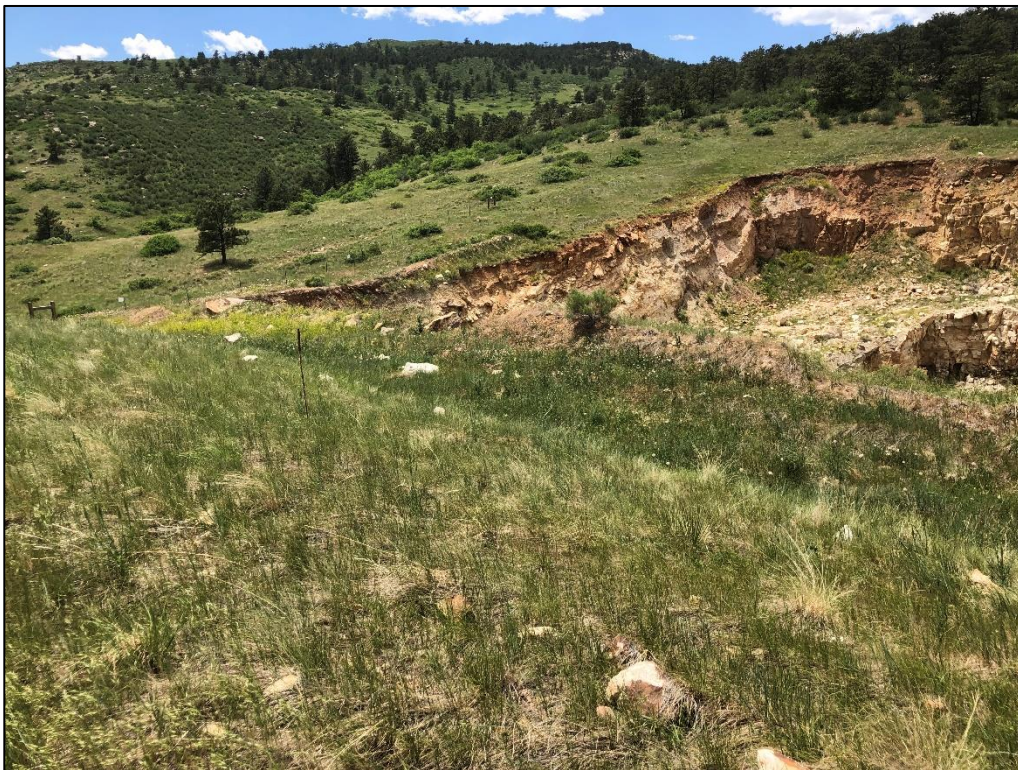
Photo 14. View looking southwest across pit from top of large topsoil stockpile.

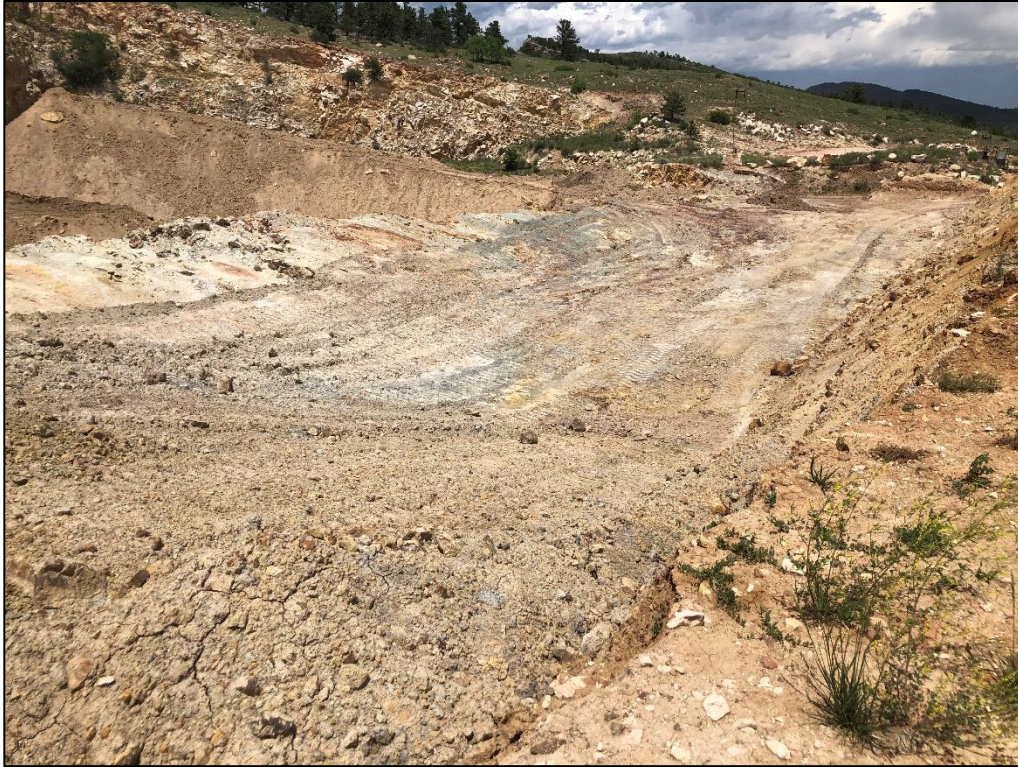
Photo 15. View looking north across area above eastern pit wall stripped in preparation for mining.

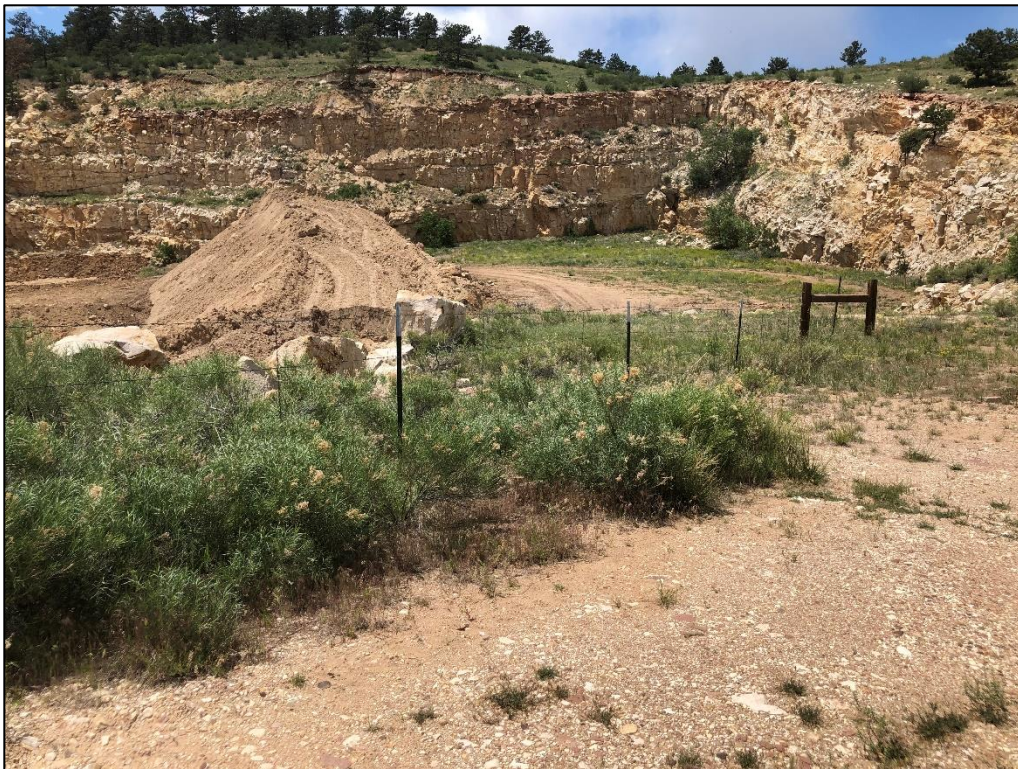
Photo 16. View looking west from processing area utilized by Loukonen, showing backfilled northern portion of pit. Note barbed wire fence separating processing area from quarry area.

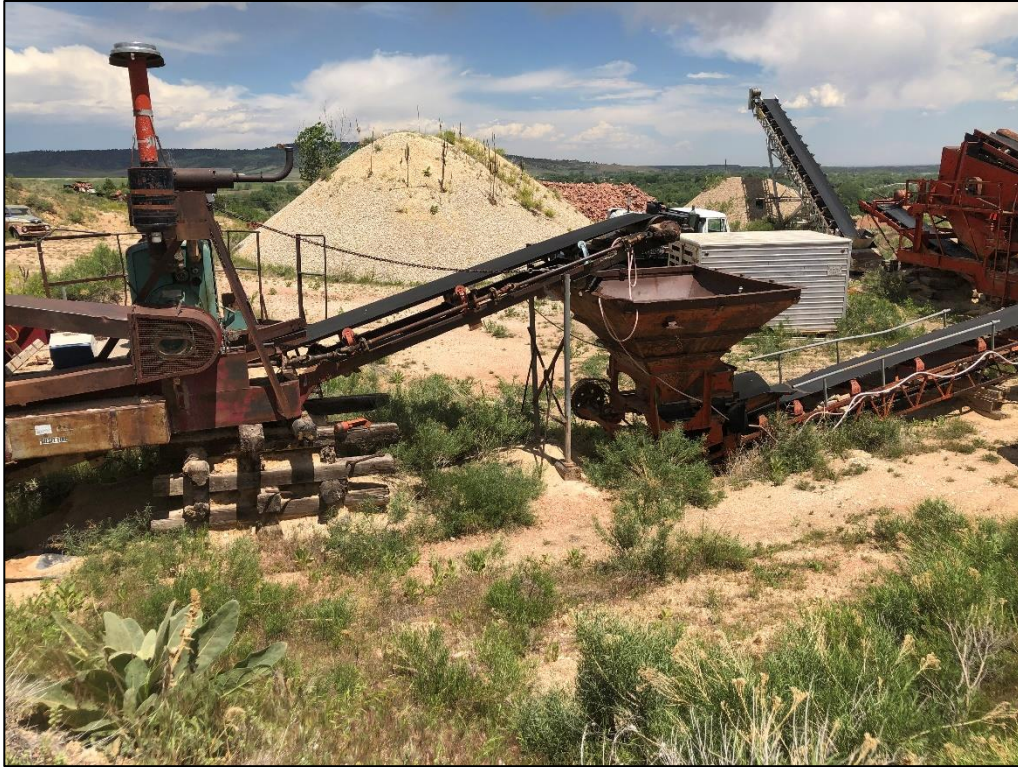
During its last inspection of the site on March 22, 2017, the Division observed a stone processing area near the main site entrance which overlaps the northeastern portion of the permit area. This processing area includes material stockpiles, a stone crusher plant, a trailer, a few small sheds, and an equipment and truck storage area. The Division estimated the disturbance located outside the permit boundary in this area to be approximately 0.85 acre. While a portion of the processing area is located within the permit area, a barbed wire fence separates this area from the quarry area. The operator informed the Division the entire processing area (east of the fence) was leased to Loukonen Bros. Stone Company for processing stone in conjunction with their adjacent commercial stone yard. The Division cited a problem for this off-site disturbance in its last inspection report, sent on April 4, 2017, requiring the operator to demonstrate to the Division the off-site affected land is not associated with the permitted operation in any way. For the corrective action, the operator provided a signed letter confirming the processing area was not associated in any way with the permitted operation. The operator also provided a notarized letter from Michael Loukonen attesting to the use of the property for processing stone by Loukonen Bros. Stone Company, and that the equipment and material stockpiles stored in the area are part of the Loukonen operation. Therefore, the Division considers this problem to be abated. If the operation were to ever have a need for using this area in any way (besides as a mine entrance), the operator would need to submit a permit revision to incorporate the use and reclamation of this area into the mining and reclamation plans, and

to update the reclamation bond accordingly. During the current inspection, the Division observed no changes in the processing area.

Photo 17. View looking east across processing area located east of quarry, which is utilized by Loukonen Brothers Stone Company in conjunction with their adjacent commercial stone yard.

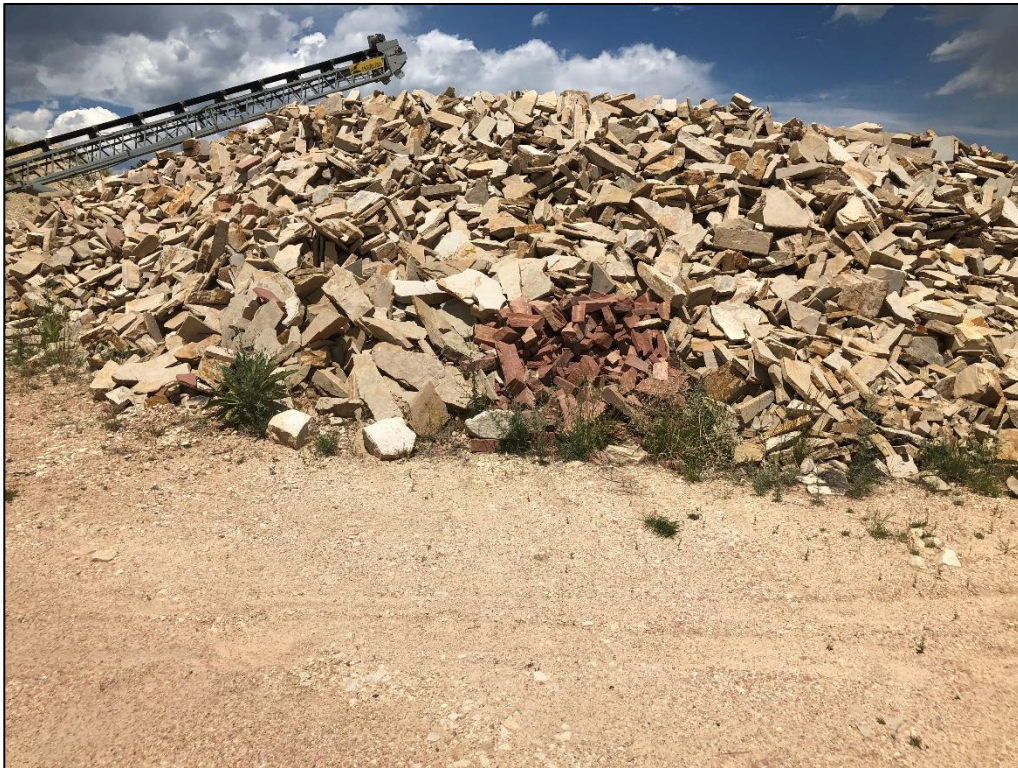
Photo 18. View of stone scrap stockpile stored in processing area east of quarry, which is utilized by Loukonen Brothers Stone Company in conjunction with their adjacent commercial stone yard.
