**PERMIT INFORMATION**

<b>Permit Number:</b> C-1981-015 <b>Mine Name:</b> Fruita No 1 & 2 <b>Operator:</b> Dorchester Coal Company <b>Operator Address:</b> Greg Lewicki 9054 South Forrest Drive Highlands Ranch, CO 80126	<b>County:</b> Mesa <b>Operation Type:</b> Underground <b>Permit Status:</b> Revoked <b>Ownership:</b> Private
	<b>Operator Representative Present:</b>  NA
<b>Operator Representative Signature:</b> (Field Issuance Only)

**INSPECTION INFORMATION**

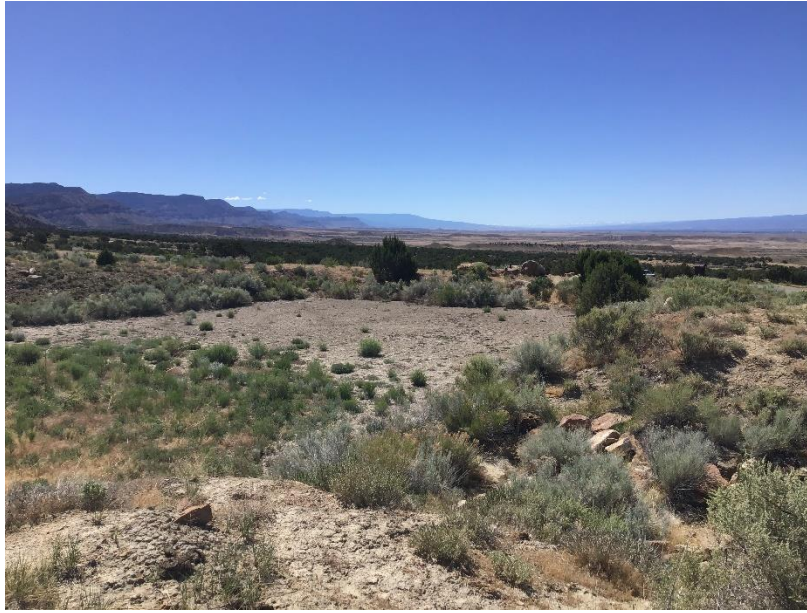
The sediment pond will remain at the site as a permanent feature. The pond was dry at the time of the inspection (Photo 1). The outlet for the pond was stable and unobstructed. The embankments for the pond were vegetated and had no indications of erosion. The rills and gullies on the reclaimed haul road have been noted in previous DRMS inspection reports. These features did not appear to have increased in size or depth. The feature appear to be stable and have become a part of the hydrologic features of the site. The runoff transported by these features ends in the drainages that lead to the sediment pond. No off site impacts had occurred. The riprap channel leading from the reclaimed bench to the pond was stable. There did not appear to be any erosional issues.

**Photo 1:** The permanent sediment pond.

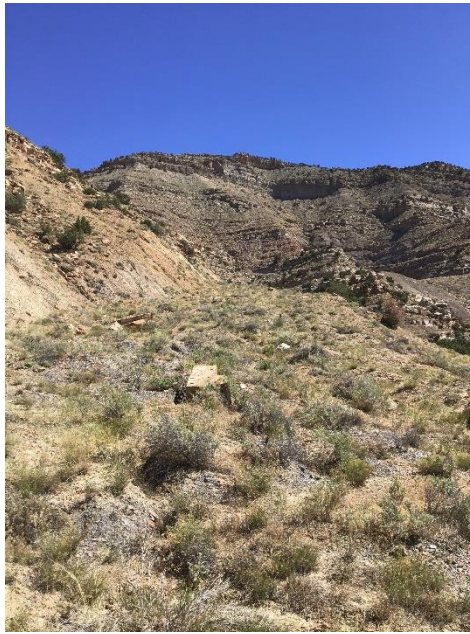
The reclaimed haul road was vegetated and stable (Photos 2 and 3). The vegetation on the reclamation matches the surrounding non-affected areas and in most places is more densely populated than some of the surrounding areas. There were no new erosional features identified. The reclaimed bench was stable and no new erosional features were observed (Photo 4). The gully running across the reclamation has been previously identified in DRMS inspection reports. The gully had not enlarged. Runoff from this gully will end up in the riprap channel. The outslope of the reclaimed bench has sparse vegetation on it. This has been documented in

**Photo 2:** The lower portion of the reclaimed haul road.

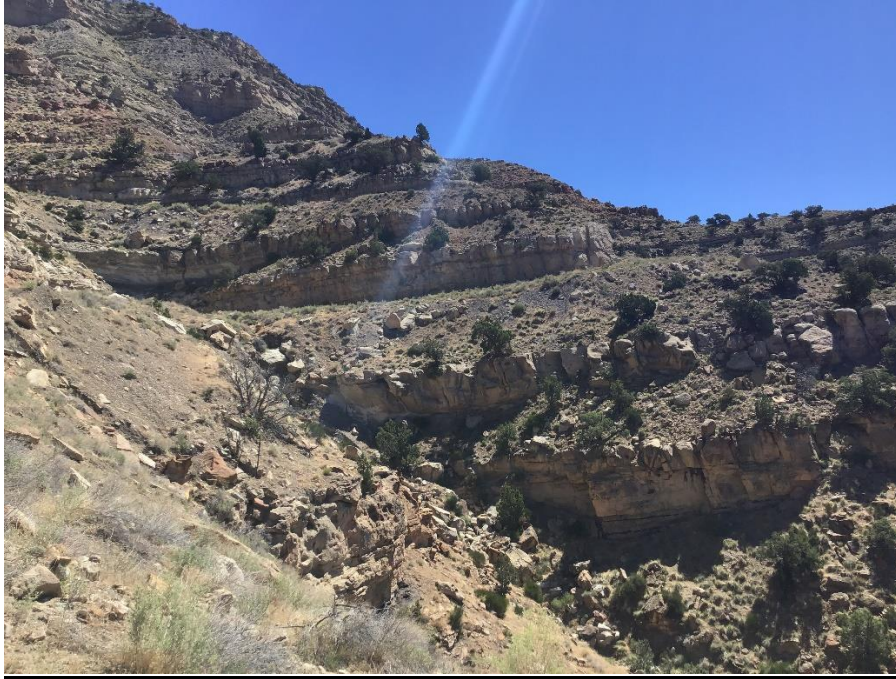
**Photo 3:** The upper portion of the haul road. The road wraps around the hill to reach the reclaimed bench.

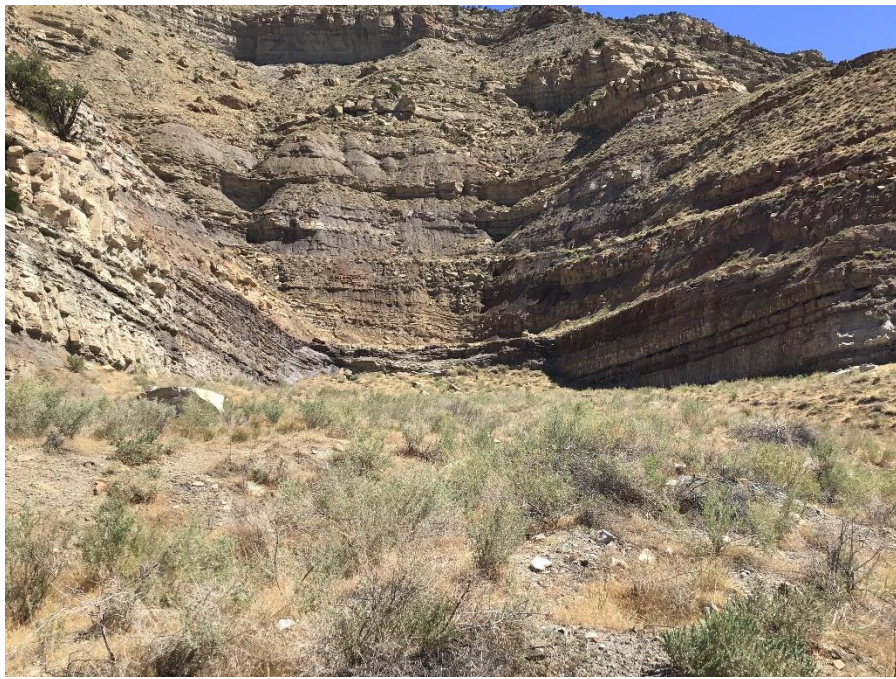
**Photo 4:** The reclaimed bench and backfilled portals.

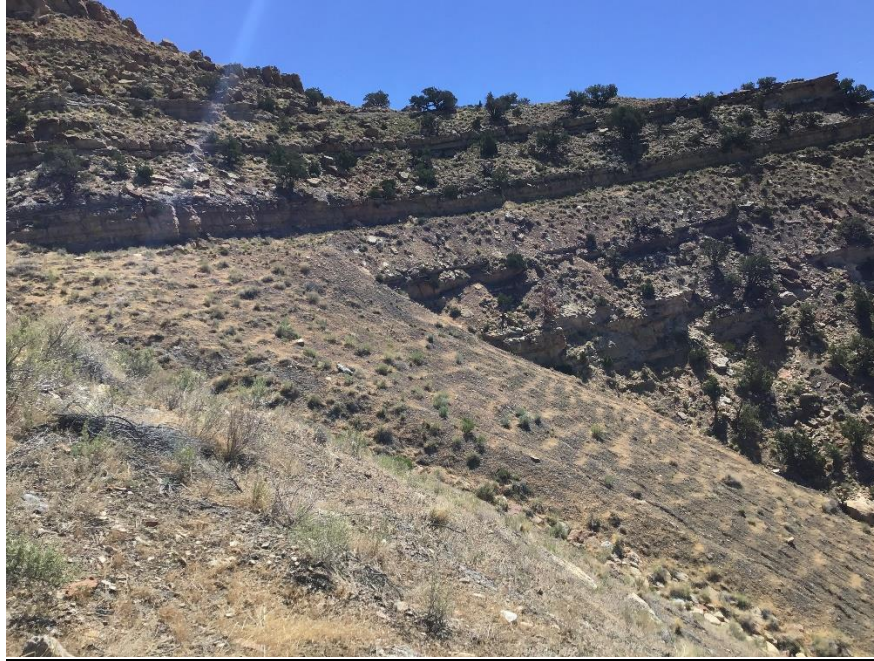
previous DRMS inspection Reports. The slope is south-facing. During the inspection a larger quantity of plants were observed to be growing in on the outcrops (Photo 5). The backfilled portals were stable with no erosional concerns. The reclaimed access road on the west side of the reclaimed bench was vegetated and stable. There were no erosional concerns.

**Photo 5:** The reclaimed out slopes of the reclaimed bench.
