COLORADO
Division of Reclamation,
Mining and Safety
Department of Natural Resources

Permit Number: C-1981-041 Mine Name: Roadside Portals Operator: Snowcap Coal Company, Inc. Operator Address: MS Tonya Hammond P.O. Box 1430 Palisade, CO 81526	County: Mesa Operation Type: Underground Permit Status: Active Ownership: Private
	Operator Representative Present: Tonya Hammond
Operator Representative Signature: (Field Issuance Only)

Inspection Start Date: June 10, 2020 Inspection Start Time: 12:45 Inspection End Date: June 10, 2020 Inspection End Time: 14:35		Inspection Type: Coal Complete Inspection Inspection Reason: Normal I&E Program Weather: Clear	
Joint Inspection Agency: None		Joint Inspection Contacts: None	
Post Inspection Agency: None		Post Inspection Contacts: None	
Inspector(s): Clayton Wein	Inspector's Signature: <i>Clayton Wein</i>		Signature Date: 6/15/2020

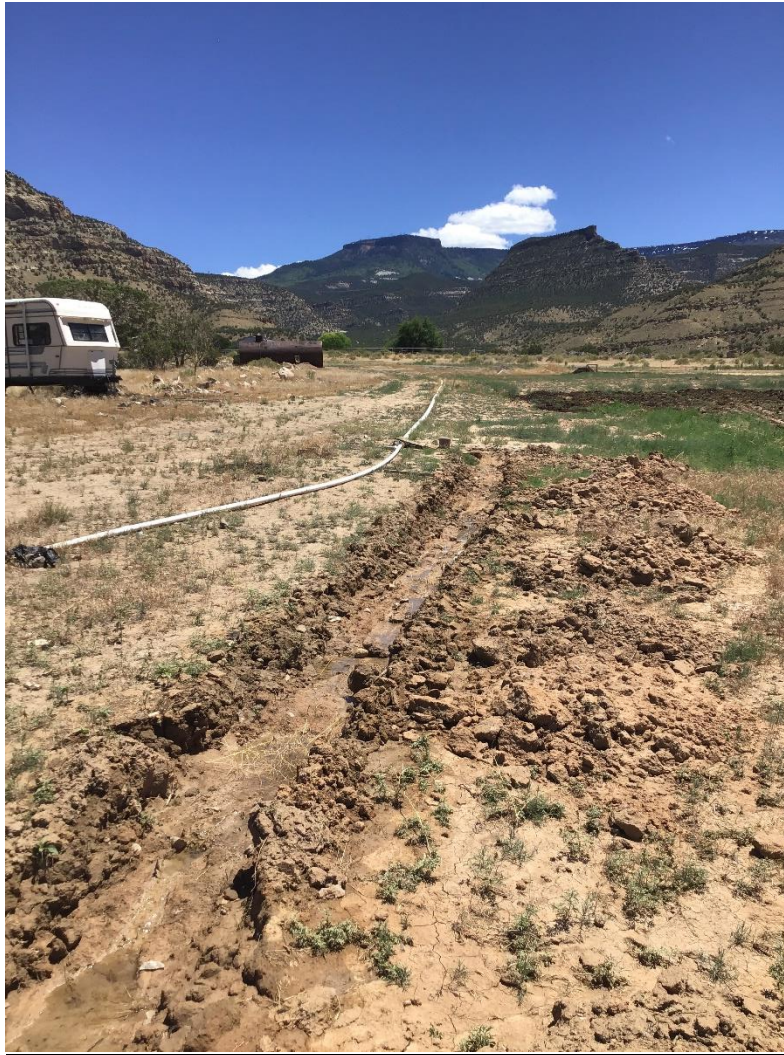
During the inspection of the TR-69 Repair Area, a new trench was identified to the east-southeast of the site (Photos 1 and 2). The trench had a north-northwest trending direction. The trench was observed to be damp. At the end of the trench, freshly ripped ground was observed heading west directly toward the TR-69 Repair Area (Photo 3). The ripped ground appeared to only be the width of the ripper equipment. The ripped path lead within approximately two to three feet from the boundary marker for the TR-69 Repair Area (Photo 4). The path then turned north and ran parallel with the repair area (Photo 5). The ripped path was followed until it ended at the junction with a trench previously created by the landowner. That trench runs parallel with an old rock wall trending east-west at the north end of tract 70.

Photo 1: A new trench created by the landowner to the east-southeast of the TR-69 Repair Area. The trench was damp at the time of the inspection. Photo taken looking to the southeast.

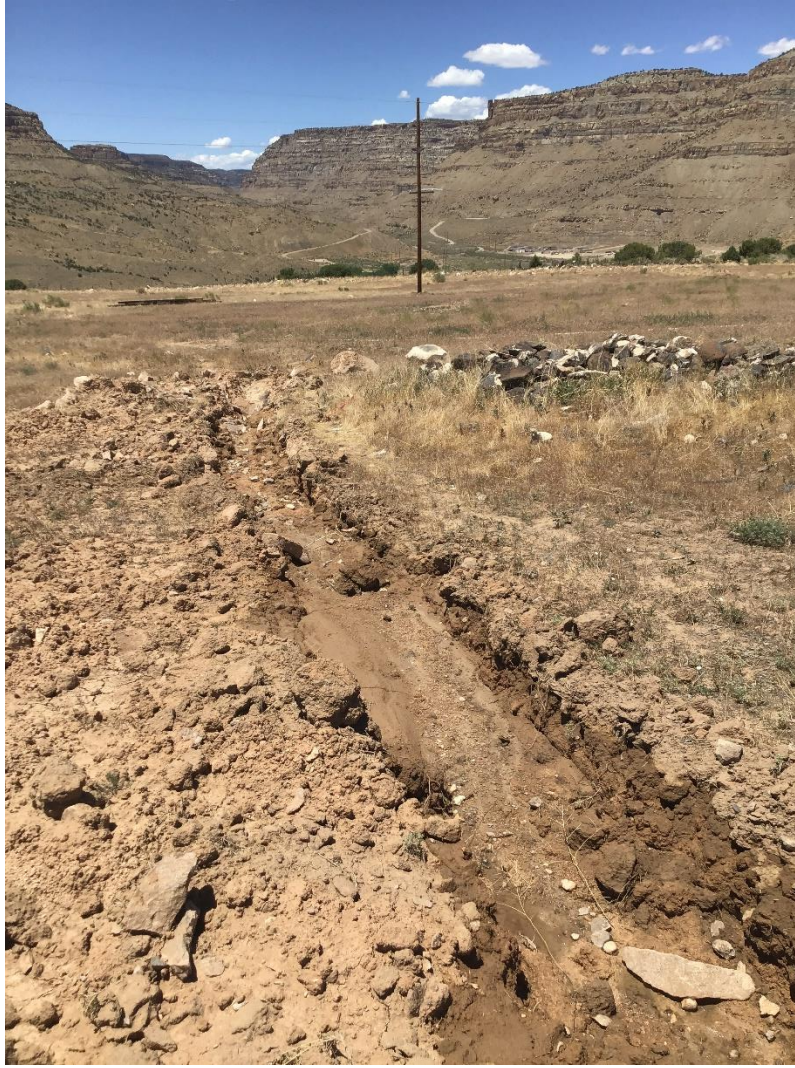
Photo 2: The same trench in Photo 1, the direction of the photo was taken looking to the northwest.

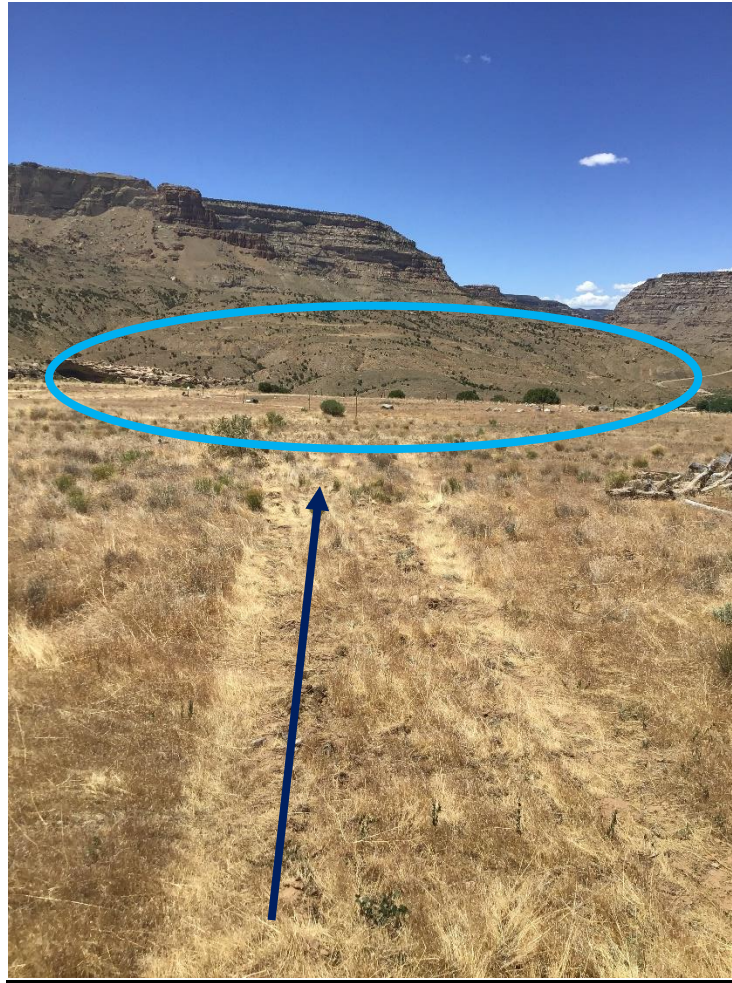
Photo 3: The blue circle in the photo indicates the location of the TR-69 Repair Area. The dark blue arrow follows the path of the ripped ground heading towards the repair area.

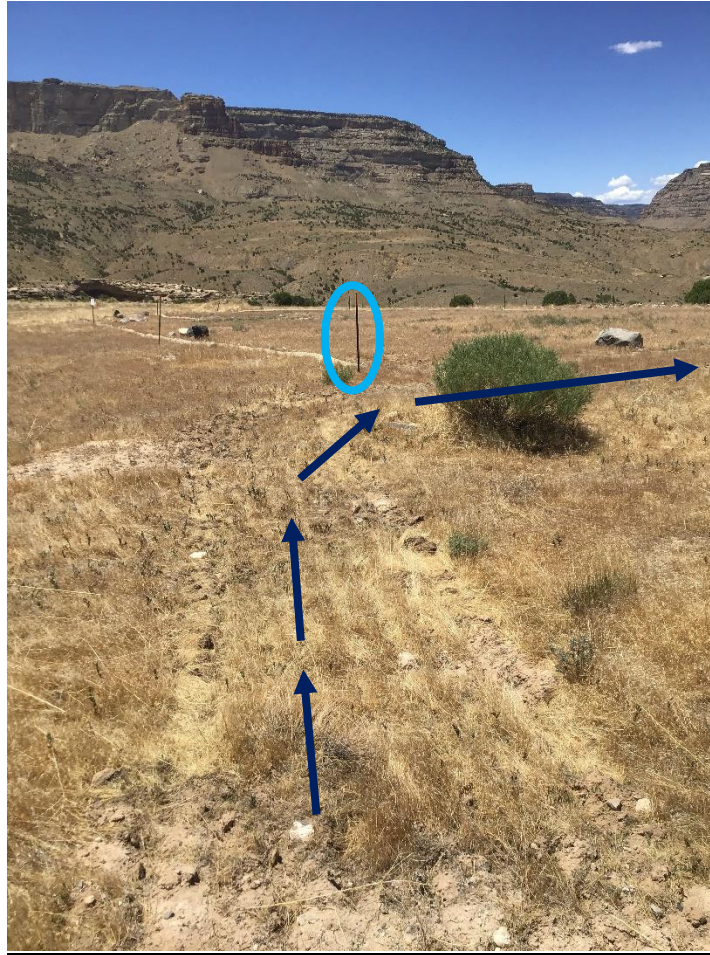
Photo 4: The ripped path ran right up near the southeast boundary marker and then turned north. The boundary marker is outlined in a blue circle. The path of the ripped soil is delineated by blue arrows

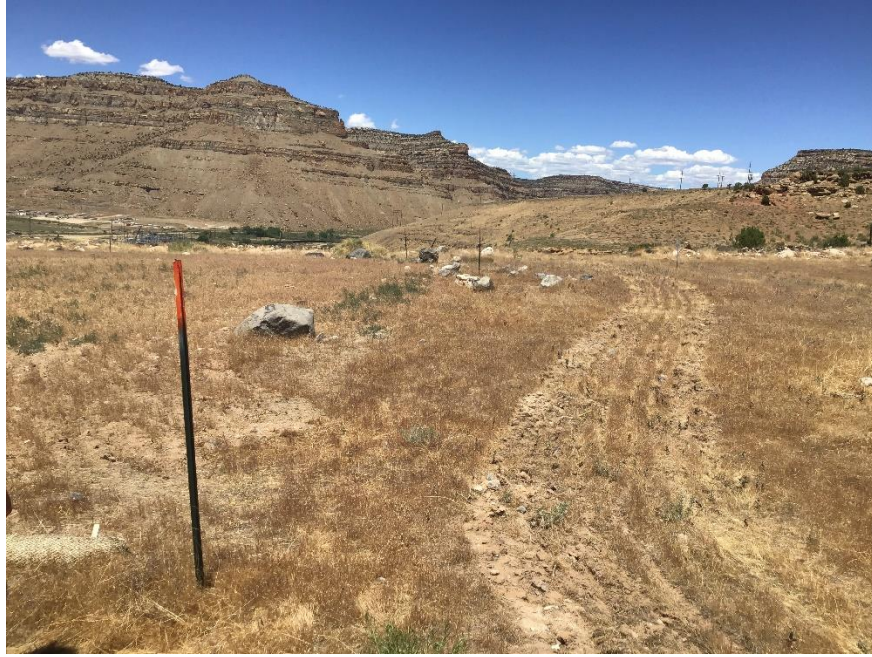
Photo 5: The ripped path running parallel with the boundary to the TR-69 Repair Area. The repair area is delineated by the posts on the left side of the photo heading towards the center of the photo. The photo was taken looking north from the southeast boundary marker.

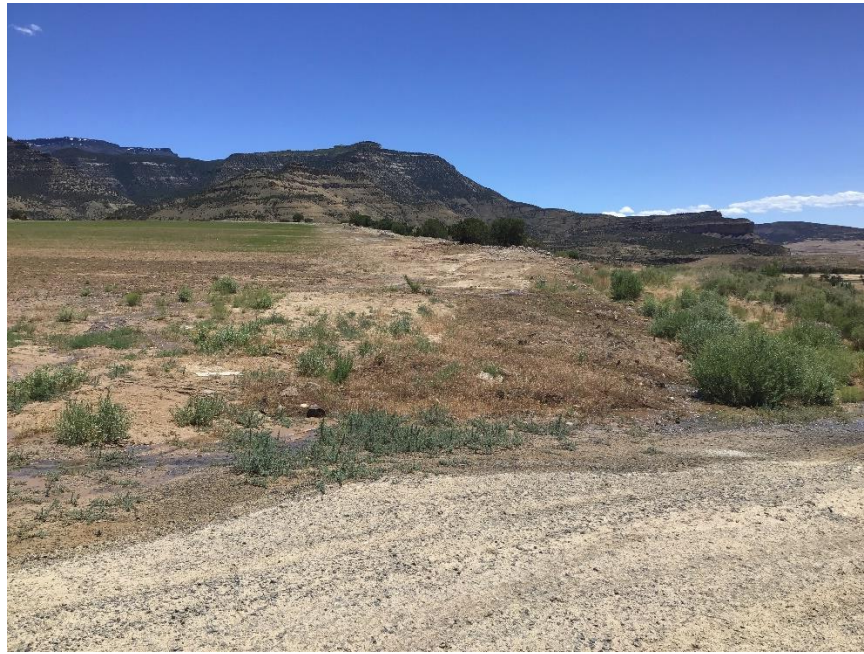
During the inspection, the Division was made aware of water flowing off of the landowner's field to the east of the TR-69 Repair area. The water was coming from the northwest end of the field from irrigation water (Photo 6). The water was flowing to the northwest off of the field and over the access road (Photo 7). The water then flowed

Photo 6: Water observed running off of the northwest corner of the landowner's field. The photo was taken looking to the southeast.

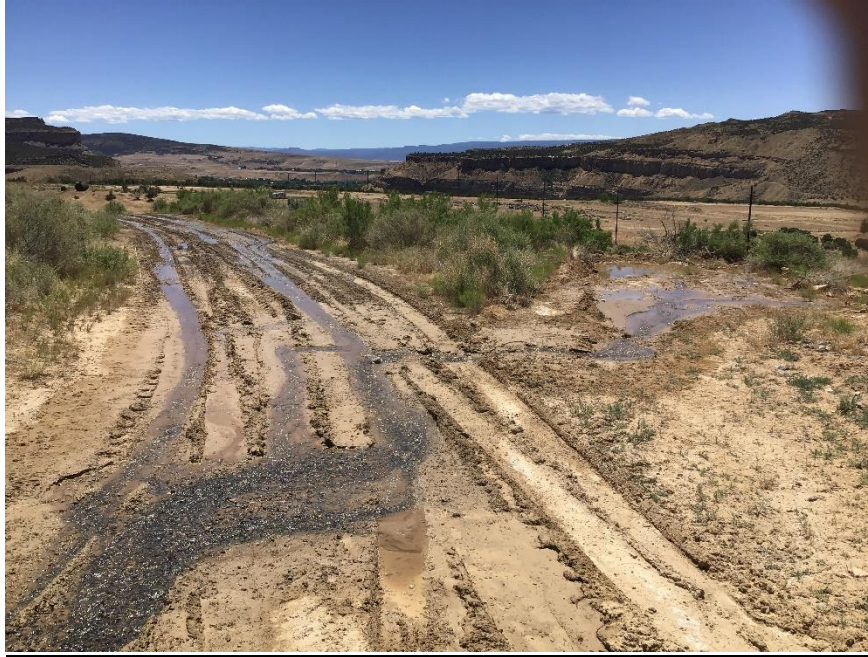
Access roads throughout the mine site were in good condition and stable. The access road to the northeast of tract 70 that leads to the Tract 71 Mesa had water flowing over it during the inspection (Photo 7). The water was tail water from the north end of the landowner's field being irrigated. The road leading down the north side of the Tract 71 Mesa was observed to have been worked on recently. The road had been widened by the landowner and the cut-slope had been pushed back into the hill.

Photo 7: The tail water from the landowner's field running across the access road. The photo was taken looking to the south. The reclaimed barrow area and drainage is located off the photo to the right.

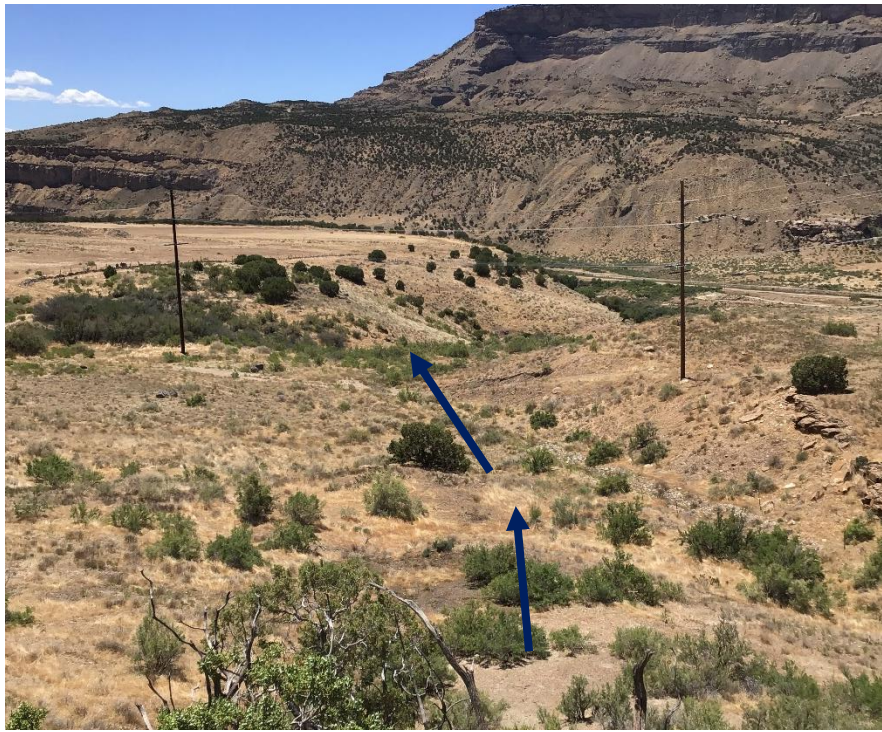
down hill to the northeast of the old barrow area (Photo 8). The water was traced entering the drainage above the reclaimed refuse pile. The Division visited the top of the reclaimed refuse pile and observed no water flowing into the upper diversion ditch (Photo 9). This indicated that the water had not yet made it through the drainage above the reclaimed refuse pile. The Division also visited the reclaimed portals. The reclaimed slope was dry and stable. There was no water observed seeping out of the hill slope or in the diversion ditches adjacent to the reclaimed portals.

Photo 8: The tail water flowing down the hill to the drainage above the reclaimed refuse pile. The dark blue arrows indicate the path the Division observed of flowing water. The photo was

taken looking to the west.

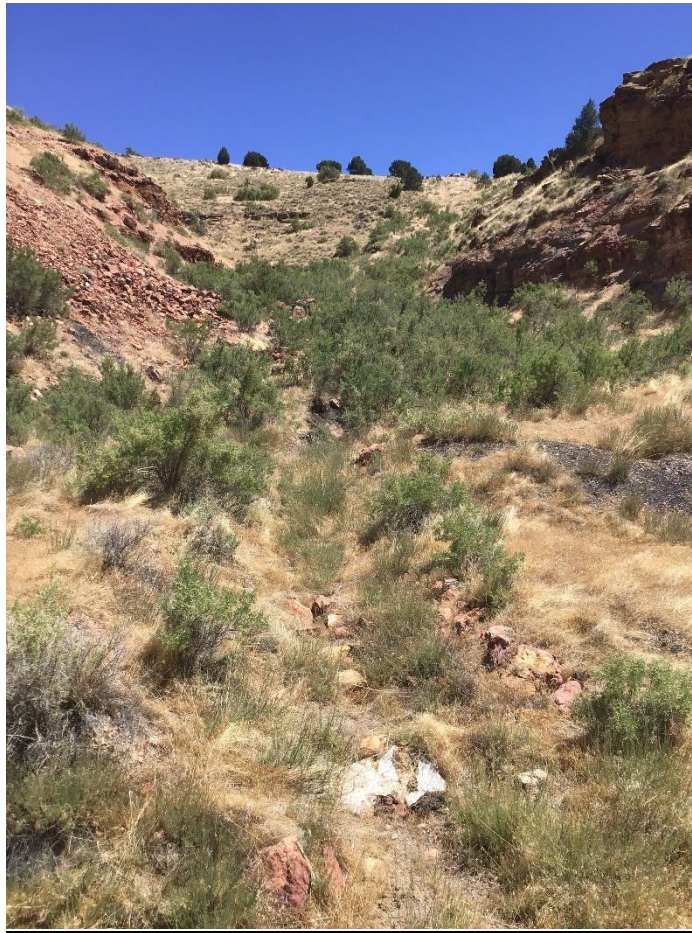
Photo 9: The photo was taken standing on top of the reclaimed refuse pile looking up the drainage. This is the same drainage that was observed from above having tail water flowing into it. There was no water observed in this part of the drainage. The upper diversion ditch for the reclaimed refused pile was dry.

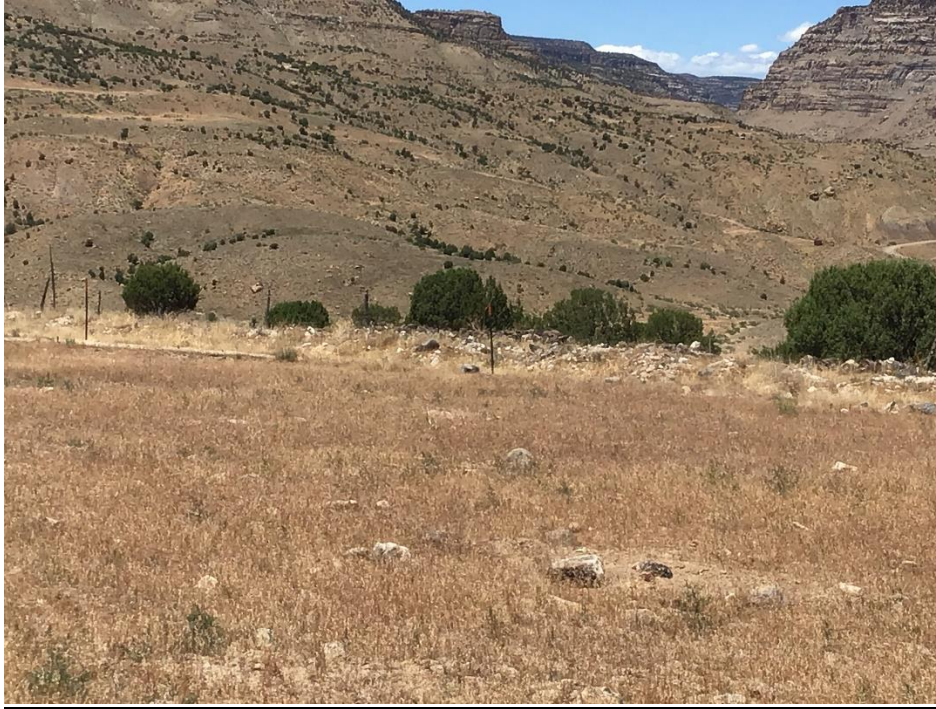
The TR-69 Repair area was beginning to have vegetation grow in on it. Some of the plant species were from the seed mix placed in the fall of 2019 (Photo 10 and 11). Cheatgrass has grown on the repair area and was similar to the amount in the surrounding area. The operator had recently sprayed for Whitetop and will be spraying for Halogeton. The site was stable and there were no indications of settling in the soil. The boundary markers were clearly marked. The sediment logs at the site were in good condition. No off-site impacts were observed.

Photo 10: The northern portion of the TR-69 Repair Area. The photo was taken looking west.

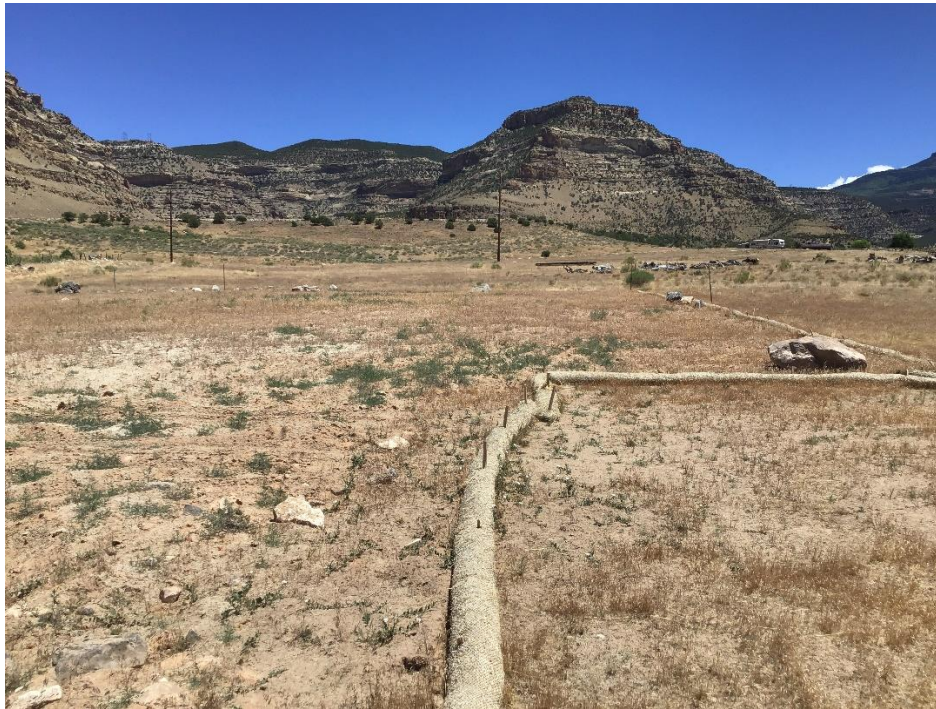
Photo 11: The eastern portion of the TR-69 Repair Area. The photo was taken looking east.
