**COLORADO**  
Division of Reclamation,  
Mining and Safety  
Department of Natural Resources

<b>Permit Number:</b> C-1980-004 <b>Mine Name:</b> McClane Canyon Mine <b>Operator:</b> McClane Canyon Mining, LLC <b>Operator Address:</b> Ronald Hull 424 Lewis Hargett Circle Suite 250 Lexington, KY 40503	<b>County:</b> Garfield <b>Operation Type:</b> Underground <b>Permit Status:</b> Temporary Cessation <b>Ownership:</b> Private
	<b>Operator Representative Present:</b>  Chuck Selingo
<b>Operator Representative Signature: (Field Issuance Only)</b>

<b>Inspection Start Date:</b> June 11, 2020 <b>Inspection Start Time:</b> 09:05 <b>Inspection End Date:</b> June 11, 2020 <b>Inspection End Time:</b> 10:00		<b>Inspection Type:</b> Coal Complete Inspection <b>Inspection Reason:</b> Normal I&E Program <b>Weather:</b> Clear	
<b>Joint Inspection Agency:</b>  None		<b>Joint Inspection Contacts:</b>  None	
<b>Post Inspection Agency:</b>  None		<b>Post Inspection Contacts:</b>  None	
<b>Inspector(s):</b>  Clayton Wein	<b>Inspector's Signature:</b>  <i>Clayton Wein</i>		<b>Signature Date:</b>  6/16/2020

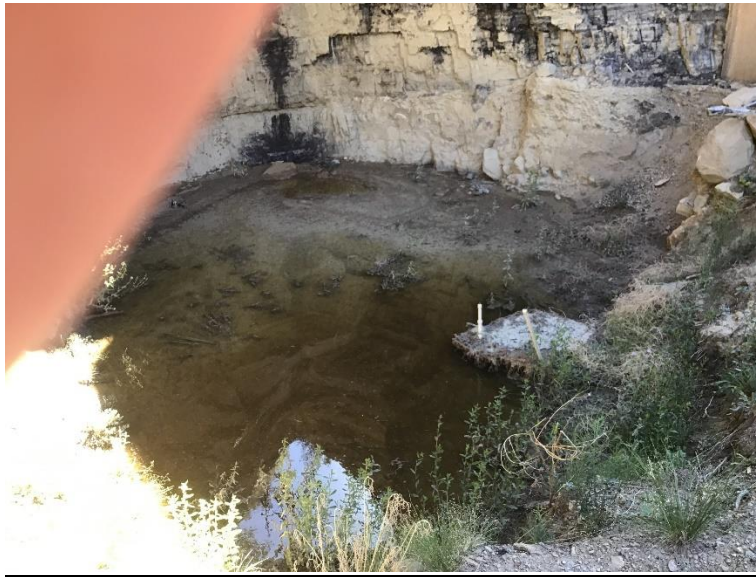
There are two sumps located at the northeast and southeast ends of the portals area. The northeast sump was holding a small amount of water. The discharge outlet was clear of obstructions. There was no discharge from the sump. The southeast sump was also holding water in it during the inspection (Photo 1). The outlet was free from obstructions. There was no discharge occurring. Ditches and diversions at the portals area were unobstructed and stable. There were no erosional concerns identified.

**Photo 1:** The southeast sump at the portals area.

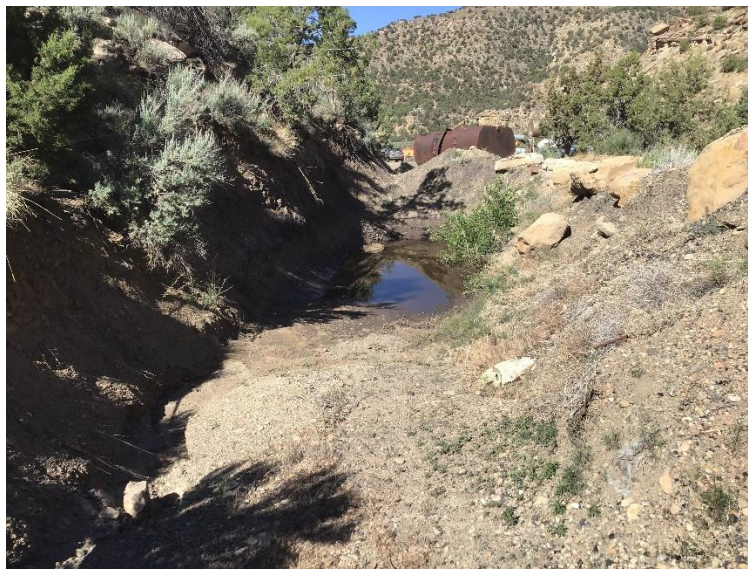
Sumps located along the haul road had small amounts of water in them (Photos 2 and 3). None of the sumps had enough water to discharge. The outlets of the sumps were well maintained.

**Photo 2:** The sump in the photo is located on the south side of the haul road, up gradient from the sediment pond.

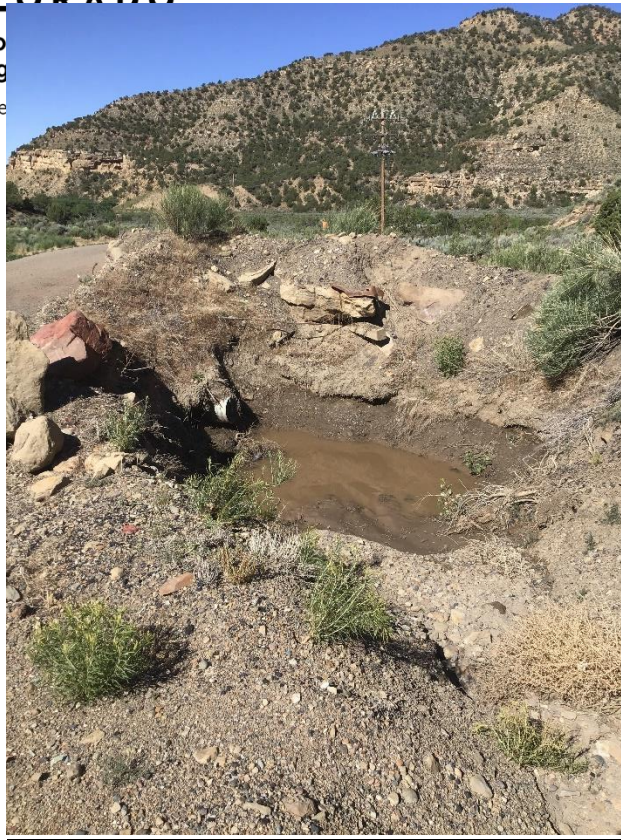
**Photo 3:** The sump in the photo is located on the north side of the haul road, across from the sediment pond.

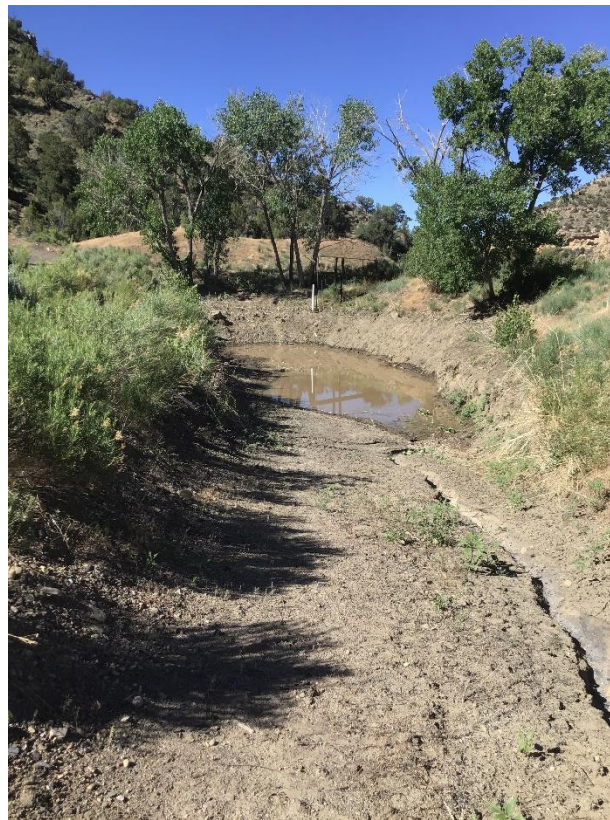
The sediment pond was impounding a small amount of water (Photo 4). The level of the water in the pond was below the primary spillway. The spillway was clear of debris. The embankments of the pond were vegetated and stable. There were no indications of erosional features.

**Photo 4:** The sediment pond.

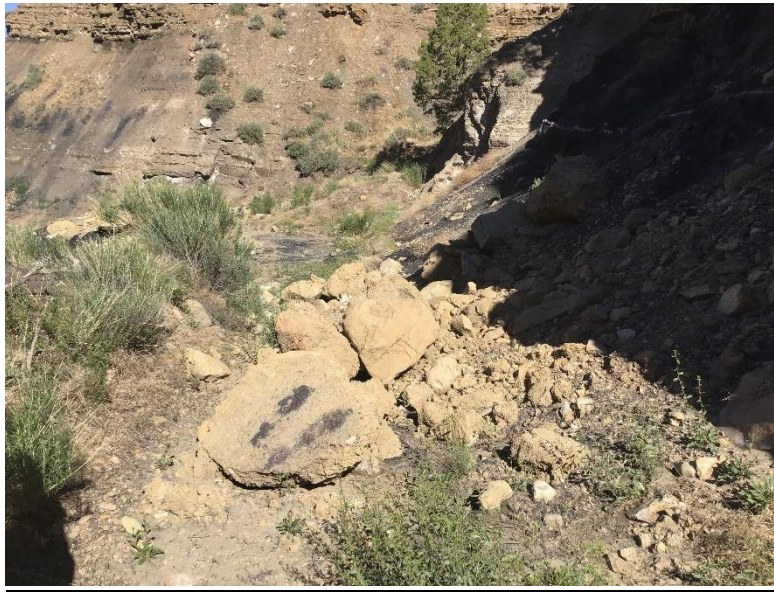
A small rockslide had occurred on the north side of the portals area (Photo 5). The rockslide was minor and no damage to the facilities occurred. The operator stated that the rocks from the slide will be removed.

**Photo 5:** The minor rockslide located on the north side of the portals area. The portals area is located off to the left side of the photo.

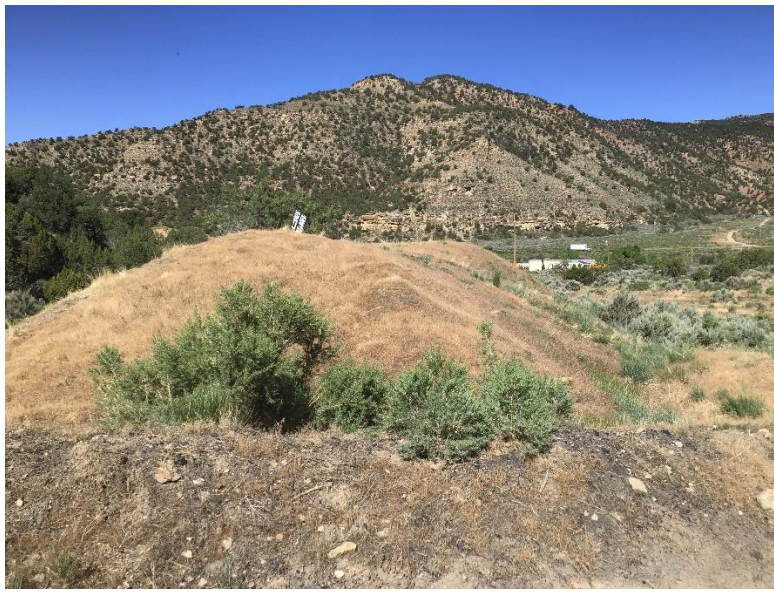
The topsoil pile was stable and vegetated (Photo 6). There were no erosional features present. The perimeter ditch was stable and vegetated. There were no erosional concerns noted. The topsoil pile marker was located on top of the pile.

**Photo 6:** The topsoil pile. The photo was taken looking to the west.
