COLORADO
Division of Reclamation,
Mining and Safety
Department of Natural Resources

Permit Number: C-2010-088 Mine Name: Fruita Loadout Operator: CAM-Colorado, LLC Operator Address: Ronald Hull 424 Lewis Hargett Circle Suite 250 Lexington, KY 40503	County: Mesa Operation Type: Loadout Permit Status: Temporary Cessation Ownership: Private
	Operator Representative Present: None
Operator Representative Signature: (Field Issuance Only)

Inspection Start Date: June 11, 2020 Inspection Start Time: 10:30 Inspection End Date: June 11, 2020 Inspection End Time: 11:05		Inspection Type: Coal Complete Inspection Inspection Reason: Normal I&E Program Weather: Clear	
Joint Inspection Agency: None		Joint Inspection Contacts: None	
Post Inspection Agency: None		Post Inspection Contacts: None	
Inspector(s): Clayton Wein	Inspector's Signature: <i>Clayton Wein</i>		Signature Date: 6/16/2020

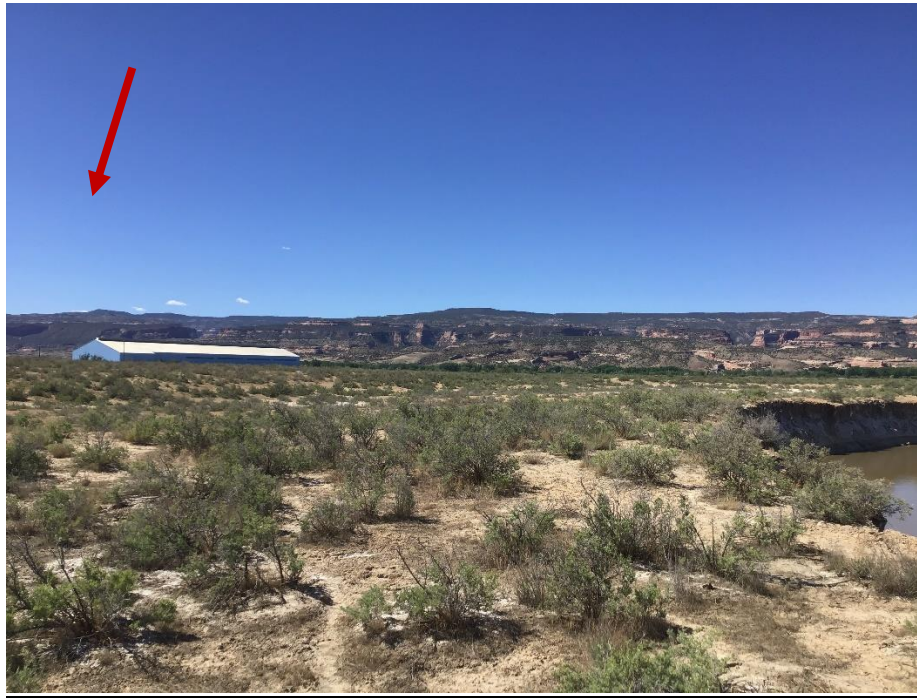
The Fruita Loadout is an inactive site and no construction or mining activity has occurred at the site to date. No disturbances have been created (Photo 1).

Photo 1: The middle portion of the permit area.

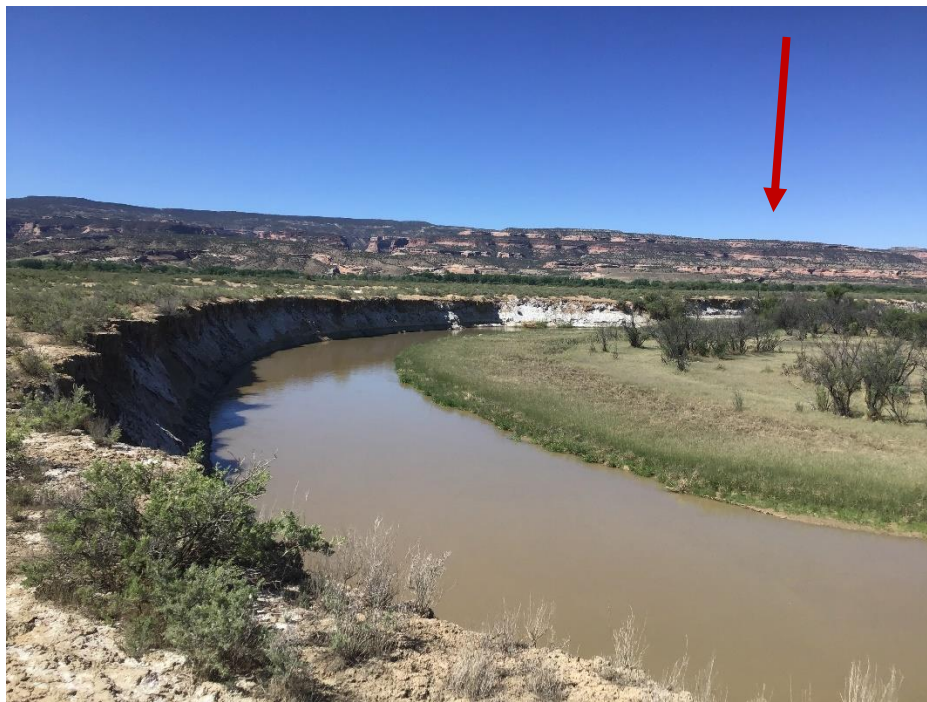
Reed wash was flowing at the time of the inspection (Photo 2). The site was stable and there were no indications of erosion.

Photo 2: Reed Wash.

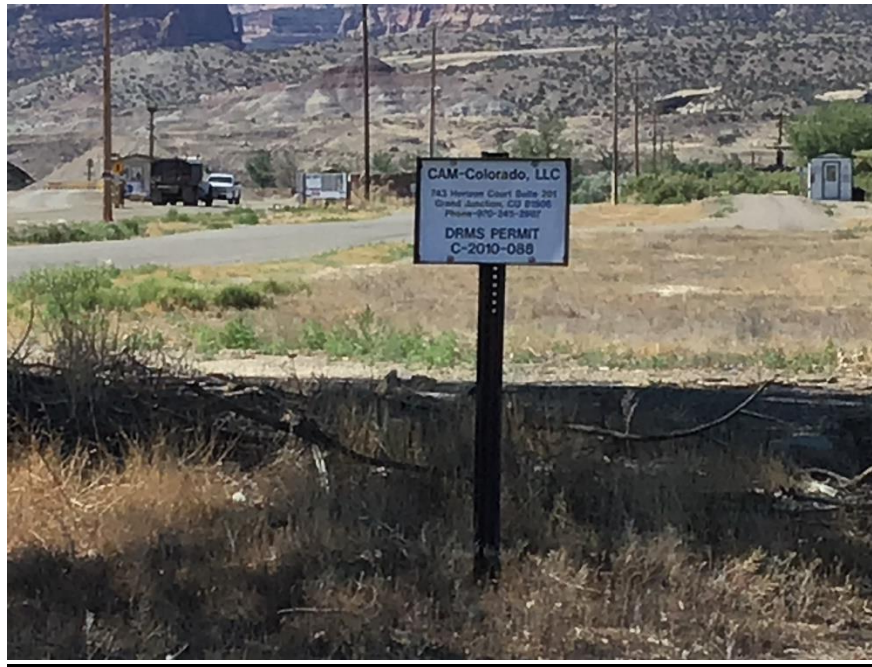
The mine identification sign was posted on the left side of the entrance to the site (Photo 3). The sign was in good condition and displayed the current information about the permit, the permittee and the Division. Mine permit boundary markers were identified during the inspection. The markers are in the correct locations and reflect the current permit boundary.

Photo 3: The mine ID sign next to the loadout entrance
