MINERALS PROGRAM INSPECTION REPORT
PHONE: (303) 866-3567

MINE NAME: Huddleson Stock Pond	MINE/PROSPECTING ID#: M-2019-009	MINERAL: Sand	COUNTY: El Paso
INSPECTION TYPE: Monitoring	INSPECTOR(S): Timothy Cazier	INSP. DATE: May 29, 2020	INSP. TIME: 13:35
OPERATOR: Luther E Huddleson	OPERATOR REPRESENTATIVE: Luther Huddleson	TYPE OF OPERATION: 111(1)(b) - Special One-Time Incidental

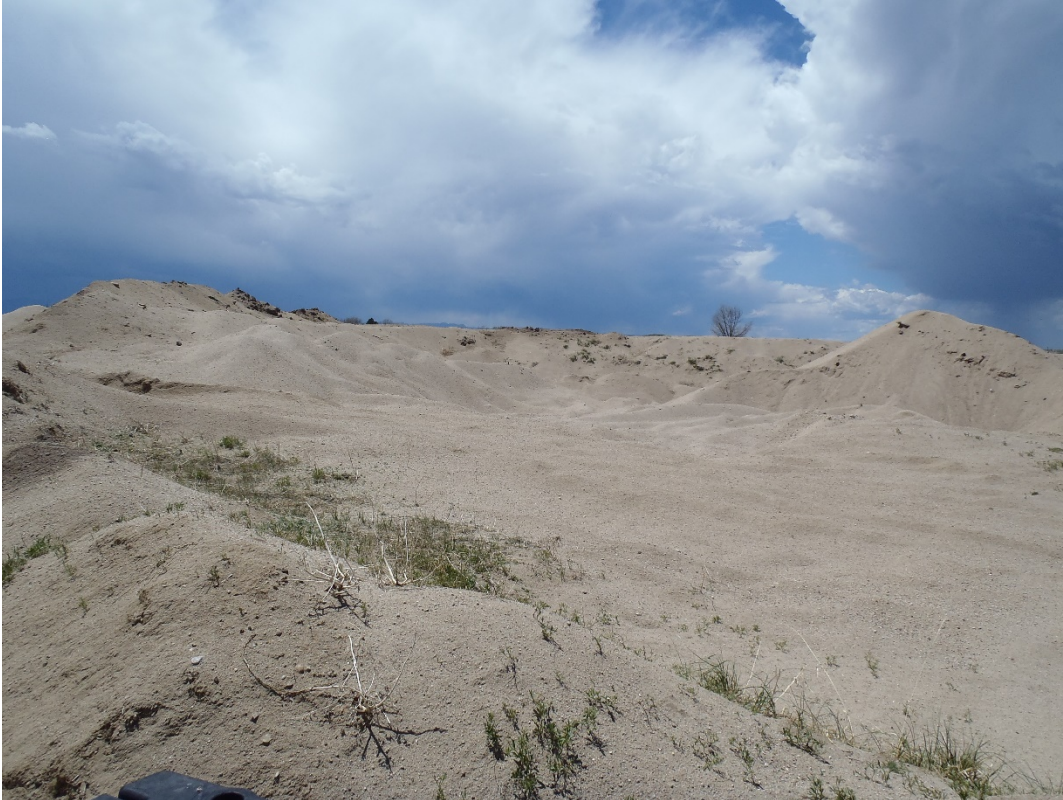
Gen. Compliance with Mine Plan: The operation appeared to be in compliance with the approved mine plan. The maximum allowed disturbed area is two acres. A Trimble Juno 3B handheld GPS unit was used to measure the disturbed area, which was determined to be 1.47 acres (see attached **Post-Inspection Map**). Mr. Huddleson stated he has ceased exporting excavated material, which is what required him to obtain a mine reclamation permit in 2019. He is now focused on completing is stock pond and all material excavated will be used for the stock pond (**#01, 03** see **Photos 1 and 2**).

Photo 1. Pond shaping (west side berm on far side – looking SW).

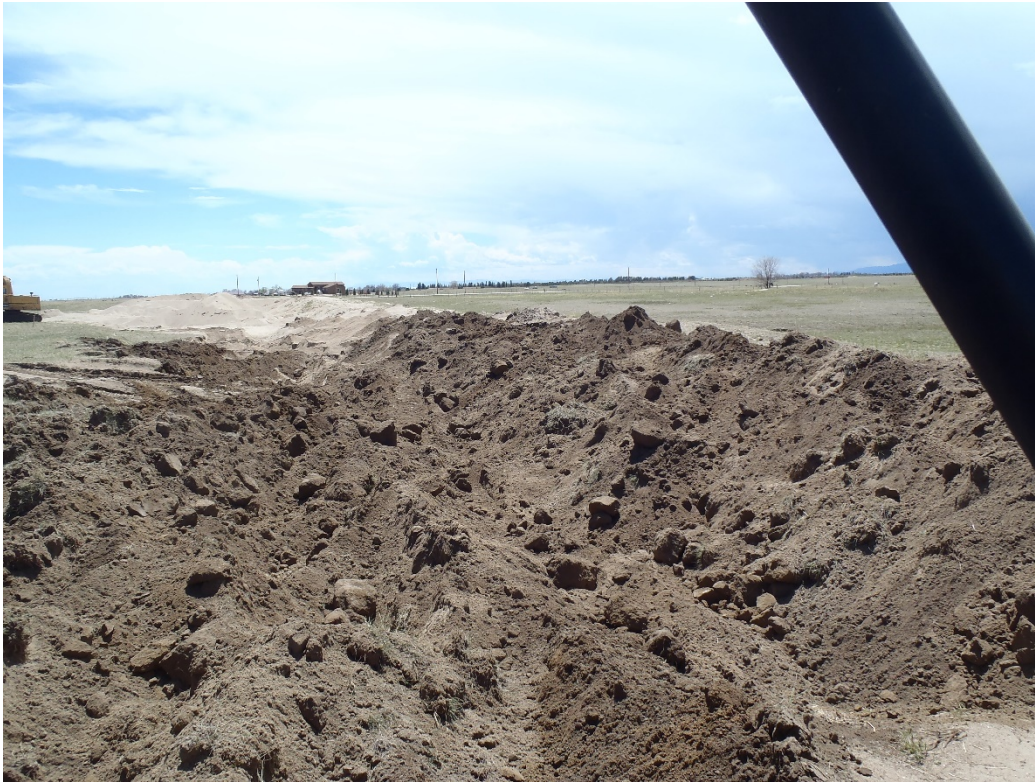
Photo 2. Pond inlet (north end, looking south).

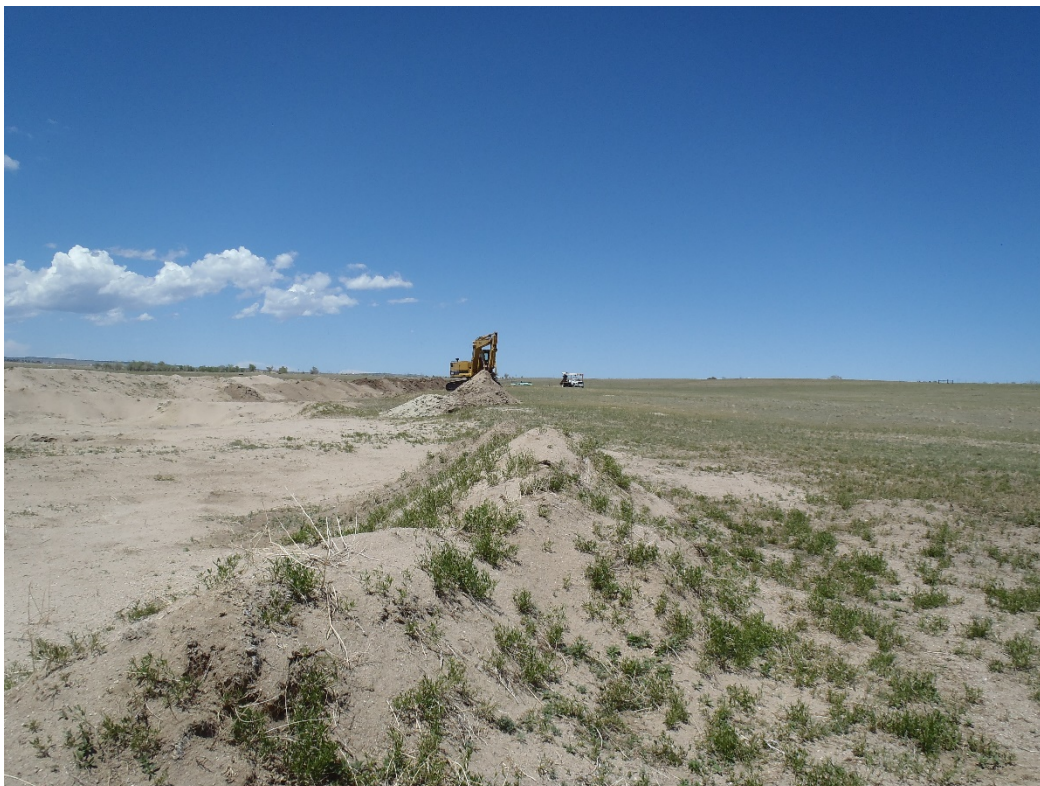
Support Facilities On-site: A trackhoe was observed on site (**#00** see **Photo 3**).

Photo 3. Trackhoe used in shaping pond (south side, looking north).

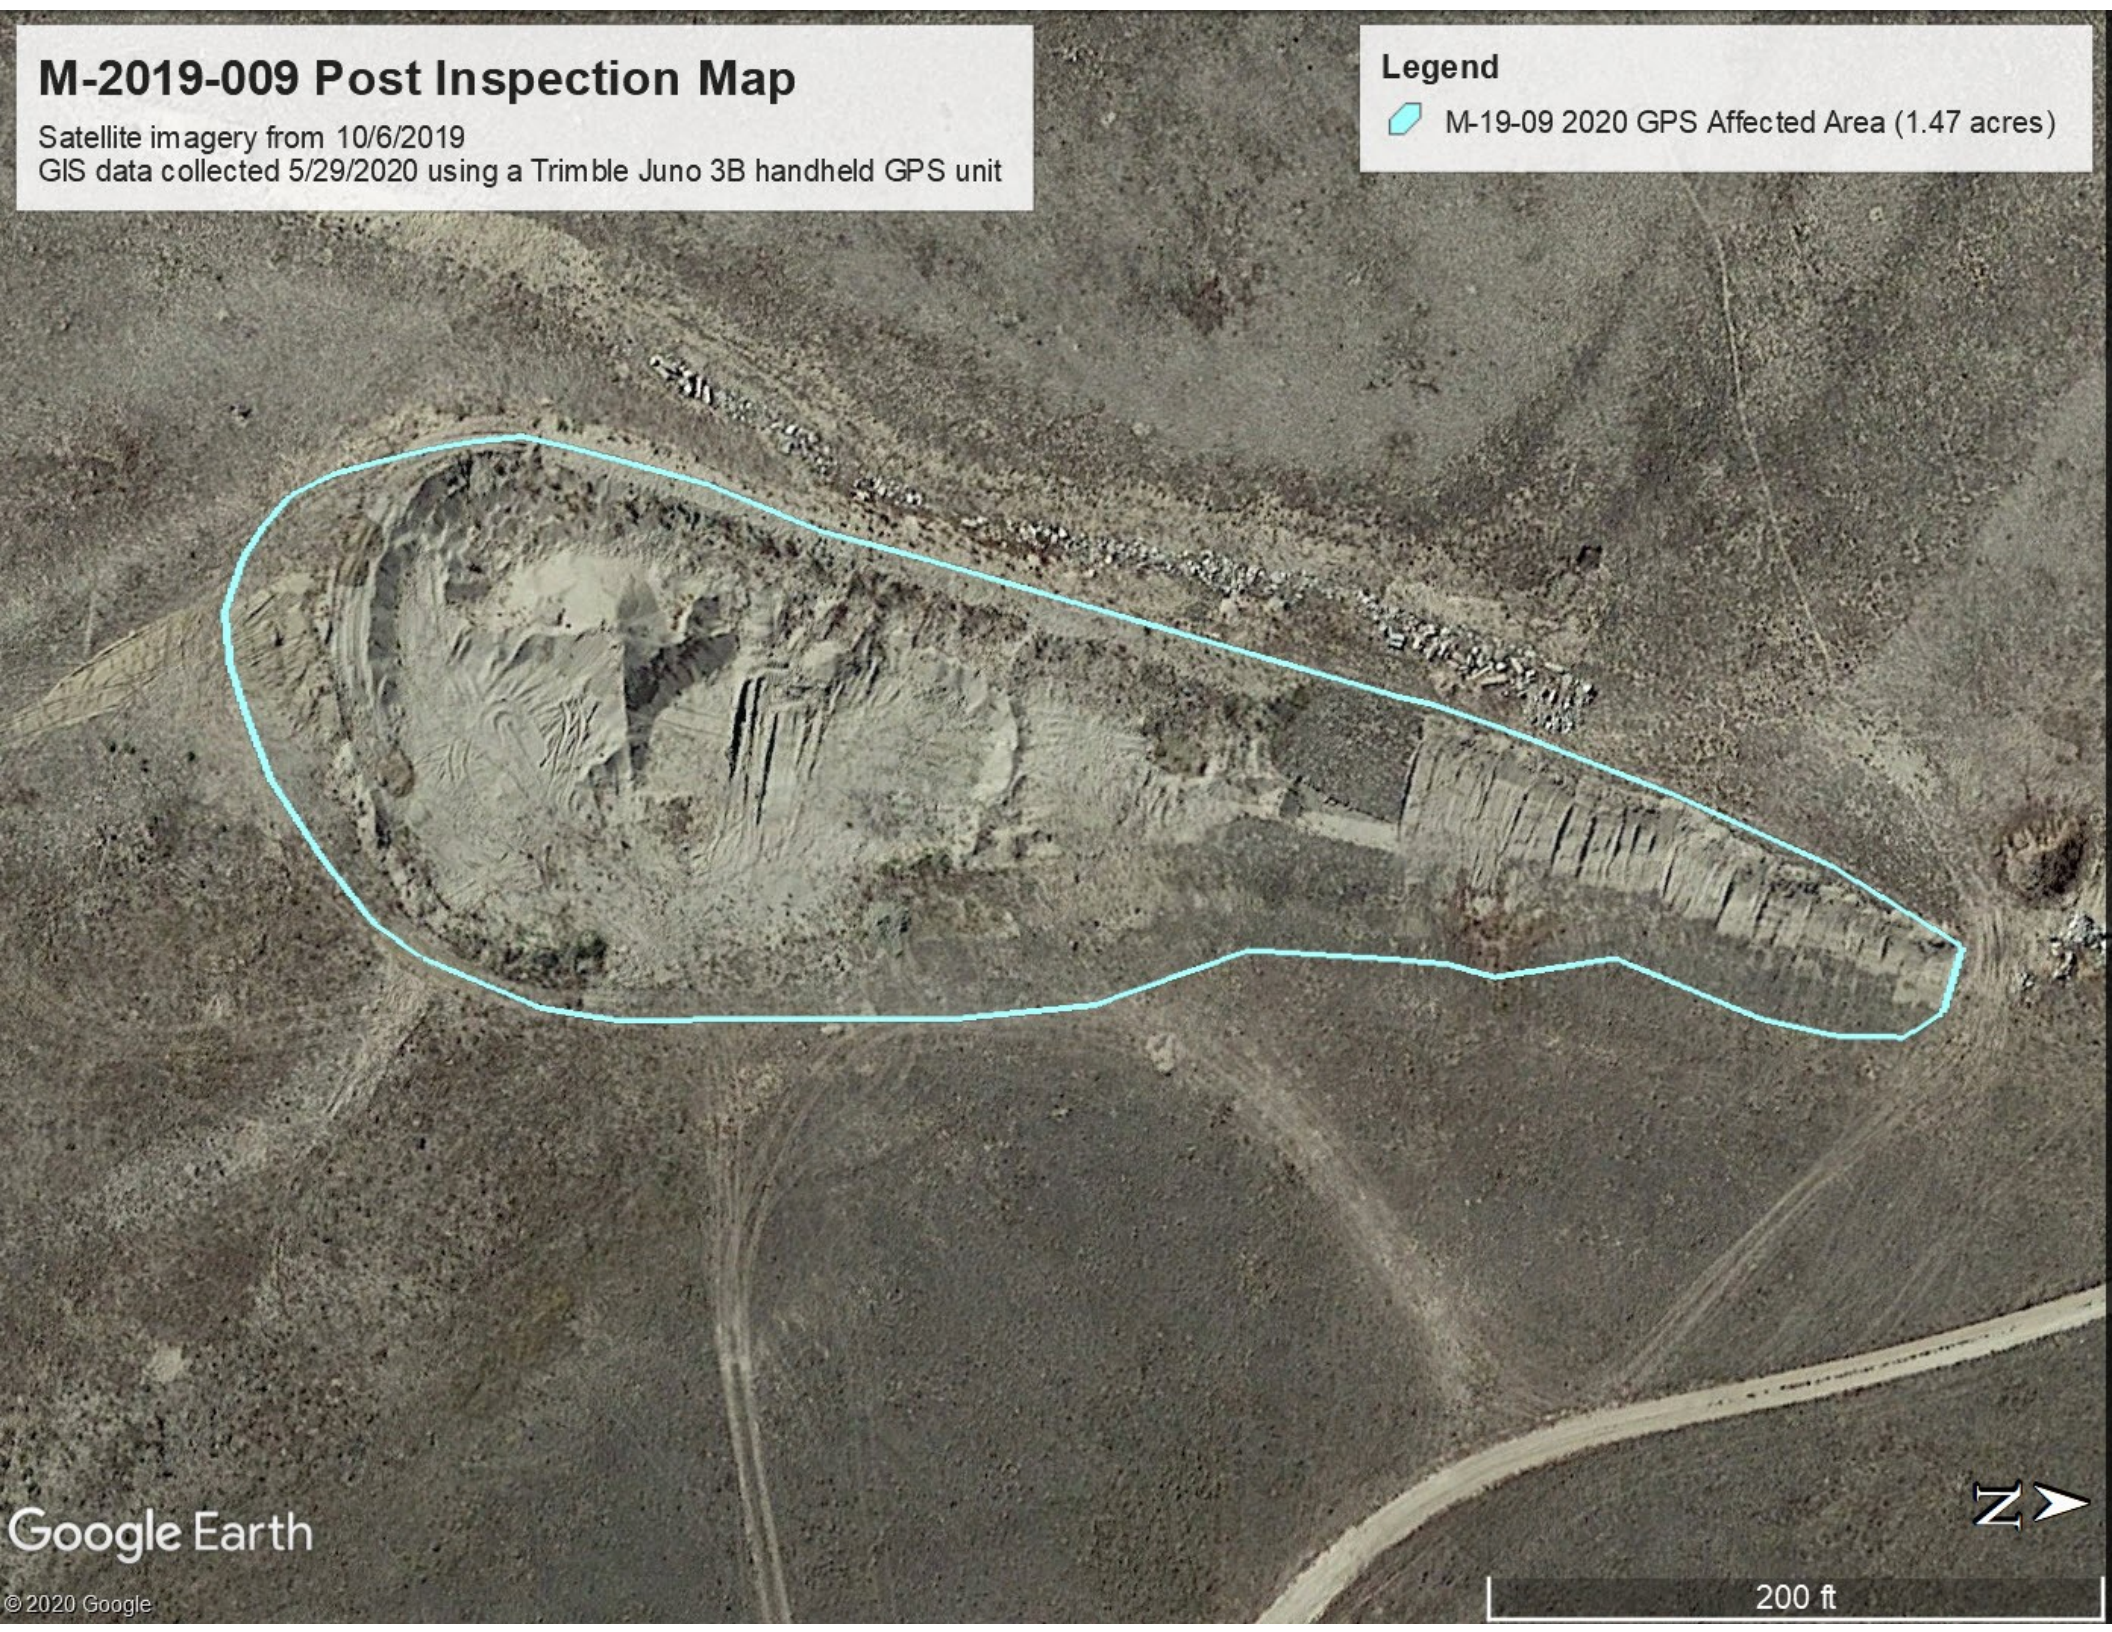
M-2019-009 Post Inspection Map

M-19-09 2020 GPS Affected Area (1.47 acres)
