MINERALS PROGRAM INSPECTION REPORT PHONE: (303) 866-3567

MINE NAME: Mitchell Mine No 1	MINE/PROSPECTING ID#: M-1986-025	MINERAL: Sand and gravel	COUNTY: El Paso
INSPECTION TYPE: Surety Release Inspection	INSPECTOR(S): Timothy Cazier	INSP. DATE: May 29, 2020	INSP. TIME: 14:45
OPERATOR: R E Monks Construction Co.	OPERATOR REPRESENTATIVE: Greigg Newlon	TYPE OF OPERATION: 110c - Construction Limited Impact

REASON FOR INSPECTION: Surety Release Requested	BOND CALCULATION TYPE: Partial Bond	BOND AMOUNT: \$11,500.00
DATE OF COMPLAINT: NA	POST INSP. CONTACTS: None	JOINT INSP. AGENCY: None
WEATHER: Cloudy	INSPECTOR'S SIGNATURE:

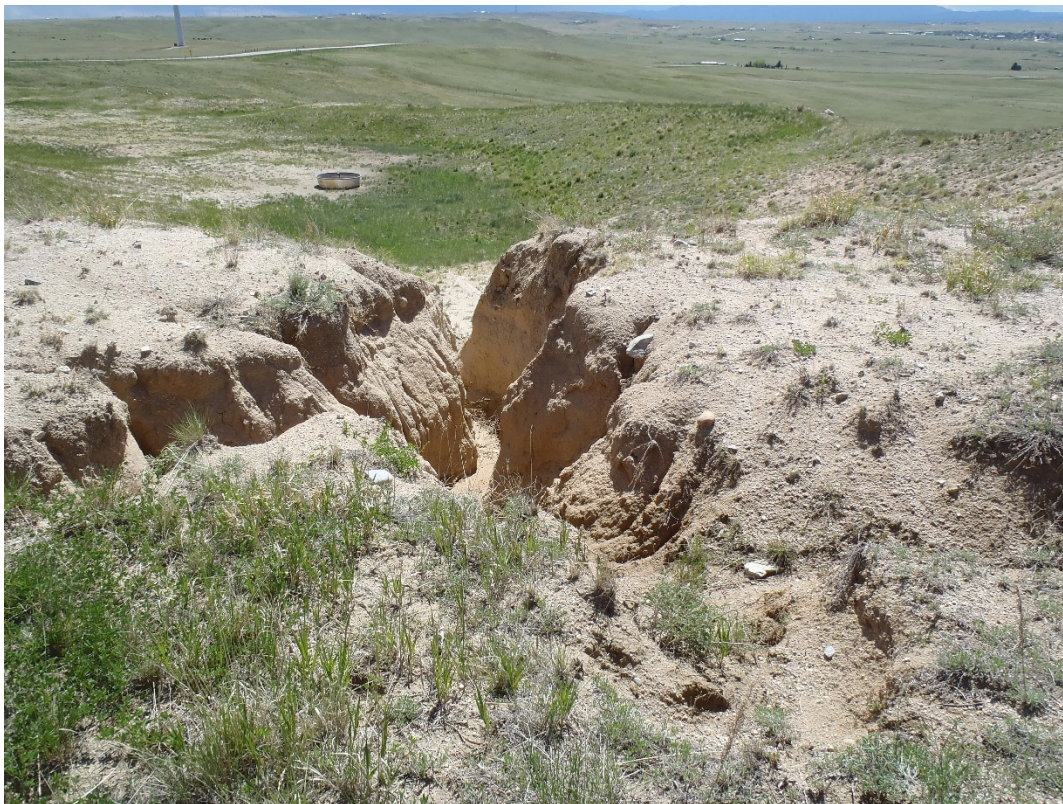
PROBLEM/POSSIBLE VIOLATION: Problem: Erosion gullies and ruts were observed on-site. This is a problem at this time for failure to protect the affected land from erosion pursuant to C.R.S. 34-32.5-116 (4) (j).

Revegetation: With the exception of the significant erosion area on the highwall (see **Photo 1**), the majority of the disturbed area has adequate vegetation (see **Photos 2 and 3**). The site soil is well drained and poses a challenge for revegetation efforts. Mr. Newlon stated the site had been seeded at least three times over the last 15 years, one of which was with a hydroseeder. Given the challenge to establishing vegetation, the Operator and the DRMS agree the repair/stabilization work necessary for the erosion gully should be done in such a way as to minimize disturbance to the surrounding slope. No noxious weeds were observed.

Sediment Control: A significant erosion gully (estimated to be 8 to 10 feet at its deepest section) was observed (see **Photos 1 and 4**). **The gully is cited as a problem on page 1 of this report** and is the reason the DRMS cannot approve the surety release request at this time. See Reclamation Success above for recommendations.

Photo 1. Observed erosion gully from highwall crest (looking SW, pit floor vegetation appears adequate).

CORRECTIVE ACTIONS: The operator shall provide photo documentation to the Division verifying erosion gullies and ruts have been repaired, and that the site has have been reconstructed and stabilized to prevent erosion damage by the corrective action date.

Reclamation Success: Grading is adequate for most of the historically disturbed two acres. However, a significant erosion gully was observed (discussed below). The approved reclamation plan, based on the March 18, 1986 Preliminary Adequacy Review response states no slopes will be steeper than 2H:1V and any slopes steeper than 3H:1V would be terraced or other erosion control methods used to stabilize the slope. Based on the site revegetation challenges, the DRMS recommends limiting the repair and stabilization effort for this gully to as localized area as practical, in order to minimize the area requiring re-seeding.

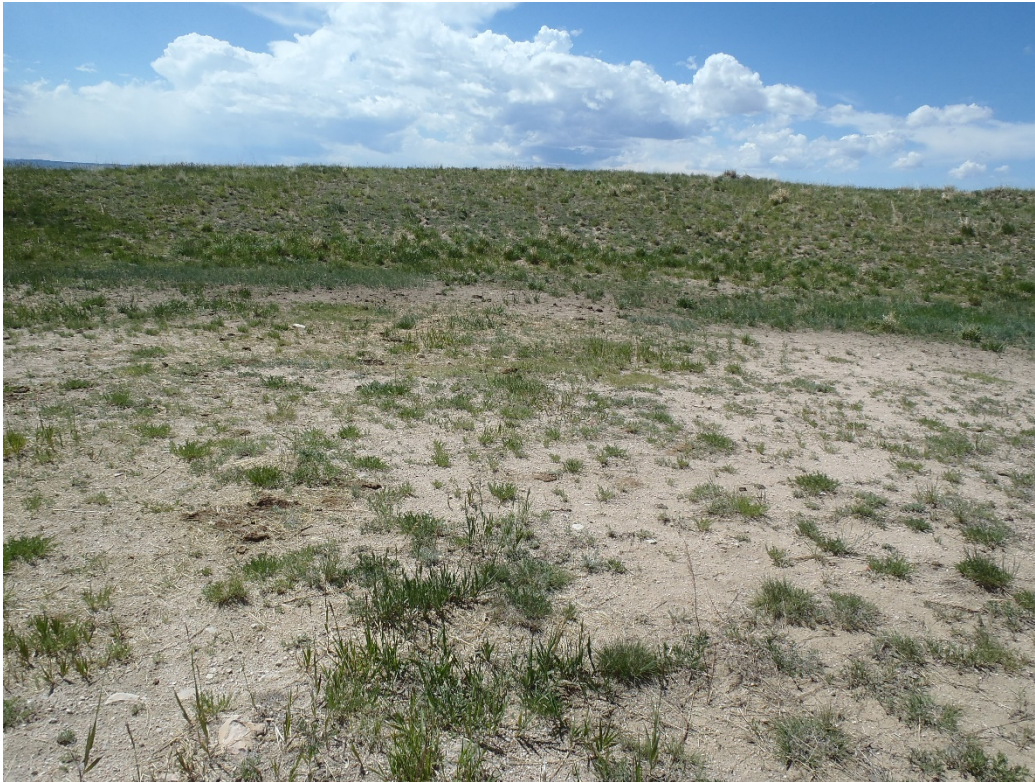
Photo 2. Pit floor and west slope vegetation (looking west).

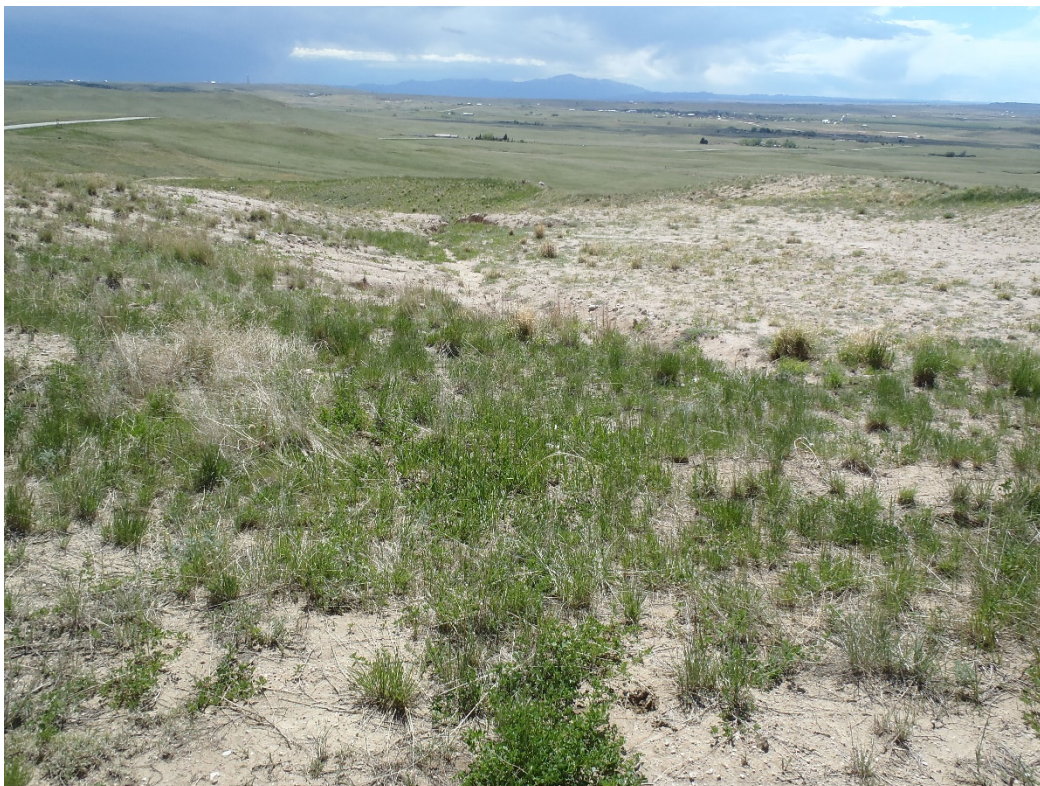
Photo 3. East pit slope and pit floor from highwall crest (looking SW).

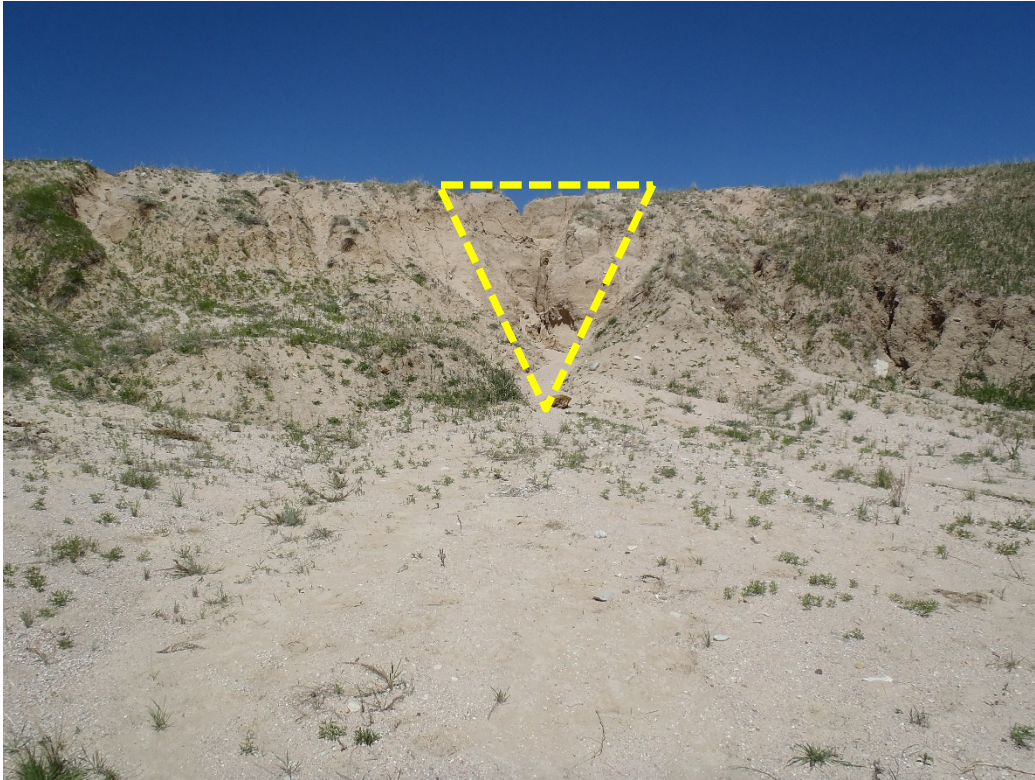
Photo 4. Observed erosion gully from highwall crest (looking NE – reveg on either side appears adequate).

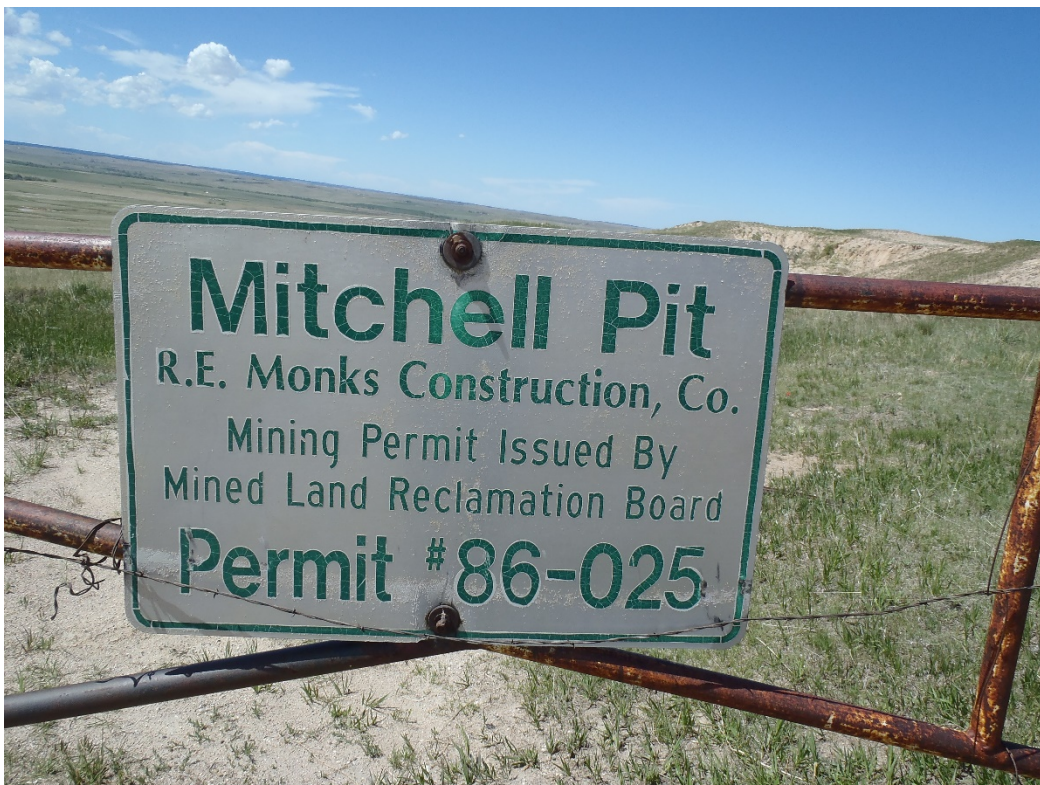
Signs and Markers: The permit sign was properly posted (see **Photo 5**).

Photo 5. Permit sign (at entrance).

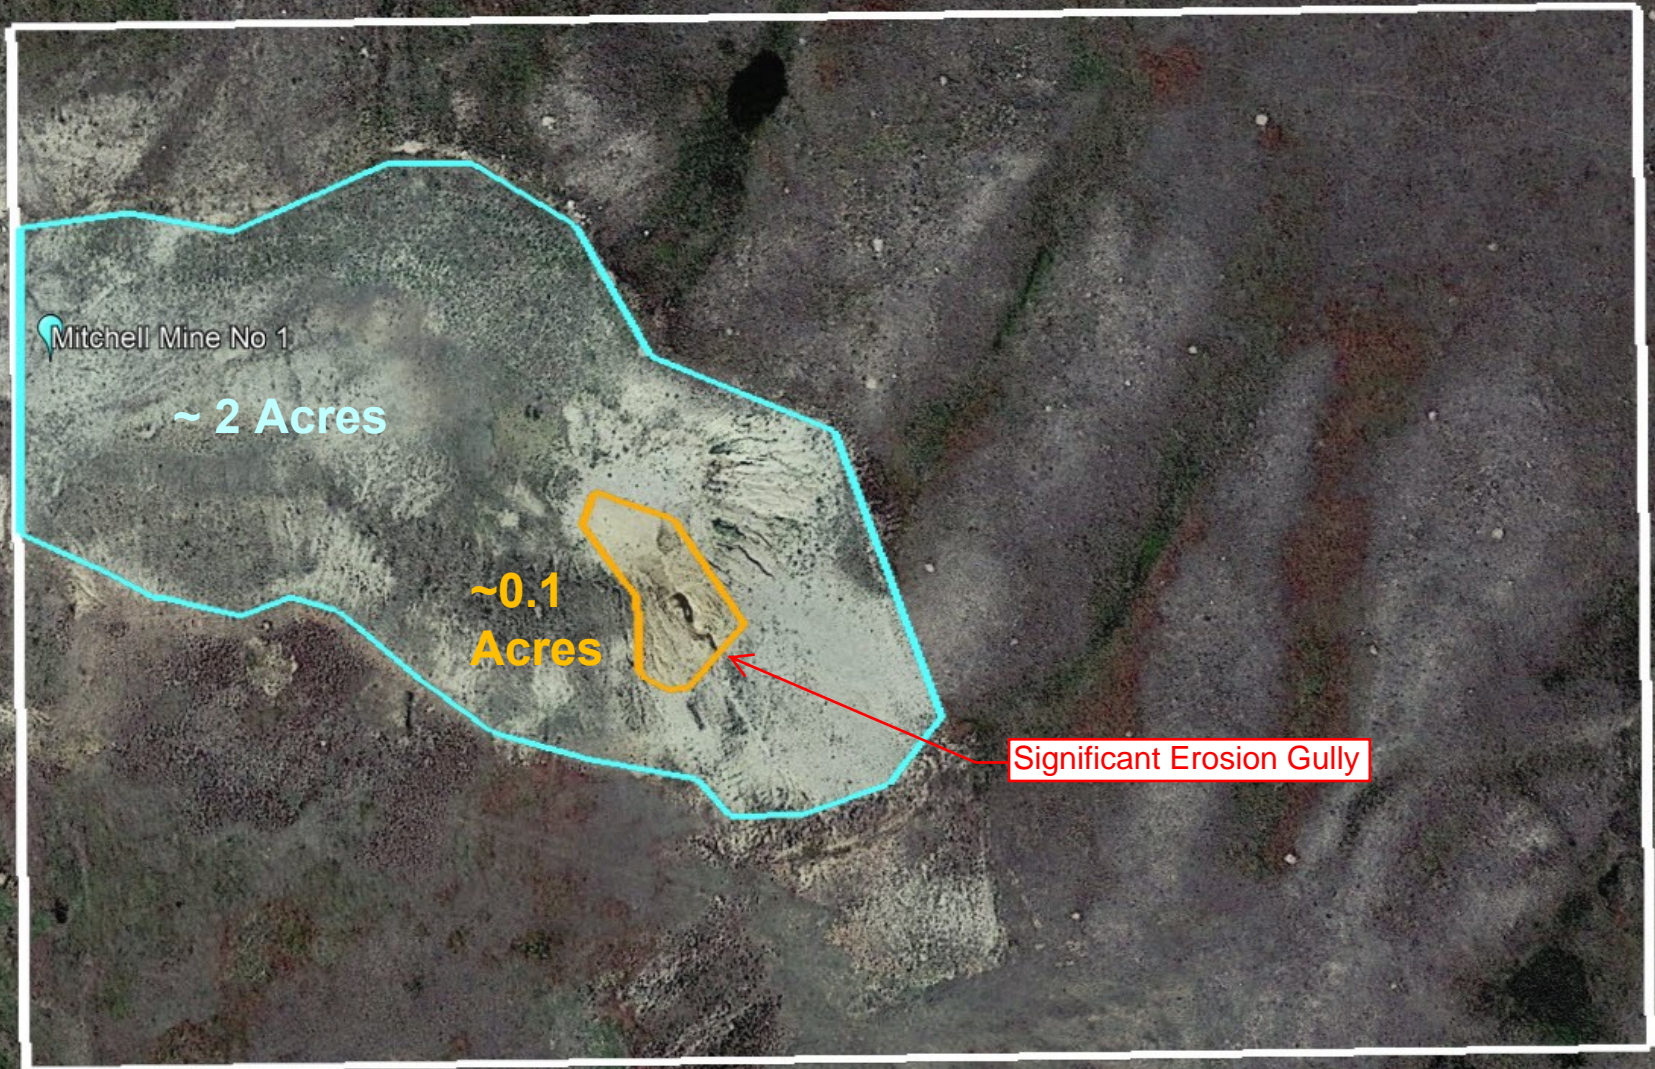
M-1986-025 Surety Release Post-Inspection Map

Gen. Compliance with Mine Plan: The operation appeared to have been in compliance with the approved mine plan. The maximum allowed disturbed area is 9.5 acres. Google Earth was used to measure the historically disturbed area, which was estimated to be approximately two acres, based on 2017 imagery (see attached **Post Inspection Map**). The additional acre of disturbance reported in the previous inspection was determined not to be related to mining and was observed to be revegetated. Mr. Newlon confirmed mining has ceased at the site, consistent with the request for a surety release.
