**MINERALS PROGRAM INSPECTION REPORT**  
**PHONE: (303) 866-3567**

| <b>MINE NAME:</b><br>Climax Mine | <b>MINE/PROSPECTING ID#:</b><br>M-1977-493 | <b>MINERAL:</b><br>Molybdenum | <b>COUNTY:</b><br>Lake, Summit |
| <b>INSPECTION TYPE:</b><br>Monitoring | <b>INSPECTOR(S):</b><br>Dustin Czaplá | <b>INSP. DATE:</b><br>June 10, 2020 | <b>INSP. TIME:</b><br>12:00 |

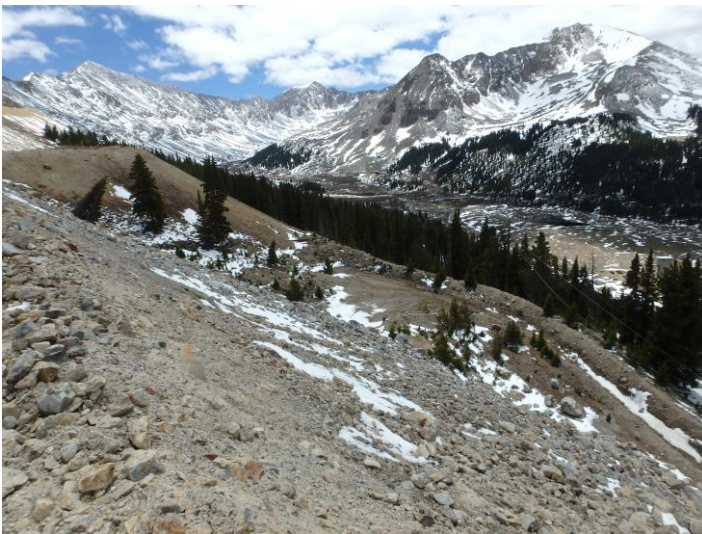
The Ceresco Seepage Collection System consists of a ditch constructed below the Ceresco Ridge haul road. The collection ditch intercepts potentially impacted water and routes it to the Camp drainage, and then to water treatment. The ditch was observed from above, viewed from the Ceresco Ridge haul road. Small snow patches were observed in the ditch, but no notable flowing water. No problems were noted in this area.

Ceresco Seepage Collection Ditch

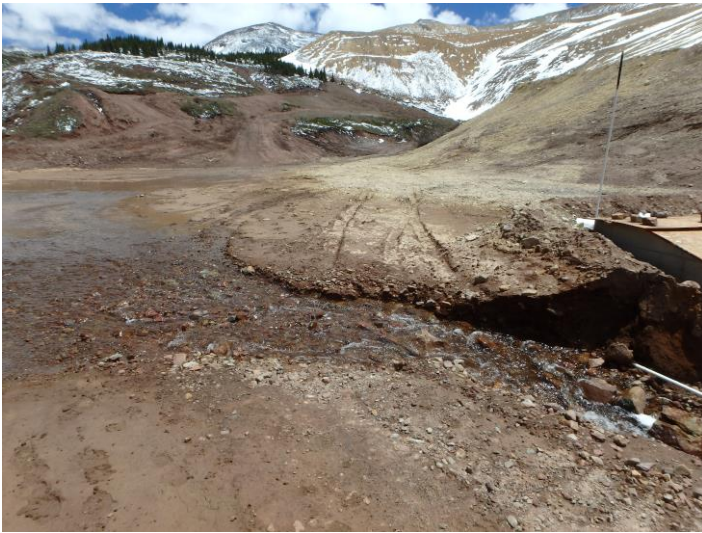
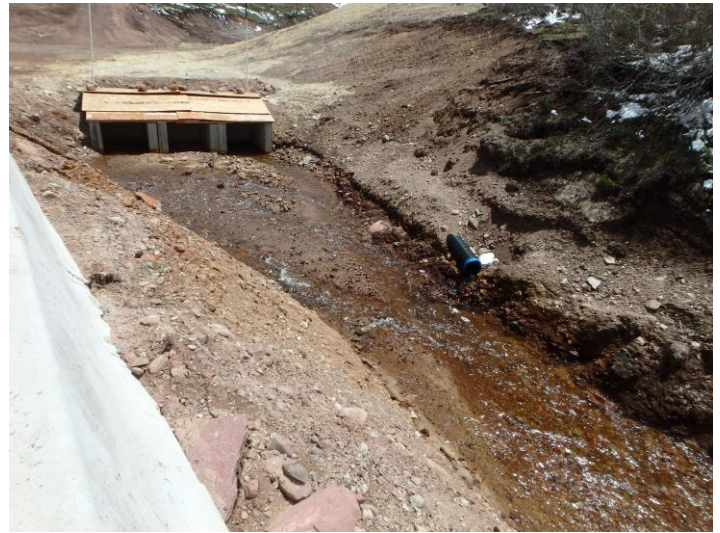
Climax reported to the Division on June 4, 2020 that the newly installed McNulty OSF underdrain system had failed to convey water as intended. The underdrain system was designed to collect contact water from the McNulty OSF and convey it through pipe to the McNulty Ditch, and then on to the SDP for first stage water treatment. It was found, by Climax staff, that contact water was bypassing the underdrain pipe and flowing into a secondary collection system, which collects other incidental contact water and flows through culvert under Hwy 91 and into the Tenmile tailings pond. The underdrain failure did not result in any discharge of contact water leaving the site and was contained within the greater Climax water treatment system. Climax has redirected flow into the McNulty ditch by constructing a small trench. The repair appeared effective for the short term. When runoff is complete, Climax will excavate the under drain inlet pipe. Graded riprap will be placed around the inlet pipe in order to allow surface water to enter the pipe directly. Climax is conducting daily inspections of the area until the improvements can be completed. No other problems were noted in the McNulty OSF area.

Surface water bypassing underdrain redirected into McNulty Ditch

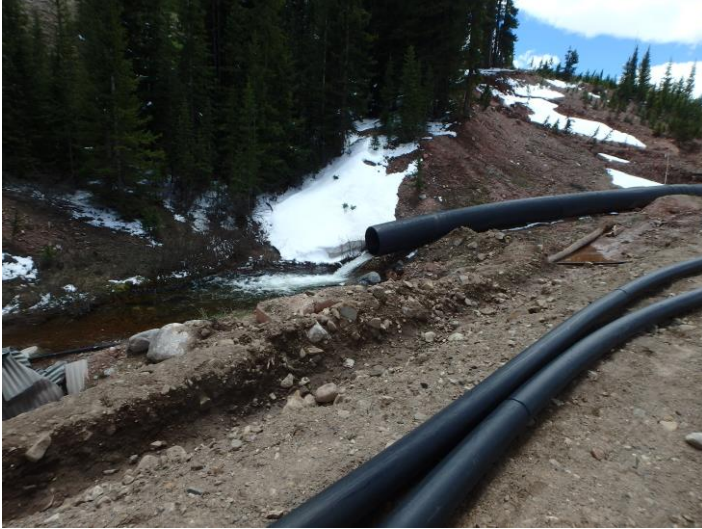
The East Interceptor conveys non-contact water to Clinton Reservoir. The interceptor consists of open channel, culverts and pipeline. Portions of the open channel were observed. No problems were noted with the East Interceptor.

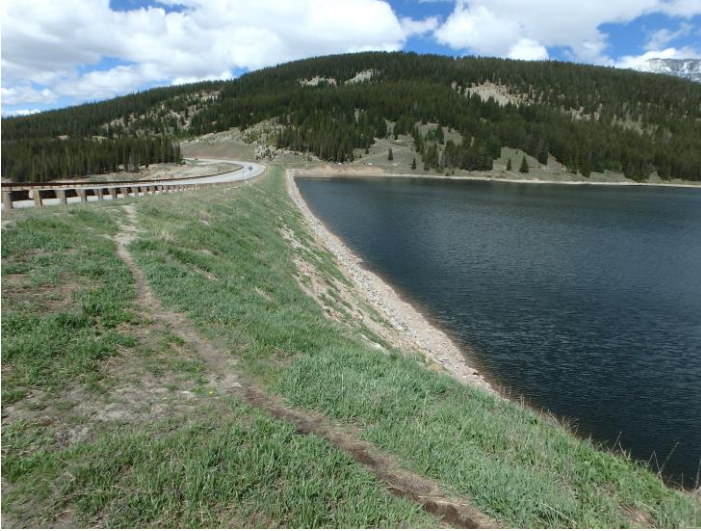
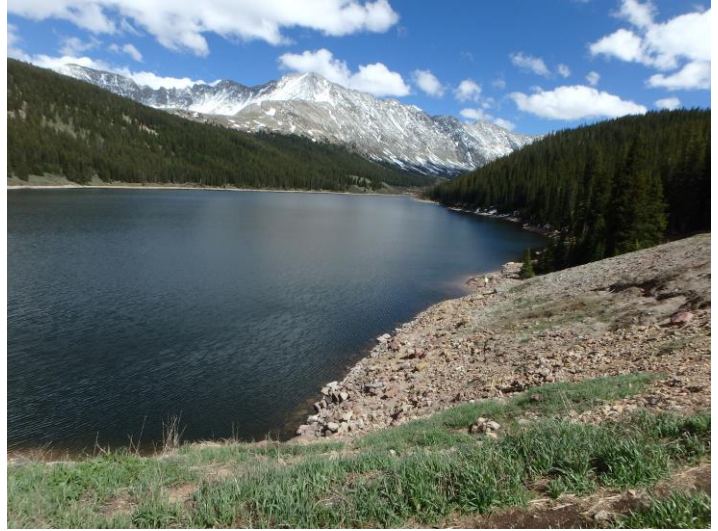
The Clinton Reservoir and Canal are considered part of the non-contact water interceptor system. The Clinton Canal consists of open channel and culverts, and conveys non-contact water from the reservoir to Tenmile Creek. The Clinton Reservoir was observed from Hwy. 91. The Clinton Canal and Clinton Dam were observed below the dam. No problems were noted in this area.

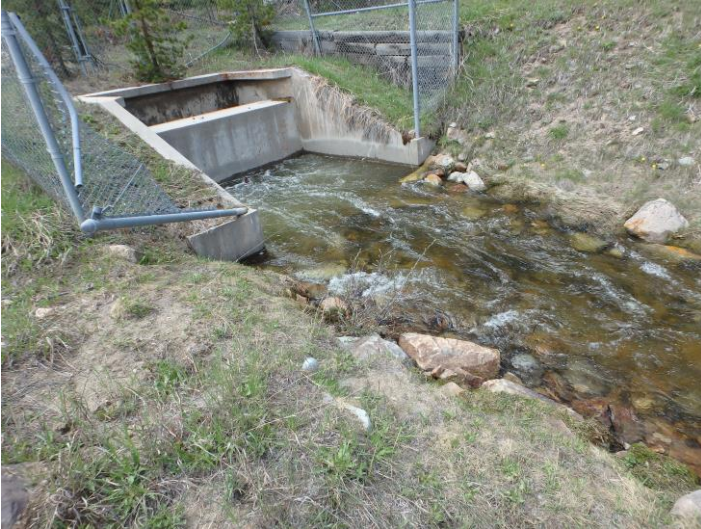
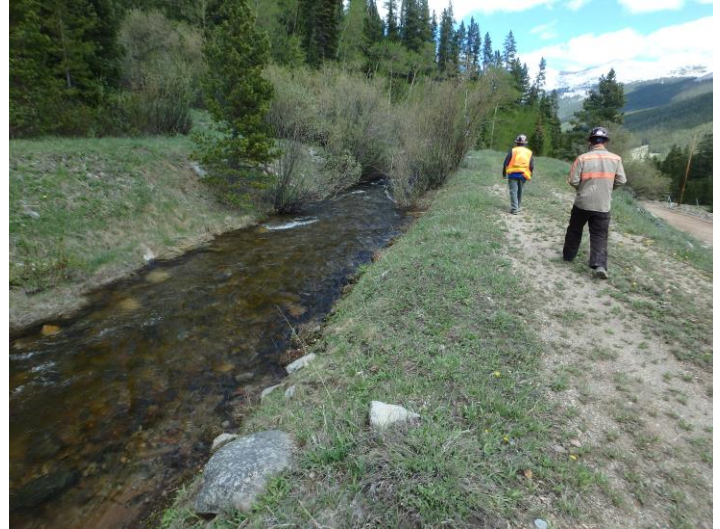
The West Interceptor captures non-contact water from the north side of the tailings ponds and conveys the freshwater east, around the mine area and into Tenmile Creek, just upstream of the PWDTP. The West Interceptor consists of open channel, pipeline and culverts. The West Interceptor was recently improved through plans approved by TR-28. For the most part, much of the West Interceptor flows along the road on the north side of the tailings area, so much of the interceptor was observed during this inspection. No problems with the West Interceptor were noted.

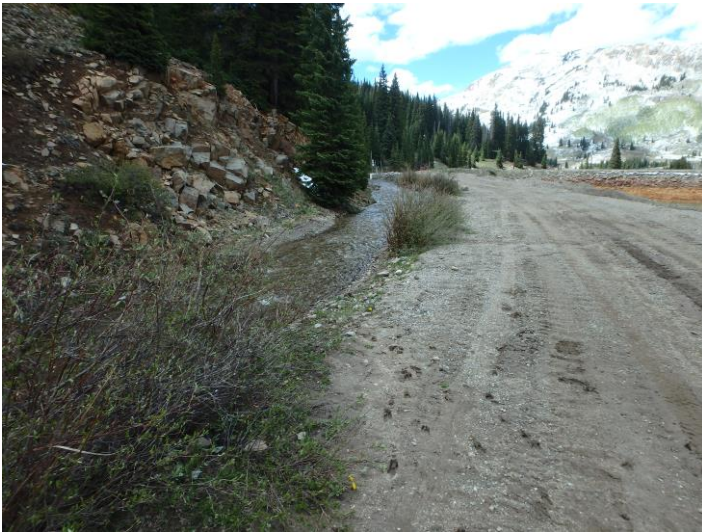
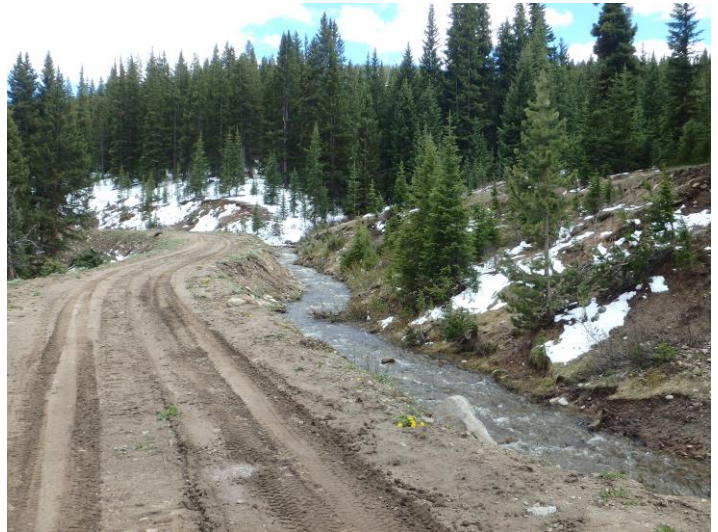
The Chalk Mountain Interceptor captures non-contact water from the Chalk Mountain drainages and conveys the freshwater to Chalk Mountain Reservoir. The Chalk Mountain Interceptor consists of open channel and culverts. The interceptor channel was observed along most of its reach, from the access road. No problems were noted with the Chalk Mountain Interceptor.
