COLORADO
Division of Reclamation,
Mining and Safety
Department of Natural Resources

Permit Number: C-1981-018 Mine Name: Deserado Mine Operator: Blue Mountain Energy, Inc. Operator Address: Mr. Kurtis Blunt 3607 County Road 65 Rangely, CO, 81648	County: Moffat, Rio Blanco Operation Type: Underground Permit Status: Active Ownership: Private
	Operator Representative Present: Kurt Blunt
Operator Representative Signature: (Field Issuance Only)

Inspection Start Date: June 9, 2020 Inspection Start Time: 10:05 Inspection End Date: June 9, 2020 Inspection End Time: 13:15		Inspection Type: Coal Complete Inspection Inspection Reason: Normal I&E Program Weather: Clear	
Joint Inspection Agency: None		Joint Inspection Contacts: None	
Post Inspection Agency: None		Post Inspection Contacts: None	
Inspector(s): Clayton Wein	Inspector's Signature: <i>Clayton Wein</i>		Signature Date: 6/18/2020

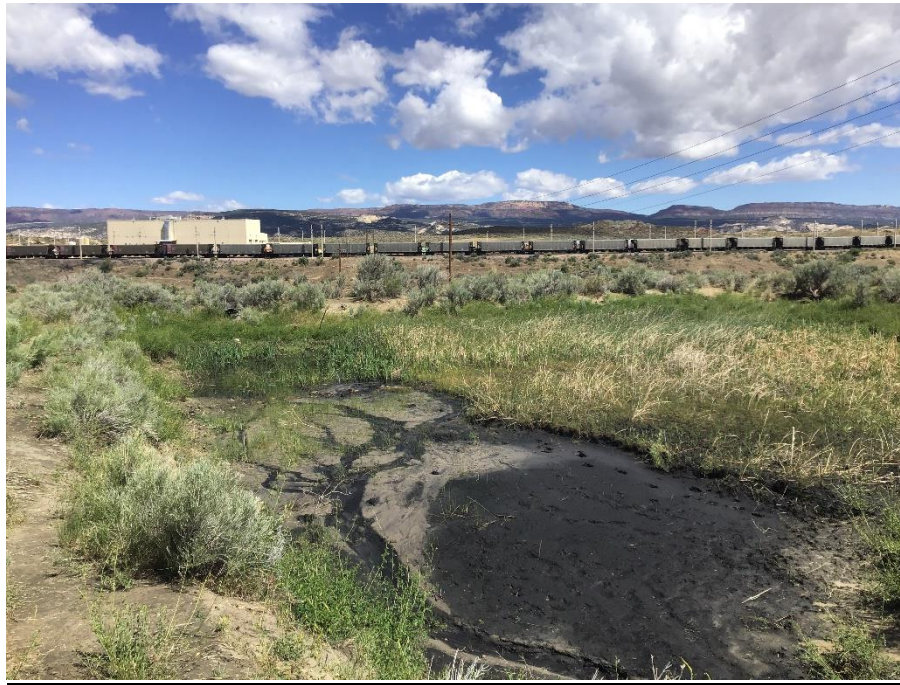
There are two sediment ponds located to the northwest (SS-2) and the north (SS-1). The SS-2 pond was dry at the time of the inspection. The embankment was stable and vegetated. There were no erosional features. The primary and emergency spillway were unobstructed. The SS-1 pond was damp (Photo 1). The embankments of the pond were stable with vegetation. No erosional concerns were noted. The spillways were clear of debris. The culvert inlet to the pond was unobstructed.

Photo 1: The SS-1 Pond.

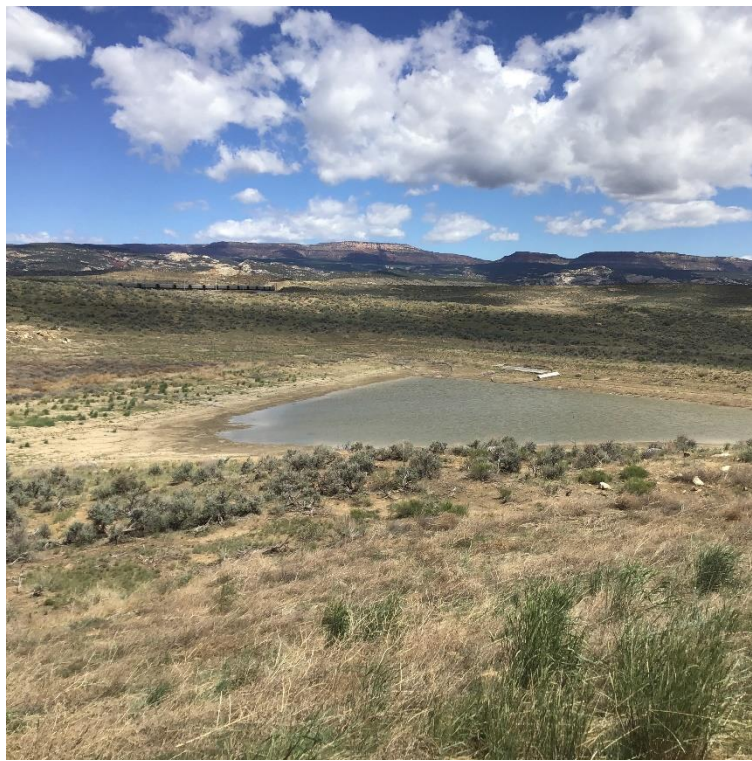
The B Seam Dewatering System No. 2 was not actively pumping during the inspection. The First cell was holding water. The level of the water in the cell had not reached the spillway. The embankments were vegetated and stable. No erosional features were observed. The spillway was clear of debris. The second cell of the system was also holding water (Photo 2). There was no discharge occurring. The embankment was stable with vegetation. No erosional concerns were identified. The spillways were unobstructed. The third cell of the system remains unused.

Photo 2: The second cell of the B Seam Dewatering System No. 2.

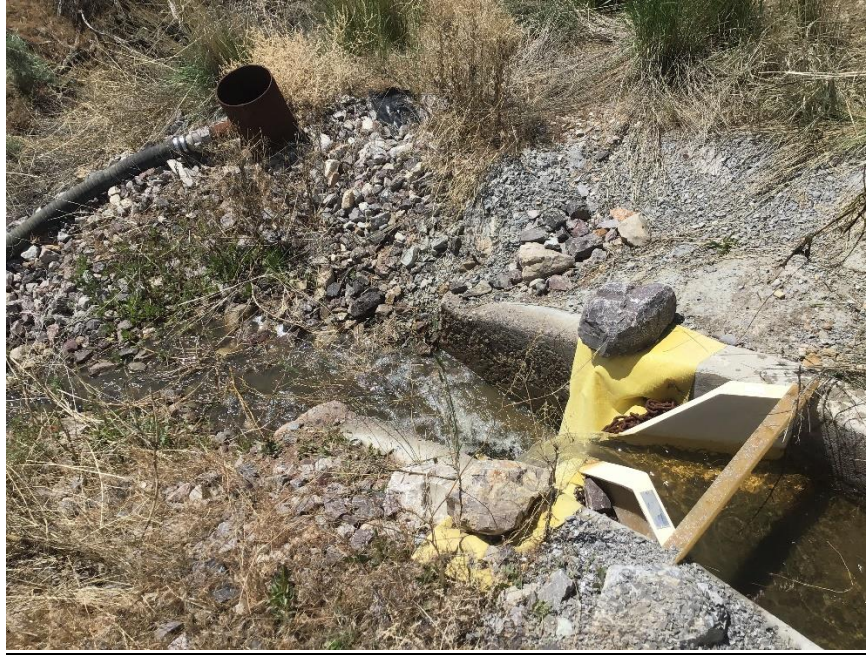
The B Seam Dewatering System No. 1 was impounding water in all of its cells. All cells of the system were full and the Last Chance Pond was discharging (Photo 3). The embankments of all the cells in the system were stable with vegetation. There were no indications of erosion. The spillways were clear of obstructions.

Photo 3: The outlet of the Last Chance Pond.

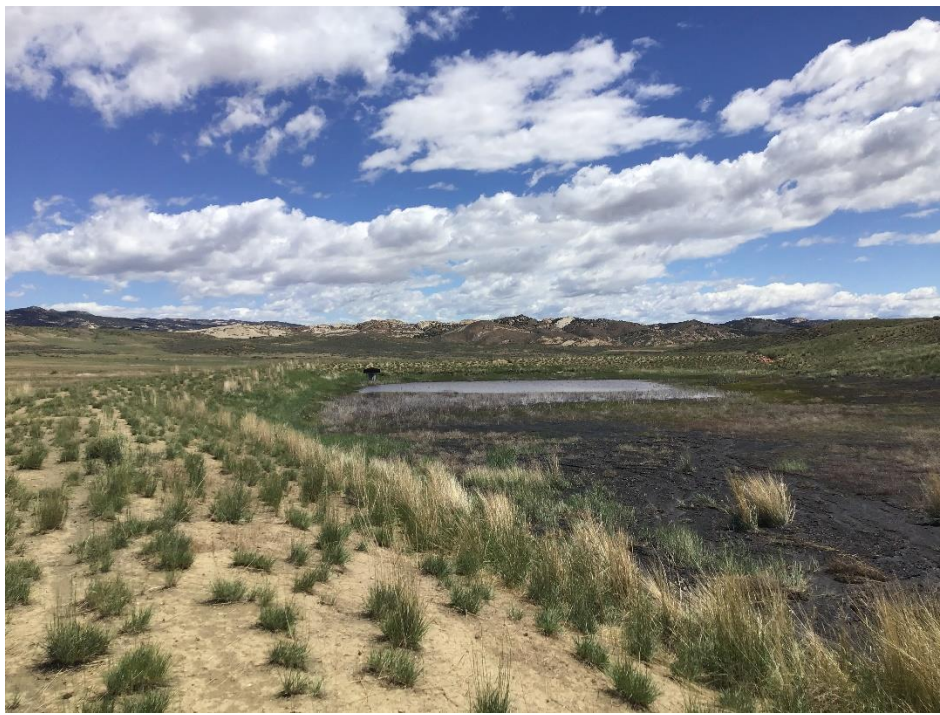
Two ponds are located at the northern base of the RP-2/3/4 refuse pile. The RP-2/3 Pond at the northeast corner and the RP-4 Pond at the northwest corner. The RP-2/3 Pond consists of three cells; the west cell, the main cell and the east cell. At the time of the inspection only the east cell was holding water. The west cell and the main cell were dry. The embankments of the cells were stable with vegetation. There were no indications of erosion. The spillways into the main cell were stable and unobstructed. The primary and emergency spillway for the main cell were clear of debris. The RP-4 Pond was holding a small amount of water (Photo 4). There was no discharge from the primary spillway. The spillways were unobstructed. The embankments were stable with vegetation. No erosional features were identified.

Photo 4: The RP-4 Pond.

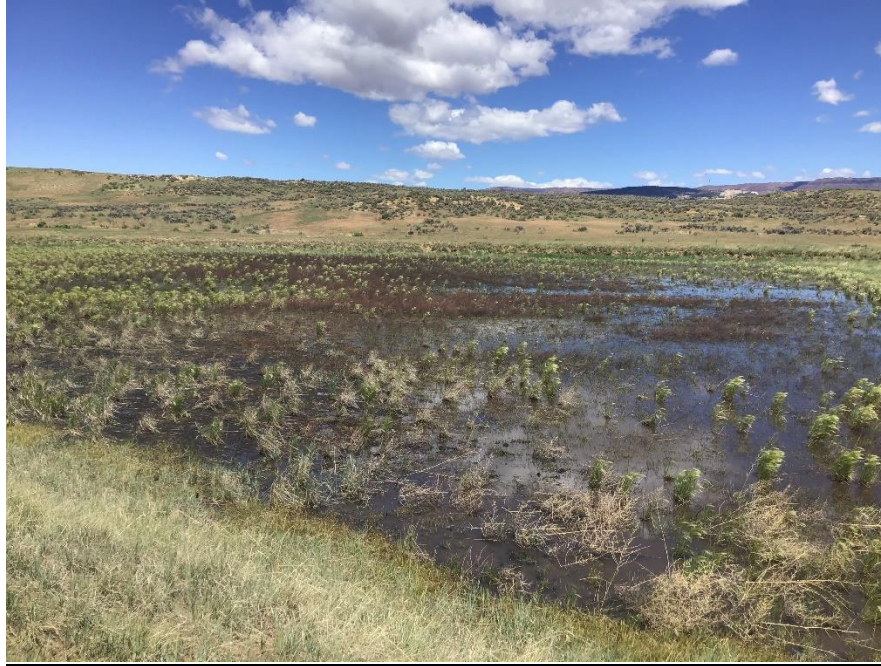
One pond is located at the northwest base of the RP-5a refuse pile (Photo 5). The pond was holding some water during the inspection. The level of water in the pond was below the primary spillway. The embankment was stable and vegetated. There were no erosional features identified. The spillways were unobstructed.

Photo 5: The RP-5 Pond.

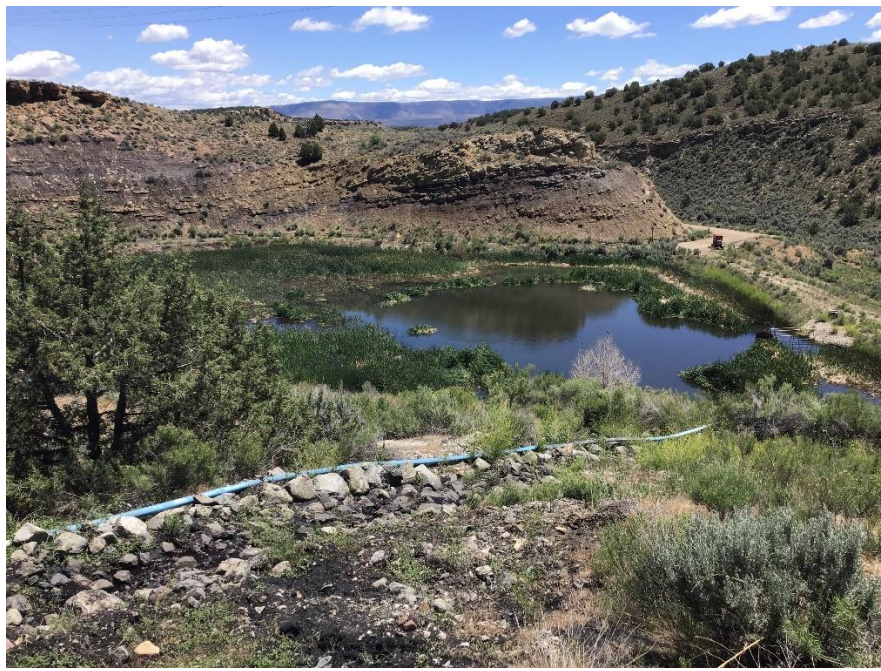
Three ponds are located at the main facilities area; the DP-1 Pond (Photo 6), the PP-1 Pond and the PP-2 Pond. The DP-1 pond was impounding water. The level of the water had reached the primary spillway and was discharging. The spillway was unobstructed. The emergency spillway was also clear of debris. The embankment of the pond was stable with vegetation. There were no indications of erosion. The PP-1 Pond was full at the time of the inspection. The embankments were vegetated and stable. There were no erosional features noted. The spillway for the pond was clear. The PP-2 Pond was holding water. The spillways were clear of debris. The embankment was stable with vegetation. No erosional concerns were identified.

Photo 6: The DP-1 Pond.

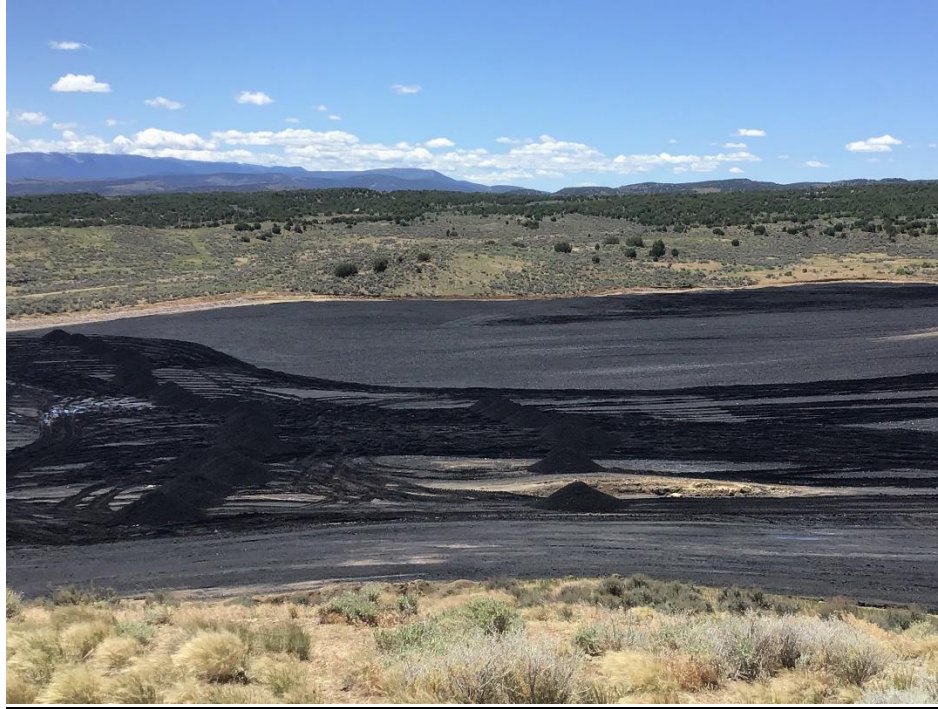
Refuse had been placed at the new refuse area, RP-A (Photo 7). Refuse had been placed on the base of the pile for drying. Some refuse material has been spread and will be compacted to create the designed base for the pile. The site was stable and there were no erosional features identified.

Photo 7: The refuse creating the base of the RP-A refuse Pile.

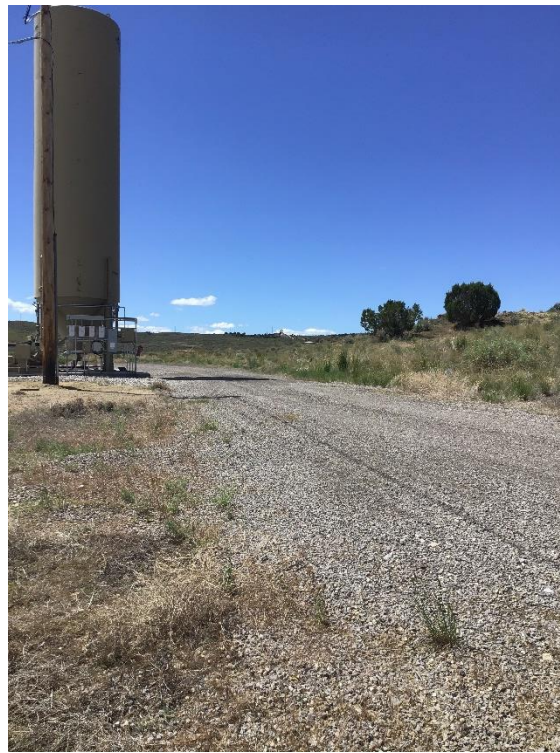
Photo 8: RDH-4.

Support facilities inspected were in good repair. The pads were observed to be stable and there were no erosional features identified. The berms on the pads were stable with vegetation. No off site impacts were observed.

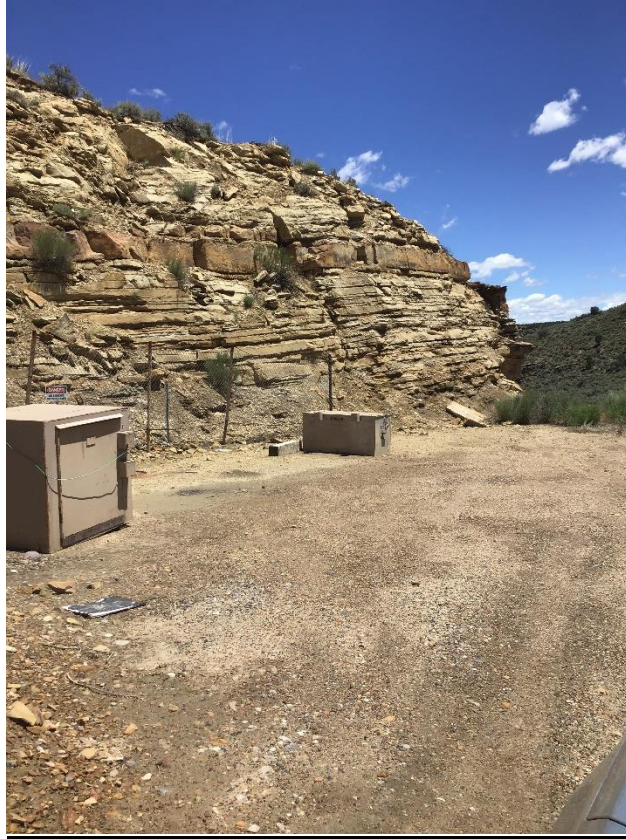
Photo 9: The explosives storage.
