## QUARTERLY SEDIMENTATION POND INSPECTION REPORT

Mine: New Elk

Inspection Period: Second Quarter 2020

**QUARTERLY SEDIMENTATION POND INSPECTION REPORT**  
**New Elk Mine- June 2, 2020**

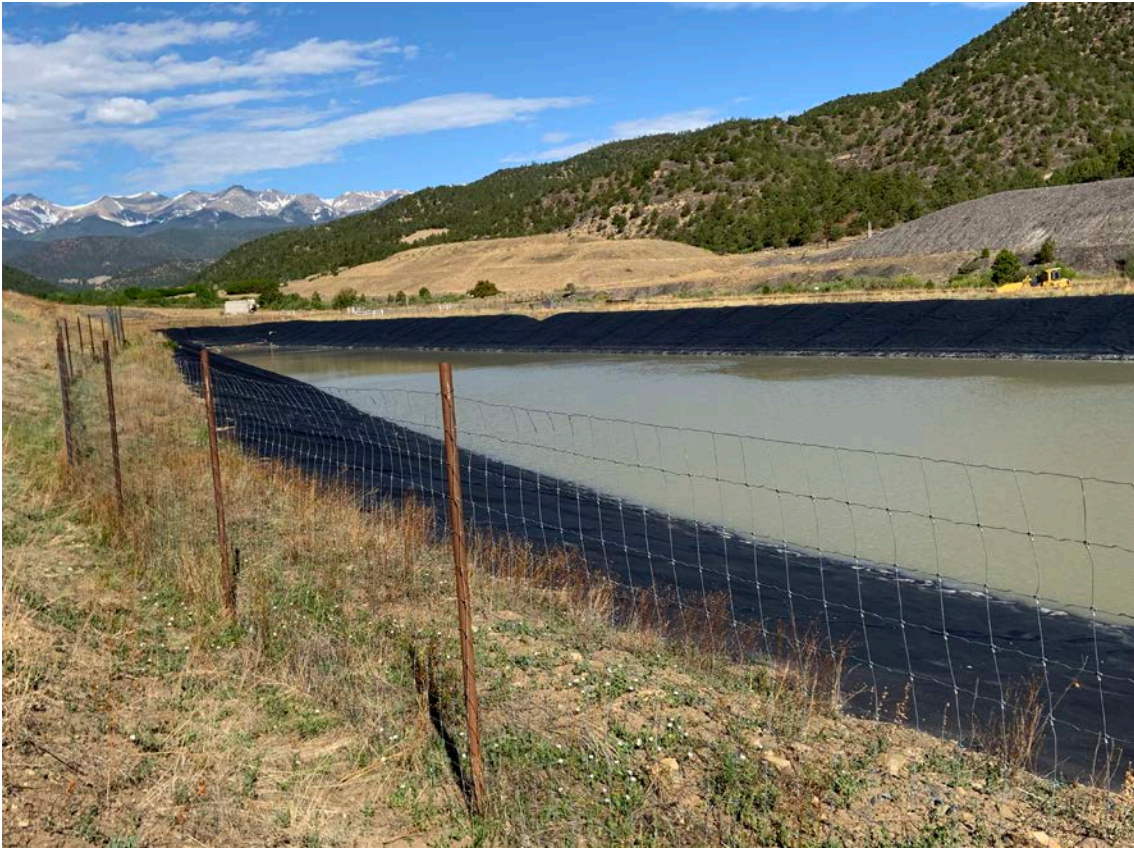
**Pond 1**

This pond is located West of the industrial building and serves as a mine water settling and water storage pond.

Pond liner is in good condition at time of inspection. Pond was holding water at time of inspection.

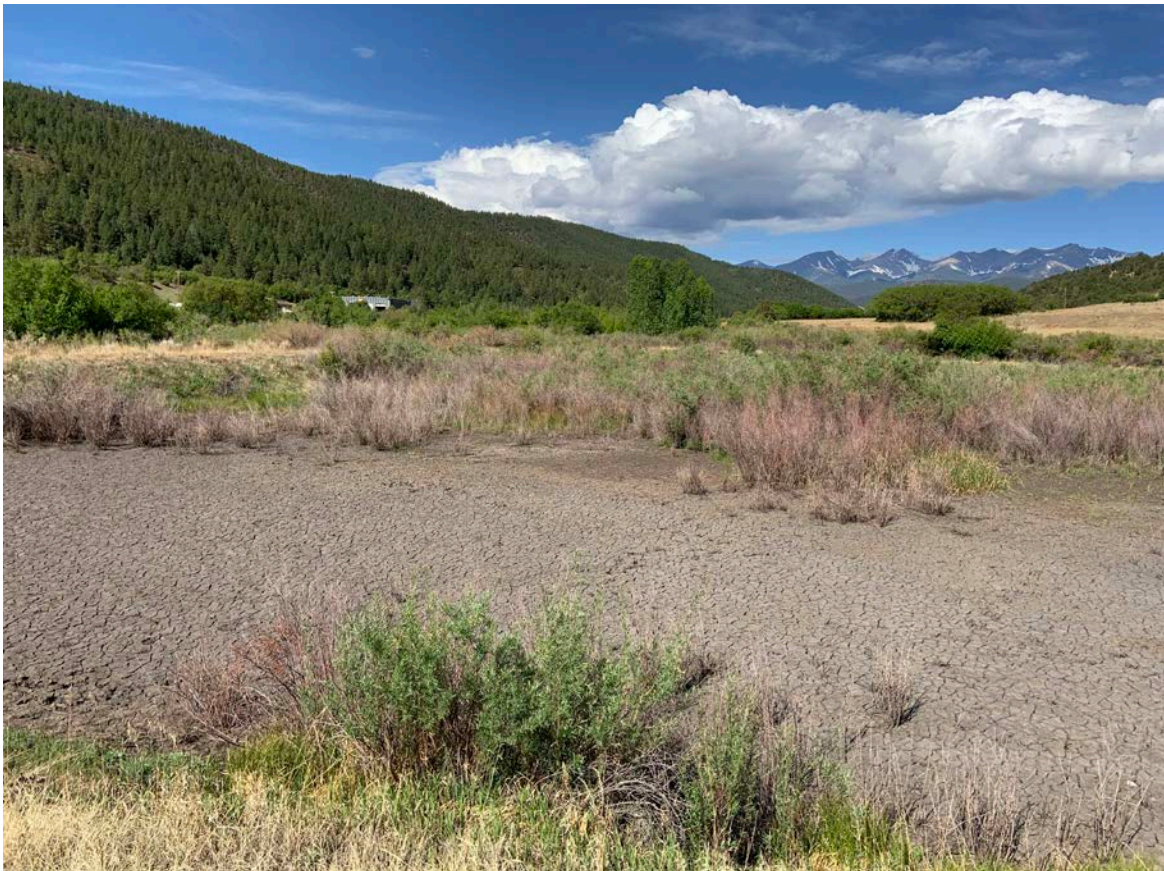
**Pond 4**

This sediment control pond lies west of the Development Waste Pile. The majority of run-off from this waste pile flows to this pond. It has never received sufficient inflow to discharge.

Pond was empty at time of inspection.

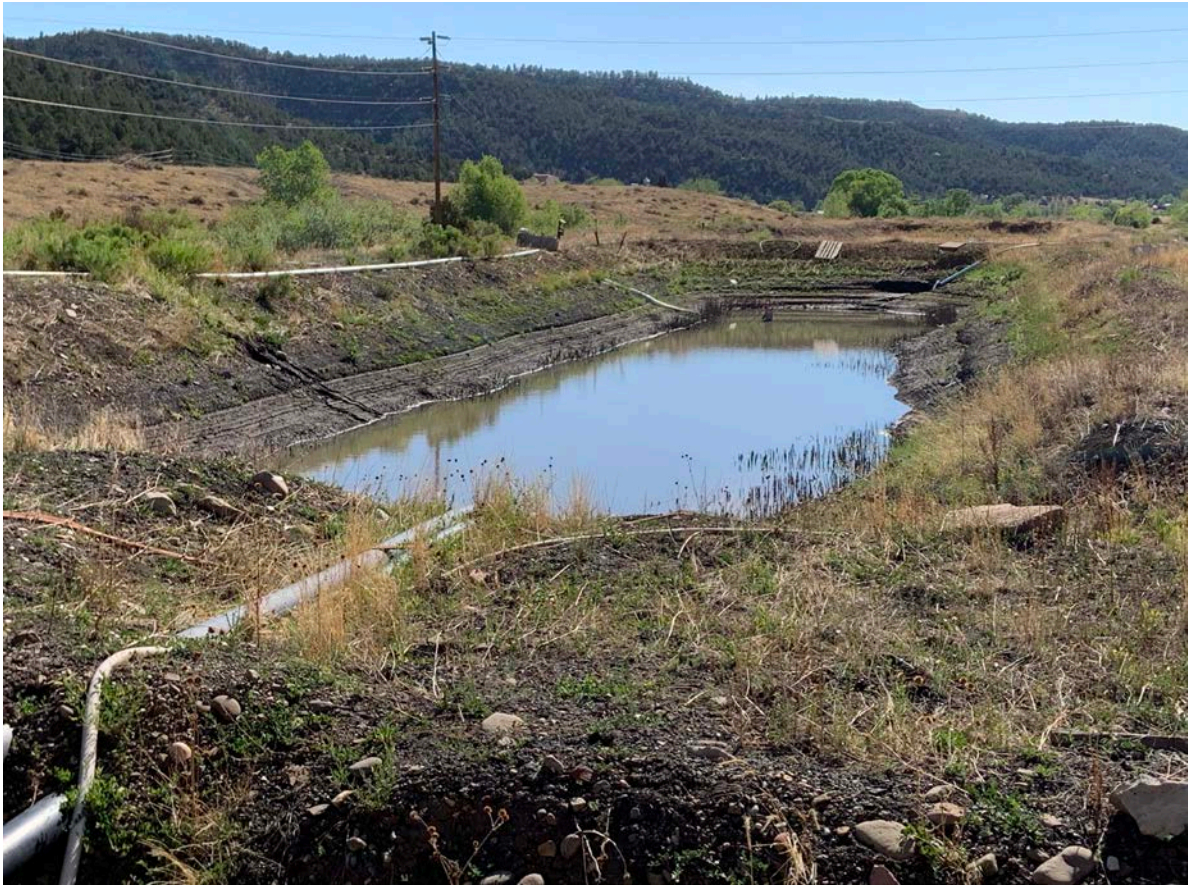
**Pond 6**

Pond 6 is a non-discharging facility designed to contain plant processing water. The plant has been idle since 1996 and the pond is now used to dewater other ponds prior to clean-out

Pond is holding a very small amount of water, not close to full.

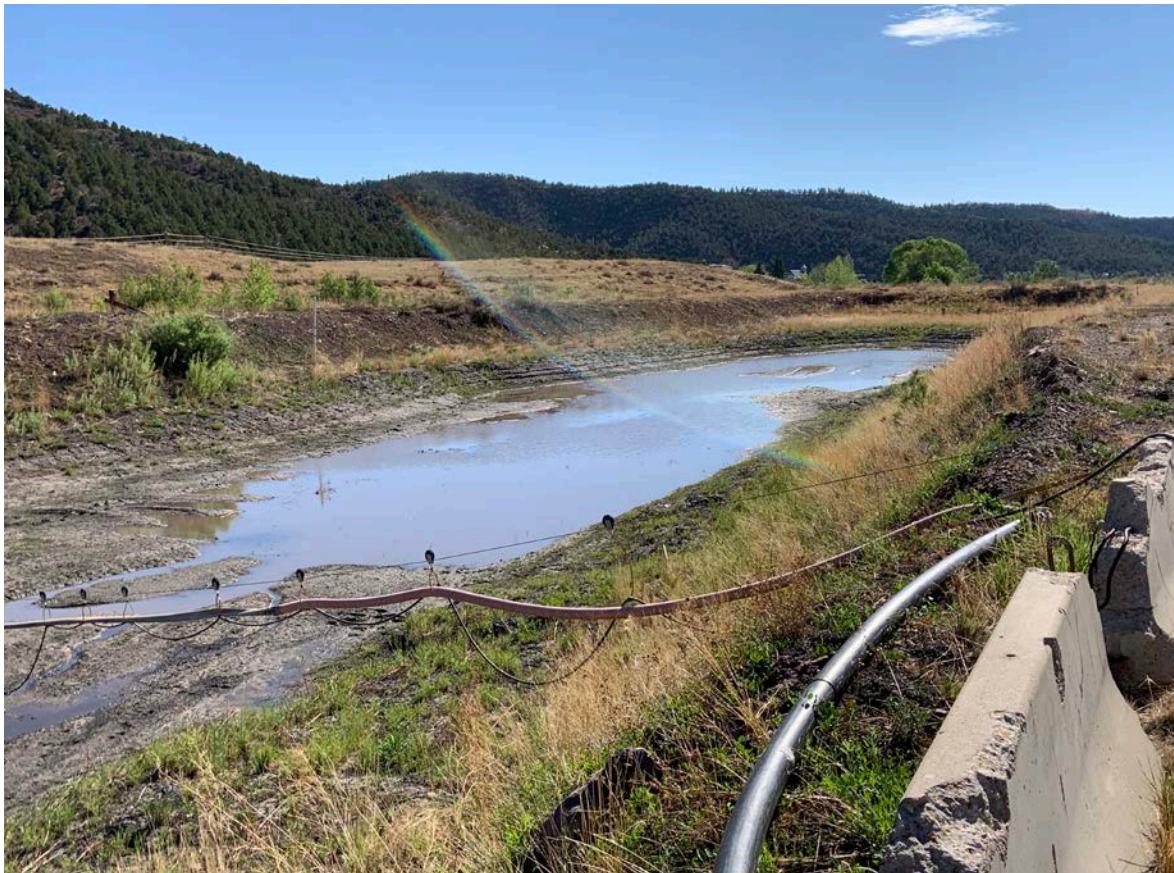
**Pond 7**

This sediment control pond lies east of the preparation plant and pond #6. It receives run-off from the majority of the active surface facilities area lying south of State Highway 12.

Explain: Visual observation. Pond cleaned in early 2017.

Pond is holding a very little amount of water, not near the level of the decant.

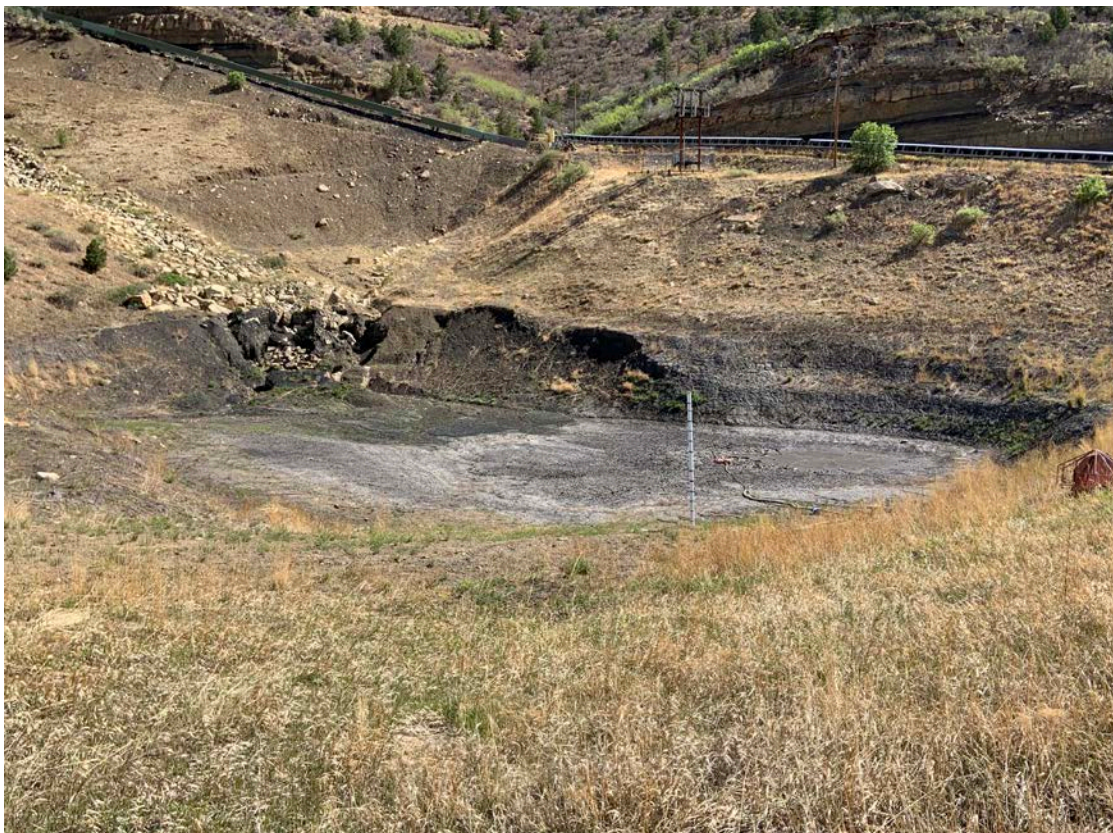
**Pond 8**

This pond lies north of Highway 12 at the base of the refuse disposal area. The pond receives run-off from the refuse disposal area.

Explain: Visual observation. Sediment cleaned out in May 2018

Pond was empty at the time of inspection. No new sediment has been deposited and there is

very little sediment in the pond.

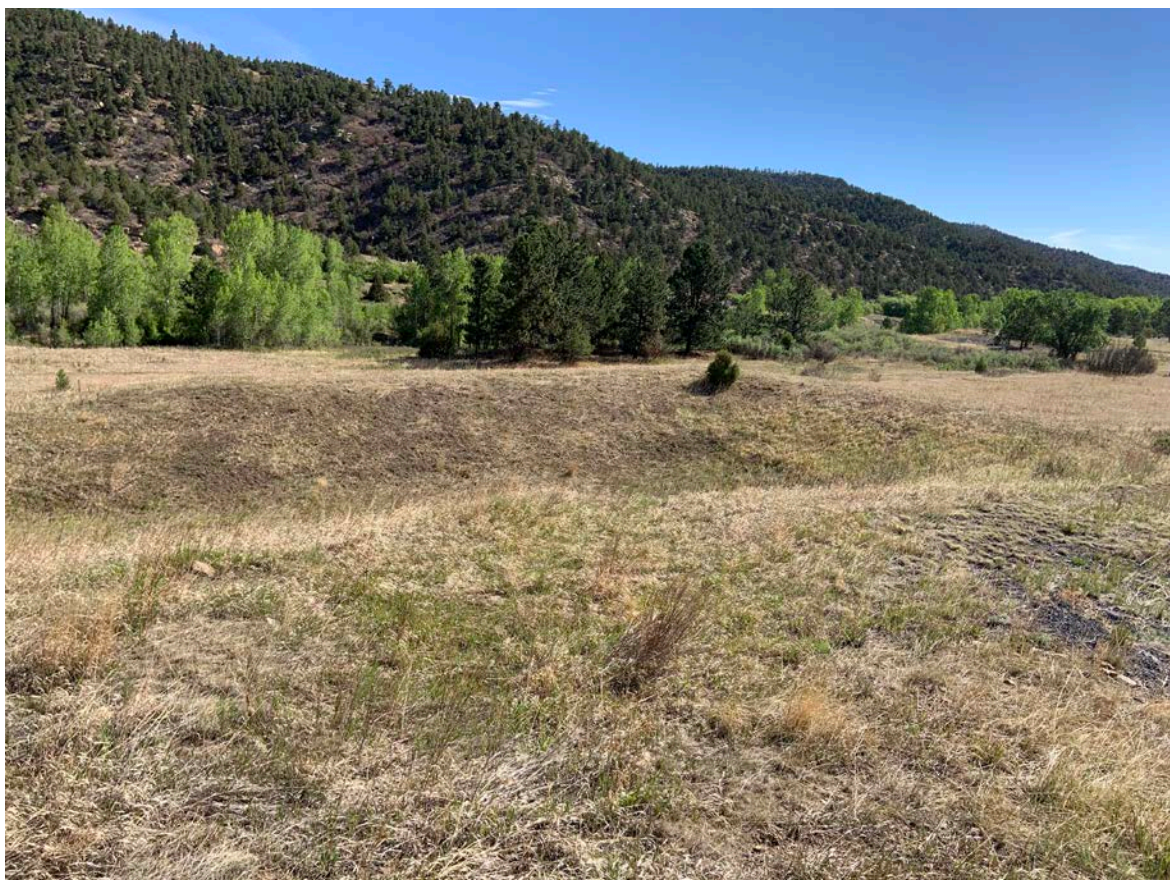
**Containment Area #1**

This containment basin is a non-discharging facility designed to contain run-off from the West Portal Warehouse area.

Containment area was empty at time of inspection.

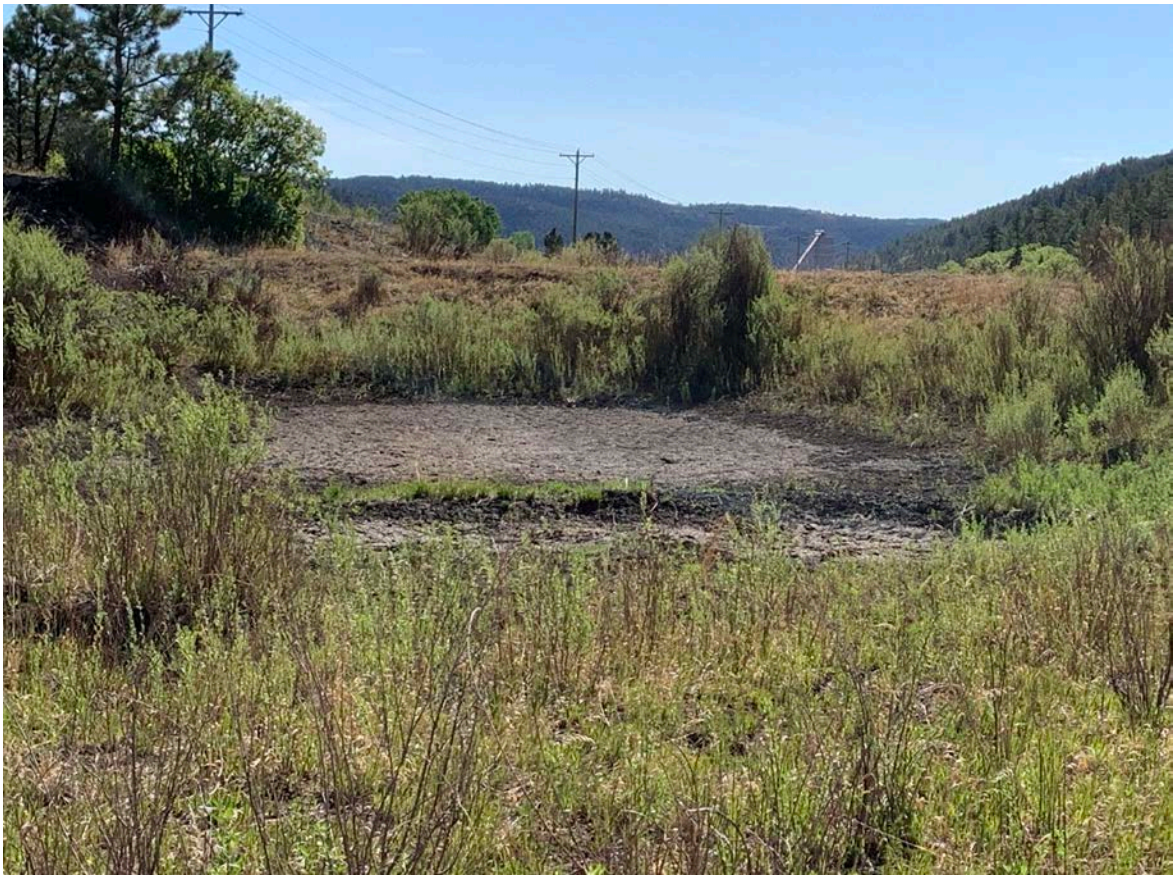
**Containment Area #2**

This containment basin is a non-discharging facility designed to contain run-off from the West Portal airshaft and manway areas.

Containment is empty.

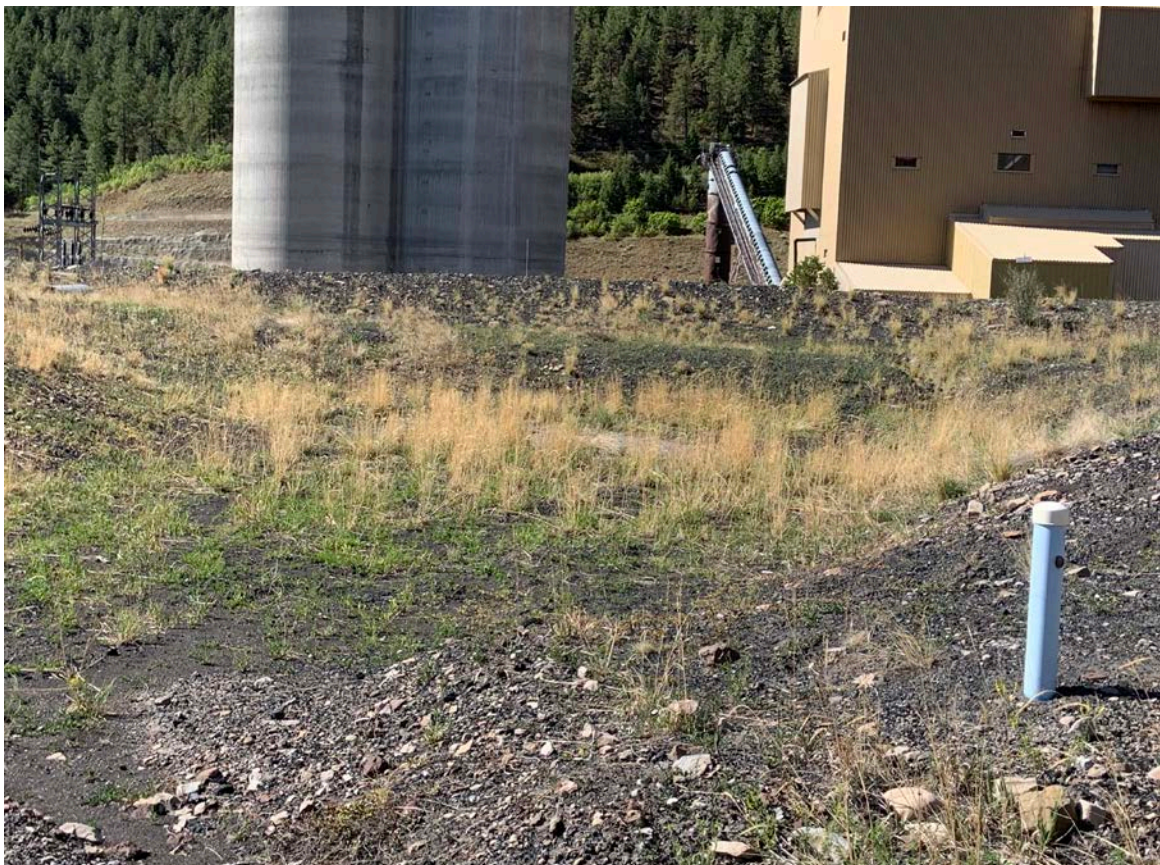
**Containment Area #3**

This partially incised containment basin is a non-discharging facility designed to contain run-off from the area east of the RDA belt conveyor and south of Highway 12.

Containment Area is dry at time of inspection.

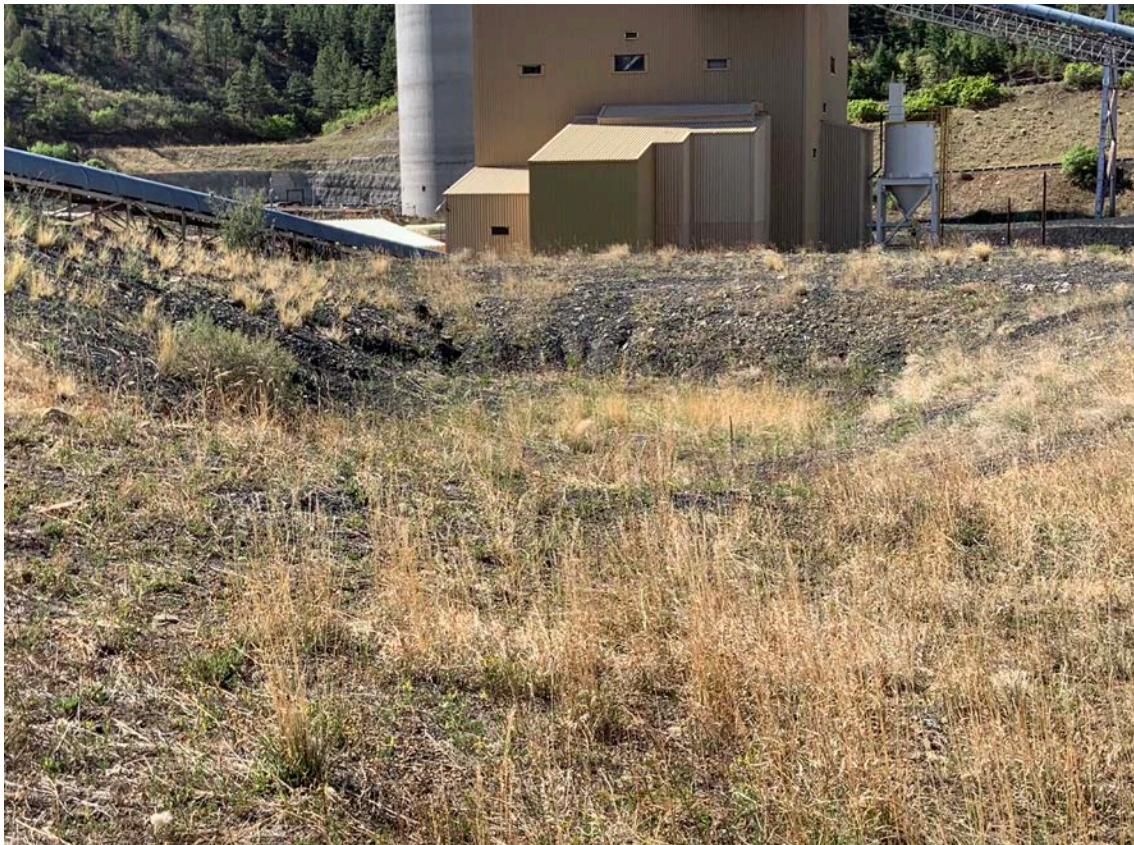
**Containment Area #4**

This partially incised containment basin is a non-discharging facility designed to contain run-off from the area west of the RDA belt conveyor and south of Highway 12.

Containment Area was dry at time of inspection.

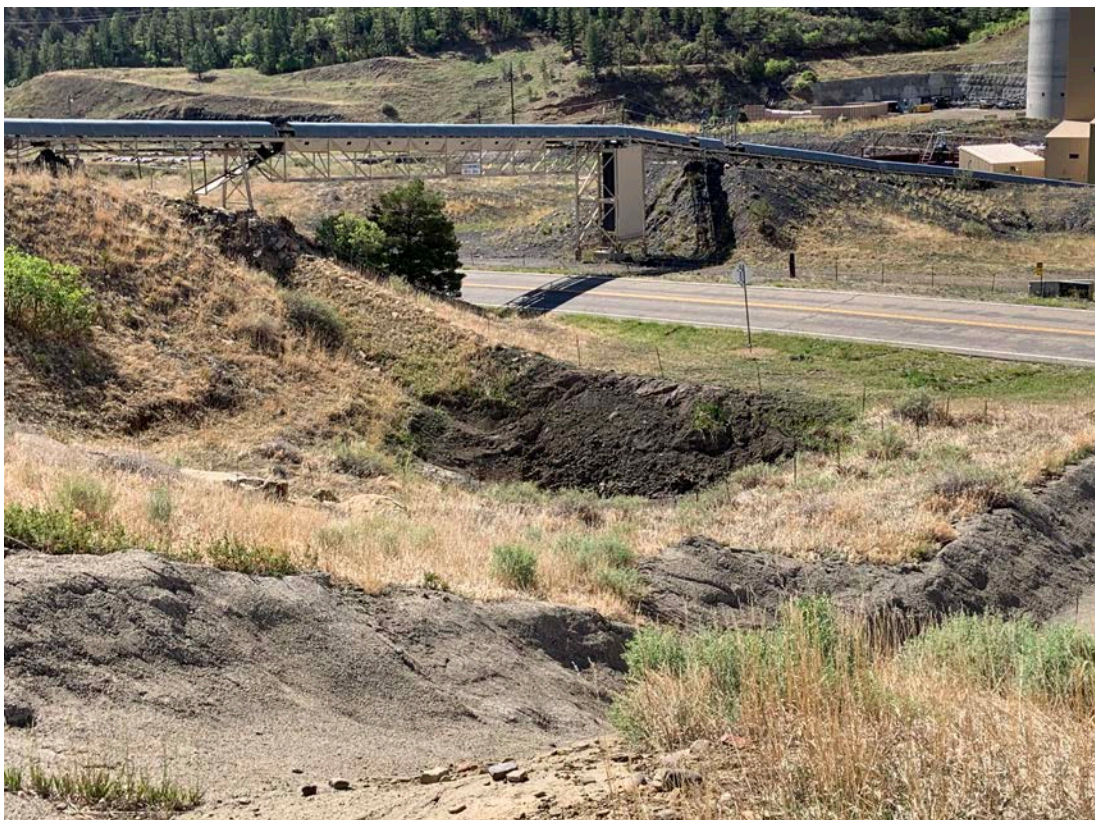
**Containment Area #5**

This partially incised containment basin is a non-discharging facility designed to contain run-off from the RDA belt conveyor area north of Highway 12.

Containment Area is empty. Containment Area was cleaned this past quarter and about 70 percent of the sediment in the containment area was removed.
