NEW ELK MINE
Permit No. C-1981-012

QUARTERLY COAL WASTE BANK INSPECTION REPORT
June 2, 2020

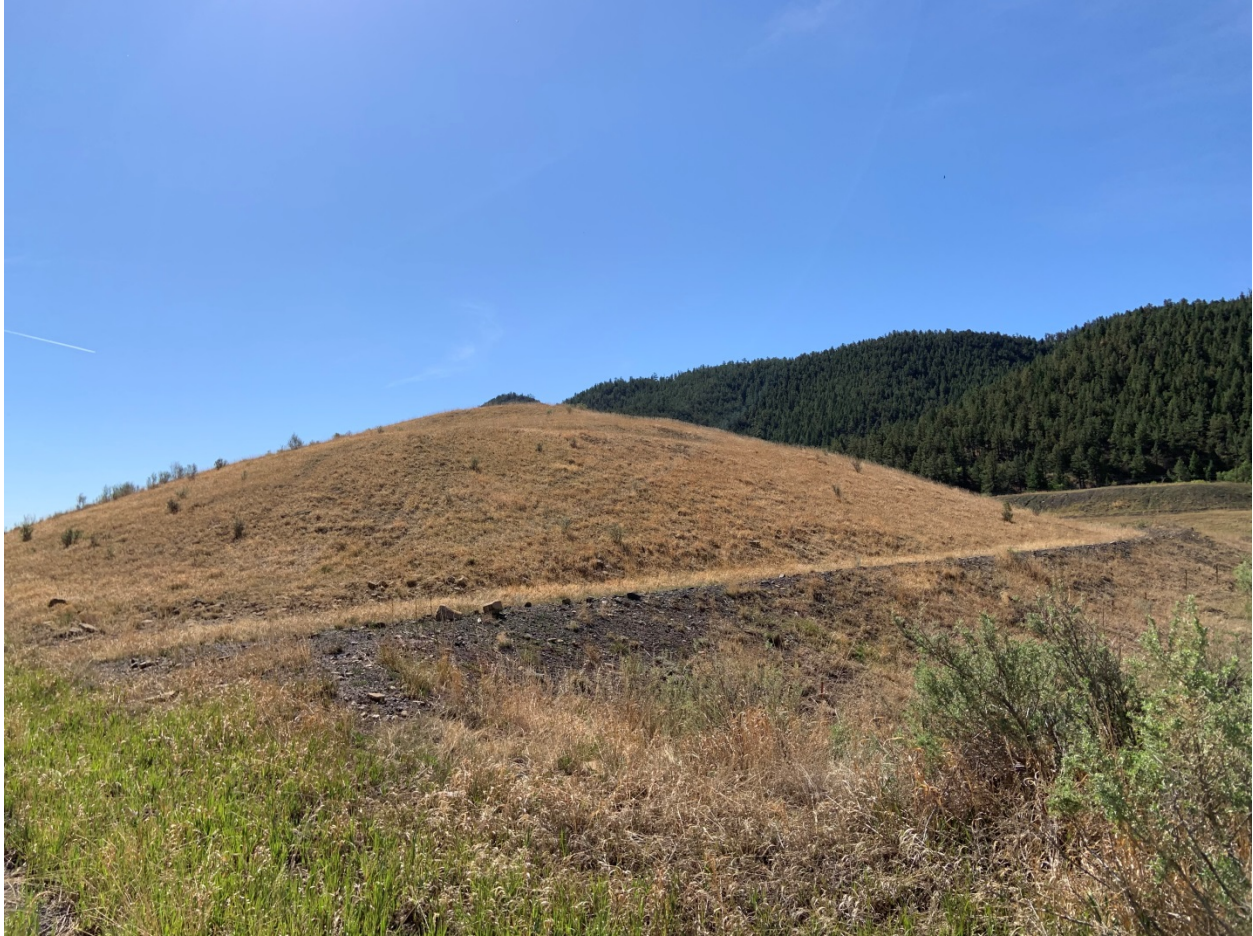
Overall the disposal area is in good condition. Vegetation is overall good for the lack of moisture in recent months.

DWDA #1 – North Facing Slope

None at this time.

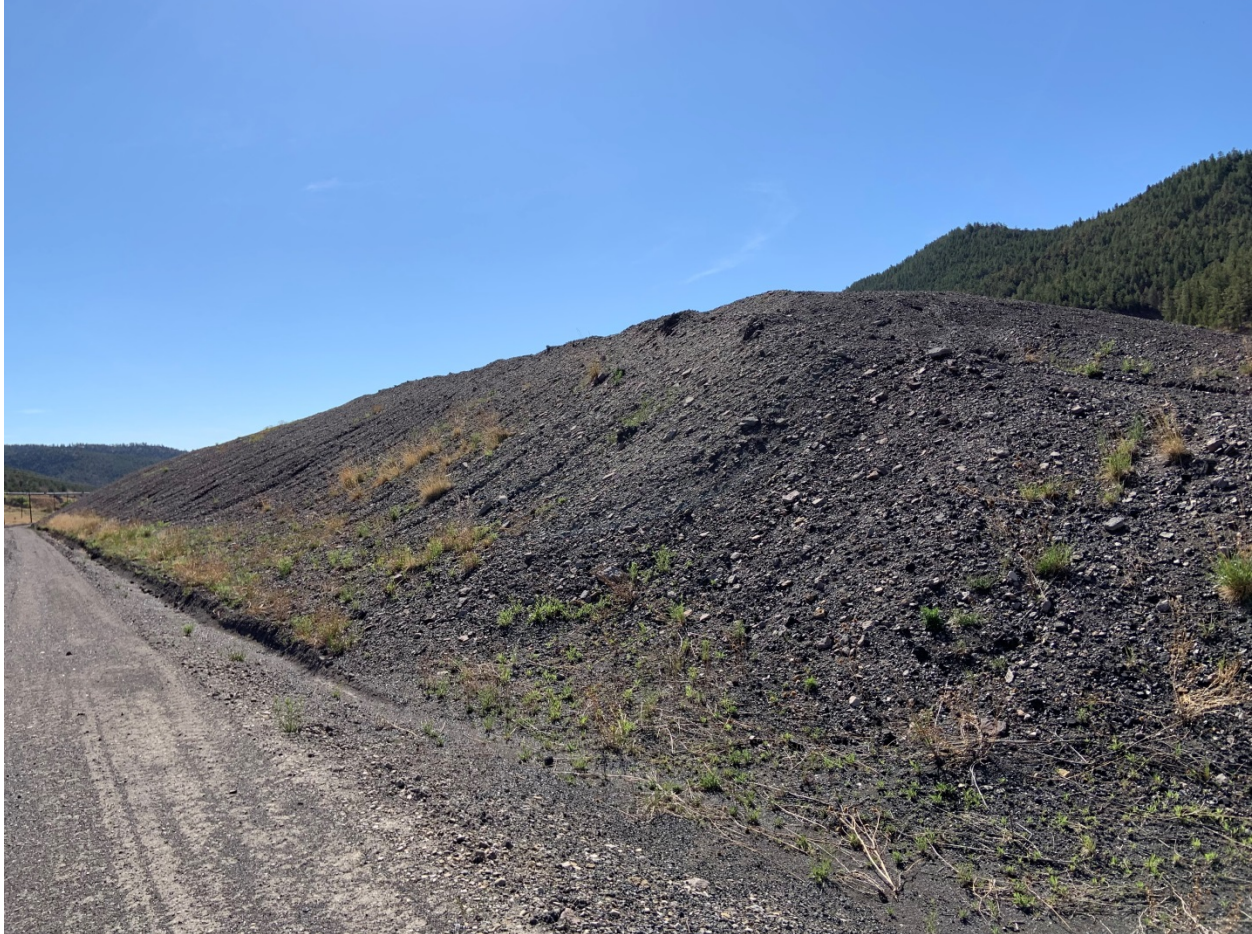
Surface and out slopes of the pile were inspected for visible signs of potential failure or instability. There was some surface erosion but not enough to make the area unstable. In all no signs of failure or instability were observed.

Overall the disposal area is in good condition.

DWDA #2 – South and West Facing Slopes

The ditch around the area has been cleaned within the past quarter as part of annual maintenance. The Rills are being monitored and have not gotten any bigger and there is no sediment loading. Operator is evaluating either reclamation of the area or permitting alternative uses of the land north of the Purgatoire River and south of Highway 12.

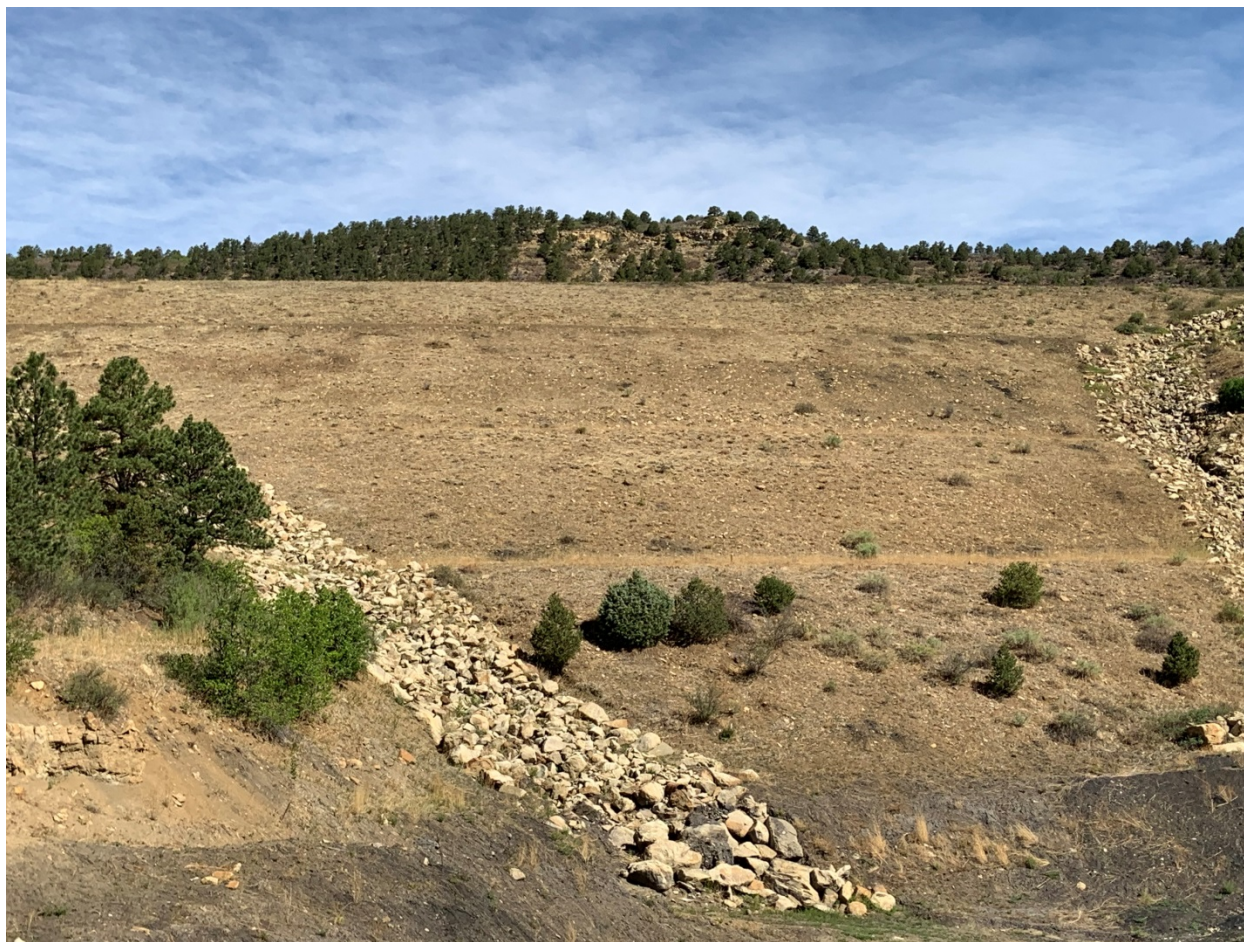
Overall the site is in good condition.

Refuse Disposal Area – Reclaimed Benches and Armored Drainage

None required at this time.
