QUARTERLY SEDIMENTATION POND INSPECTION REPORT

Mine: Lorencito

Inspection Period: Second Quarter 2020

Inspection Date: 6/3/2020

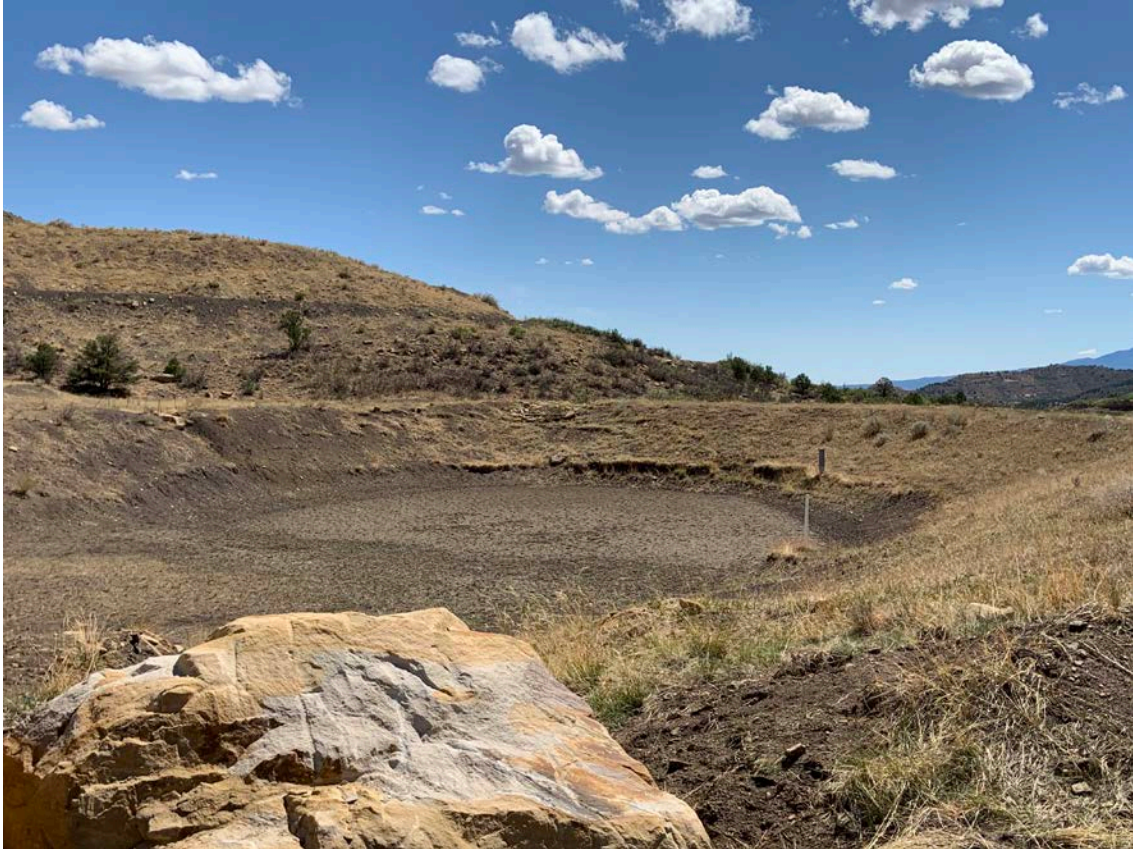
Pond 6

Pond is empty at time of inspection.

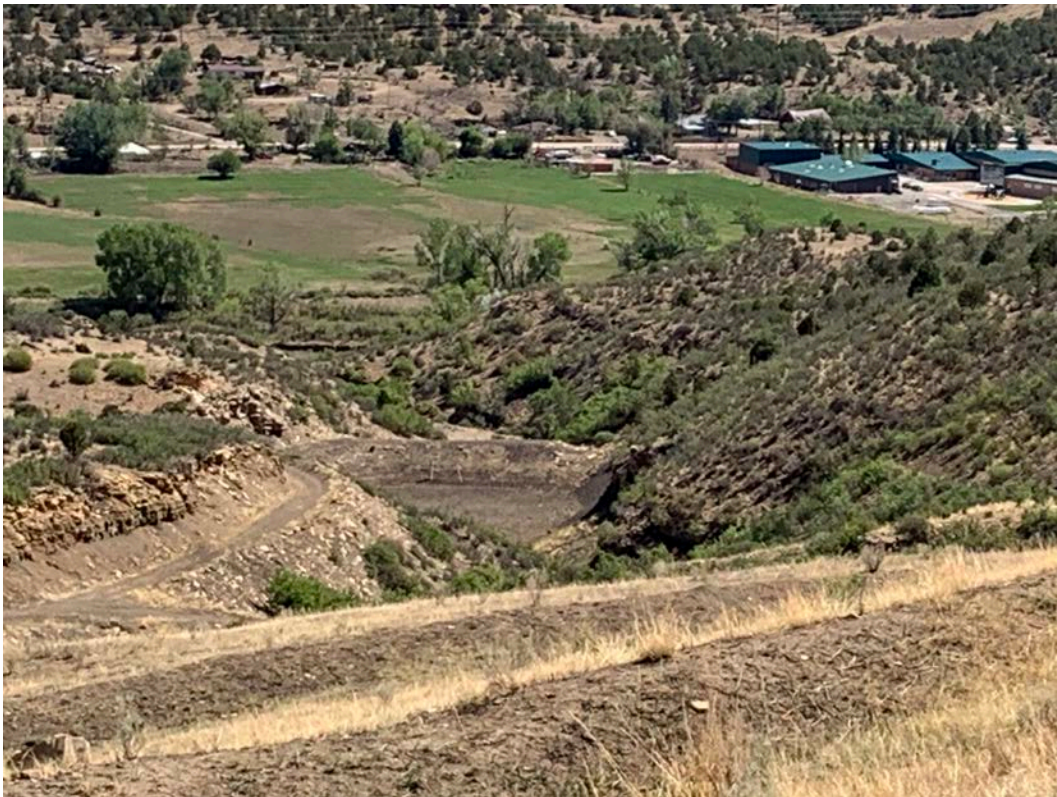
Pond 8

Pond empty at time of inspection.

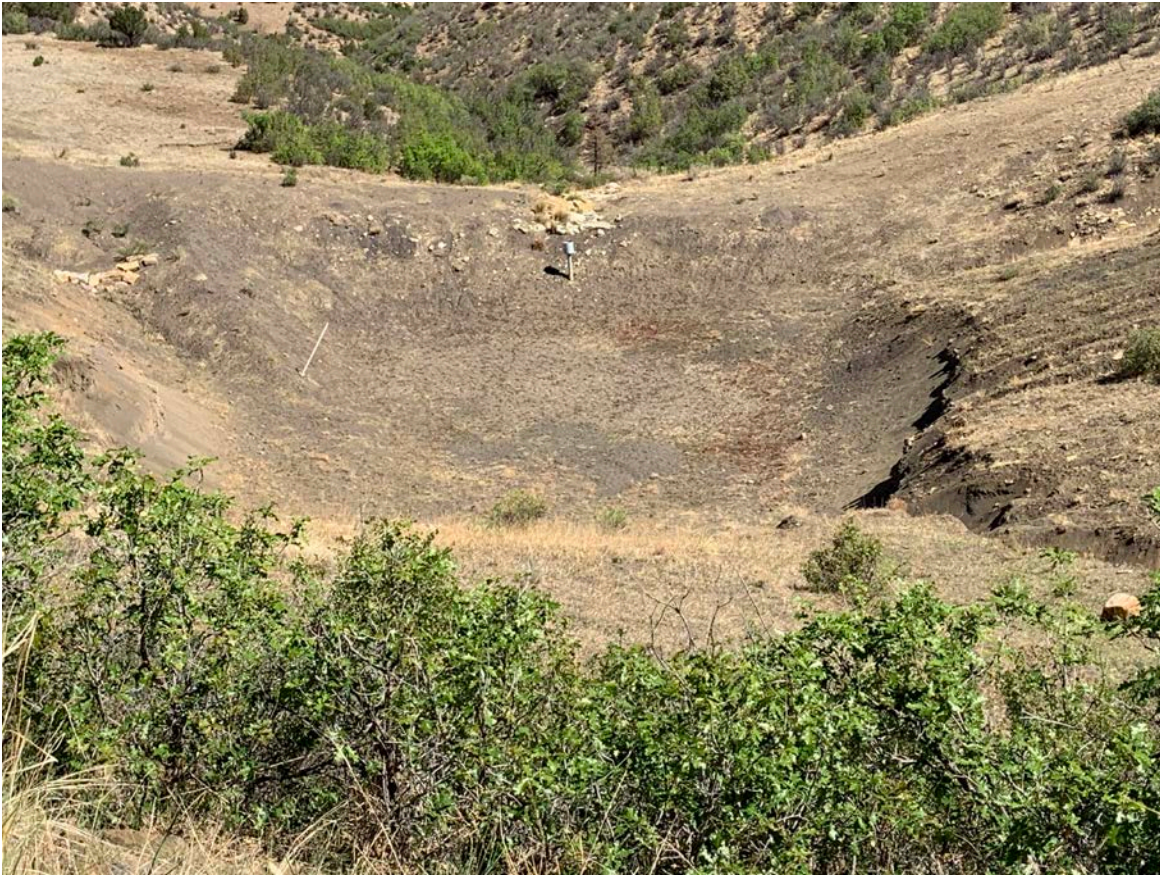
Pond 9

Pond empty at time of inspection.

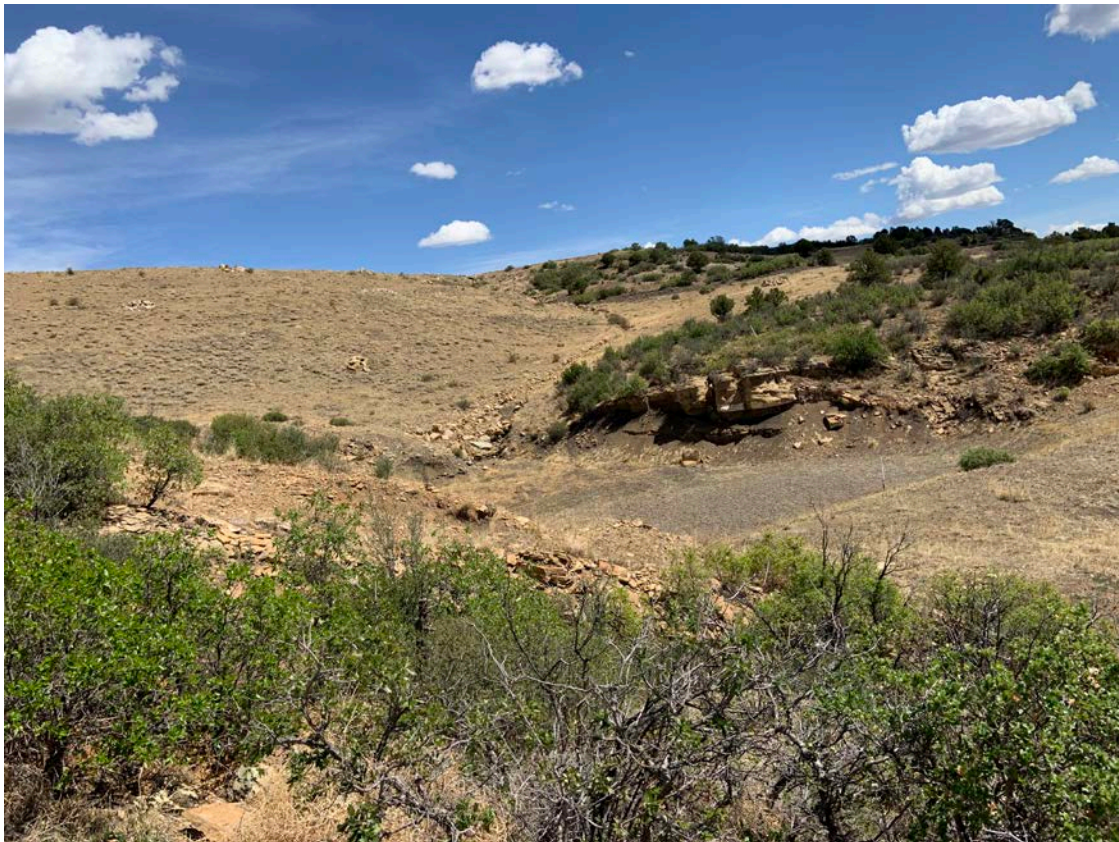
Pond 9a

Pond was not holding water at time of inspection.
