LORENCITO CANYON MINE
Permit No. C-1996-084

INSPECTION OF EXCESS SPOIL-FILLS 7, 8, & 9
June 2, 2020

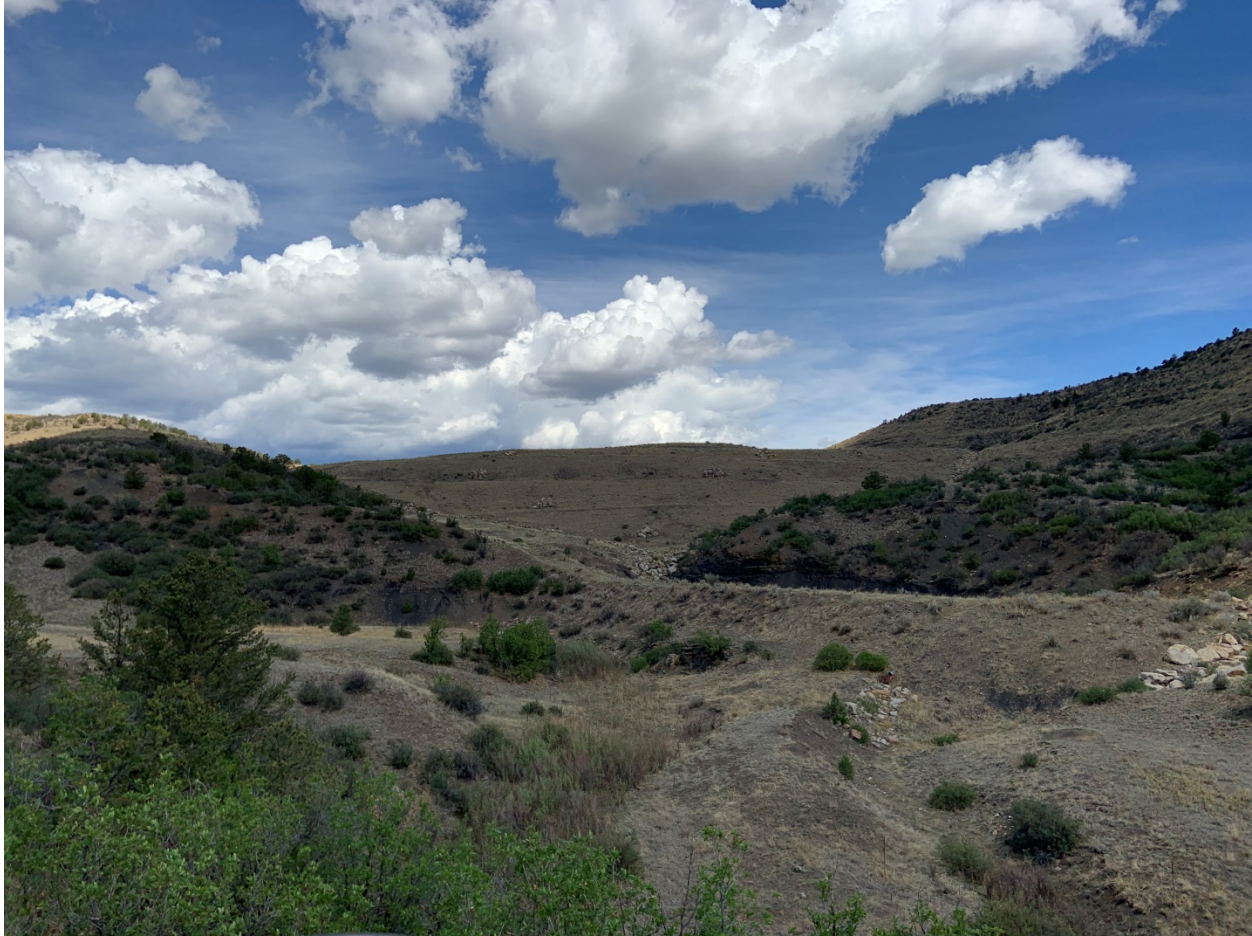
Fill #7

The entire excess spoil fill facility was examined for signs of failure and instability such as tension cracks, ground movement, springs and seeps, and standing water. There was no indication of potential instability at time of inspection.

Overall the site is in good condition. The vegetation on the fill is encouraging.

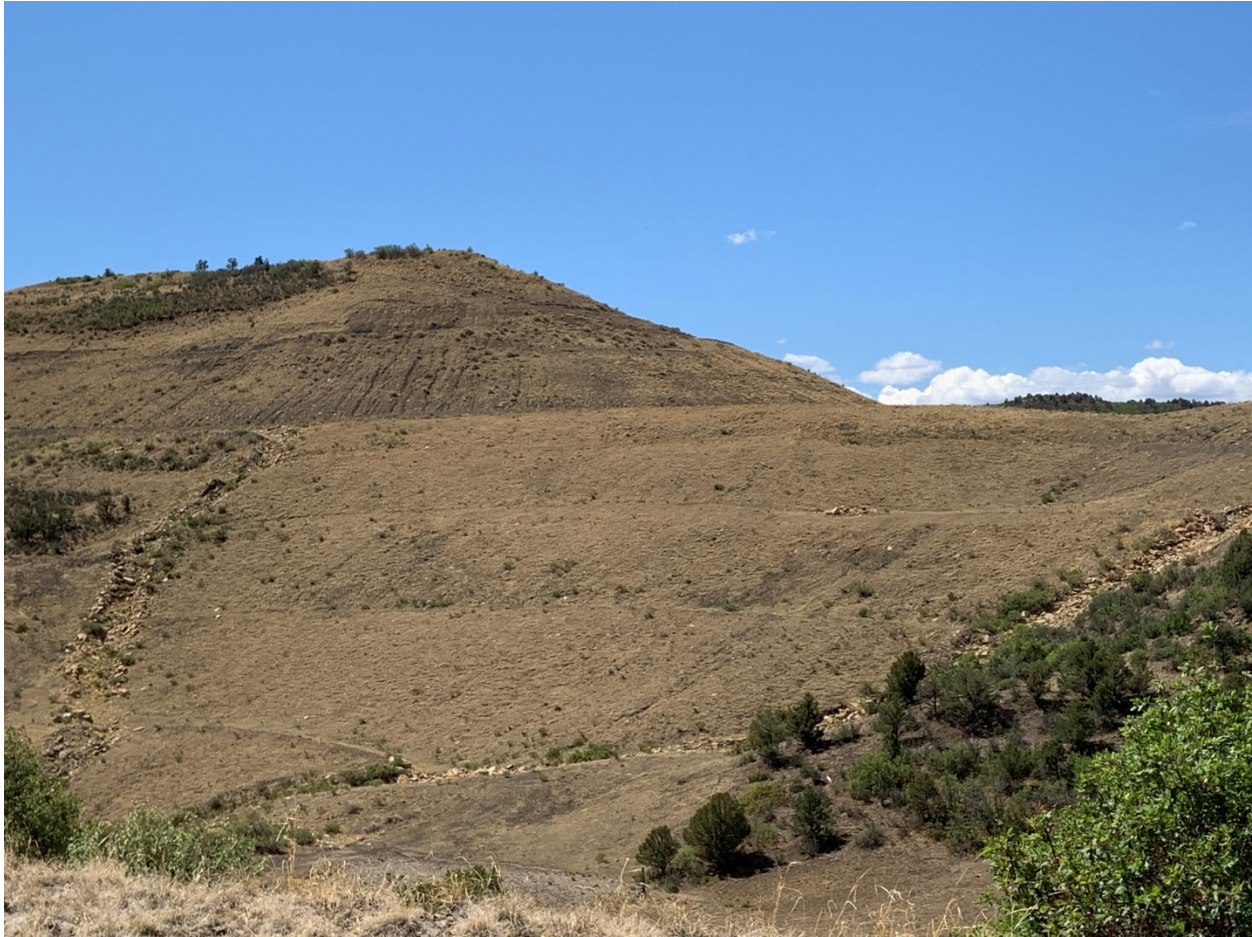
Fill #8

The entire excess spoil fill facility was examined for signs of failure and instability such as tension cracks, ground movement, springs and seeps, and standing water. There was no indication of potential instability at time of inspection.

Overall the site is in good condition. Vegetation is very good on the fill.

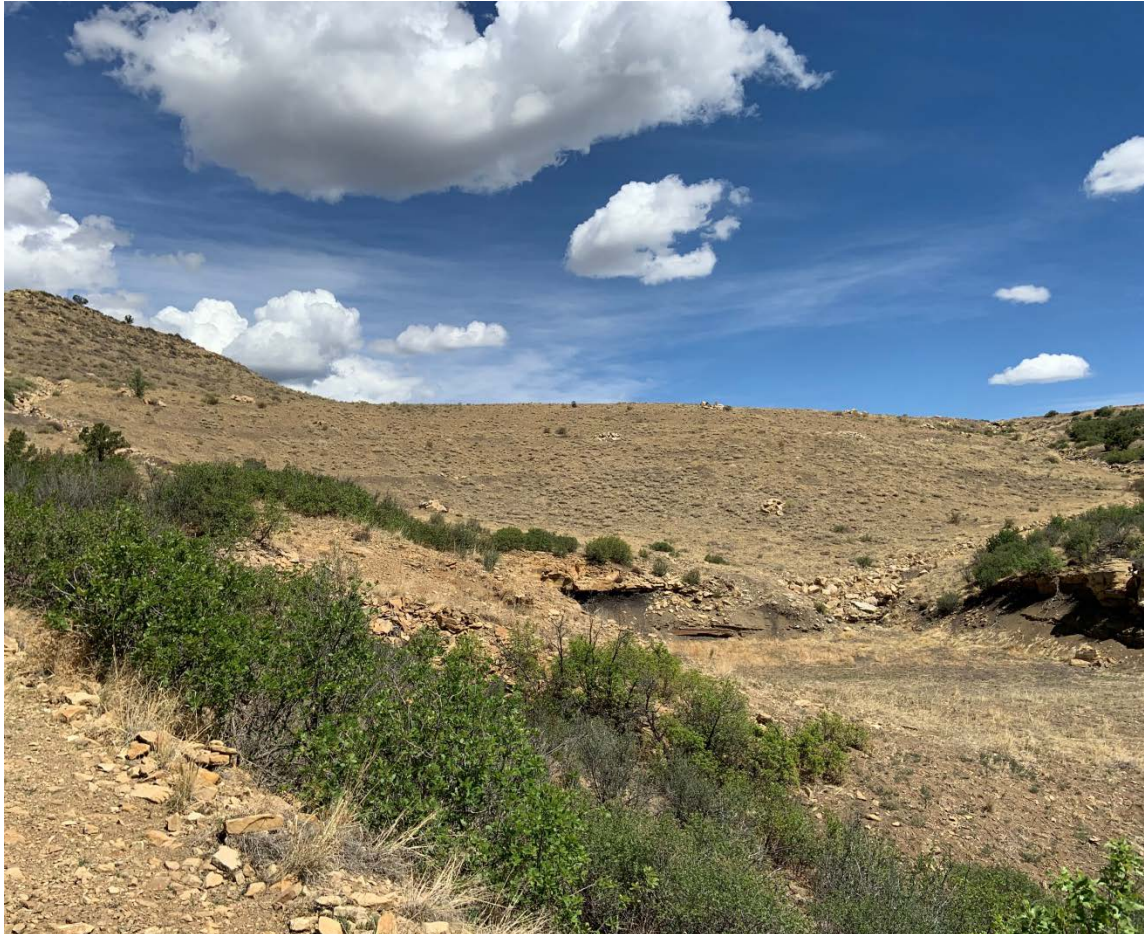
Fill #9

The entire excess spoil fill facility was examined for signs of failure and instability such as tension cracks, ground movement, springs and seeps, and standing water. There was no indication of potential instability at time of inspection.

Overall the site is in good condition. Vegetation is fine for this time of year.
