COLORADO

Division of Reclamation,
Mining and Safety

MINERALS PROGRAM INSPECTION REPORT PHONE: (303) 866-3567

MINE NAME: Cresson Project	MINE/PROSPECTING ID#: M-1980-244	MINERAL: Gold	COUNTY: Teller
INSPECTION TYPE: Monitoring	INSPECTOR(S): Timothy Cazier	INSP. DATE: June 2, 2020	INSP. TIME: 09:00
OPERATOR: Cripple Creek & Victor Gold Mining Company	OPERATOR REPRESENTATIVE: Justin Bills & Jeana Ratcliff	TYPE OF OPERATION: 112d-3 - Designated Mining Operation

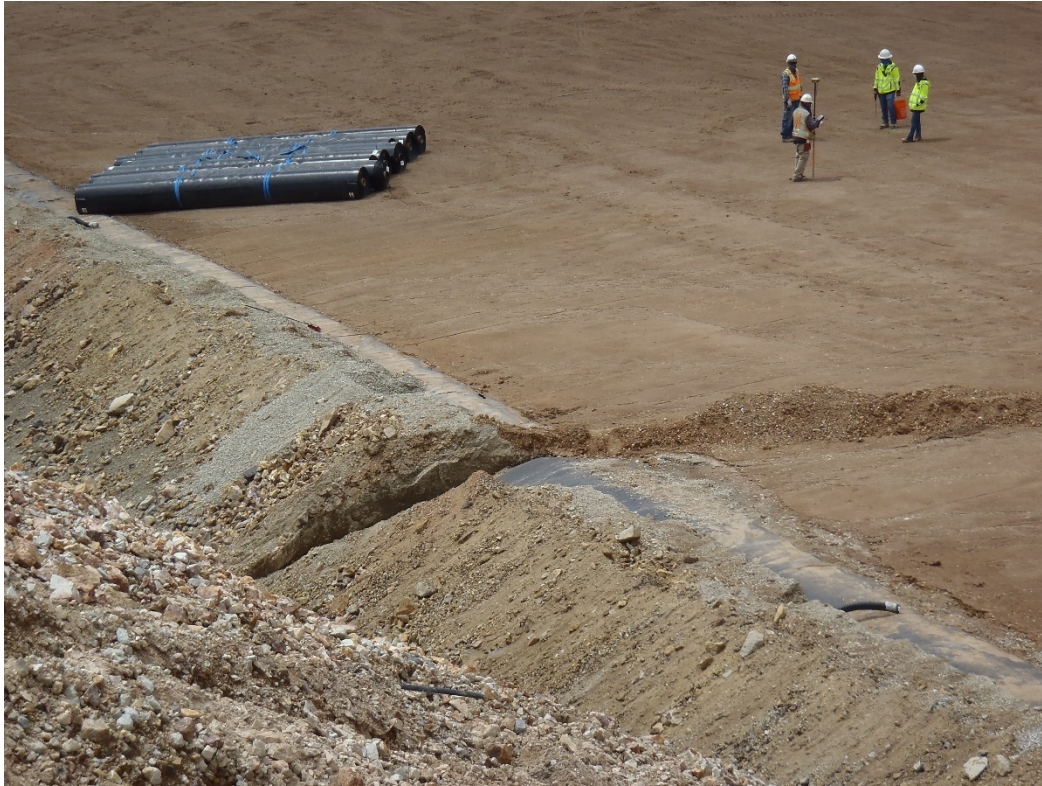
Photo 10. Crew verifying SLF required thickness.
