### MINERALS PROGRAM INSPECTION REPORT PHONE: (303) 866-3567

<b>MINE NAME:</b> Cresson Project	<b>MINE/PROSPECTING ID#:</b> M-1980-244	<b>MINERAL:</b> Gold	<b>COUNTY:</b> Teller
<b>INSPECTION TYPE:</b> Monitoring	<b>INSPECTOR(S):</b> Timothy Cazier	<b>INSP. DATE:</b> June 2, 2020	<b>INSP. TIME:</b> 09:00
<b>OPERATOR:</b> Cripple Creek & Victor Gold Mining Company	<b>OPERATOR REPRESENTATIVE:</b> Justin Bills & Jeana Ratcliff	<b>TYPE OF OPERATION:</b> 112d-3 - Designated Mining Operation

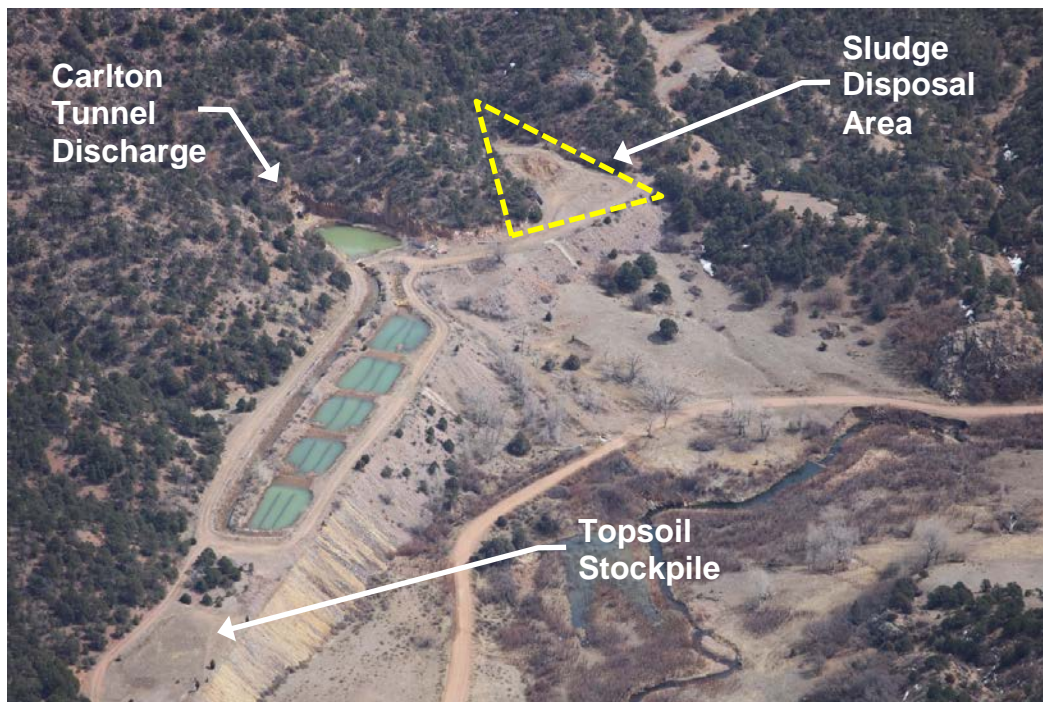
Photo 1. DRMS March 16, 2020 Aerial image of the Carlton Tunnel.

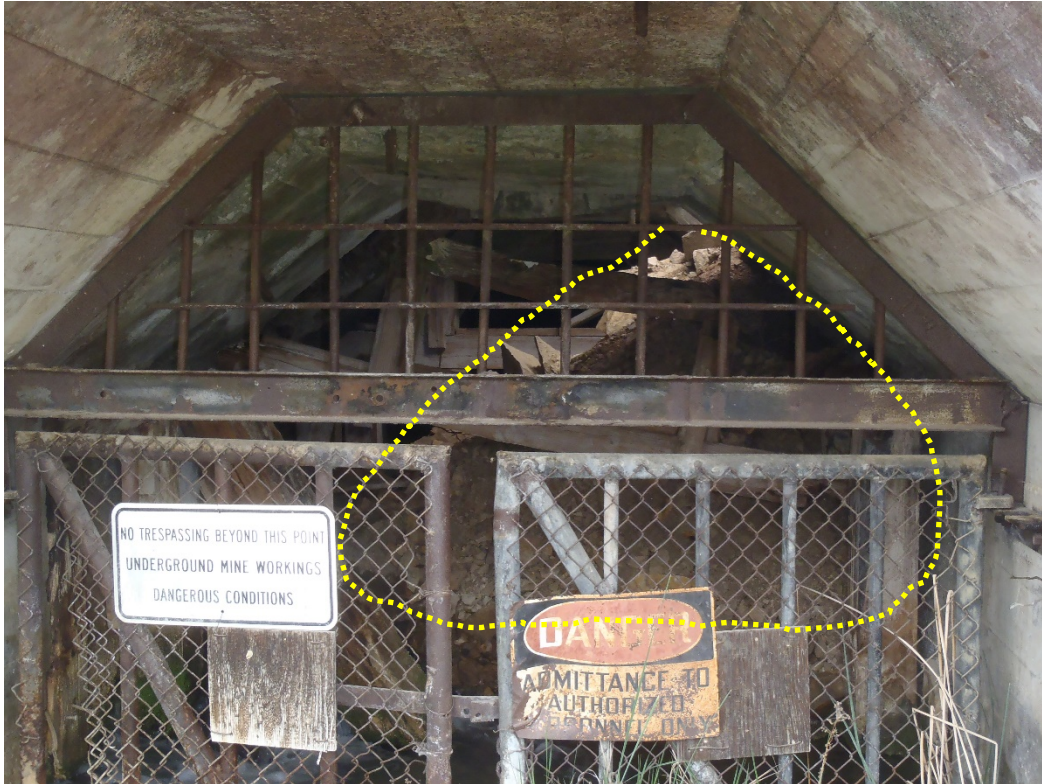
Carlton Tunnel: Mr. Bills and Ms. Ratcliff accompanied the DRMS (via separate vehicles) to the Carlton Tunnel area. The DRMS was notified on March 11, 2020 of a minor structural failure in the Carlton Tunnel. Based on a review of flow data, they believe the failure occurred on February 11<sup>th</sup> when flows were reduced to around 500gpm. They reported on March 11<sup>th</sup> the flows had returned to normal and were averaging 850gpm. They also reported there had not been any impact to water quality as a result of the failure. On March 16, 2020, the DRMS performed an aerial inspection of the site which included the Carlton Tunnel as the planned on-site inspection was cancelled due to the pandemic. A photo of the Carlton Tunnel outlet (see **Photo 1**) showed some disturbance south of the tunnel. The purpose of visiting the Carlton Tunnel during this inspection was two-fold: 1) to assess the impact of the reported structural failure, and 2) investigate the aerially observed disturbed area south of the tunnel. The failure was observed from both the outlet (see **Photo 2**) and from above (see **Photo 3**). The condition was consistent with that reported by CC&V on March 11<sup>th</sup>. It did not appear the failure was damming or significantly impeding the discharge and the opening appeared adequately secured to prevent unauthorized entry. CC&V representatives indicated the disturbed area south of the tunnel is material removed from the passive treatment ponds which are periodically cleaned out. The sludge disposal area was fenced (see **Photos 4 and 5**). The fenced area was measured using a Trimble Juno 3B handheld GPS unit and determined to be 0.14 acres. Enclosed are post inspection maps based on Google Earth images from June 2016 (**Post Inspection Map Figure 1**) and September 2013 (**Post Inspection Map Figure 2**) illustrating the changing nature of this area, while also considering the DRMS March 16 aerial photo. No boundary markers could be found in the Carlton Tunnel area. **The missing boundary markers are cited as a Problem on page 1 of this report.** Without boundary markers the DRMS could not verify how much, if any of the sludge disposal area is outside the affected area boundary. Once the boundary markers are placed, the DRMS will follow-up during a subsequent inspection to determine if revisions need to be made to the permit. A topsoil stock pile was also observed northwest of the Carlton Tunnel treatment ponds (see **Photo 6**).

Photo 2. Carlton Tunnel outlet view of failure material (outlined).

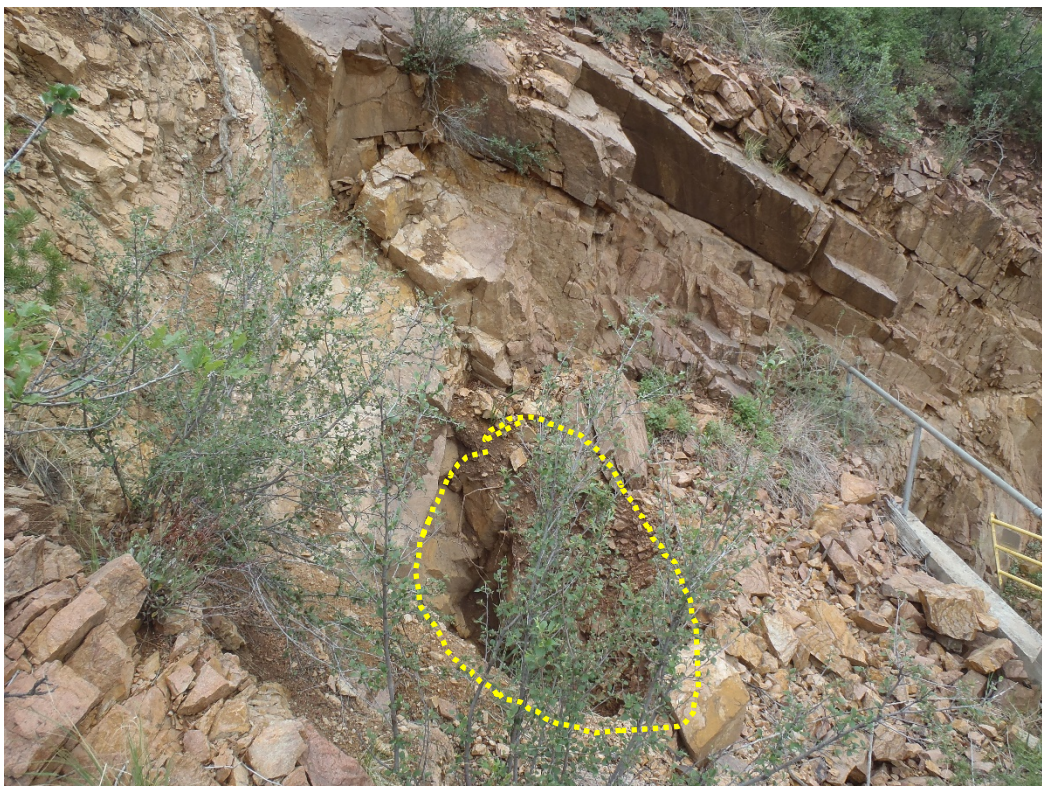
Photo 3. View of Carlton Tunnel failure from above outlet.

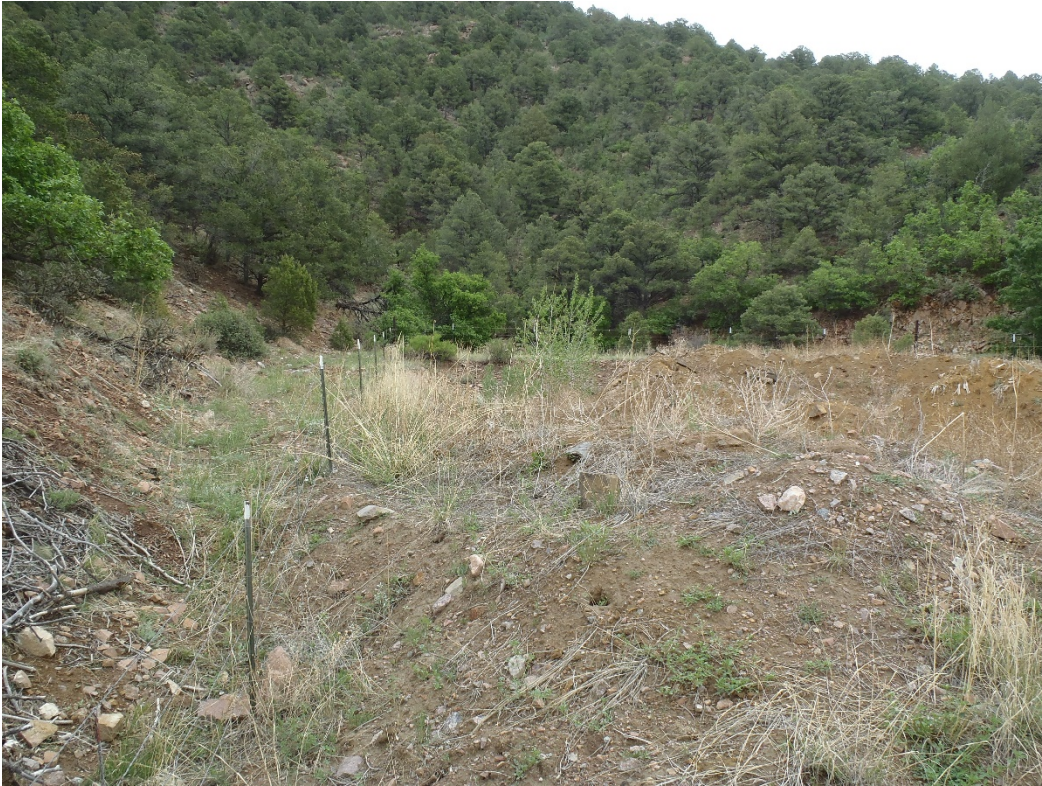
Photo 4. Carlton Tunnel sludge disposal area (1 of 2 – looking east).

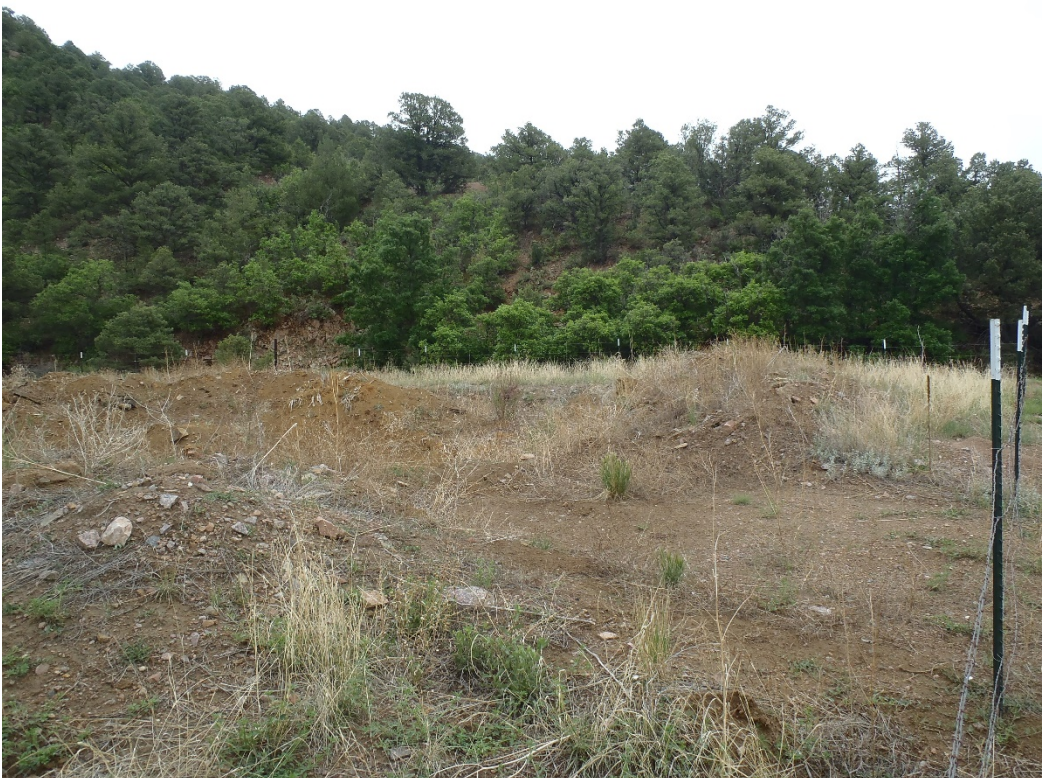
Photo 5. Carlton Tunnel sludge disposal area (2 of 2 – looking SSE).

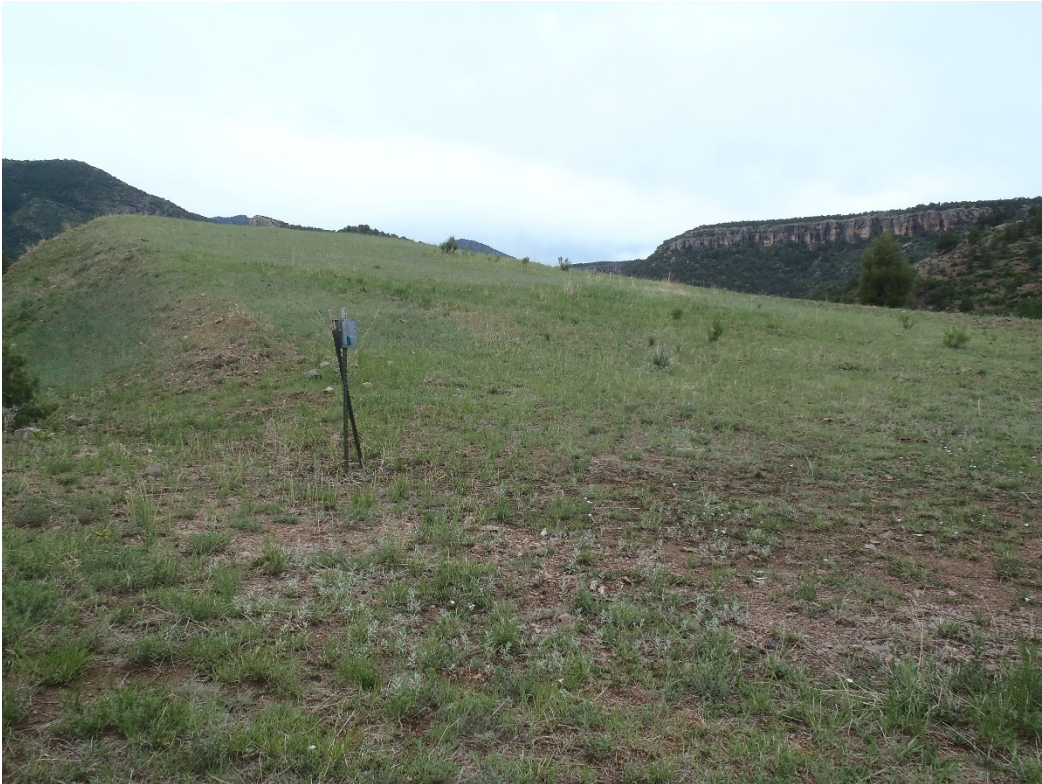
Photo 6. Carlton Tunnel topsoil stockpile (NW of treatment ponds – looking SE).

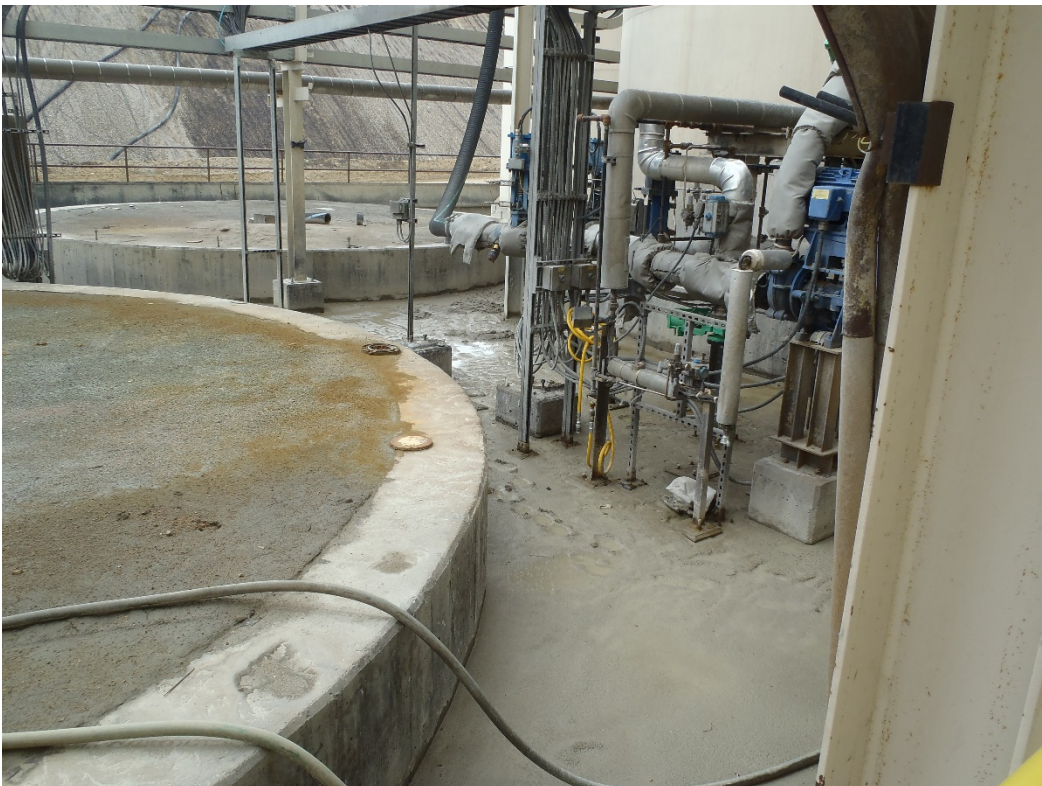
High Grade Mill: Mr. Andrew Orser accompanied the DRMS on the mill exterior walk-around inspection. The purpose was to perform a visual inspection for leaks, spills and secondary containment problems. Both the east and west sides of the mill exterior were inspected, as well as the area around the concentrate storage facility (Con Barn). No problems were observed. Some sludge was observed in the Vat Leach tank area on the west side of the HGM (see **Photo 7**). Mr. Orser explained the sludge was from recent maintenance and was being

removed. As it was being addressed and did not appear to significantly impact storage volume, it was not cited as a problem. A pile of ore concentrate (about six feet high and estimated to be 15 to 20 feet in diameter) was observed on the concrete apron outside the con barn cover. As this was unusual, Mr. Orser explained they are experiencing rail transportation problems at the transfer point between the trucks hauling the concentrate off site and the rail yard.

Photo 7. Sludge in HGM vat leach area.

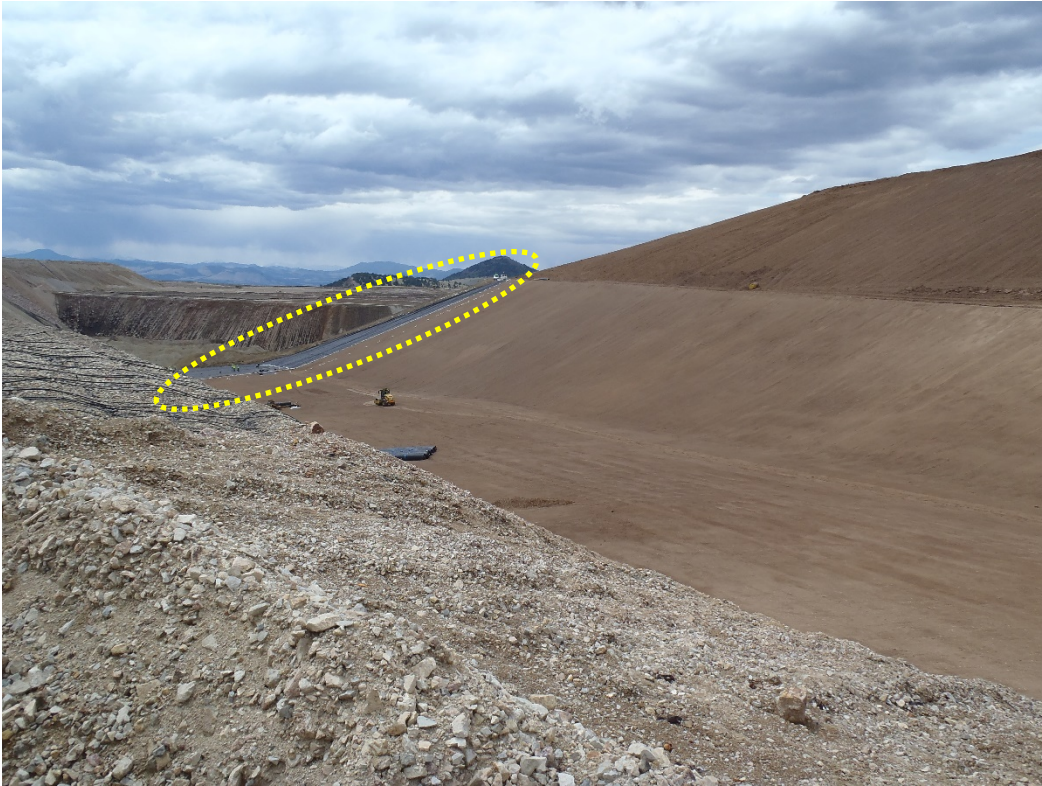
Squaw Gulch Valley Leach Facility (VLF2): Mr. Steve Blaskovich accompanied the DRMS to the crest of the pad on the north side of VLF 2 to observe construction. They were working in the Phase 2 A-5 area. Mr. Blaskovich indicated the geomembrane liner installation (see **Photo 8**) had just started the previous week. Equipment was observed compacting the soil liner fill (SLF - see **Photo 9**) and a crew was observed checking SLF thickness (see **Photo 10**). Anchor trenches were observed on the uphill side of the area being prepared for geomembrane liner installation.

Photo 8. VLF 2 Phase 2 beginning of geomembrane installation.

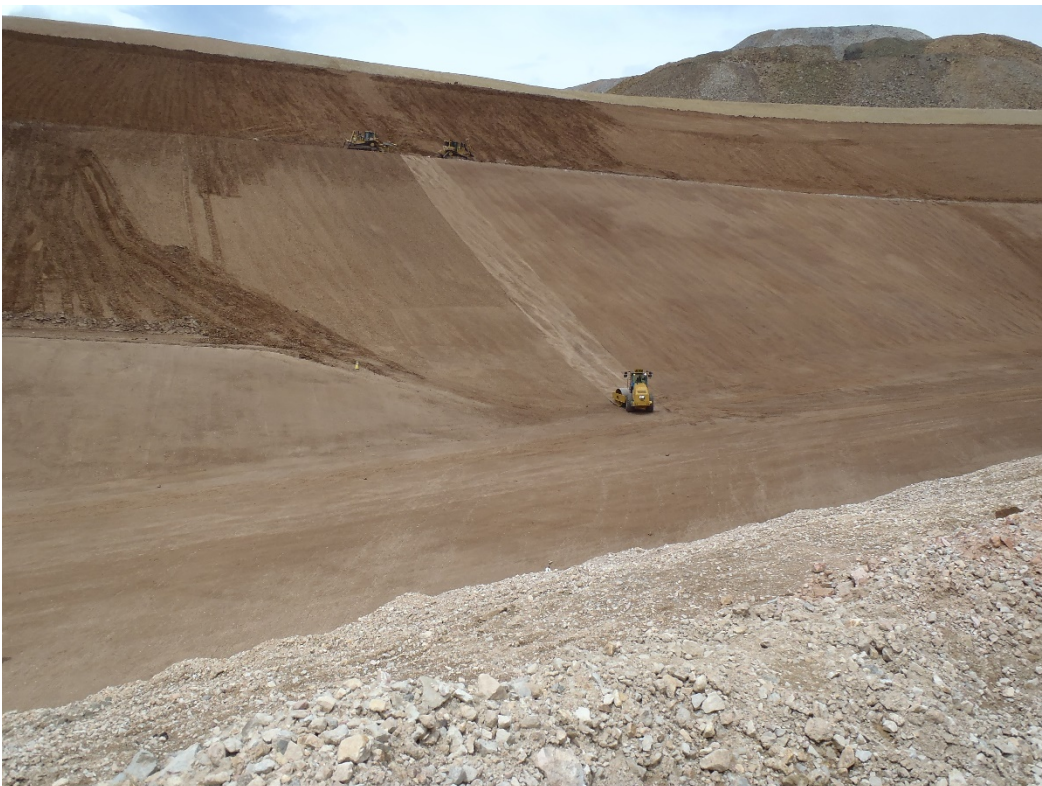
Photo 9. VLF 2 Phase 2 SLF compaction effort.

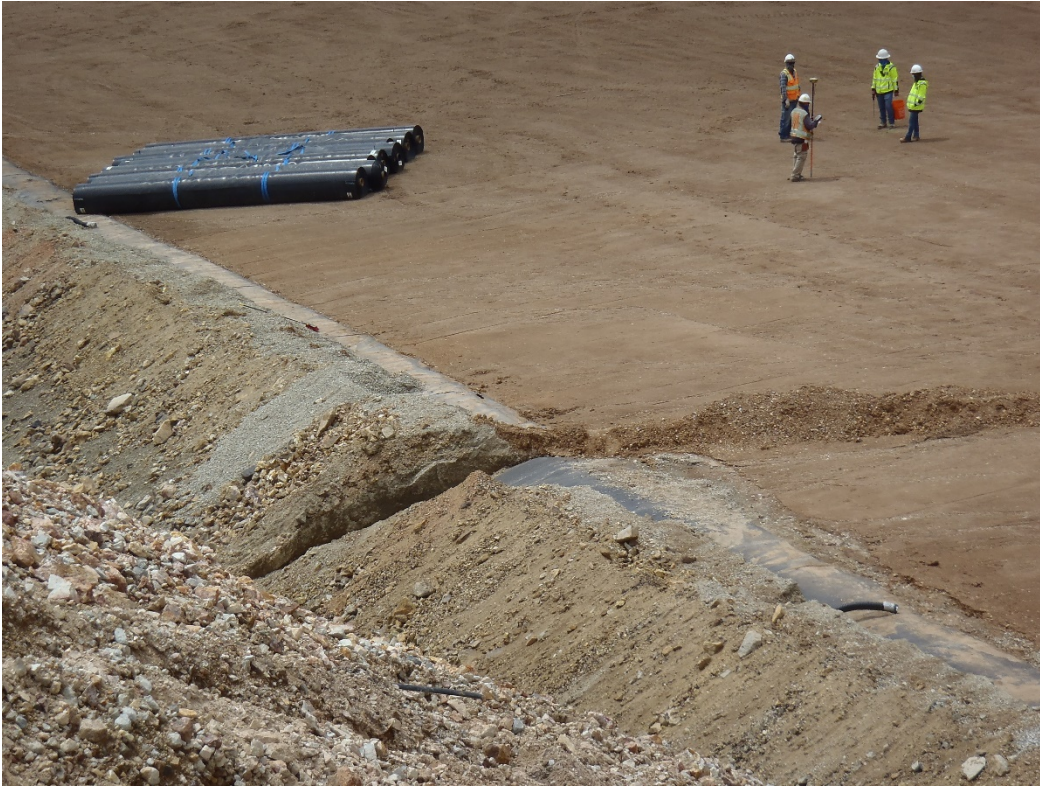
Photo 10. Crew verifying SLF required thickness.

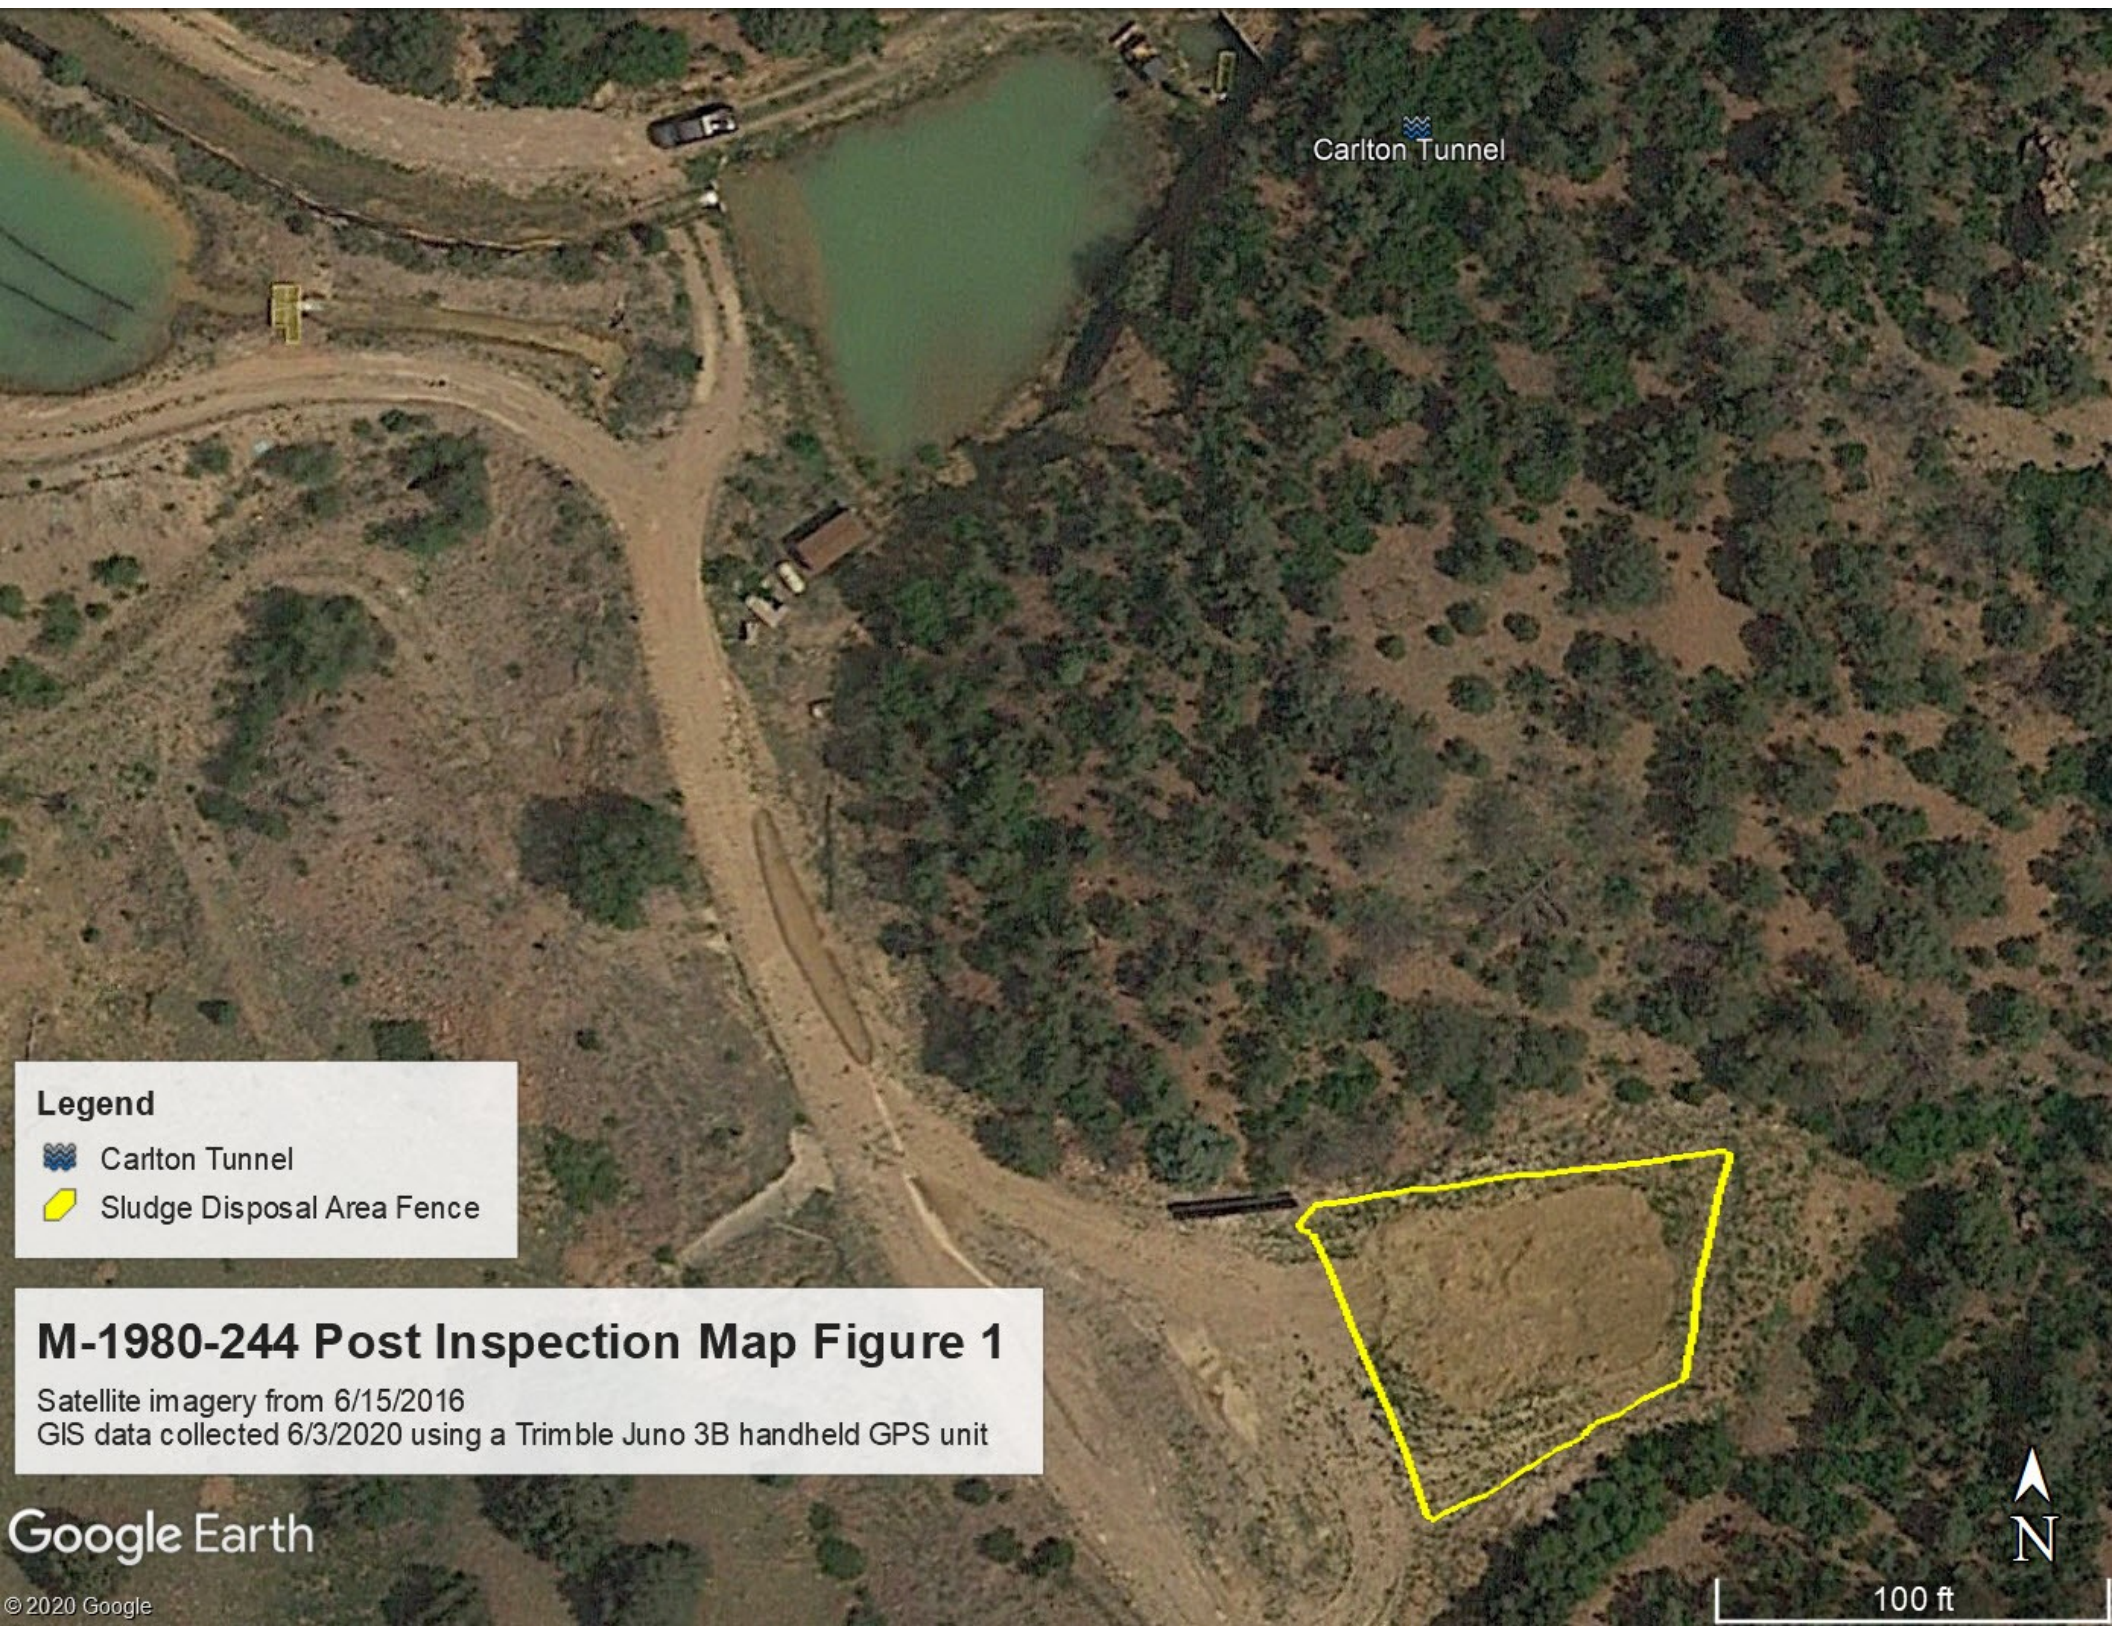
## M-1980-244 Post Inspection Map Figure 1

**PROBLEM/POSSIBLE VIOLATION:** Problem: The affected area boundary markers at the Carlton Tunnel could not be located. This is a problem for failure to maintain boundary markers around the affected area as required by Section 3.1.12(2) of the rule.

**CORRECTIVE ACTIONS:** The operator shall conduct a survey and replace the boundary markers in the correct location(s). The operator shall provide proof to the Division that this has been done by the corrective action date.
