MINERALS PROGRAM INSPECTION REPORT PHONE: (303) 866-3567

MINE NAME:		MINE/PROSPECTING ID#:	MINERAL:	COUNTY:
Rafert Pit		M-2004-052	Sand and gravel	Phillips
INSPECTION TYPE:		INSPECTOR(S):	INSP. DATE:	INSP. TIME:
Monitoring		Brock Bowles	June 15, 2020	11:30
OPERATOR:		OPERATOR REPRESENTATIVE:	TYPE OF OPERATION:	
Phillips County		Mike Salyards	112c - Construction Regular Operation	
		DOIN 611 611 1 1 1 1 1 1 1 1 1 1 1 1 1 1 1		
REASON FOR INSPECTION:		BOND CALCULATION TYPE:	BOND AMOUNT:	
Normal I&E Program		None	\$0.00	
DATE OF COMPLAINT:		POST INSP. CONTACTS:	JOINT INSP. AGENCY:	
NA		None	None	
WEATHER:	INSPECTOR'S SIGNATURE:		SIGNATURE DATE:	
Clear	Brah Sauls		June 22, 2020

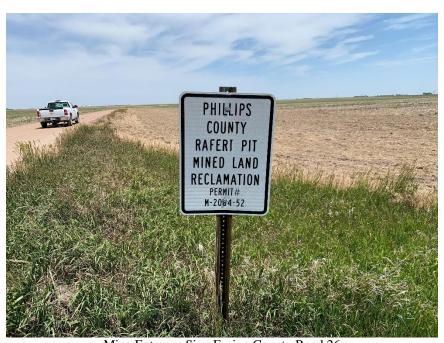
The permit identification sign was in place at the mine entrance and was legible. The mine boundary was marked with a fence on all four sides. The topsoil stockpile is located along the north fenceline and is vegetated. The bottom of the pit had a lot of vegetation indicating no mining had recently taken place which seems consistent with the annual report that states the last mining activity took place in June 2019.

Mine Entrance Sign Facing County Road 26

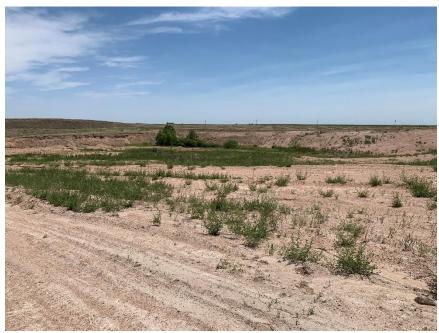
No mining activity was being conducted and no equipment was on site. A pile of gravel was pushed up on the south side of the pit. No standing water was seen in the pit area. The spit slopes were approximately at a 3h:1v slope.

Pit Area Facing Northeast

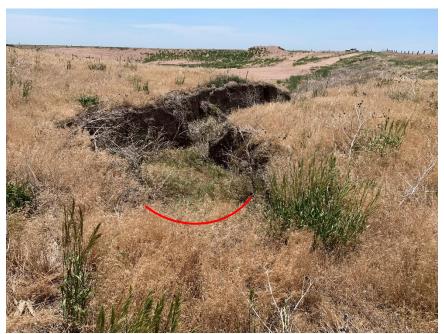
A large gully has formed on the northwest corner of the mined area. The gully was completely within the permit boundary but it is not stable in its current condition. The gully needs to be repaired and closely monitored so it does not cross the permit boundary.

Gully in northwest corner. Picture facing south. Red line indicates head cut area.
