MINERALS PROGRAM INSPECTION REPORT
PHONE: (303) 866-3567

MINE NAME: State Land-Jensen Pit	MINE/PROSPECTING ID#: M-1983-050	MINERAL: Sand and gravel	COUNTY: Sedgwick
INSPECTION TYPE: Preoperation Inspection	INSPECTOR(S): Brock Bowles	INSP. DATE: June 15, 2020	INSP. TIME: 10:00
OPERATOR: Phillips County	OPERATOR REPRESENTATIVE: Mike Salyards	TYPE OF OPERATION: 110c - Construction Limited Impact	
REASON FOR INSPECTION: Preoperation Inspection	BOND CALCULATION TYPE: None	BOND AMOUNT: \$0.00	
DATE OF COMPLAINT: NA	POST INSP. CONTACTS: None	JOINT INSP. AGENCY: None	
WEATHER: Clear	INSPECTOR'S SIGNATURE:

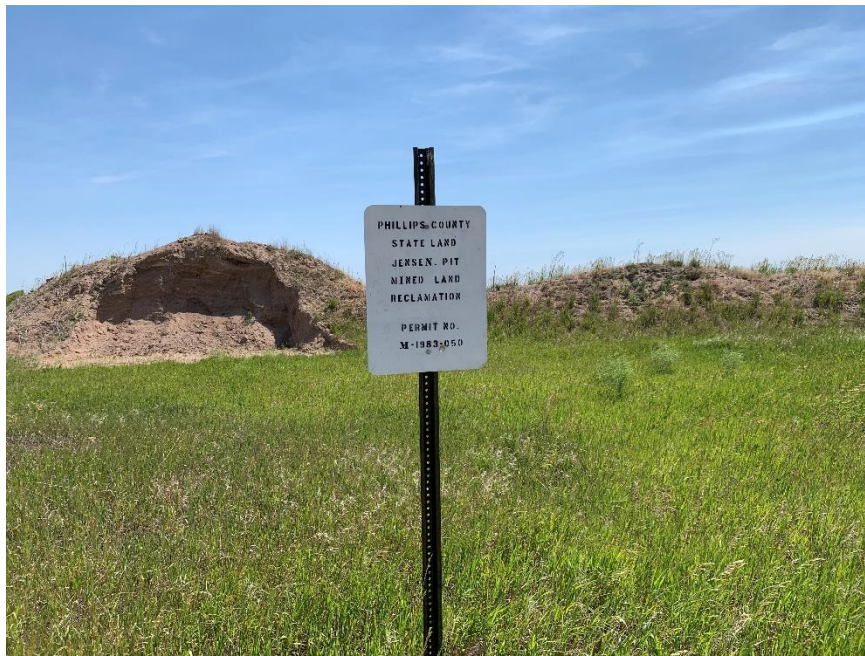
The permit identification sign was in place at the mine entrance and was legible. The permit boundary markers were in place for the current boundary and markers were also in place for the proposed permit boundary. All markers were identified during this inspection. The conversion application notice sign required by Rule 1.6.2(1)(b) was posted facing County Road 41.

Mine Identification Sign Facing County Road 41

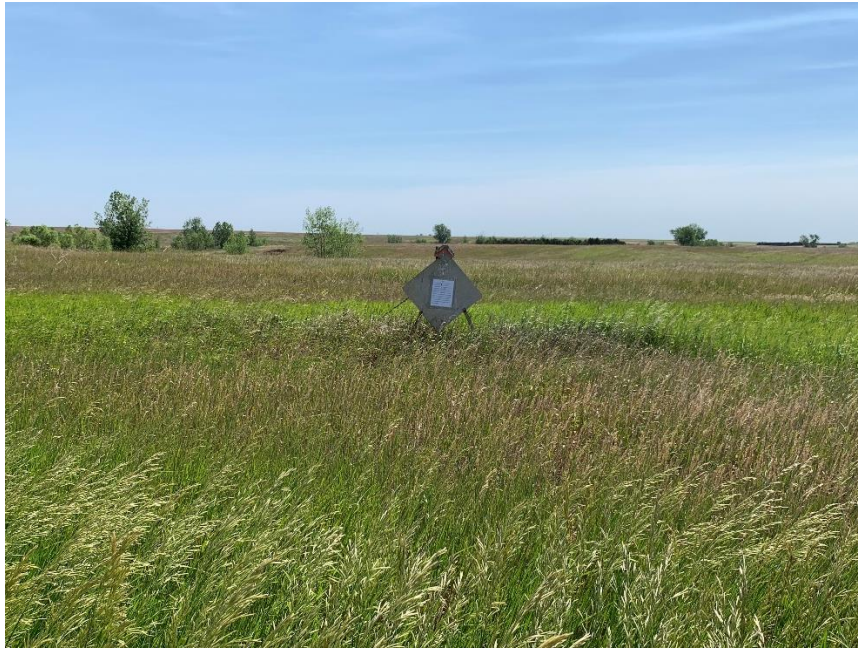
Proposed Mine Application Sign Facing County Road 41

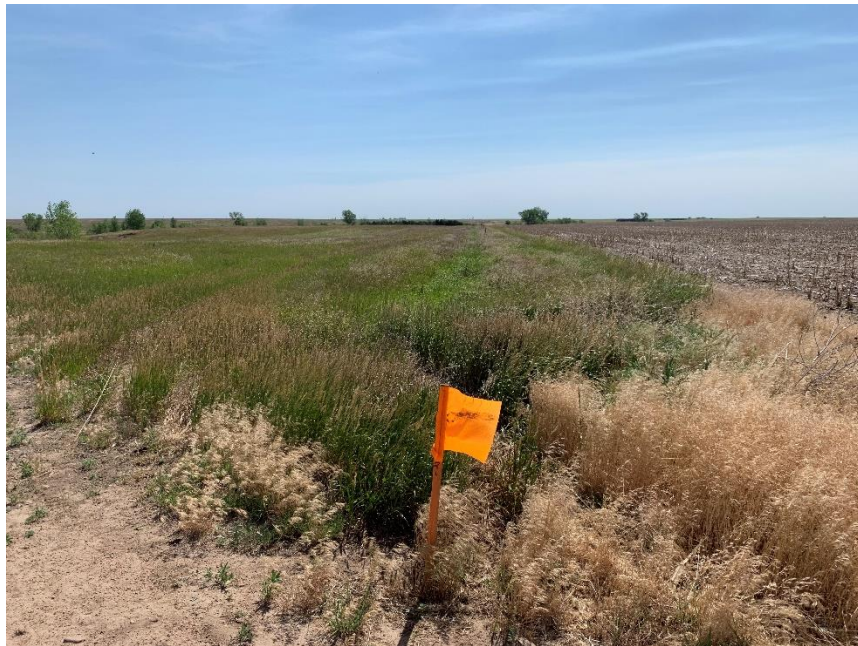
Southern Permit Boundary Marker Looking East

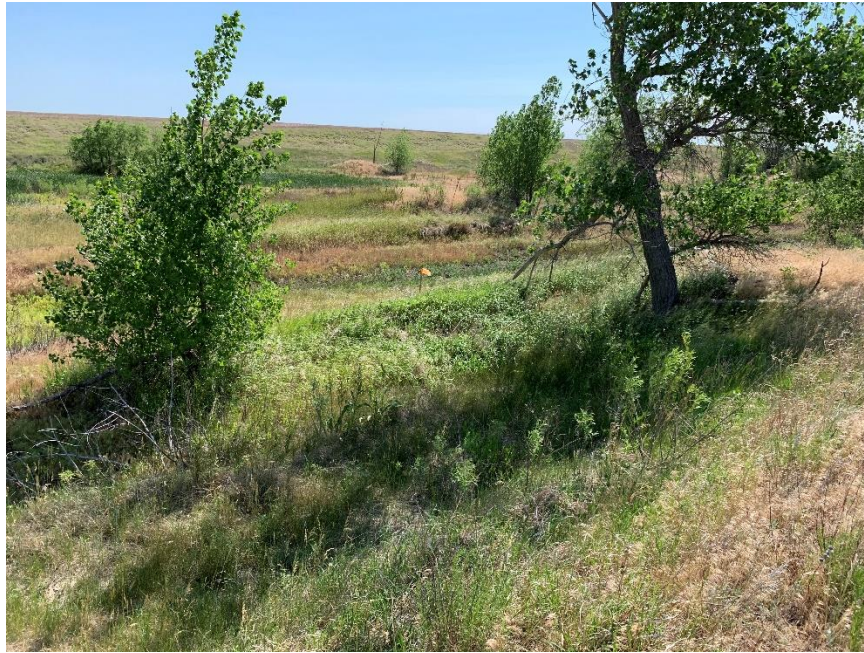
North Marker of the Eastern Most Boundary Facing Northeast

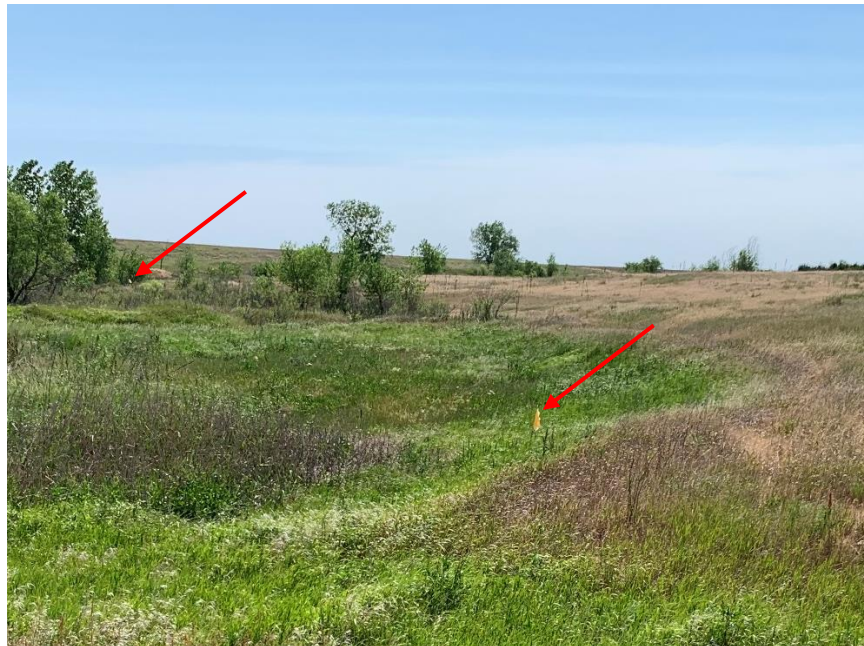
Two Boundary Markers Along Dry Creek Facing East

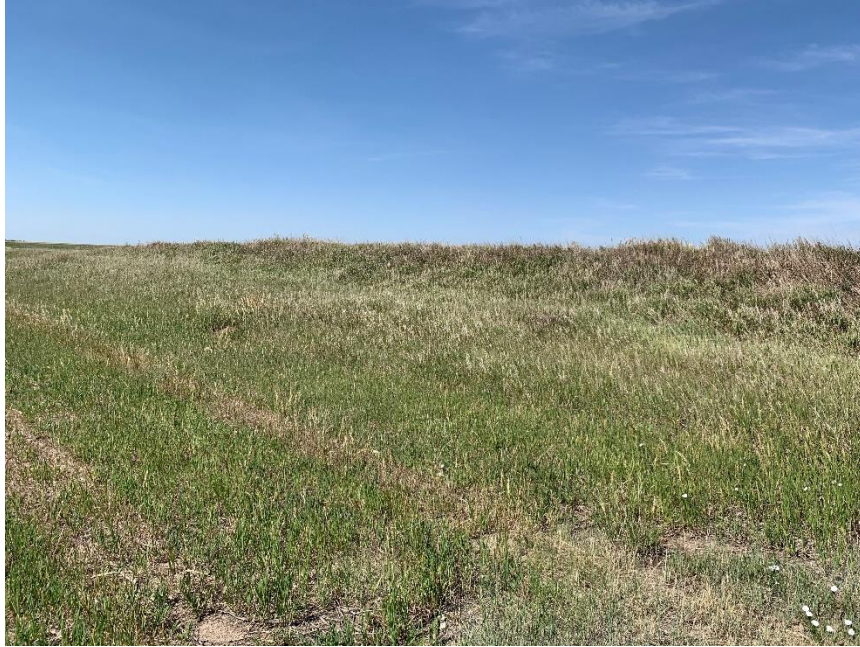
The topsoil pile on the western boundary along County Road 41 was well vegetated and appeared stable. The mullein plants were recently treated.

Topsoil Stockpile Along County Road 41 Facing Southwest
