**RE: Colowyo Coal Mine
Permit No. C-1981-019
Fill Monitoring Certifications
Second Quarter 2020**

South Taylor Fill Inspection Certification

INSPECTION REPORT ~ SOUTH TAYLOR FILL
(Including Both the East Taylor and West Taylor Fill Segments)

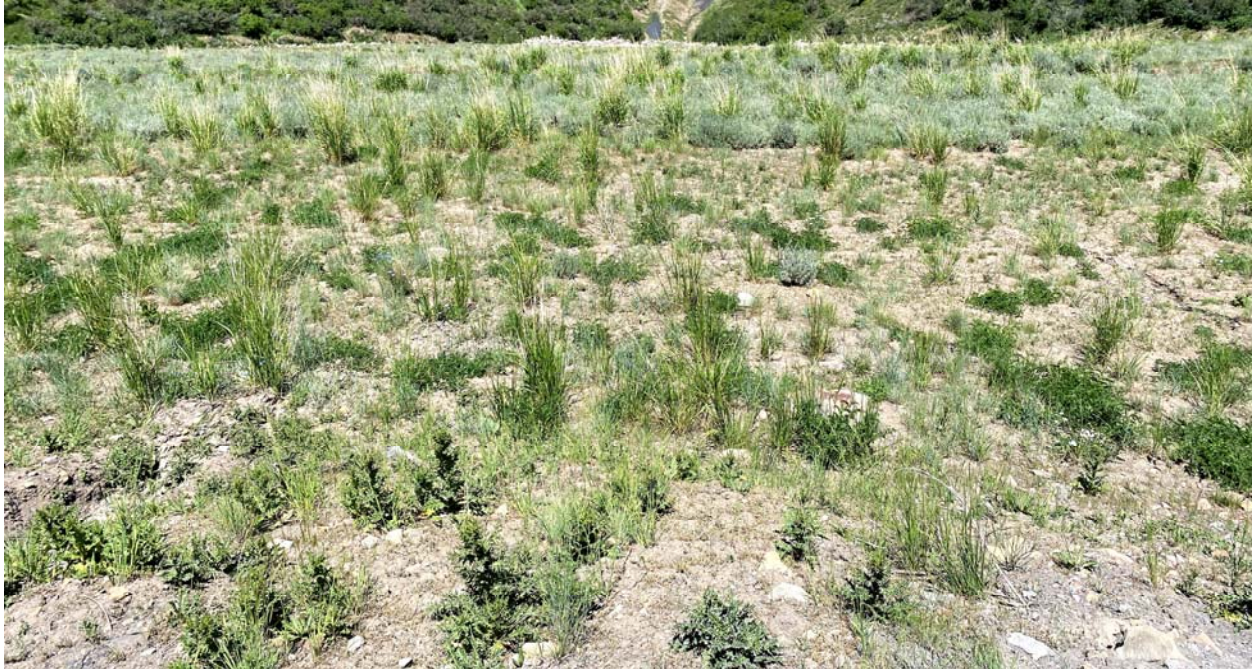
West Taylor Fill with A-A' and B-B' Underdrain Area The East Tributary of the West Taylor fill has rip-rap installed up to the 7840' elevation. The West Tributary of the West Taylor fill has rip-rap installed up to the 7820' elevation.

No structural weakness, signs of instability, or other hazards were noted at the time of inspection.

06-17-20 - West Taylor fill looking north from monitoring well location

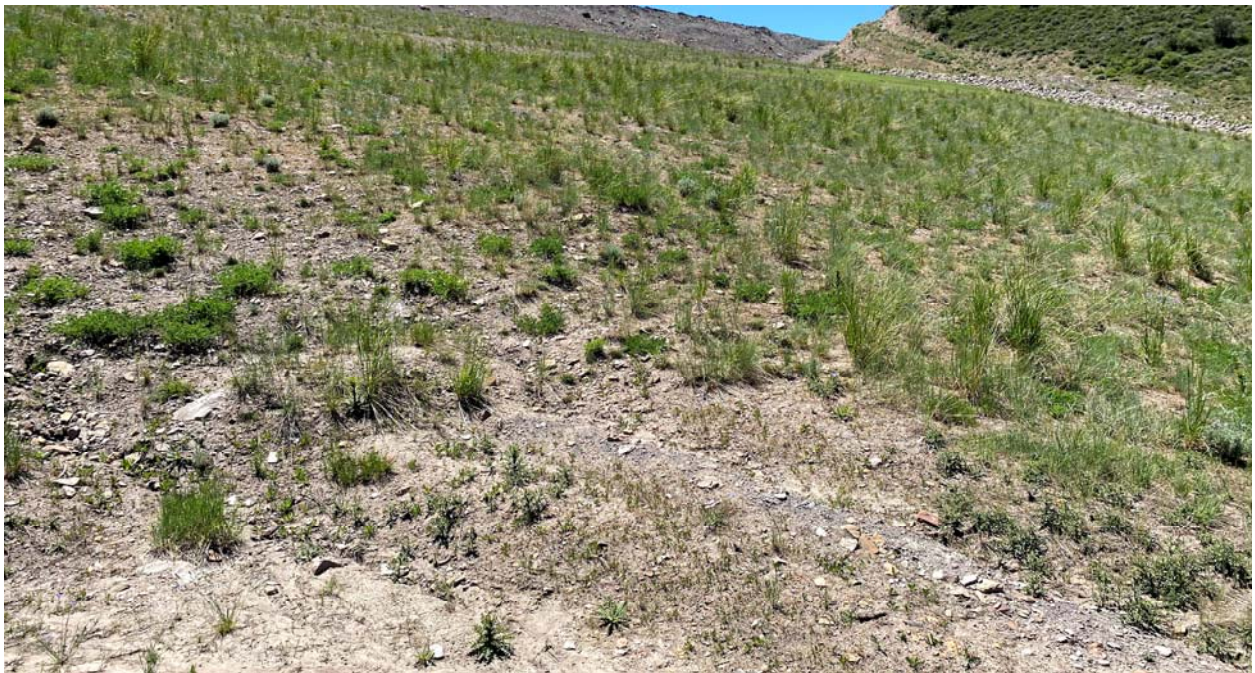
06-17-20 - West Taylor Fill West Flank from monitoring well location

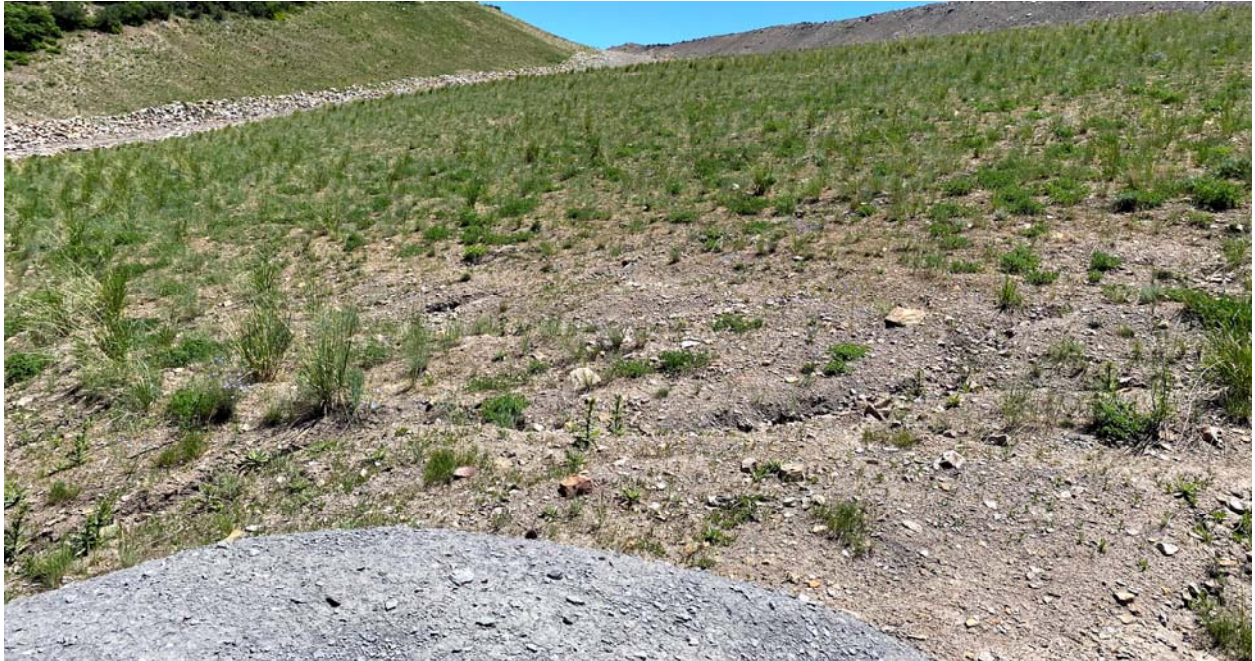
06-17-20 - West Taylor Fill East Flank from monitoring well location

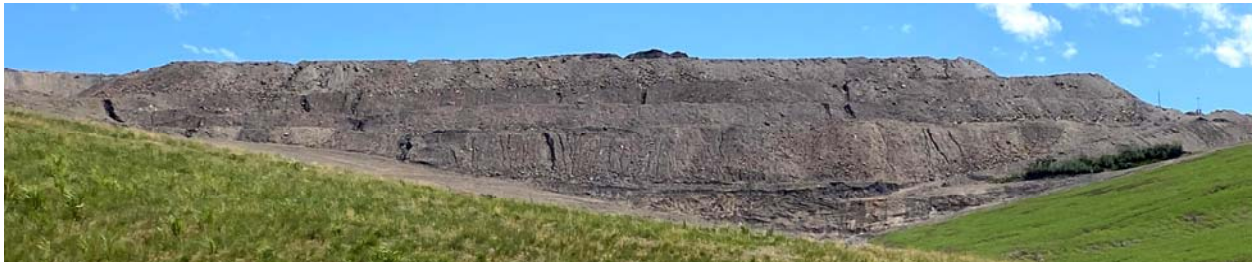
East Taylor Fill with C-C' Underdrain Area: Reclamation activity including removal of material from the top of the fill area along with rock crusher operations have taken place within the East Taylor fill during this quarter.

No structural weakness, signs of instability, or other hazards were noted at the time of inspection.

06-17-20 - East Taylor Fill looking south from the West Pit reclamation
