MINERALS PROGRAM INSPECTION REPORT PHONE: (303) 866-3567

MINE NAME:		MINE/PROSPECTING ID#:	MINERAL:	COUNTY:
Red Dirt Pit		M-2008-008	Sand and gravel	Grand
INSPECTION TYPE:		INSPECTOR(S):	INSP. DATE:	INSP. TIME:
Monitoring		Peter Hays	June 16, 2020	14:00
OPERATOR:		OPERATOR REPRESENTATIVE:	TYPE OF OPERATION:	
Grand County		Micah Benson, Jason Schroer	110c - Construction Limited Impact	
	ī		T	
REASON FOR INSPECTION:		BOND CALCULATION TYPE:	BOND AMOUNT:	
Normal I&E Program		None	\$0.00	
DATE OF COMPLAINT:		POST INSP. CONTACTS:	JOINT INSP. AGENCY:	
NA		None	None	
WEATHER:	INSPECTOR'S SIGNATURE:		SIGNATURE DATE:	
Clear	fthe.		June 23, 2020

PERMIT #: M-2008-008 INSPECTOR'S INITIALS: PSH INSPECTION DATE: June 16, 2020

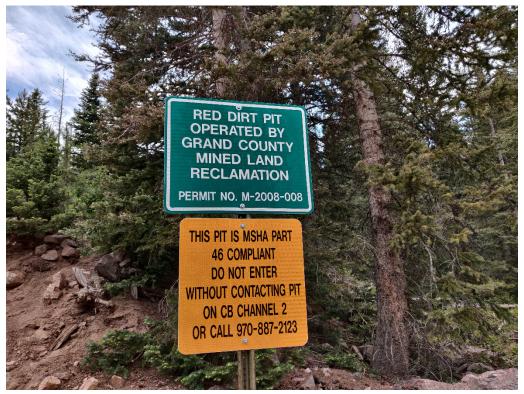
The mine sign and permit boundaries were observed as required by Rule 3.1.12.

Red Dirt Pit mine sign

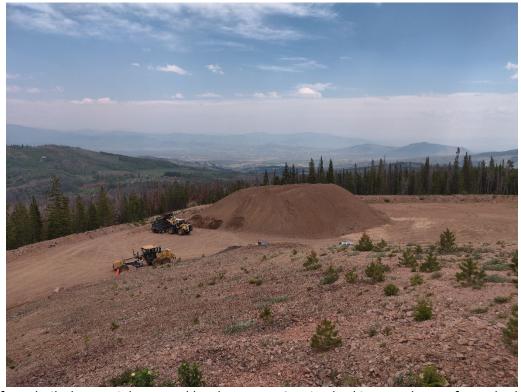
The approved Mining Plan states the material on-site is decomposed granite suitable for graveling roads in the area. The site appeared unchanged from the 2017 inspection. A roadbase stockpile was located in the northeast corner of the pit floor. Material was being actively removed by the Forest Service for nearby road maintenance.

View of stockpiled material removal by the Forest Service looking northwest from the highwall

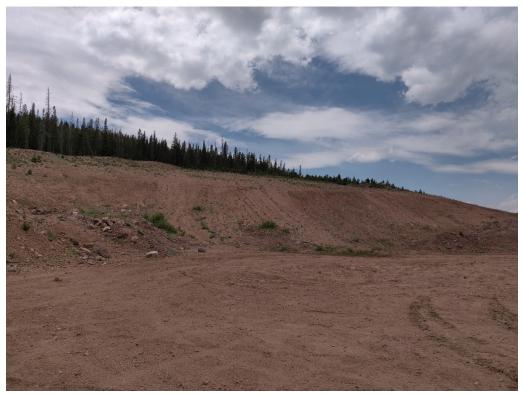
View of the temporarily graded mining highwall from the pit floor looking west

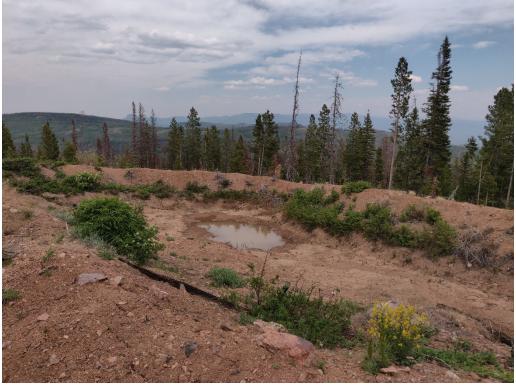
The sedimentation pond located in the northwest corner of the permit boundary contained a small pond of water and appeared to be functioning properly.

View of the sedimentation pond in the northwest corner of the site

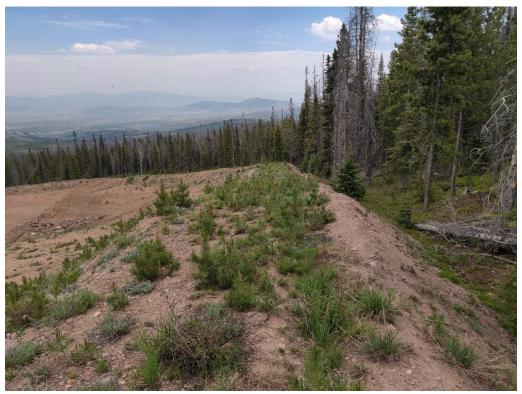
The approved post-mining land use for the site is rangeland. Reclamation activities have not begun at the site. The approved Reclamation Plan states 1 to 3 inches of topsoil will be salvaged for use in reclamation. Topsoil stockpiles were observed along the south and east boundaries. The stockpiles were stable and vegetation was establishing on the stockpiles. Site reclamation will result in a final 2H:1V slope. The active mine face was temporarily sloped at approximately a 2H:1V slope. Erosion features, rills, were observed on the highwall, but overall the slope appeared stable.

View of trees establishing on the south topsoil berm looking east
