MINERALS PROGRAM INSPECTION REPORT
PHONE: (303) 866-3567

MINE NAME: Blue Valley Pit	MINE/PROSPECTING ID#: M-2015-008	MINERAL: Sand and gravel	COUNTY: Grand
INSPECTION TYPE: Monitoring	INSPECTOR(S): Peter Hays	INSP. DATE: June 17, 2020	INSP. TIME: 14:00
OPERATOR: Kirkland Construction, L.L.P.	OPERATOR REPRESENTATIVE: Tim Gerken	TYPE OF OPERATION: 111 - Construction by Government Agency	
REASON FOR INSPECTION: Normal I&E Program	BOND CALCULATION TYPE: Partial Bond	BOND AMOUNT: \$18,078.00	
DATE OF COMPLAINT: NA	POST INSP. CONTACTS: None	JOINT INSP. AGENCY: None	
WEATHER: Clear	INSPECTOR'S SIGNATURE:

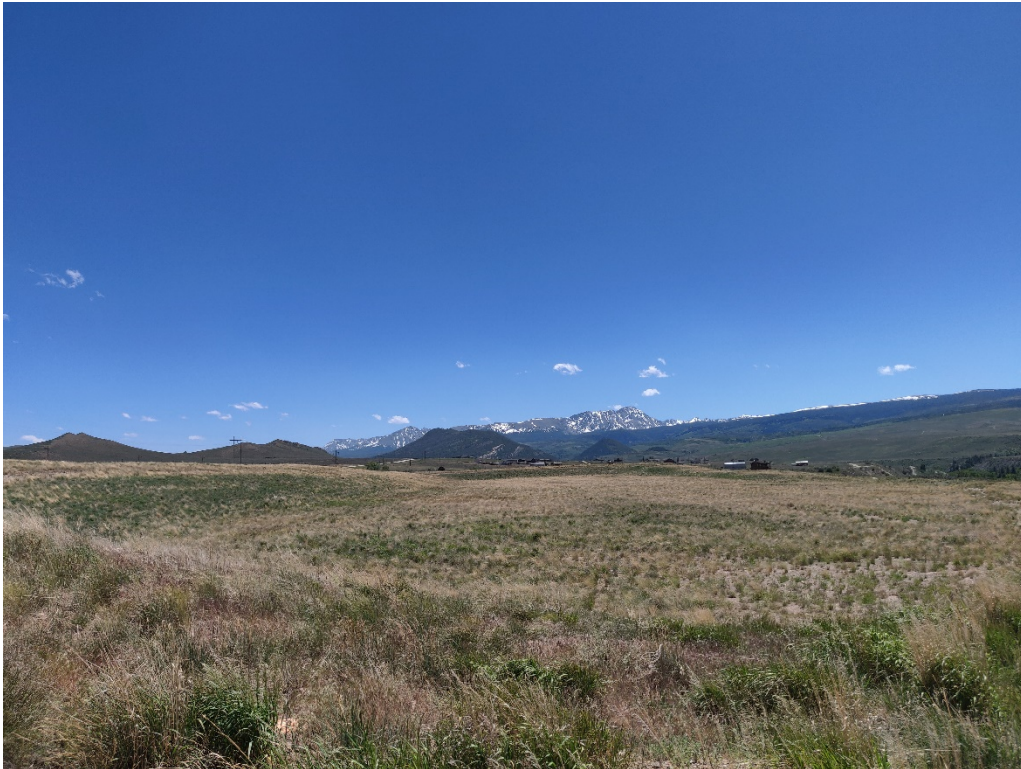
View of the site from the north end looking south

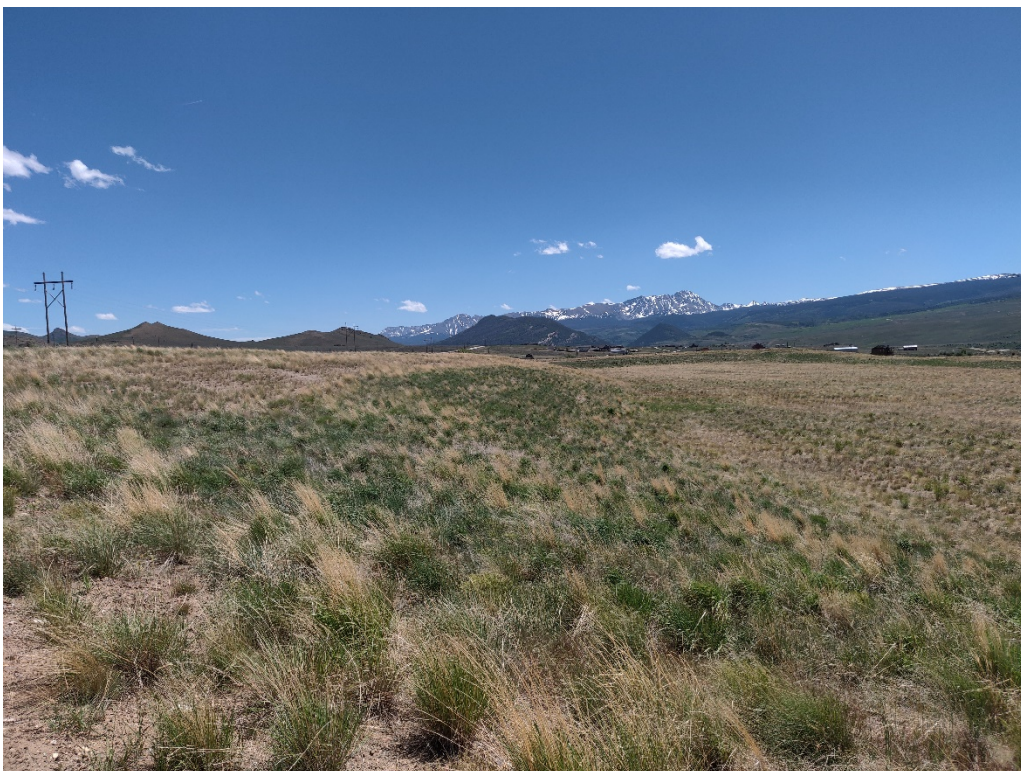
View of the east slope from the north end of the slope looking south

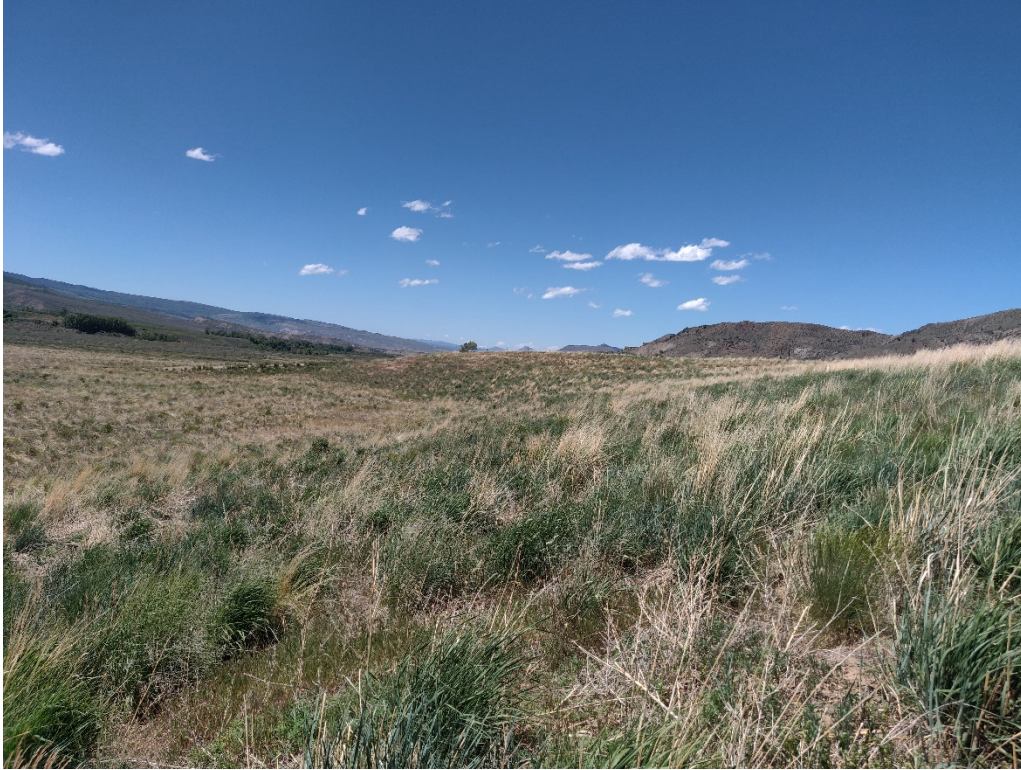
View of the vegetation on the east slope looking north

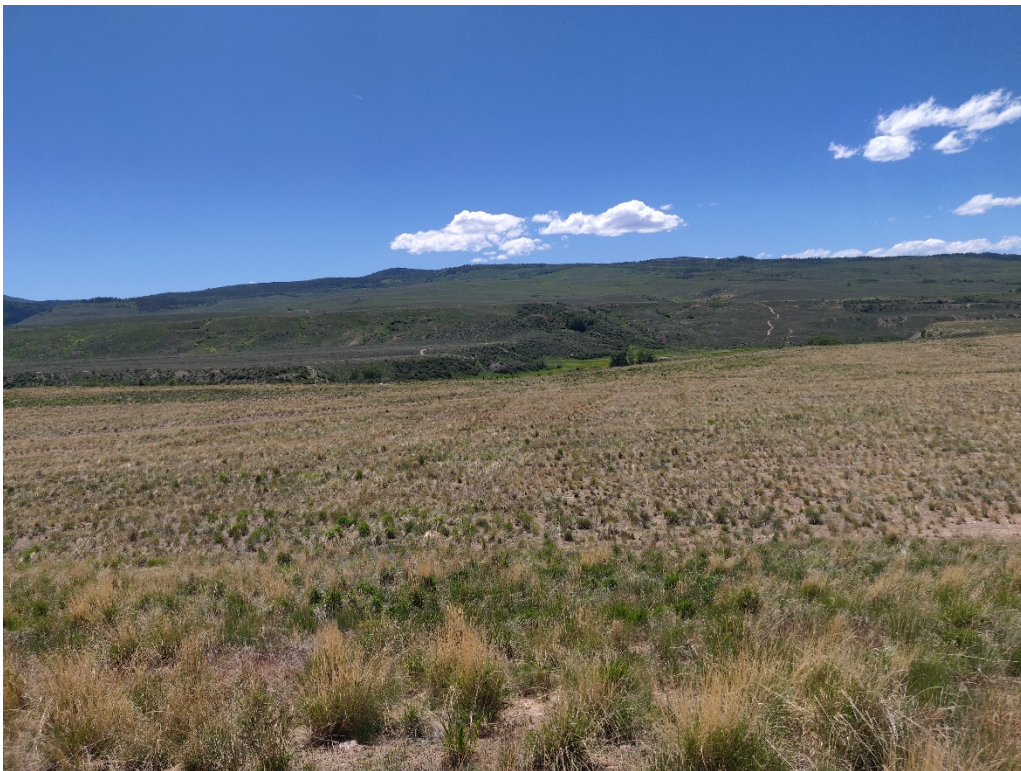
View of the pit floor from the east slope looking west

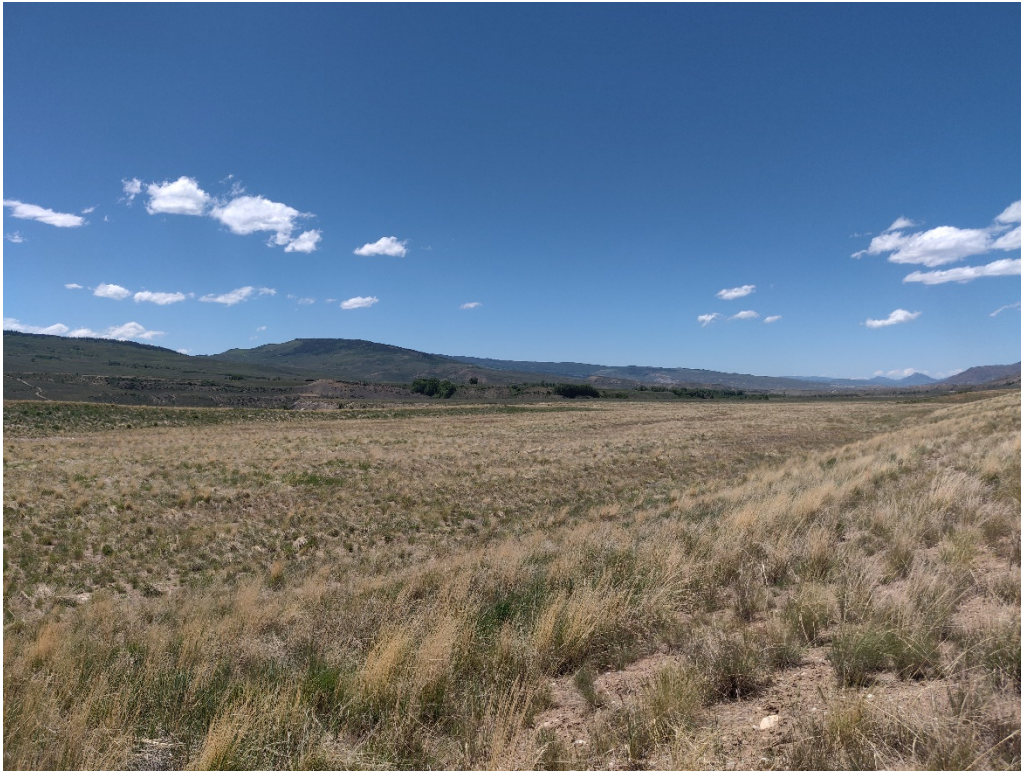
View of the site from the southeast corner of the site looking northwest

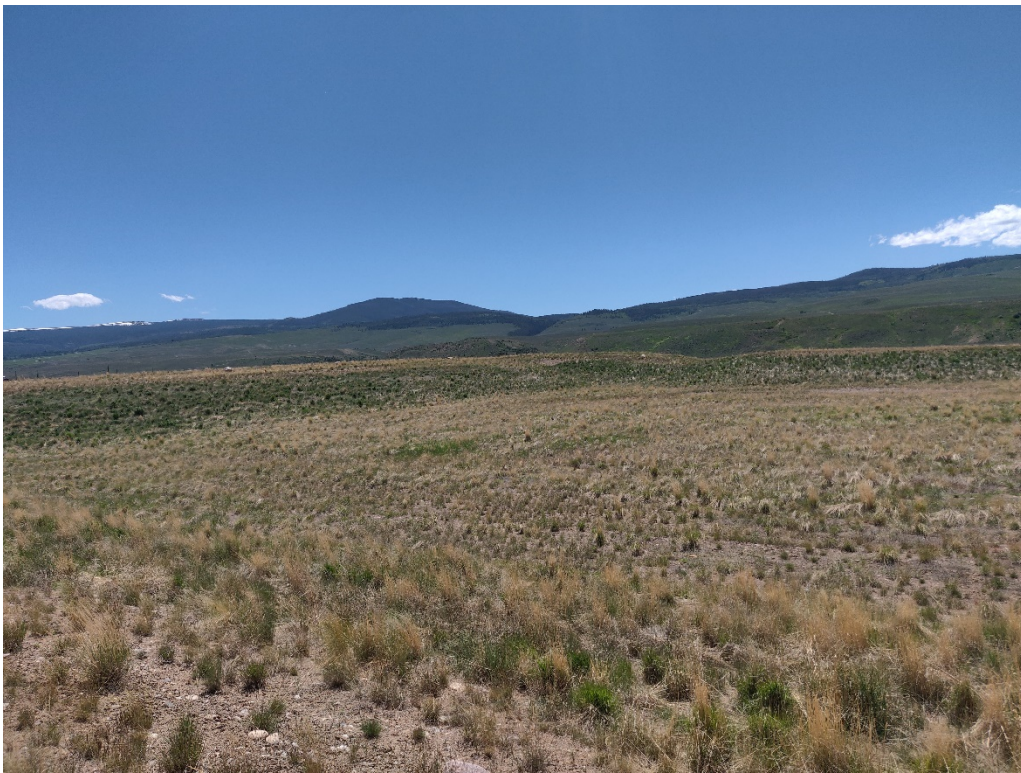
View of the south and west slopes and pit floor from the east slope

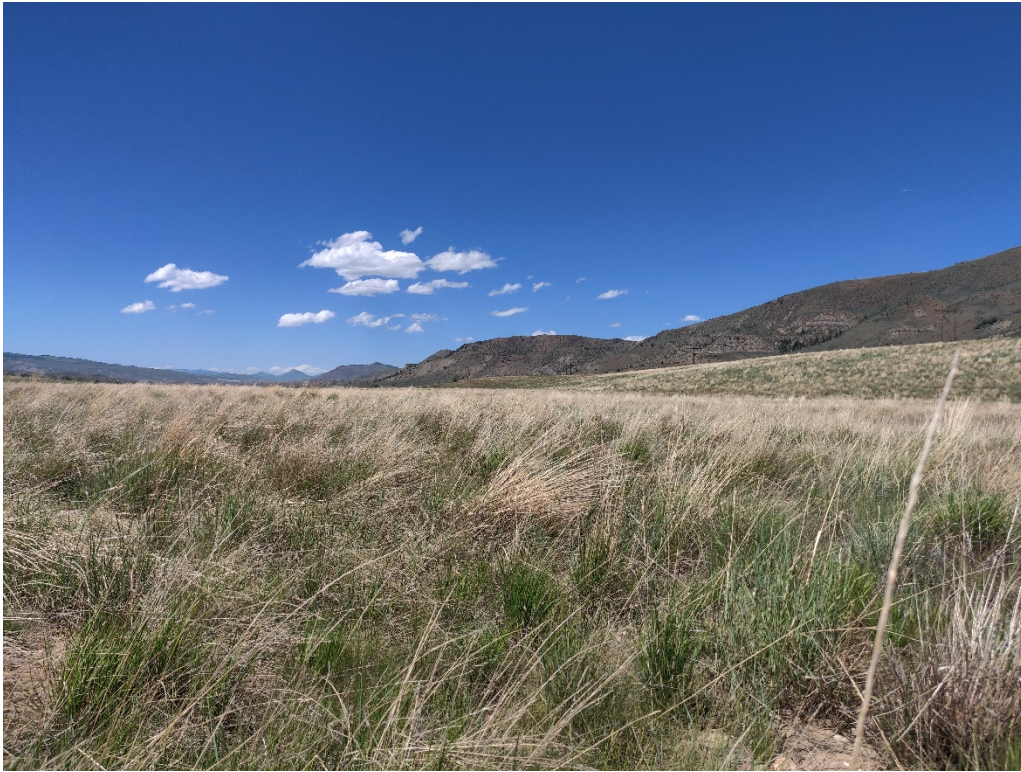
View of the pit floor vegetation in the southern portion of the site looking south

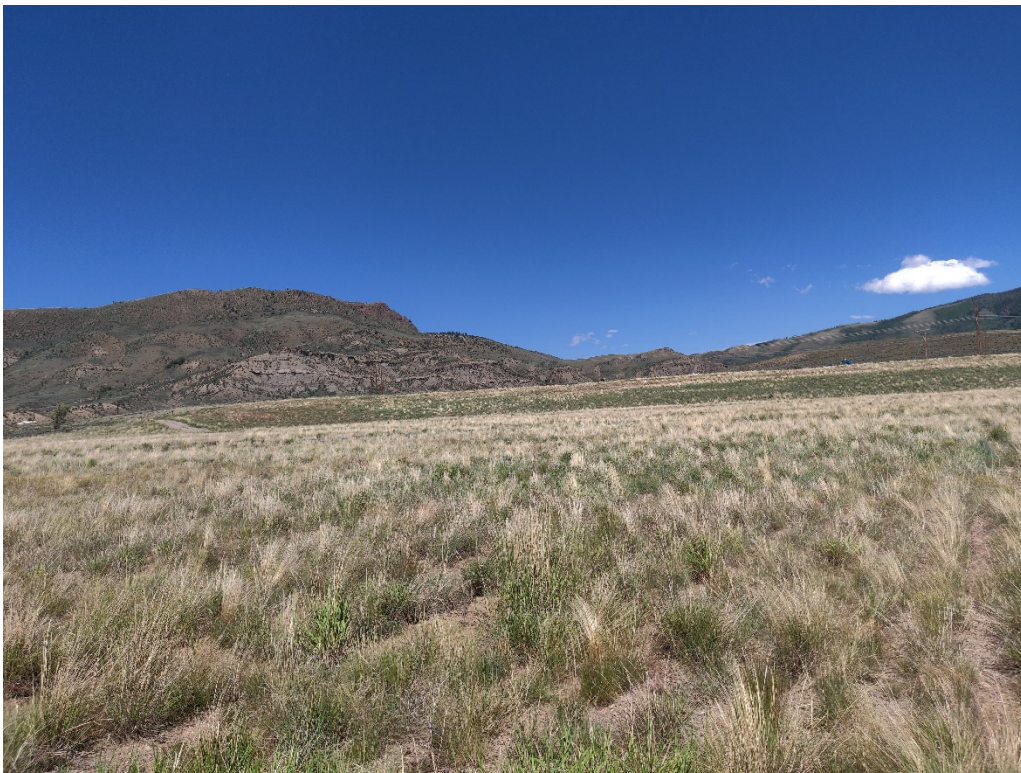
View of the pit floor vegetation in the northern portion of the site looking northeast

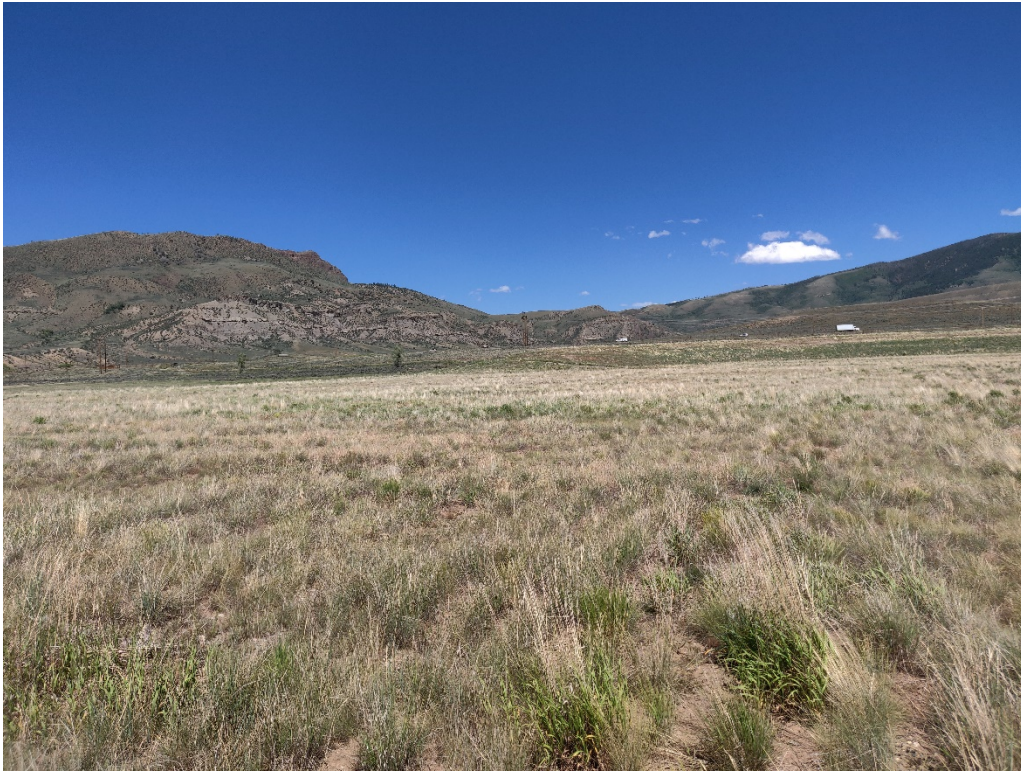
View of the site from the northwest corner of the site looking east

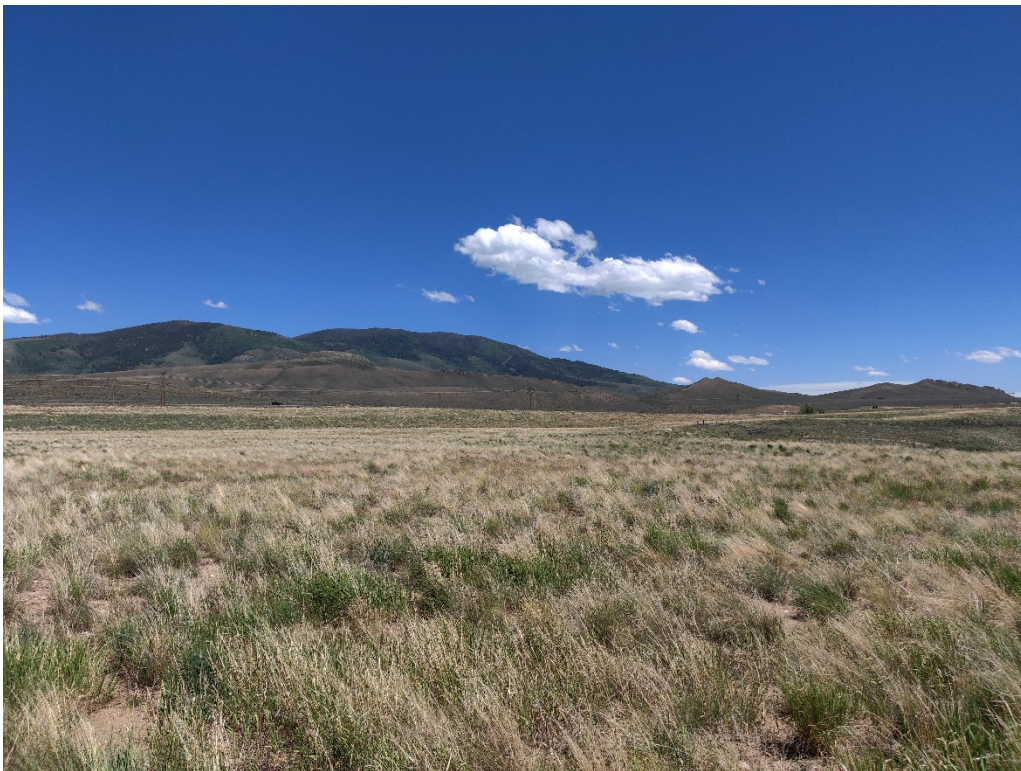
View of the site from the northwest corner of the site looking southeast
