MINERALS PROGRAM INSPECTION REPORT
PHONE: (303) 866-3567 Ext. 8183

MINE NAME: Logan Wash	MINE/PROSPECTING ID#: M-1977-424	MINERAL: Oil shale	COUNTY: Garfield
INSPECTION TYPE: Monitoring	INSPECTOR(S): Amy Yeldell	INSP. DATE: June 18, 2020	INSP. TIME: 09:30
OPERATOR: Occidental Oil Shale, Inc.	OPERATOR REPRESENTATIVE: Bruce Smith	TYPE OF OPERATION: 112 - Hard Rock Regular Operation	
REASON FOR INSPECTION: Priority	BOND CALCULATION TYPE: None	BOND AMOUNT: \$570,428.00	
DATE OF COMPLAINT: NA	POST INSP. CONTACTS: None	JOINT INSP. AGENCY: None	
WEATHER: Clear	INSPECTOR'S SIGNATURE:

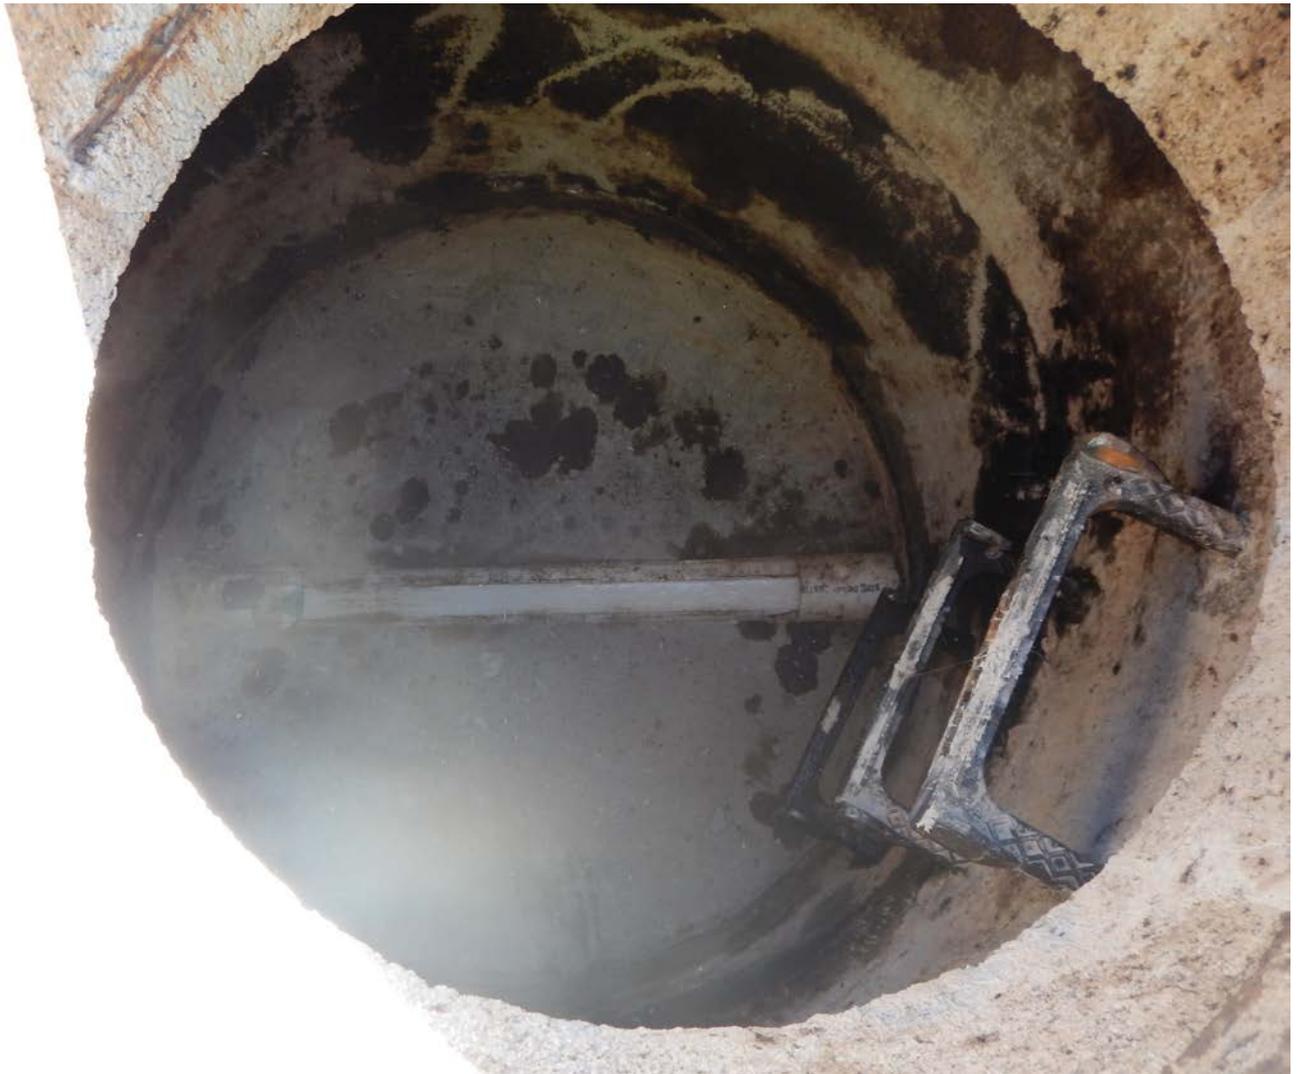
In this case water was observed leaking from MH-10 and never reached the evaporation pond, likely due to a plug in the pipe. The line was shut in at the mine and pumper trucks were utilized to vacuum the excess water leaking from MH-10. Additionally sludge and sediment was removed from MH-10. All water and sludge removed were properly disposed of. Soils that were impacted by the retort water have been sent to the lab for testing and results are pending.

Upon inspection no evidence of a spill was visible in the ditches that came into contact with the retort water. Mr. Smith opened the MH-10 cover and the vault was free from any sediment or sludge. Water is now flowing freely to the evaporation pond.

The rest of the mine site was not inspected. At this time no additional action is required of the Operator. Pending the soil sample results soil removal or remediation may be necessary. It is noted that water was contained to the already bare borrow ditch.
