MINERALS PROGRAM INSPECTION REPORT
PHONE: (303) 866-3567

MINE NAME: Craig Pit	MINE/PROSPECTING ID#: M-1976-027	MINERAL: Sand and gravel	COUNTY: La Plata
INSPECTION TYPE: Surety Release Inspection	INSPECTOR(S): Lucas West	INSP. DATE: June 11, 2020	INSP. TIME: 16:33
OPERATOR: Skanska USA Civil West Rocky Mountain Di	OPERATOR REPRESENTATIVE: None	TYPE OF OPERATION: 112c - Construction Regular Operation	
REASON FOR INSPECTION: Surety Release Requested	BOND CALCULATION TYPE: None	BOND AMOUNT: \$158,692.74	
DATE OF COMPLAINT: NA	POST INSP. CONTACTS: None	JOINT INSP. AGENCY: None	
WEATHER: Clear	INSPECTOR'S SIGNATURE:

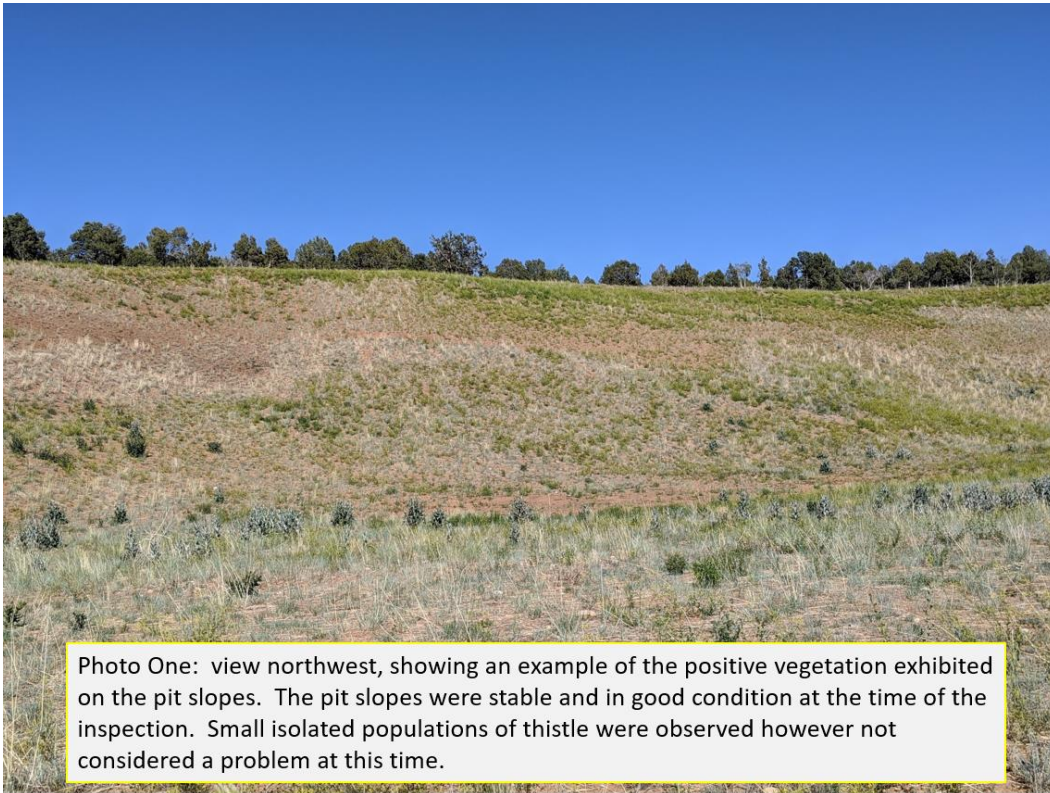
Photo One: view northwest, showing an example of the positive vegetation exhibited on the pit slopes. The pit slopes were stable and in good condition at the time of the inspection. Small isolated populations of thistle were observed however not considered a problem at this time.

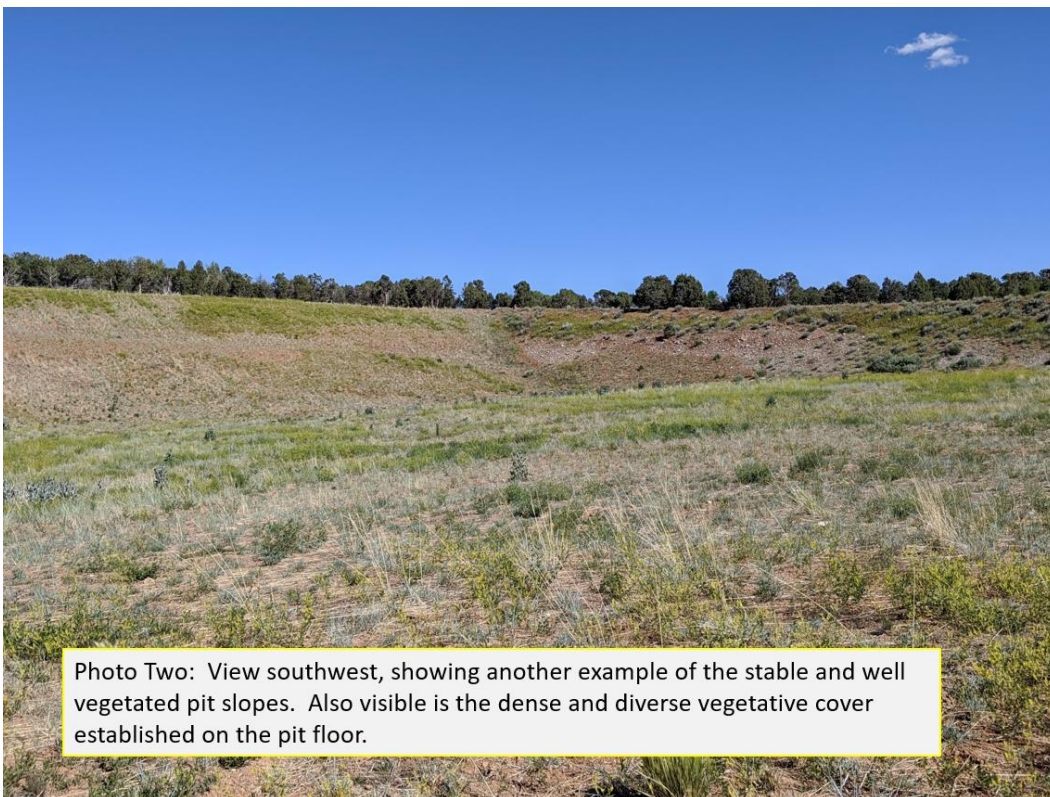
Photo Two: View southwest, showing another example of the stable and well vegetated pit slopes. Also visible is the dense and diverse vegetative cover established on the pit floor.

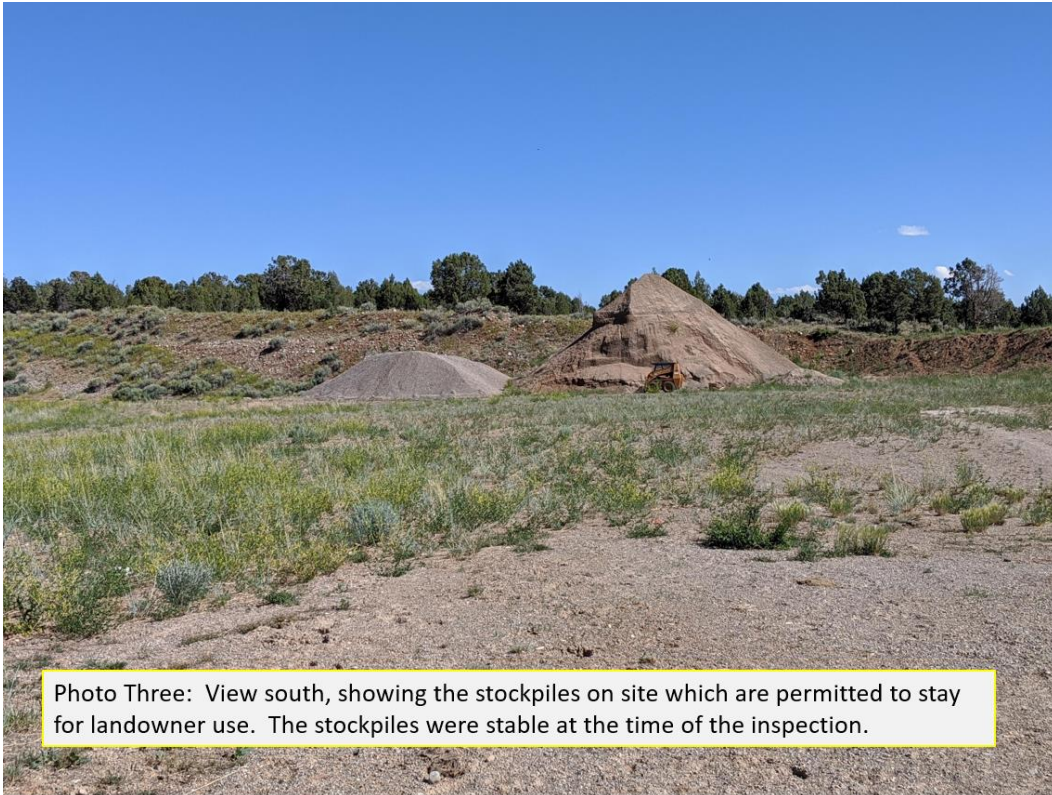
Photo Three: View south, showing the stockpiles on site which are permitted to stay for landowner use. The stockpiles were stable at the time of the inspection.

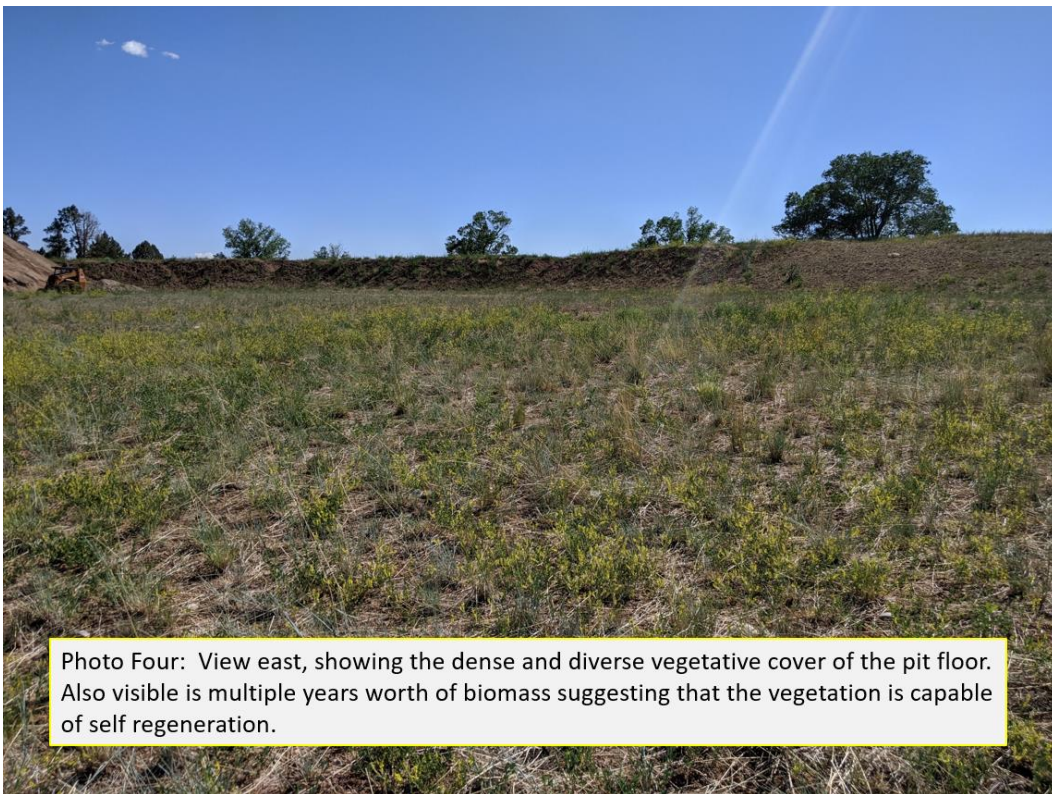
Photo Four: View east, showing the dense and diverse vegetative cover of the pit floor. Also visible is multiple years worth of biomass suggesting that the vegetation is capable of self regeneration.

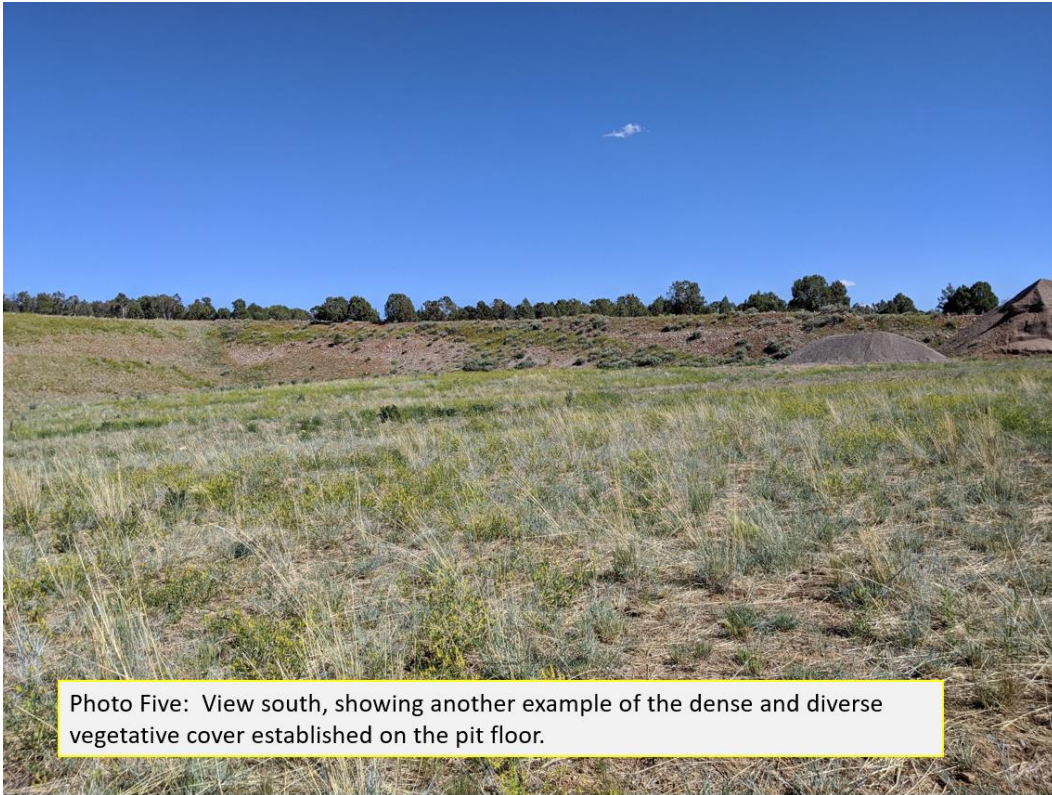
Photo Five: View south, showing another example of the dense and diverse vegetative cover established on the pit floor.
