MINERALS PROGRAM INSPECTION REPORT
PHONE: (303) 866-3567 Ext. 8187

MINE NAME: Deep Creek Placer	MINE/PROSPECTING ID#: M-1986-102	MINERAL: Limestone (general)	COUNTY: San Miguel
INSPECTION TYPE: Monitoring	INSPECTOR(S): Lucas West	INSP. DATE: June 11, 2020	INSP. TIME: 10:30
OPERATOR: Collins Morehead, LLC	OPERATOR REPRESENTATIVE: None	TYPE OF OPERATION: 110c - Construction Limited Impact

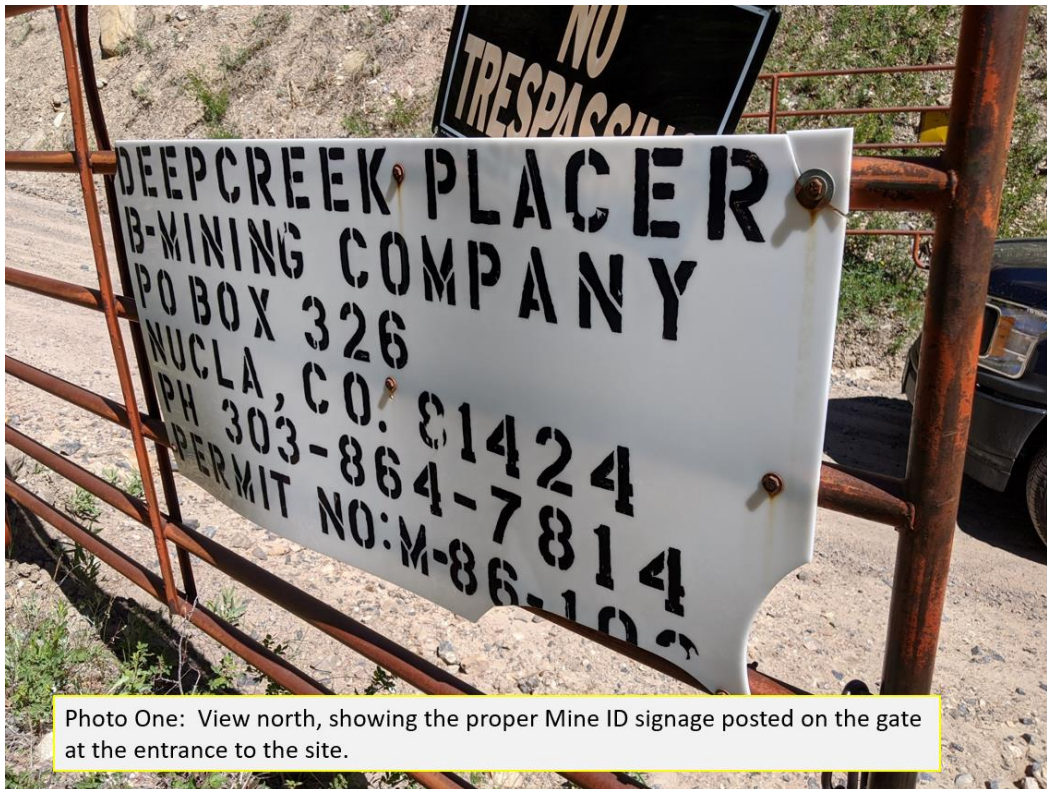
Photo One: View north, showing the proper Mine ID signage posted on the gate at the entrance to the site.

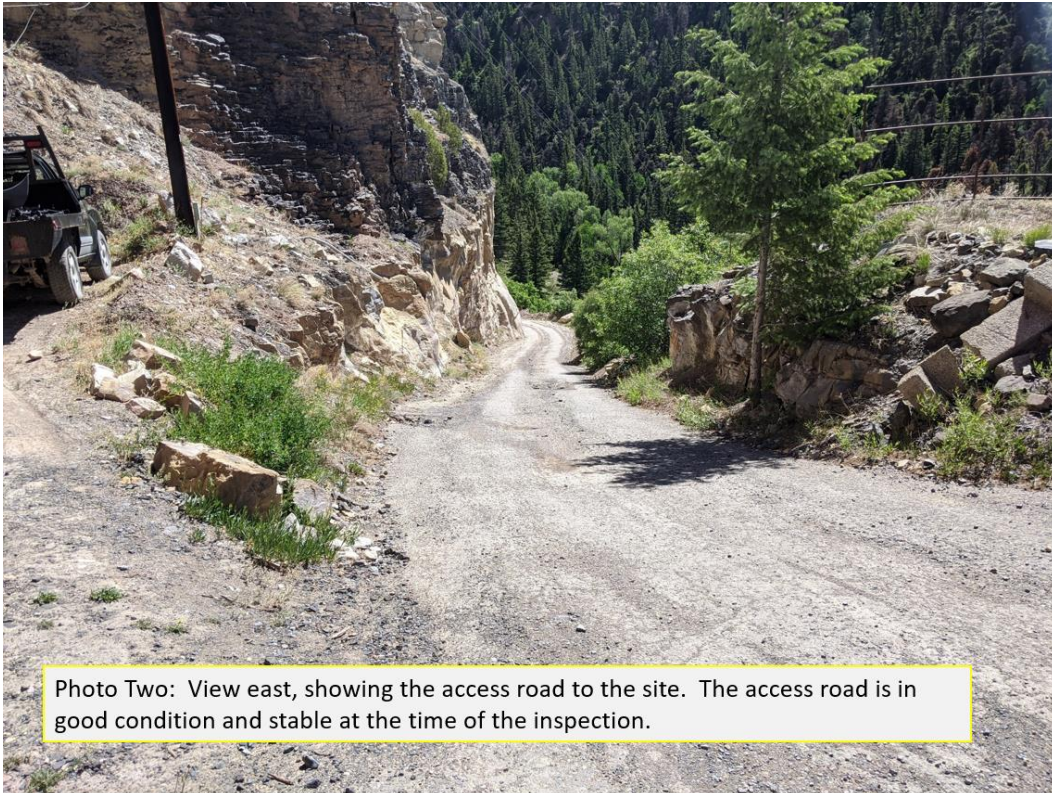
The proper Mine Identification sign was posted on the gate at the bottom of the access road that can be seen in Photo One. The access road leading up to the equipment apron and portal areas is in good condition. No signs of significant erosion were noted and all storm water control features associated with the access road appeared to be functioning as designed at the time of the inspection. The access road can be seen in Photo Two.

Photo Two: View east, showing the access road to the site. The access road is in good condition and stable at the time of the inspection.

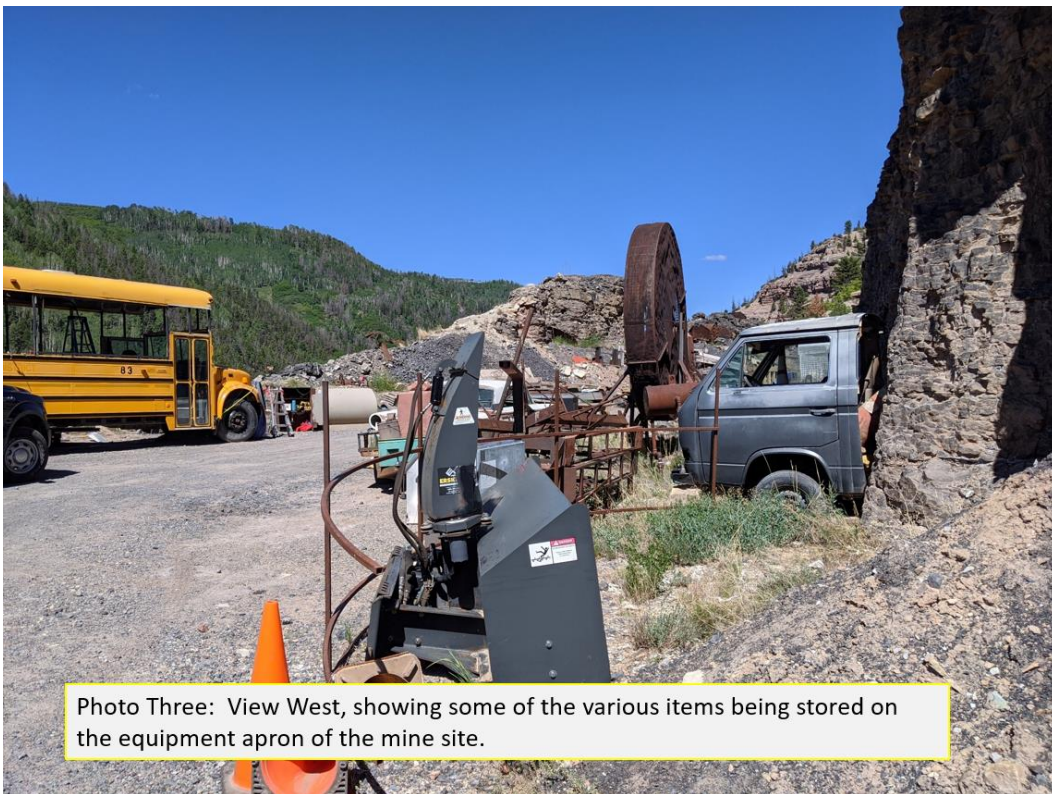
INSPECTION TOPIC: other
PROBLEM/POSSIBLE VIOLATION: Problem: Trash and refuse was noticed on the site. This is a problem at this time for failure to dispose of refuse in a manner that controls unsightliness or deleterious effects of such refuse pursuant to C.R.S. 34-32.5-116(4)(e).
CORRECTIVE ACTIONS: The operator shall submit a written notice to the Division with photo documentation, that the trash has been removed from the site by the corrective action date.
CORRECTIVE ACTION DUE DATE: 7/31/20

Photo Three: View West, showing some of the various items being stored on the equipment apron of the mine site.

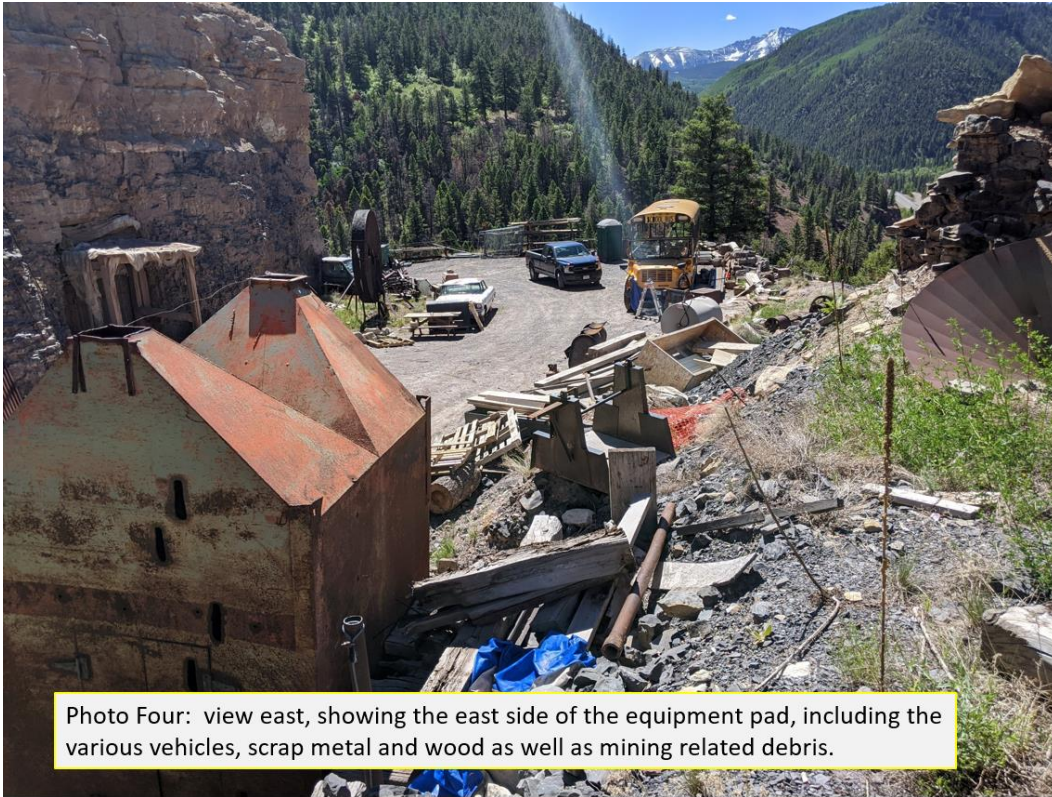
Photo Four: view east, showing the east side of the equipment pad, including the various vehicles, scrap metal and wood as well as mining related debris.

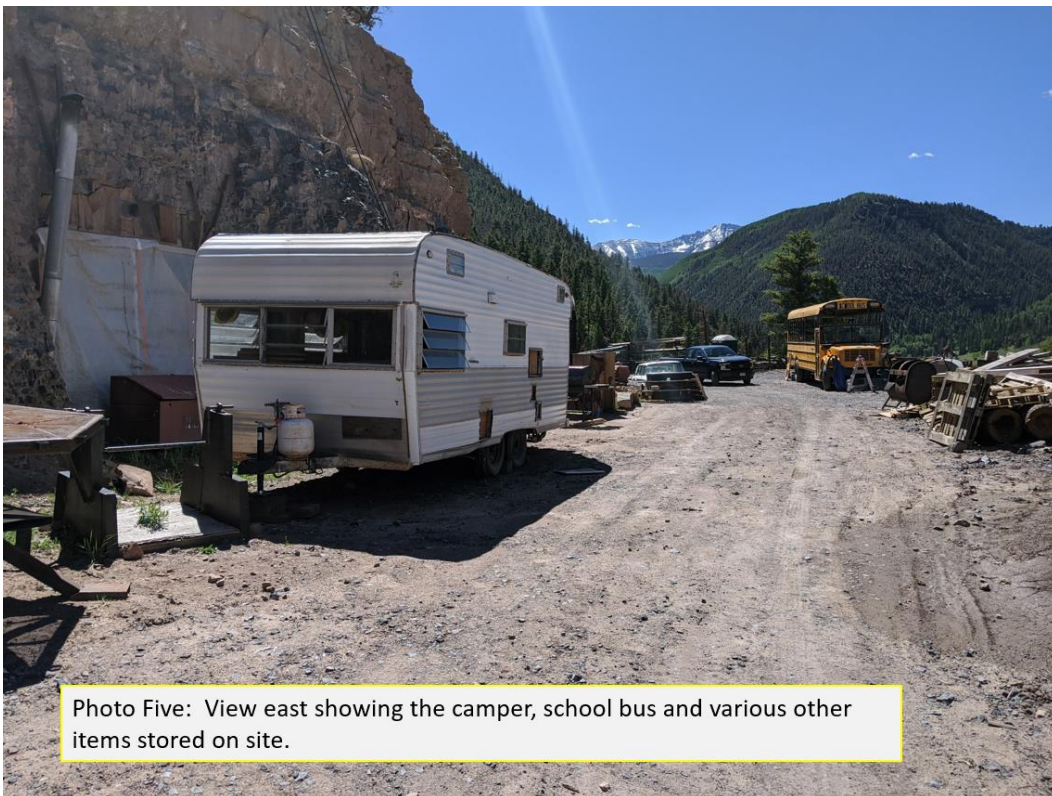
Photo Five: View east showing the camper, school bus and various other items stored on site.

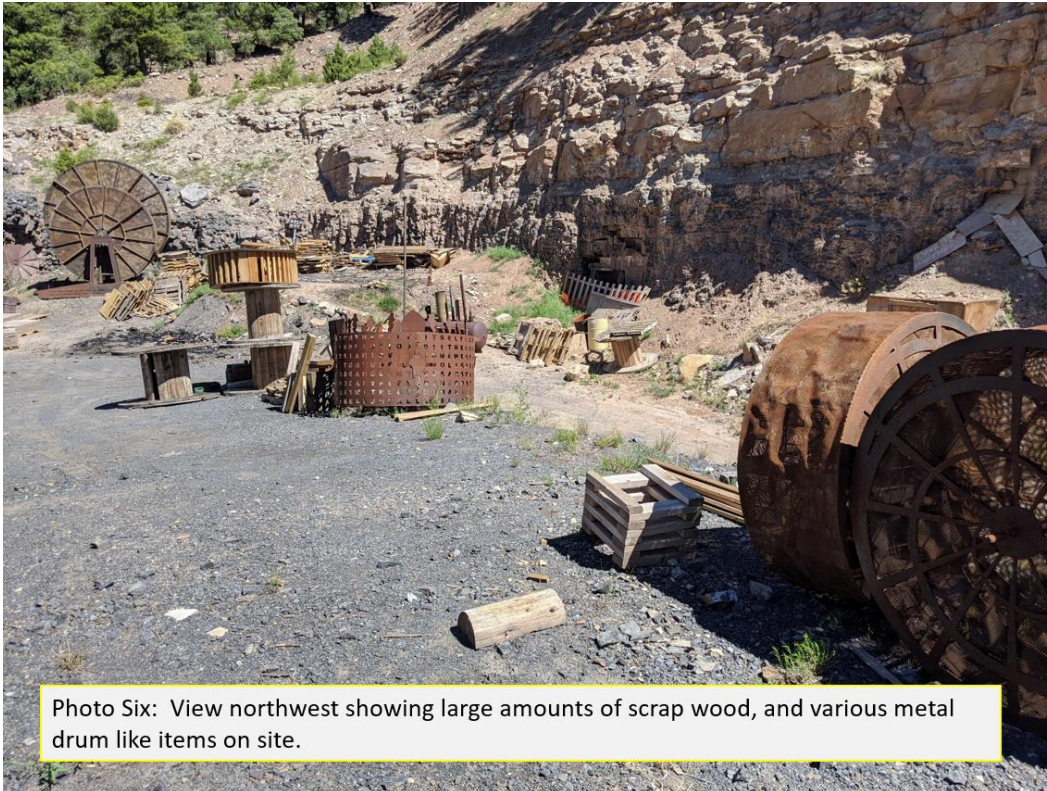
Photo Six: View northwest showing large amounts of scrap wood, and various metal drum like items on site.

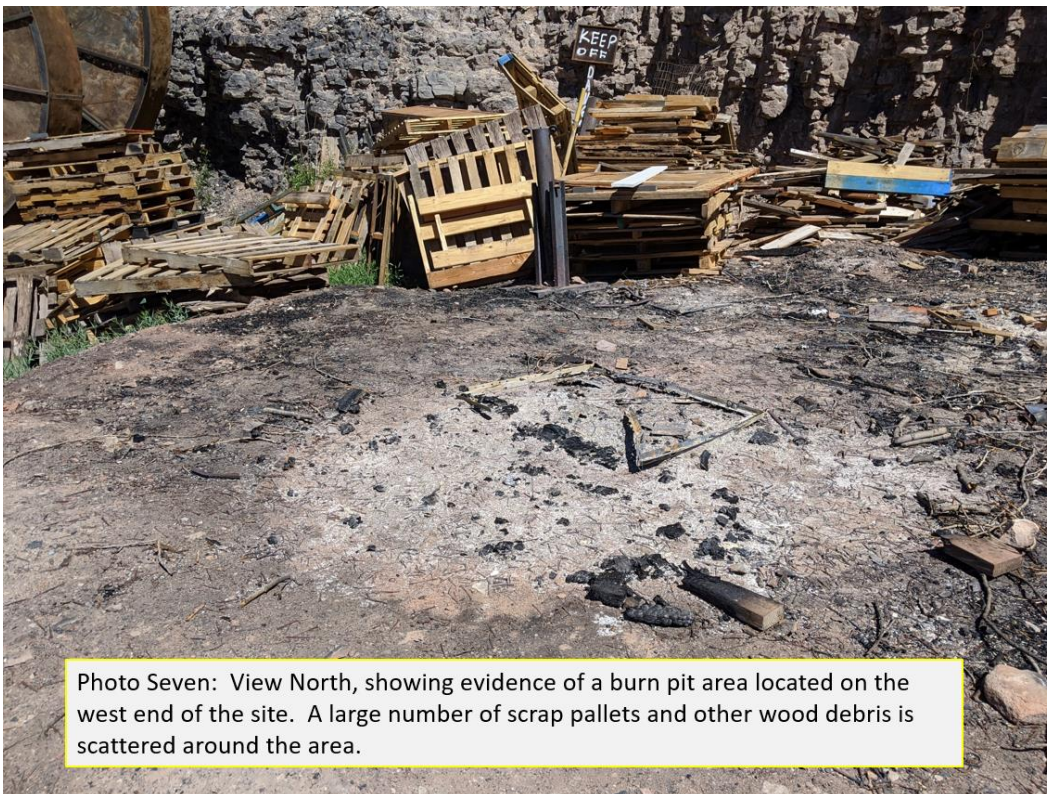
Photo Seven: View North, showing evidence of a burn pit area located on the west end of the site. A large number of scrap pallets and other wood debris is scattered around the area.

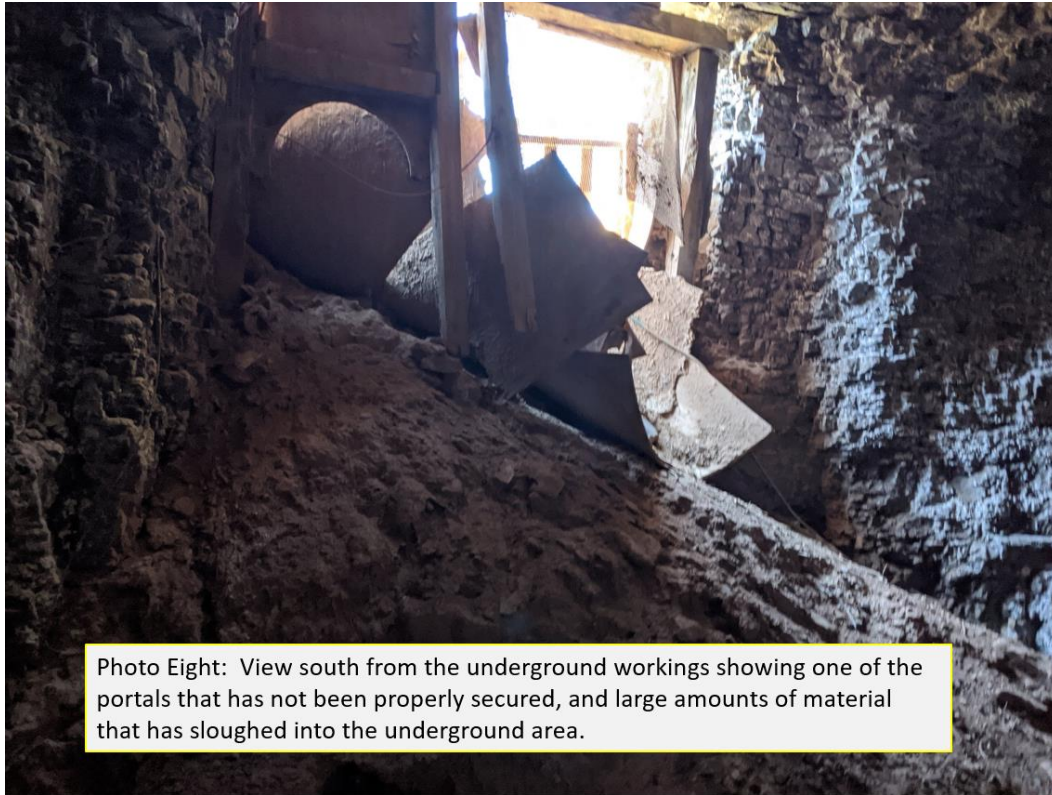
The portals located on site leading to the underground workings appeared to be in good condition. All portals used for access to the workings were equipped with lockable steel gates, which were un-secured at the time to allow for inspection. The portals were in good condition and appeared to be stable at the time of the inspection. One portal that is secured and covered with a light density plastic to allow light to filter to the underground workings had evidence of material sloughing into the underground workings. The amended reclamation plan states that the remaining portals will either be sealed with concrete block or with a lockable steel gates, this portal appeared have to neither closure method installed. The portal can be seen in Photo Eight from the underground workings. The material that has sloughed off should be cleared of the opening, and one of the approved closure methods should be installed. This task must be completed in accordance with the approved Reclamation Plan before a full reclamation permit release can be completed.

Photo Eight: View south from the underground workings showing one of the portals that has not been properly secured, and large amounts of material that has sloughed into the underground area.
