MINERALS PROGRAM INSPECTION REPORT
PHONE: (303) 866-3567

MINE NAME: Lyons Quarry	MINE/PROSPECTING ID#: M-1977-141	MINERAL: Quartz (quartzite/quartzose ss)	COUNTY: Boulder
INSPECTION TYPE: Monitoring	INSPECTOR(S): Amy Eschberger	INSP. DATE: June 3, 2020	INSP. TIME: 10:00
OPERATOR: Aggregate Industries - WCR, Inc.	OPERATOR REPRESENTATIVE: Jeremy Deuto	TYPE OF OPERATION: 112c - Construction Regular Operation

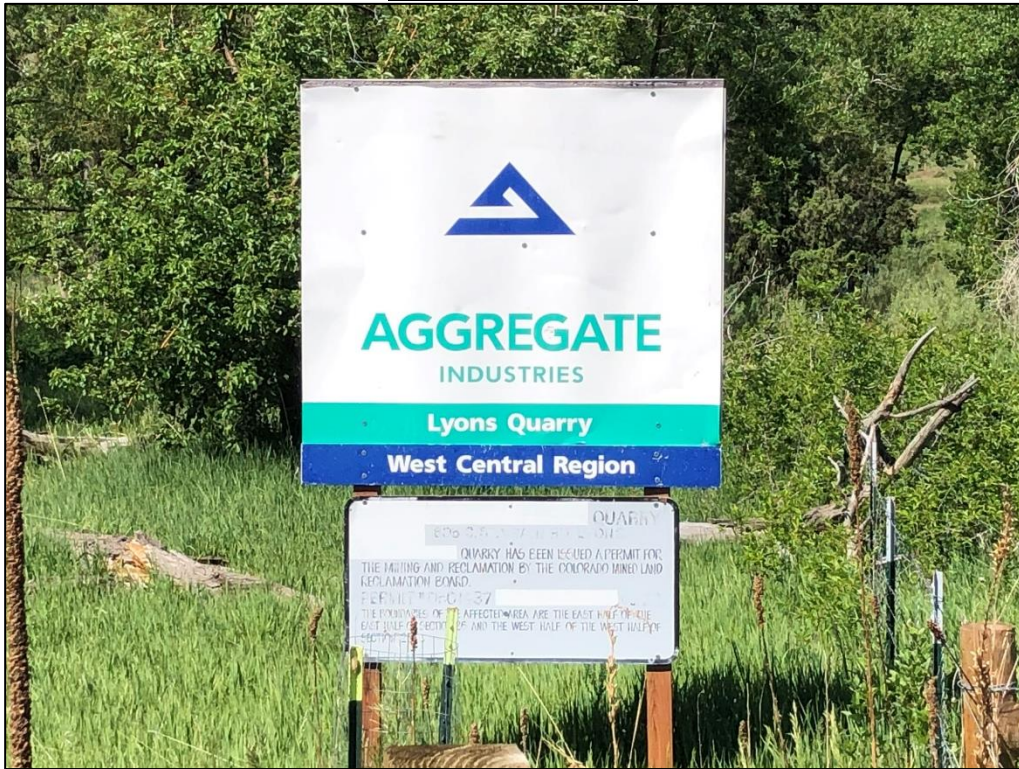
PROBLEM #1: The mine identification sign posted at the site entrance does not meet the requirements of Rule 3.1.12(1). In particular, some of the information on the sign is faded and difficult to read, and the permit number is incorrect.

At the time of the inspection, the weather was hot and dry. A mine identification sign was posted at the exit off Hwy 7. However, some of the information on the sign was faded and difficult to read. Additionally, the permit number on the sign did not match the permit number assigned to the site (M-1977-141). This matter is being cited as Problem #1 in this report, and will require corrective actions by the operator. Please see page 1 of this report for additional information. The Division did not check permit boundary markers during this inspection. However, the operator should be reminded that Rule 3.1.12(2) requires the boundaries of the affected area/permit area to be marked by monuments or other markers that are clearly visible and adequate to delineate such boundaries.

Photo 1. View of permit sign posted at main site entrance. The operator should ensure all items required by Rule 3.1.12(1) are included on the sign and visible from the access road, including the correct permit number issued for the operation.

CORRECTIVE ACTIONS: The operator shall post a sign at the entrance to the mine site which is clearly visible from the access road with a minimum size equaling 187 square inches (e.g., 11 inches x 17 inches) with appropriate font size, including the following information: (a) the name of the operator and the operation name, (b) a statement that a reclamation permit for the operation has been issued by the Colorado Mined Land Reclamation Board, and (c) the permit number. By the corrective action date, the operator shall submit photographic evidence showing an appropriate mine identification sign has been posted at the site.

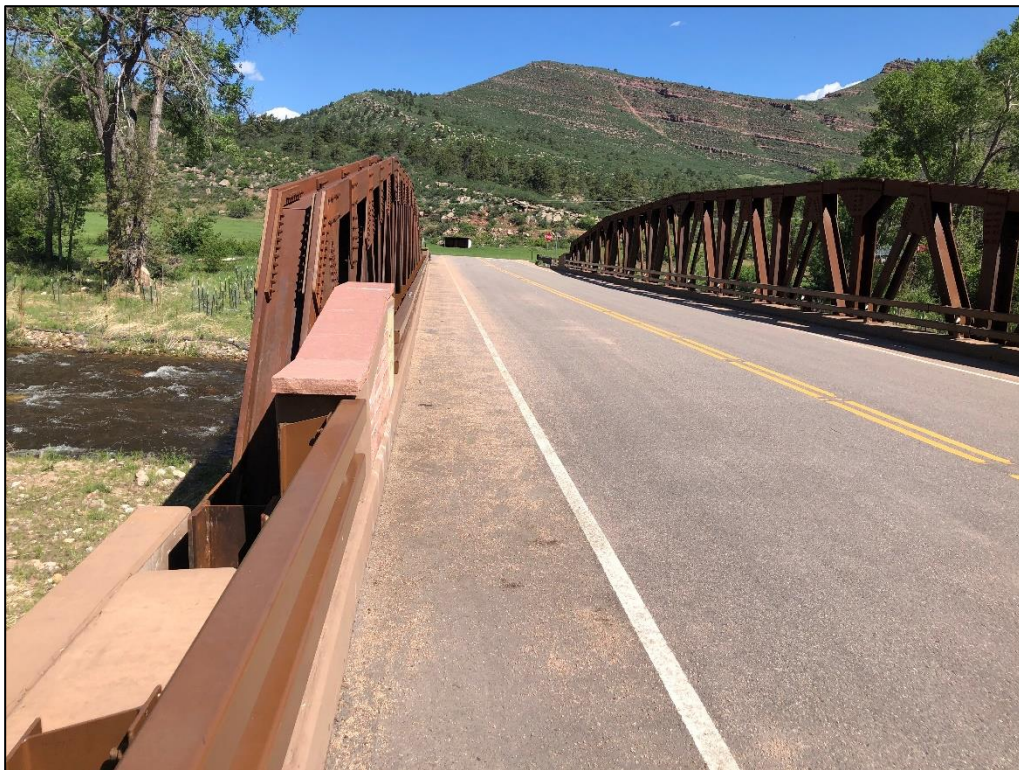
Photo 2. View looking northwest across new steel truss bridge constructed by county connecting Hwy 7 to Old St Vrain Rd. Construction of this bridge restored access to the Lyons Quarry.

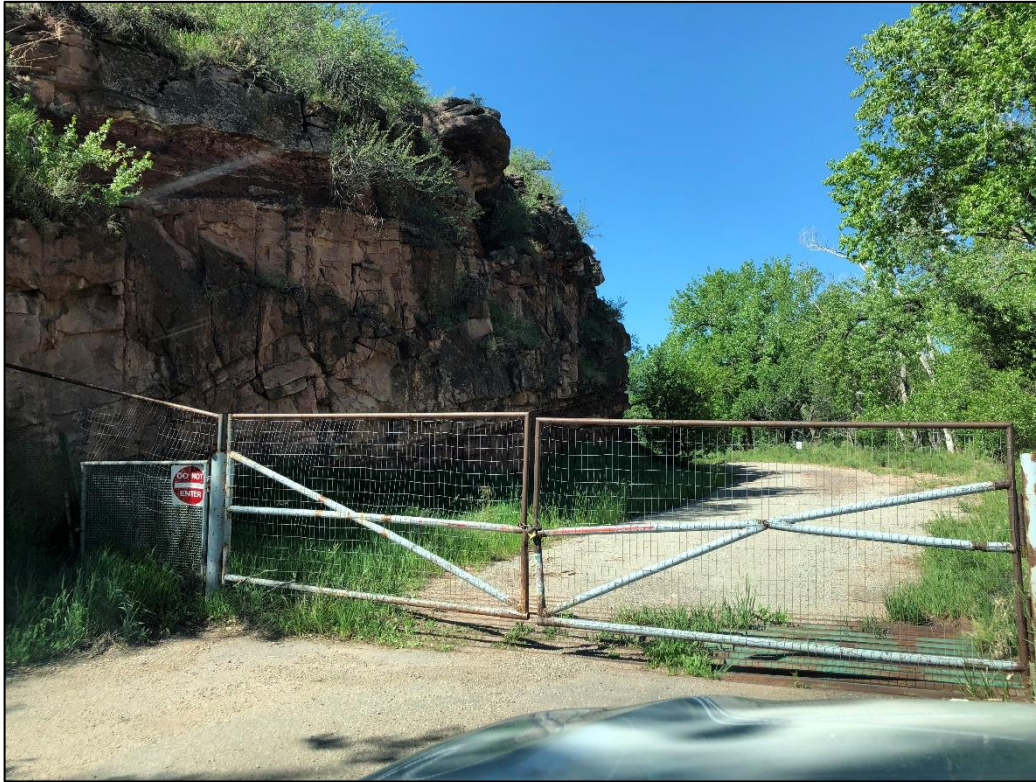
Photo 3. View looking west/southwest showing gated entrance to mine site off Old St Vrain Rd.

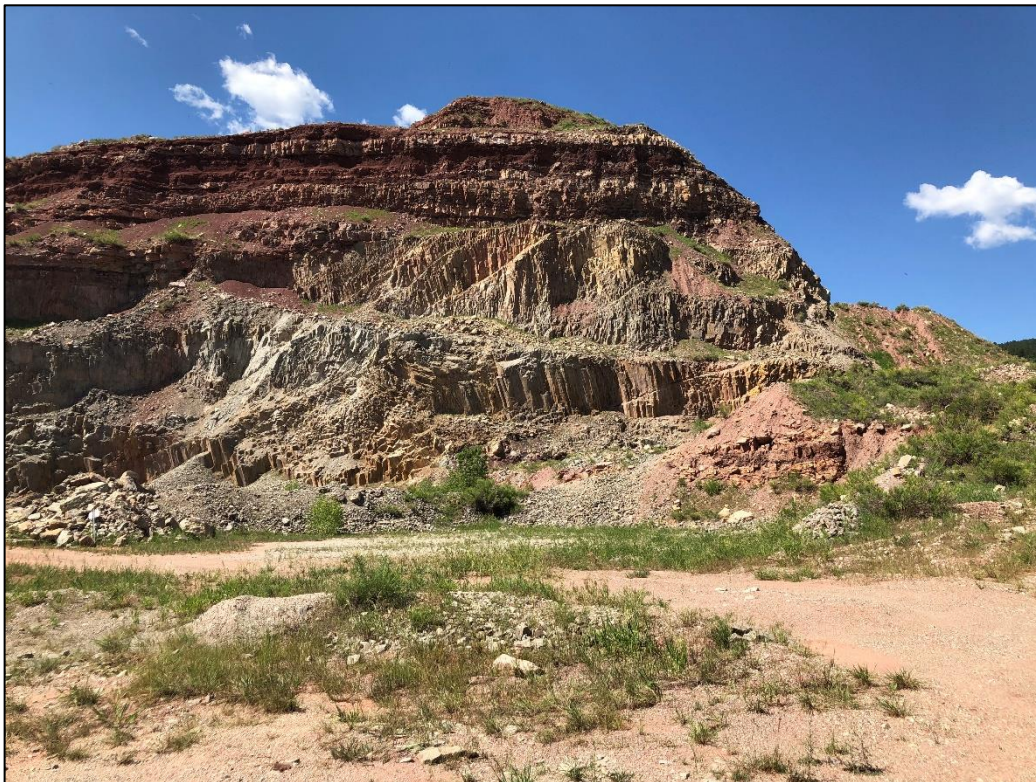
Photo 4. View looking southwest across central portion of quarry, showing highwall in background up to approximately 150 feet in height with near vertical slopes.

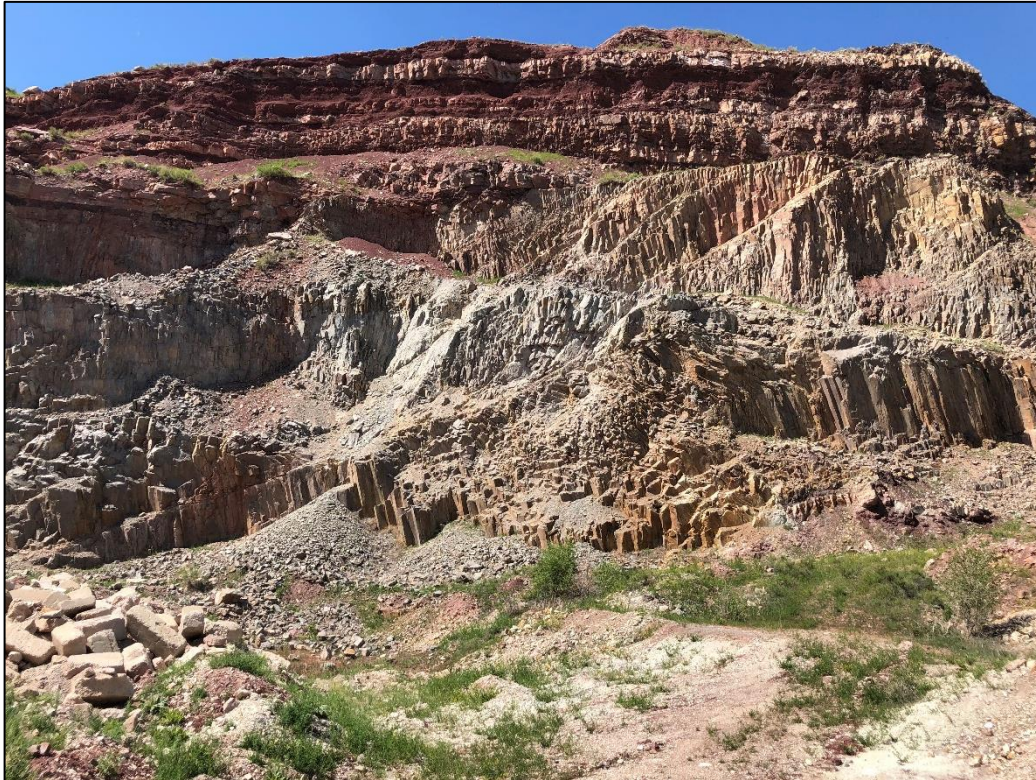
Photo 5. Closer view of central portion of highwall shown in Photo 4.

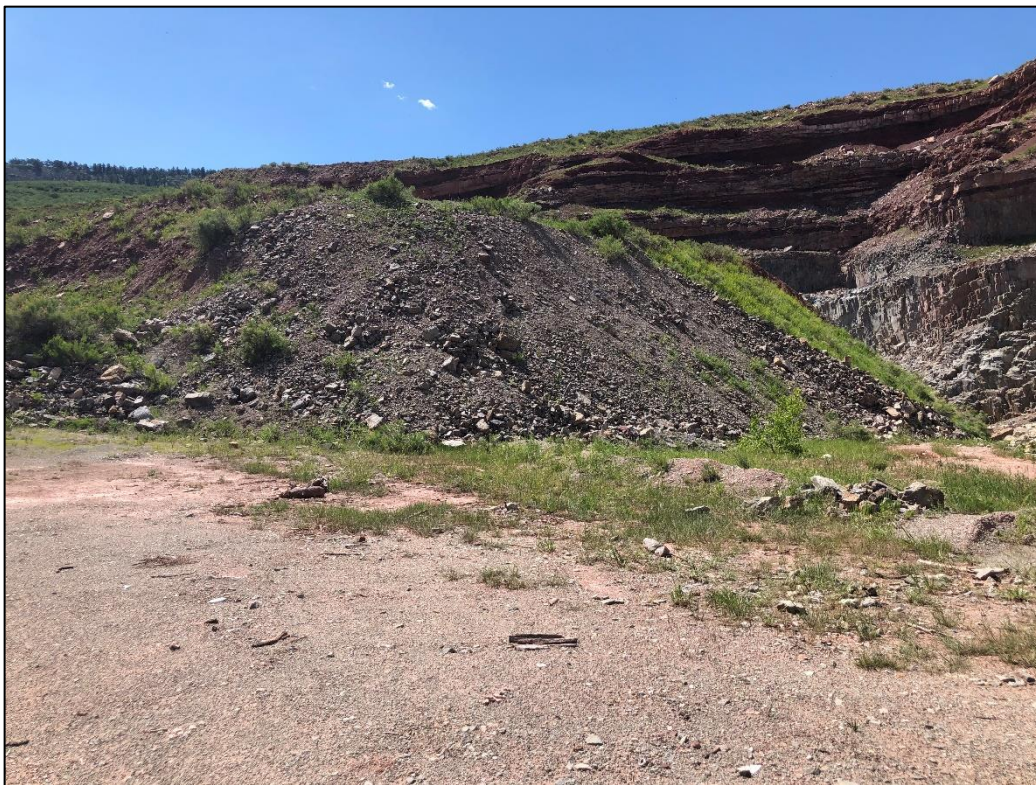
Photo 6. View looking southeast at overburden/waste rock stockpile stored on pit floor

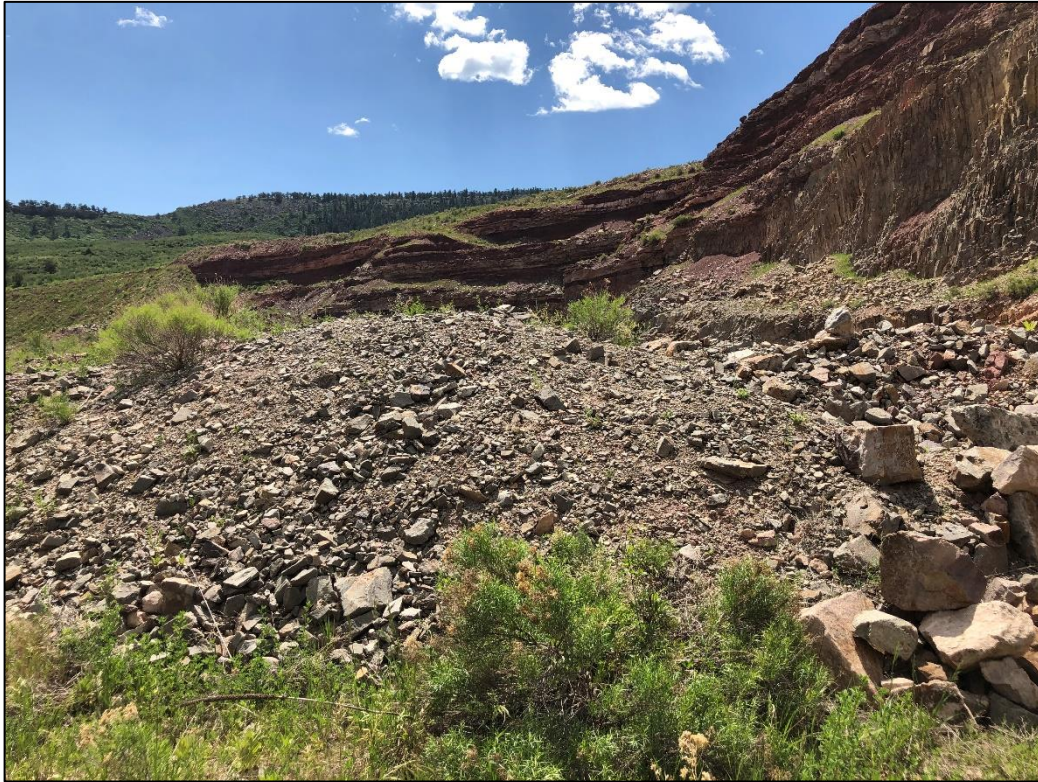
Photo 7. View looking east at overburden/waste rock stockpile stored along haul road connecting western and eastern portions of quarry.

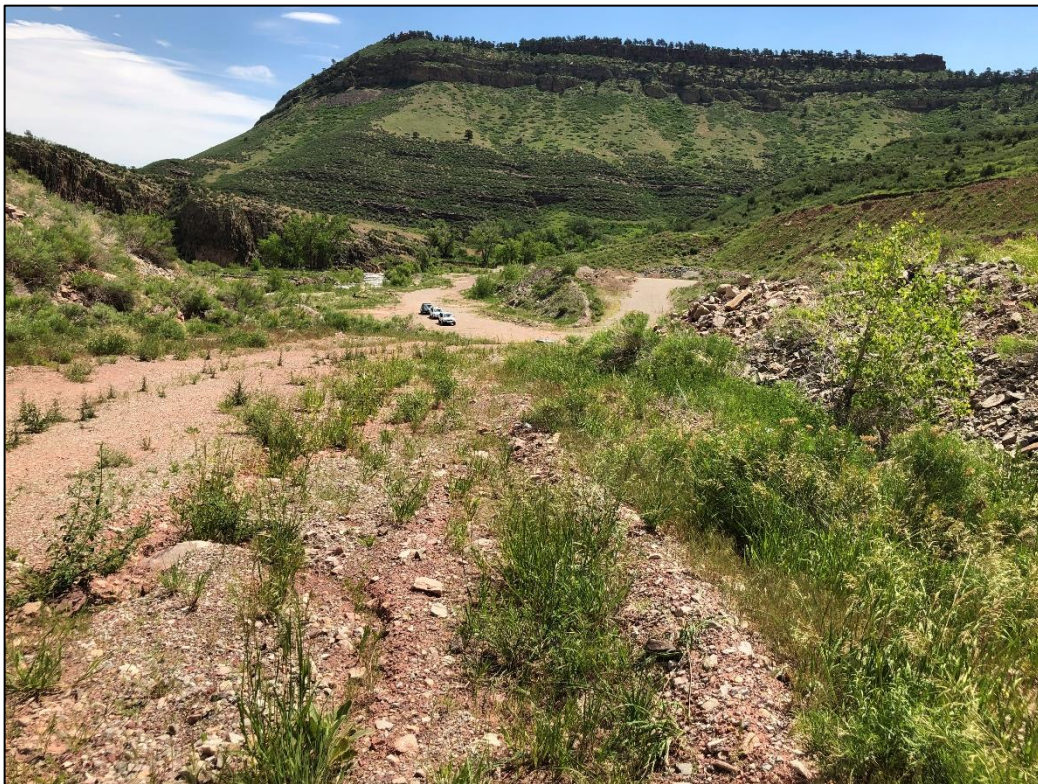
Photo 8. View looking east across haul road connecting western and eastern portions of quarry.

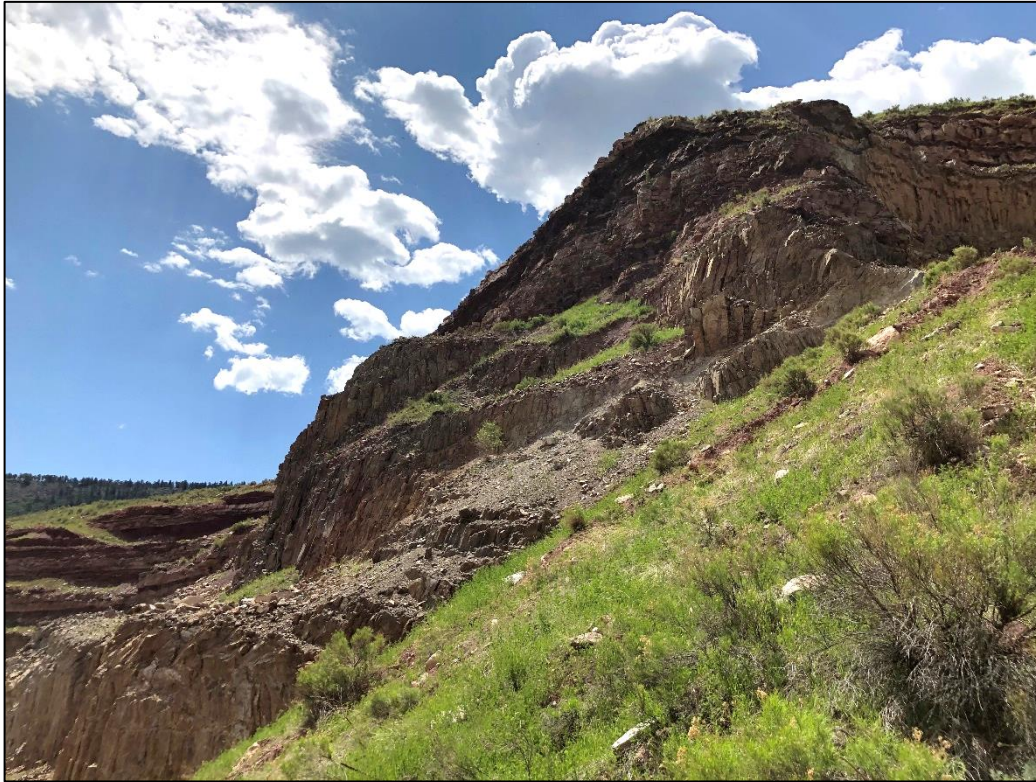
Photo 9. View looking southeast across central portion of highwall which has some irregular benching with near vertical slopes.

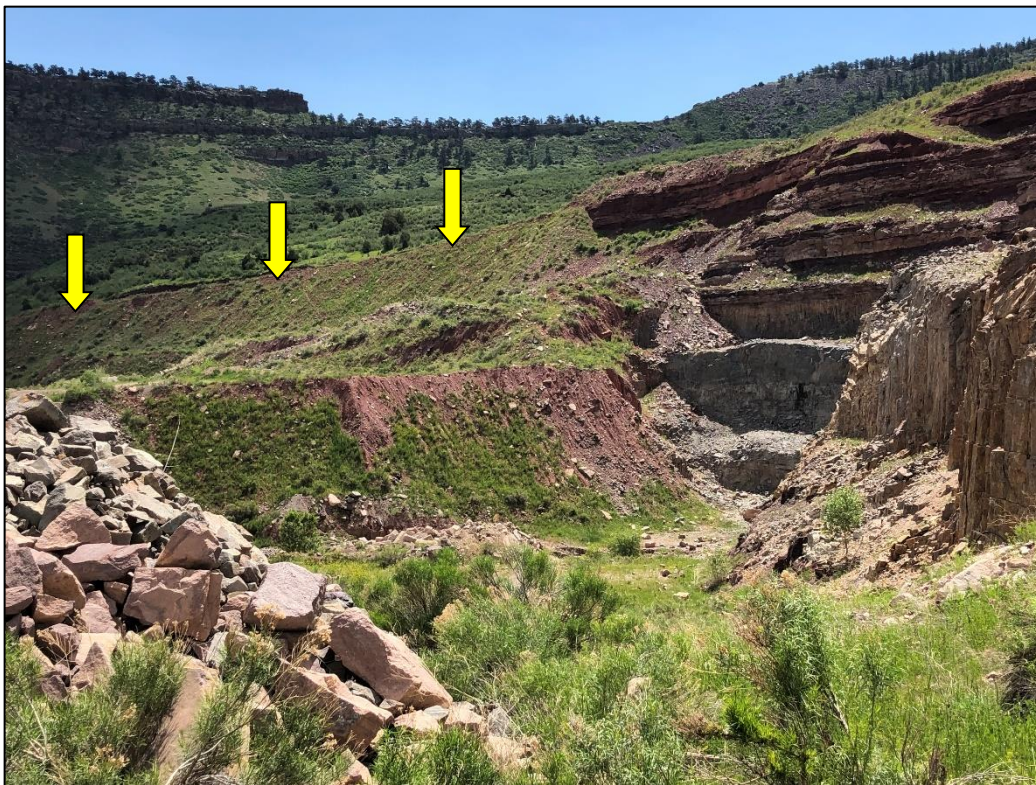
Photo 10. View looking east/southeast across pit floor of larger eastern portion of quarry. Note backfilled portion of highwall in background (indicated). Edge of backfill visible on pit floor.

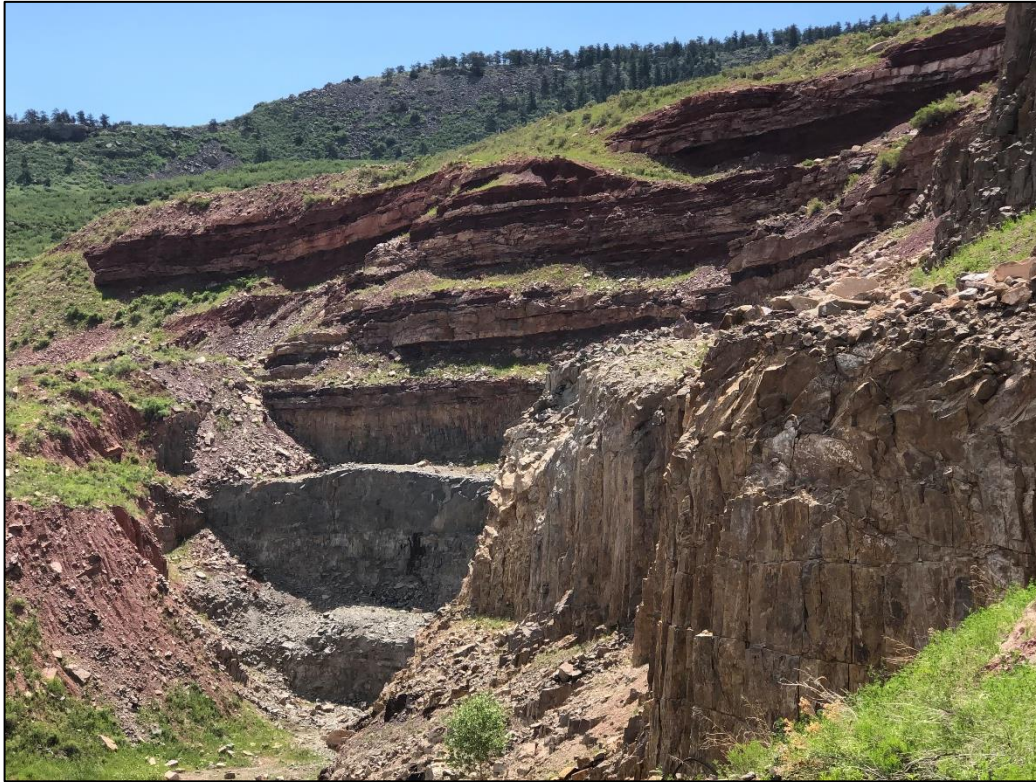
Photo 11. Closer view of unbackfilled eastern portion of highwall (shown in Photo 10), benched with near vertical slopes.

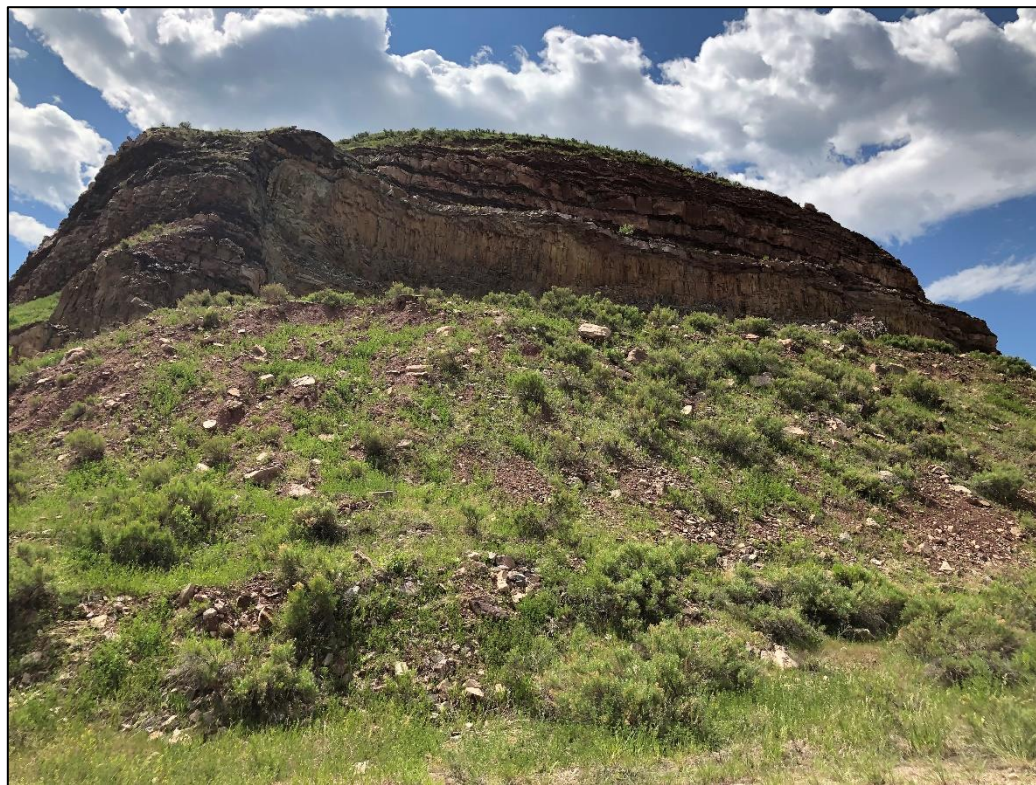
Photo 12. View looking southeast at highwall along edge of ridge which extends into quarry, separating larger eastern pit from smaller western pit. Large overburden/waste rock stockpile visible in foreground.

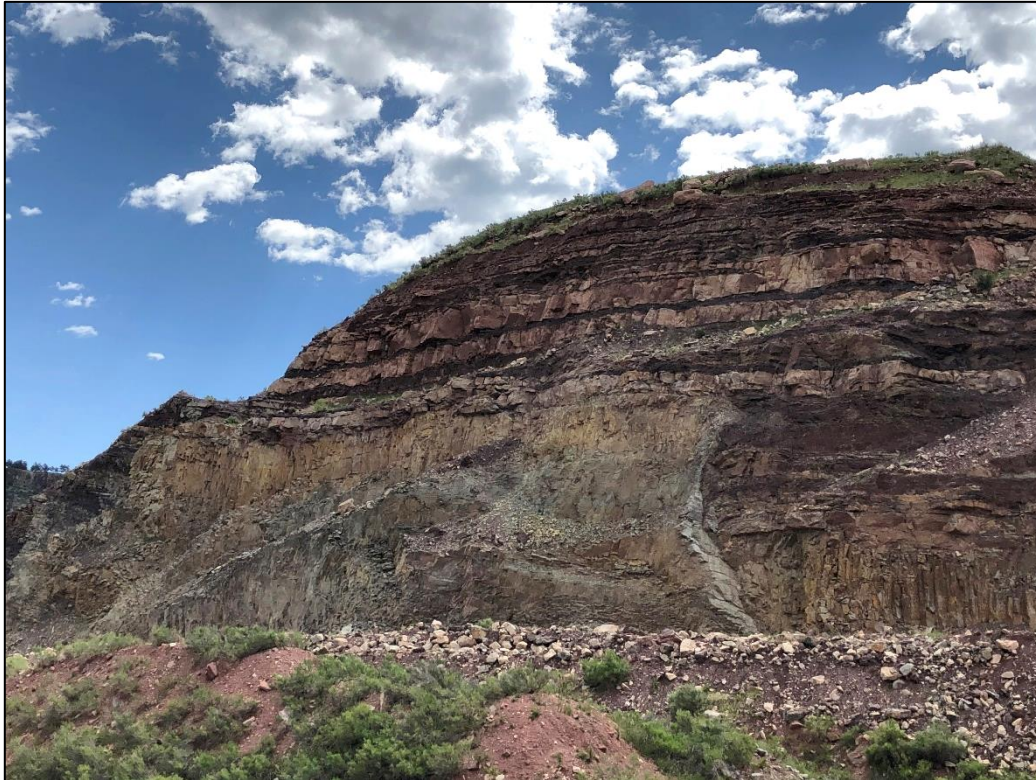
Photo 13. Closer view of highwall along edge of ridge (shown in Photo 12) which extends into quarry, separating larger eastern pit from smaller western pit.

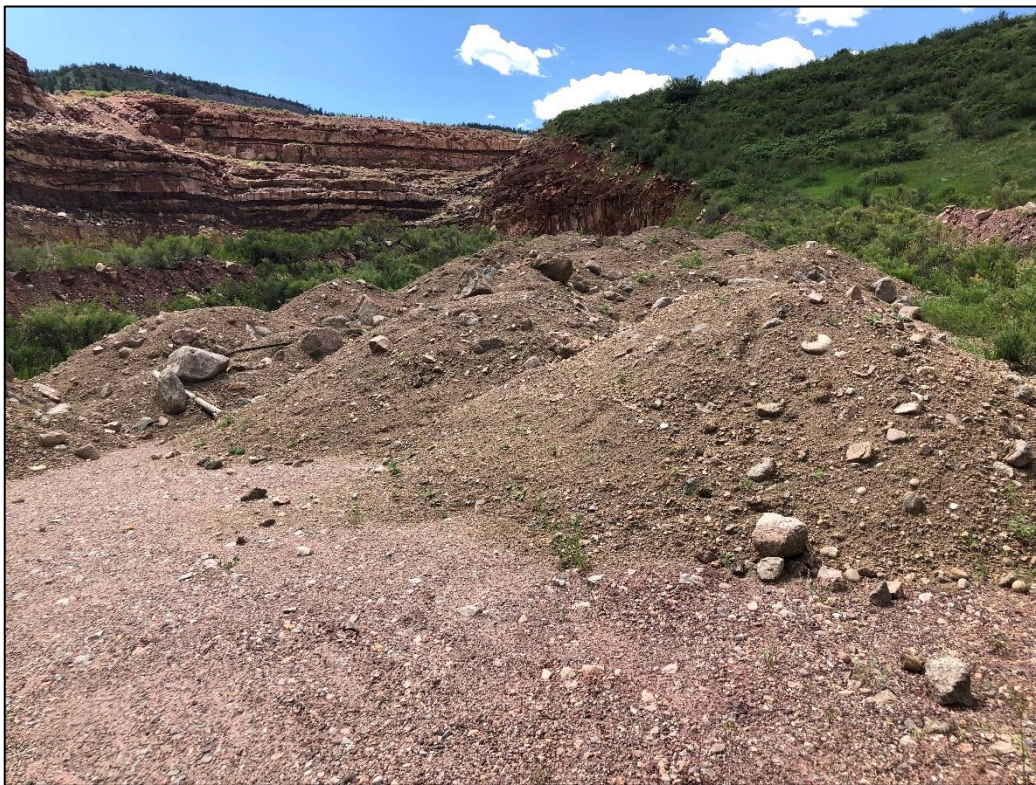
Photo 14. View looking south at inert backfill material temporarily stored near western portion of quarry. This material was imported to the site by the county in accordance with TR-3.

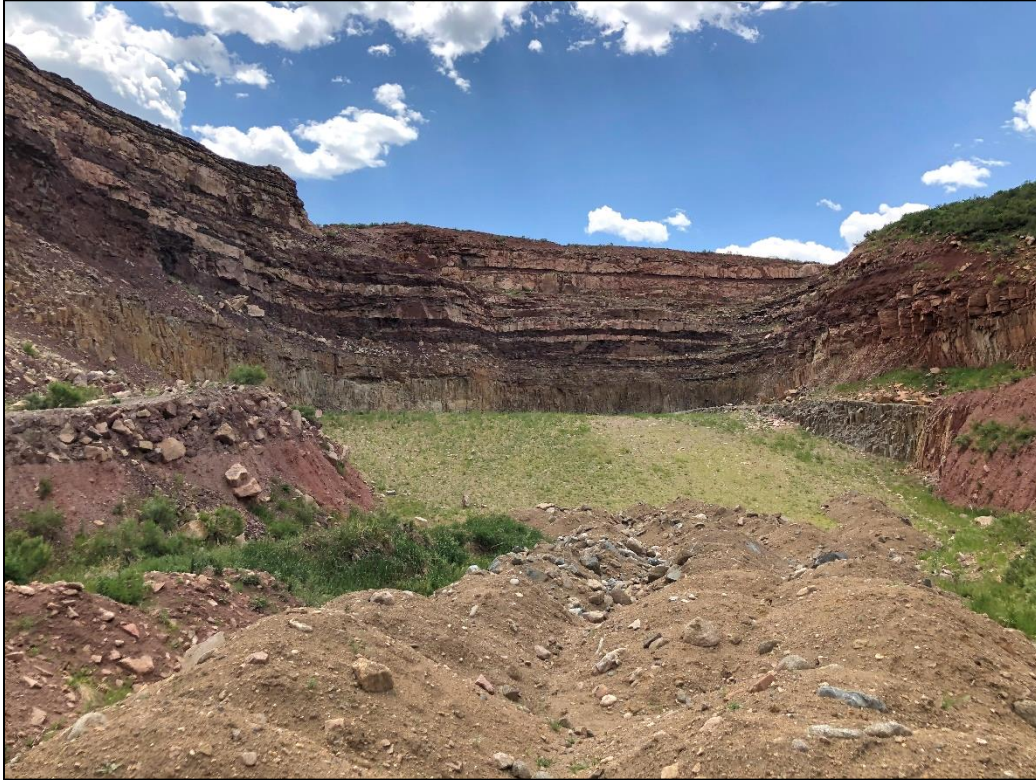
Photo 15. View looking south across western portion of quarry where county has placed imported inert backfill material in accordance with TR-3. Approximately 80-100 feet of near vertical highwall remains above current backfill surface.

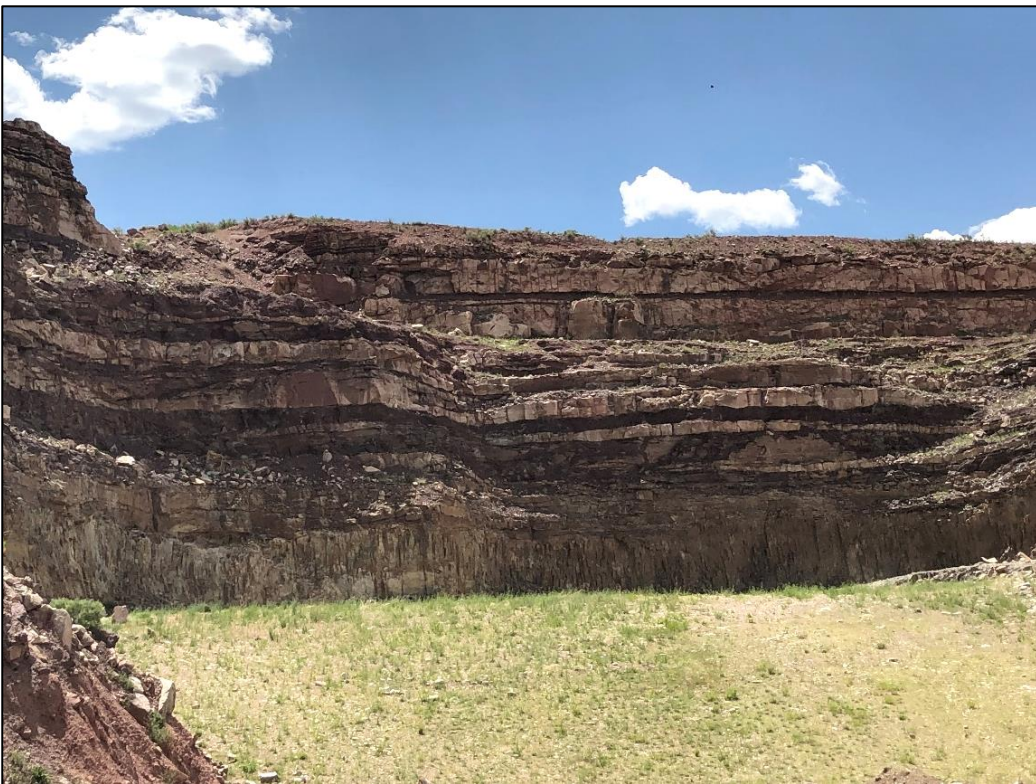
Photo 16. Closer view of near vertical highwall in western portion of quarry (shown in Photo 15). Current backfill surface is shown at bottom.

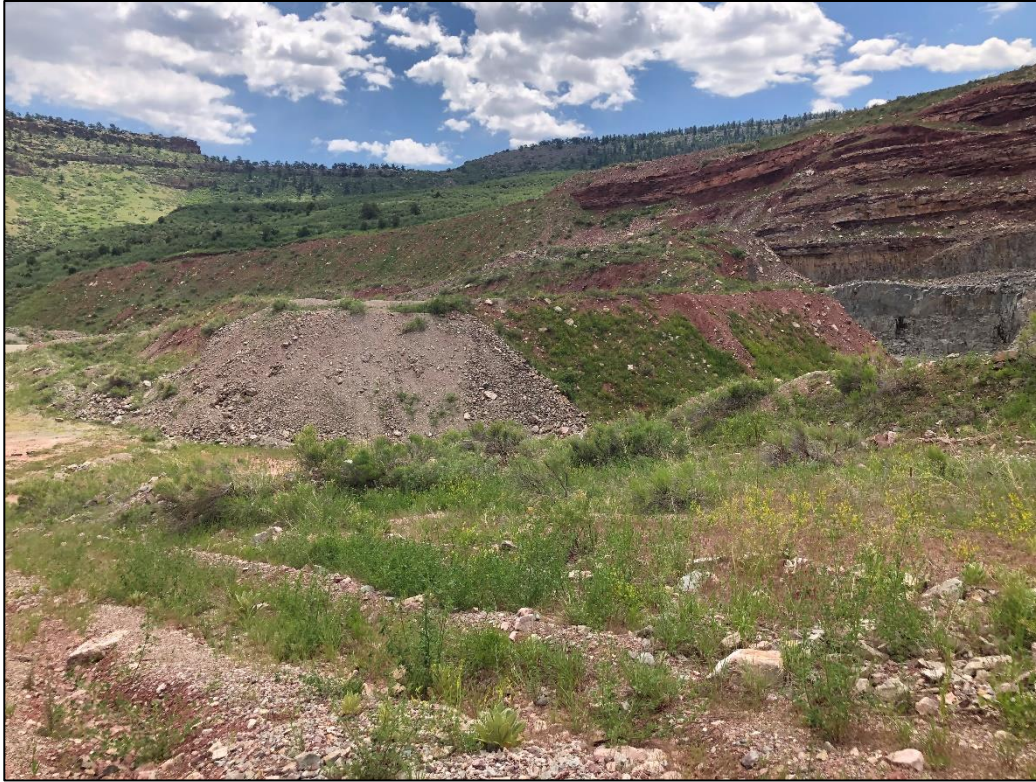
Photo 17. View looking east/southeast across pit floor showing overburden/waste rock stockpile (at center) stored on pit floor.

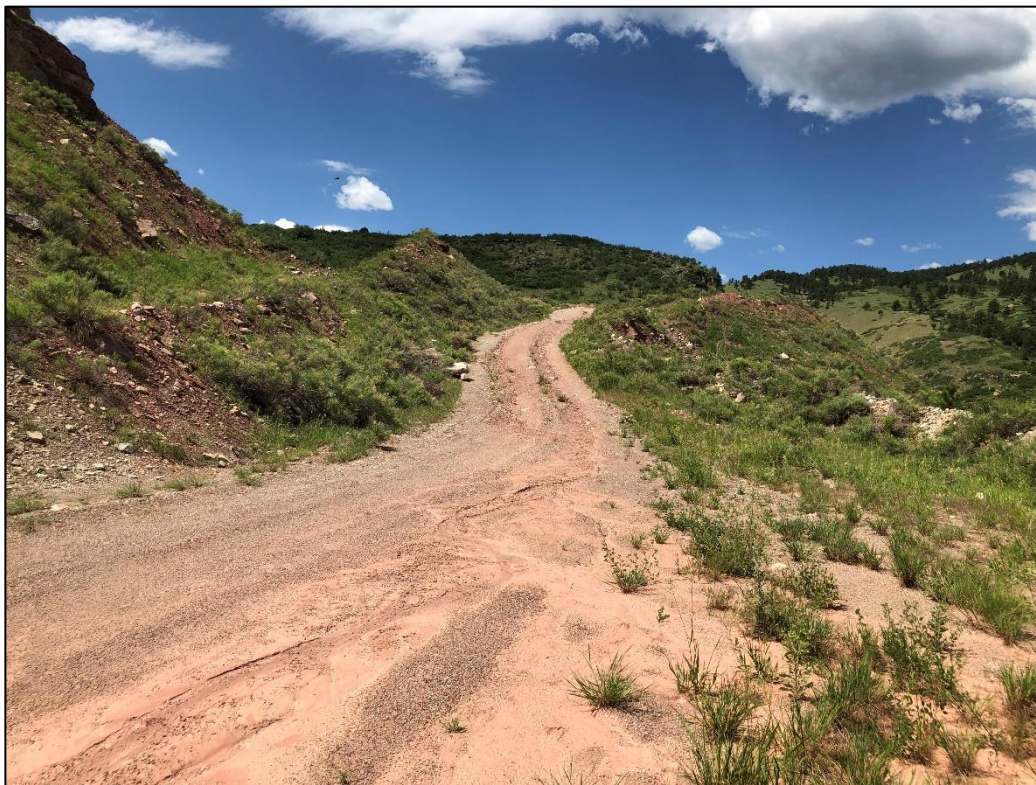
Photo 18. View looking west/southwest across haul road connecting western and eastern portions of quarry.

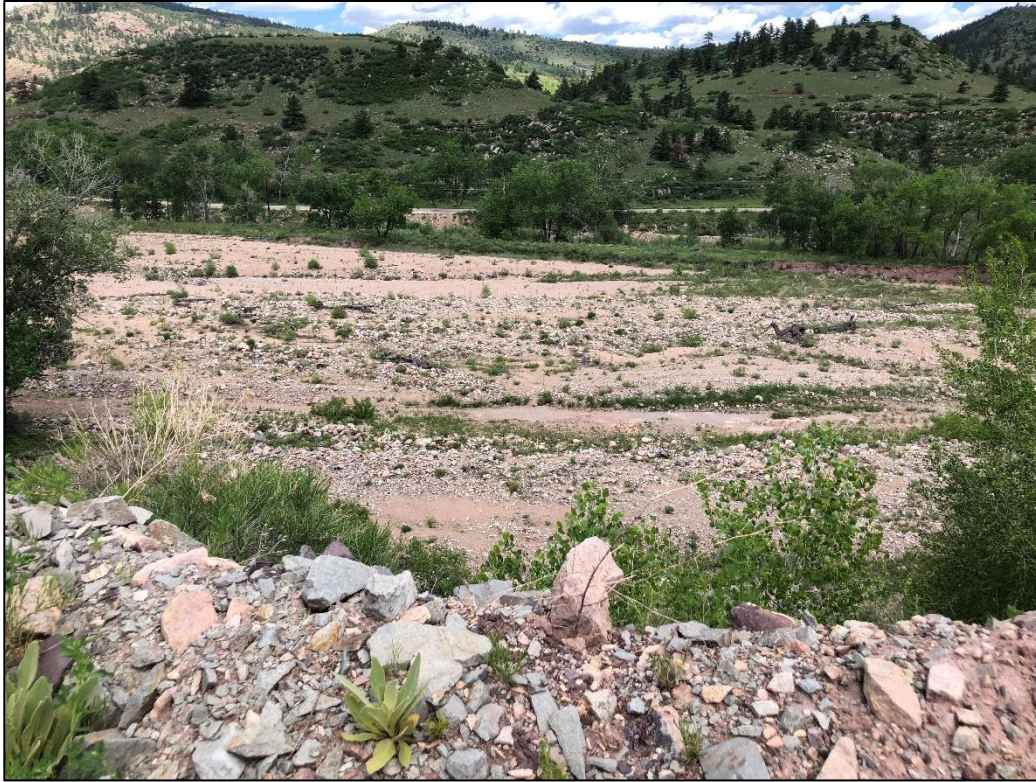
Photo 19. View looking north/northwest across former processing/stockpiling/storage area which was impacted by September 2013 flood.

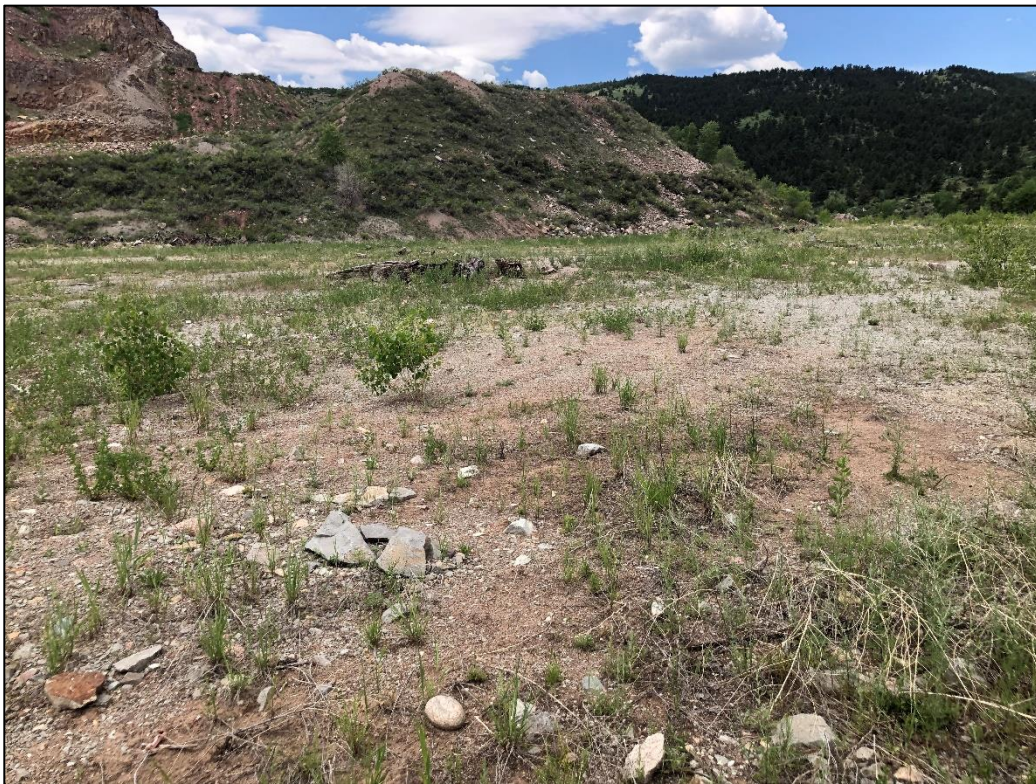
Photo 20. View looking southwest across former processing/stockpiling/storage area which was impacted by September 2013 flood.

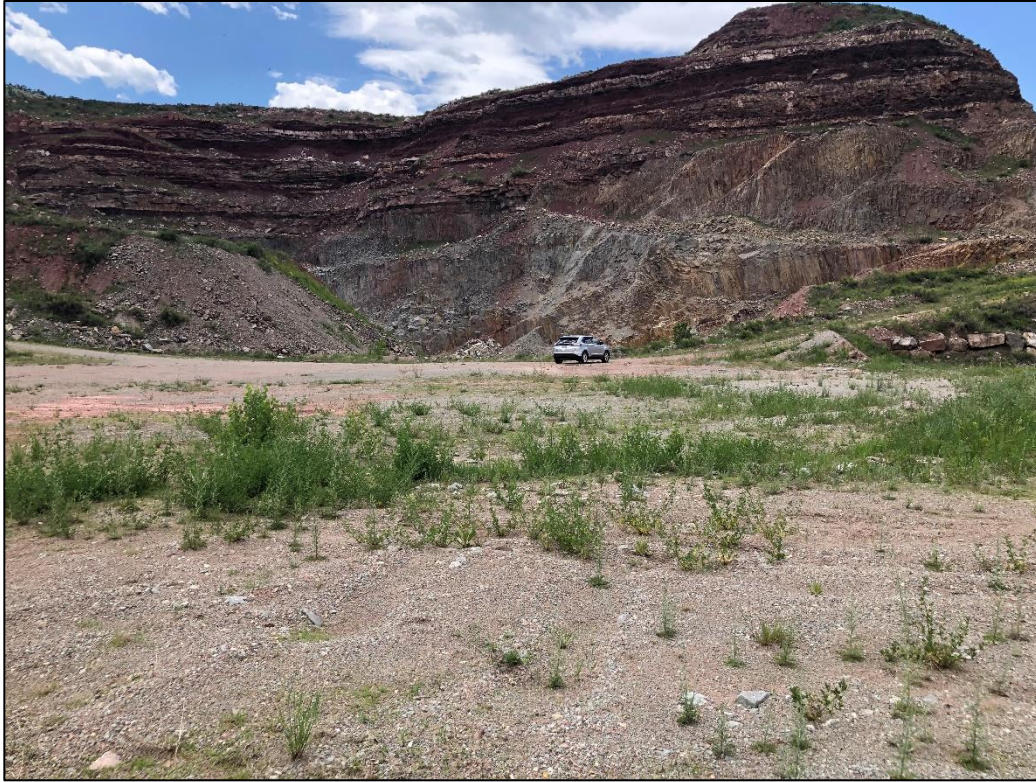
Photo 21. View looking south across former processing/stockpiling/storage area (in foreground) which was impacted by September 2013 flood. Quarry highwall shown in background.

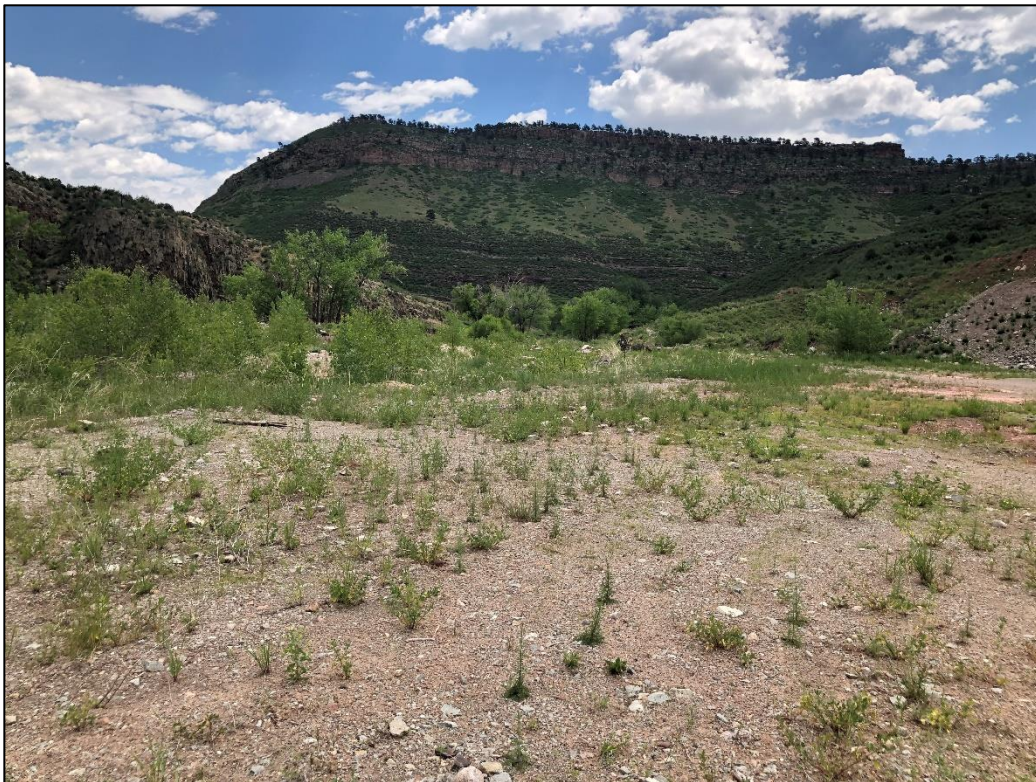
Photo 22. View looking east across former processing/stockpiling/storage area which was impacted by September 2013 flood.

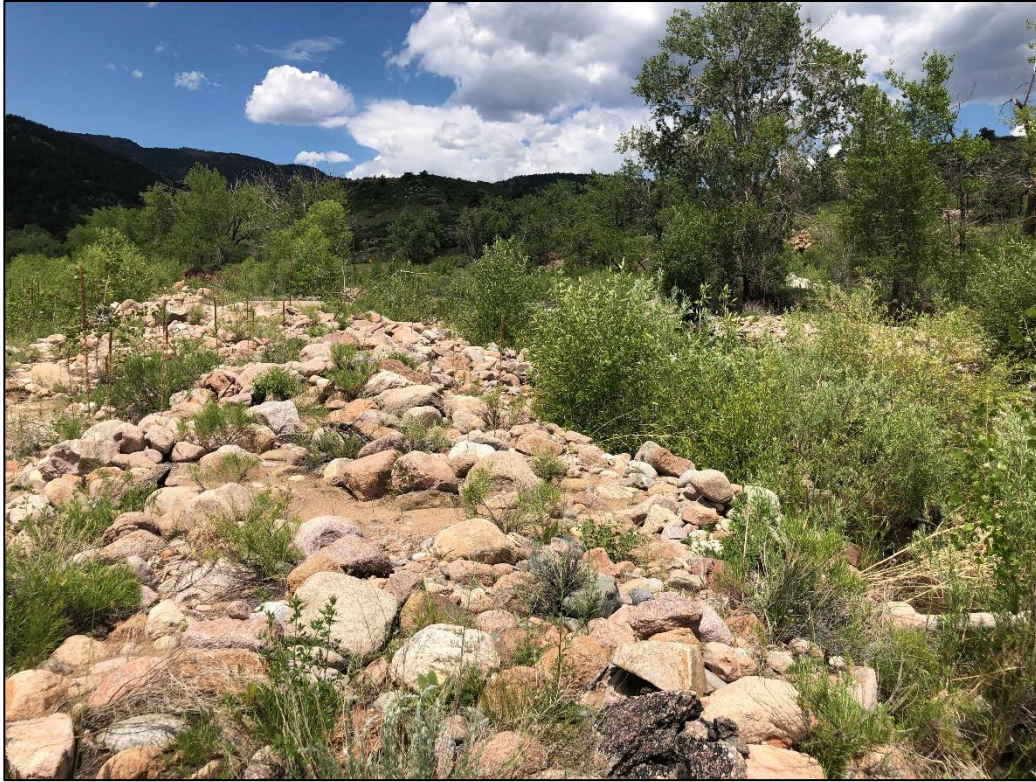
Photo 23. View looking west across former processing/stockpiling/storage area which was impacted by September 2013 flood. Note cobbles and boulders deposited across area by flood.

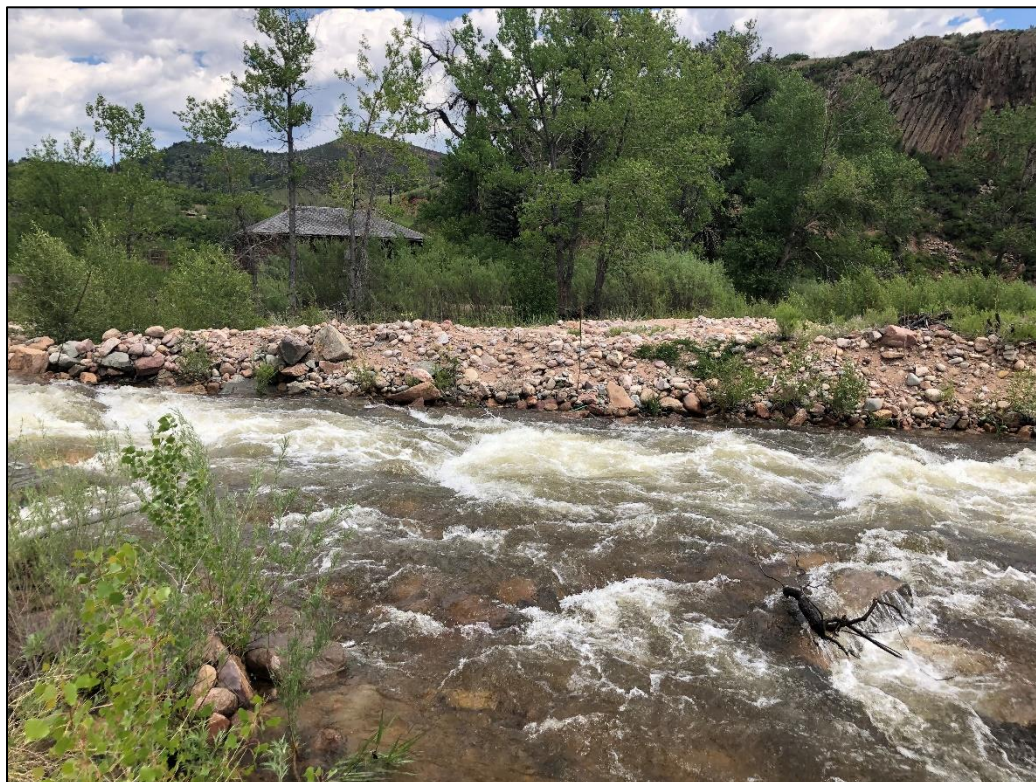
Photo 24. View looking north/northwest across South Saint Vrain Creek, showing flood deposit along northern edge of channel.

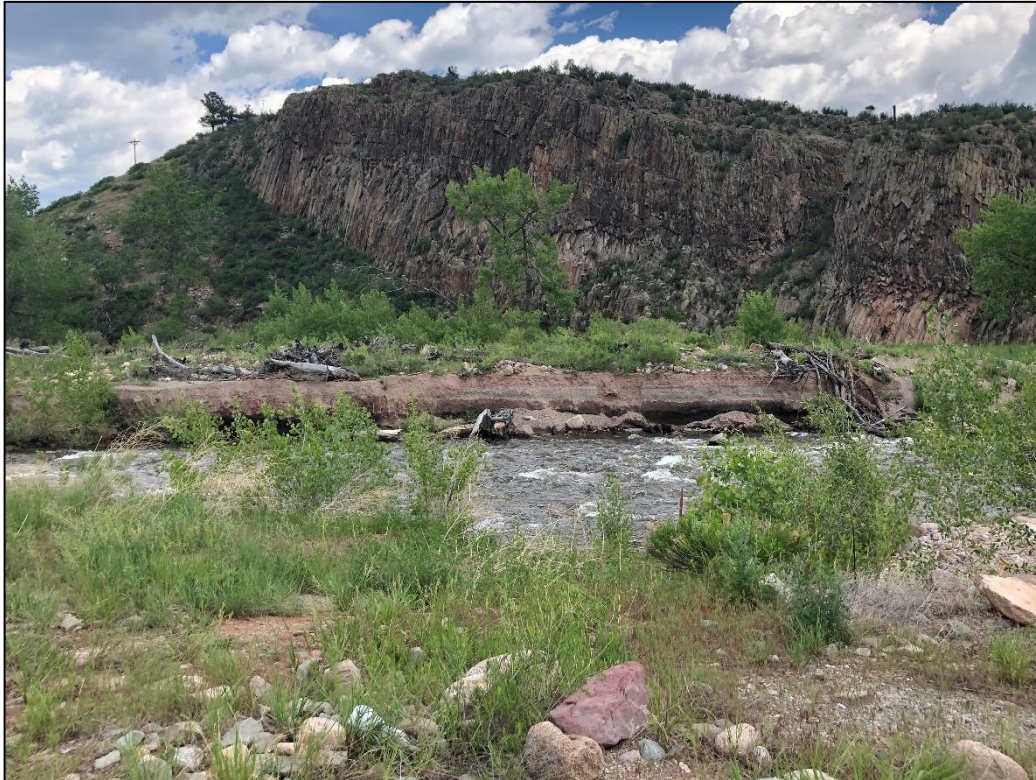
Photo 25. View looking north/northeast across segment of South Saint Vrain Creek which remains outside its pre-flood channel in northeastern portion of permit area. This is the eastern edge of the former processing/stockpiling/storage area where the maintenance shop was located.

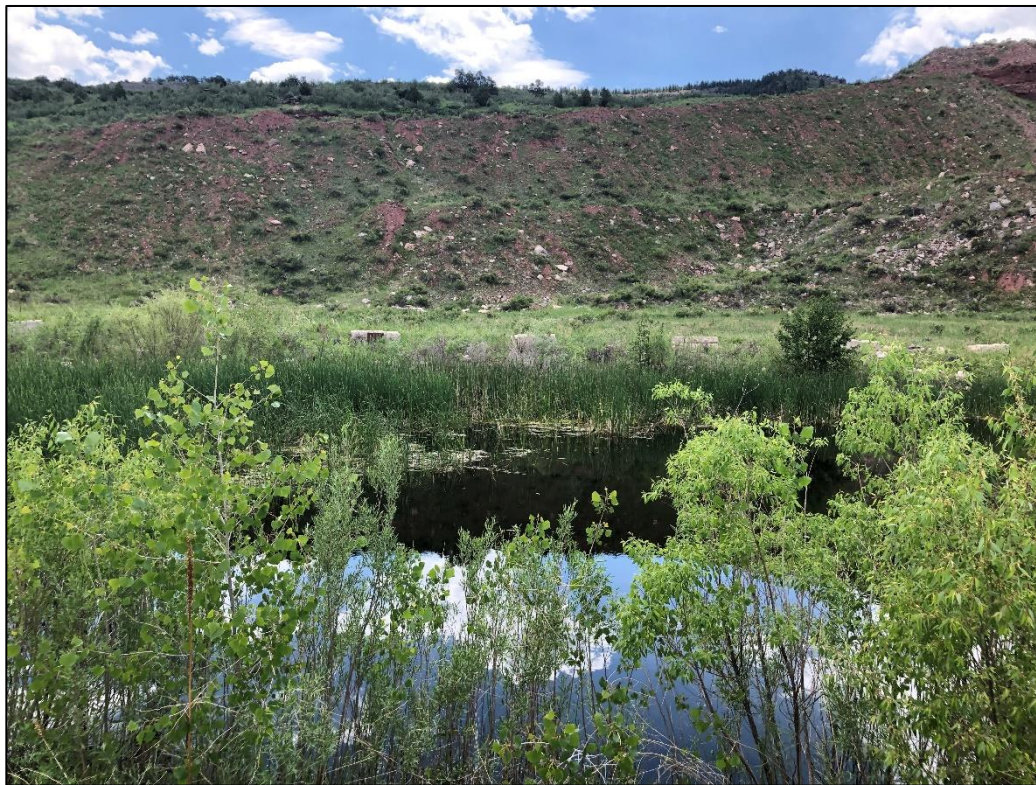
Photo 26. View looking south across small pond present at northeastern edge of pit area. Note natural vegetation present along pond perimeter and southern pond slope relatively flat. Backfilled eastern portion of quarry highwall visible in background.
