MINERALS PROGRAM INSPECTION REPORT
PHONE: (303) 866-3567

MINE NAME: Lyons Quarry	MINE/PROSPECTING ID#: M-1977-141	MINERAL: Quartz (quartzite/quartzose ss)	COUNTY: Boulder
INSPECTION TYPE: Monitoring	INSPECTOR(S): Amy Eschberger	INSP. DATE: June 3, 2020	INSP. TIME: 10:00
OPERATOR: Aggregate Industries - WCR, Inc.	OPERATOR REPRESENTATIVE: Jeremy Deuto	TYPE OF OPERATION: 112c - Construction Regular Operation

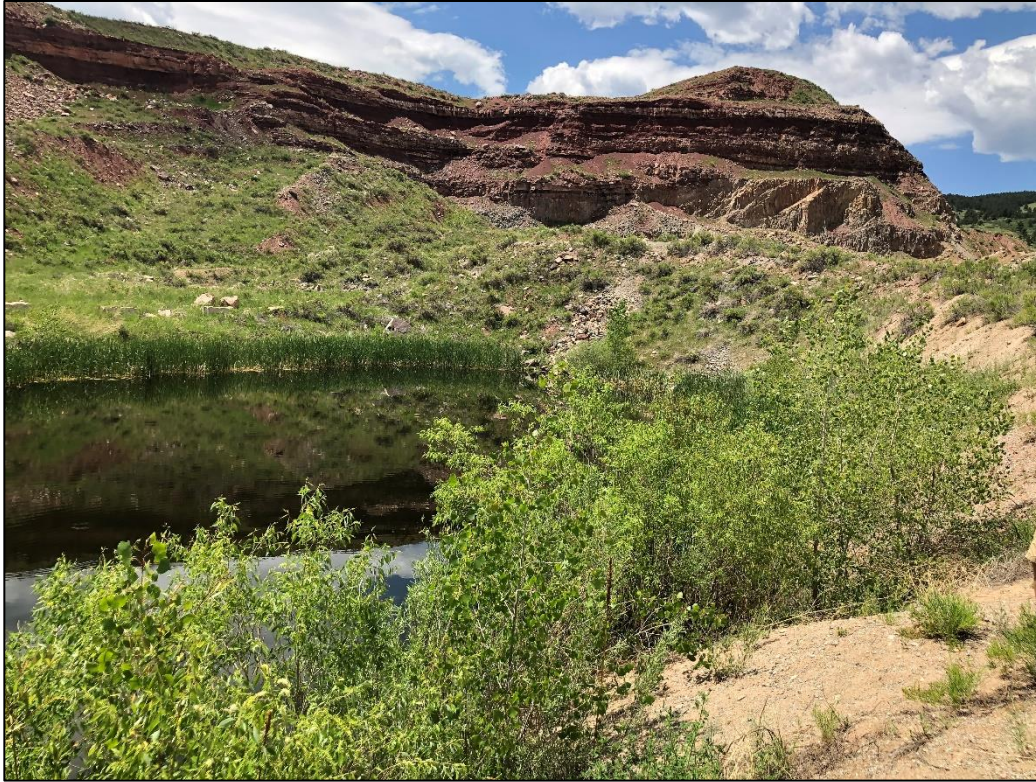
Photo 27. View looking southwest across small pond present at northeastern edge of pit area. Note natural vegetation present along pond perimeter and western pond slope steeper than 3H:1V. Central portion of quarry highwall visible in background.

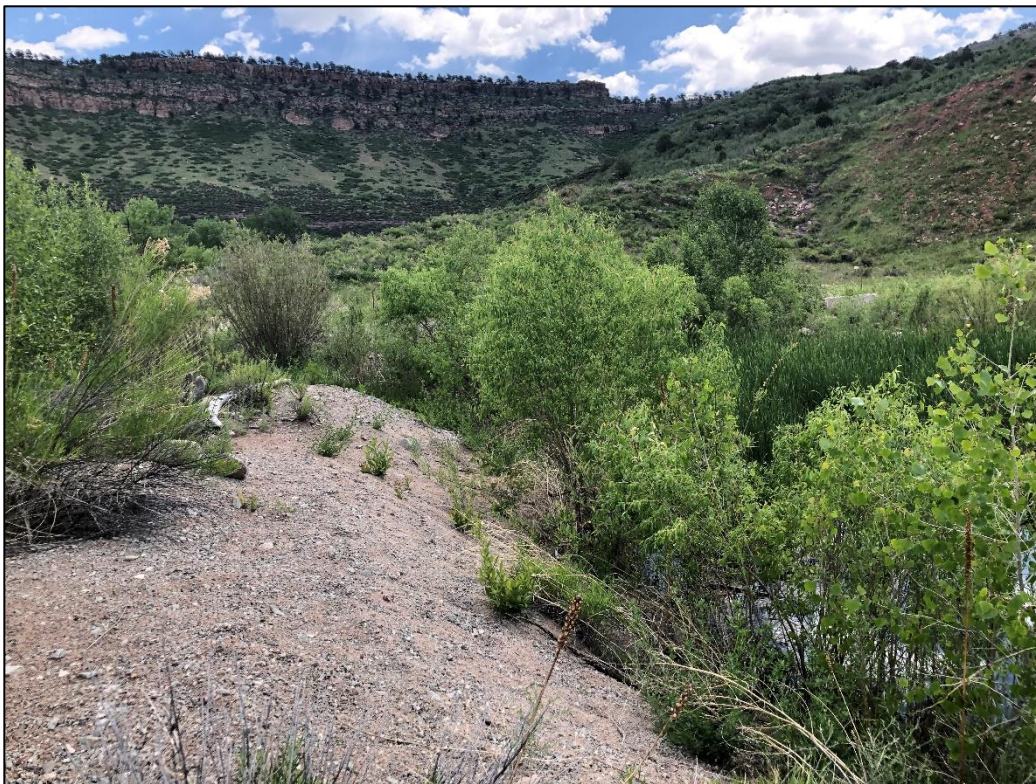
Photo 28. View looking northeast across northern shoreline of small pond present at northeastern edge of pit area. Note natural vegetation present along pond perimeter and northern pond slope steeper than 3H:1V.
