Re: King I Mine, C-1981-035
Stoner Engineering: Quarterly Inspection: Water Quality Improvements
2nd Quarter 2020

Re: King Coal I – Quarterly Water Quality Improvements Inspection

On June 22, 2020, Ryan Griglak, P.E. visited the GCC Energy, LLC King I Mine site to conduct the quarterly inspection of the water quality features installed to prevent contaminated storm water runoff from escaping the site in events smaller than the 100-year storm event.

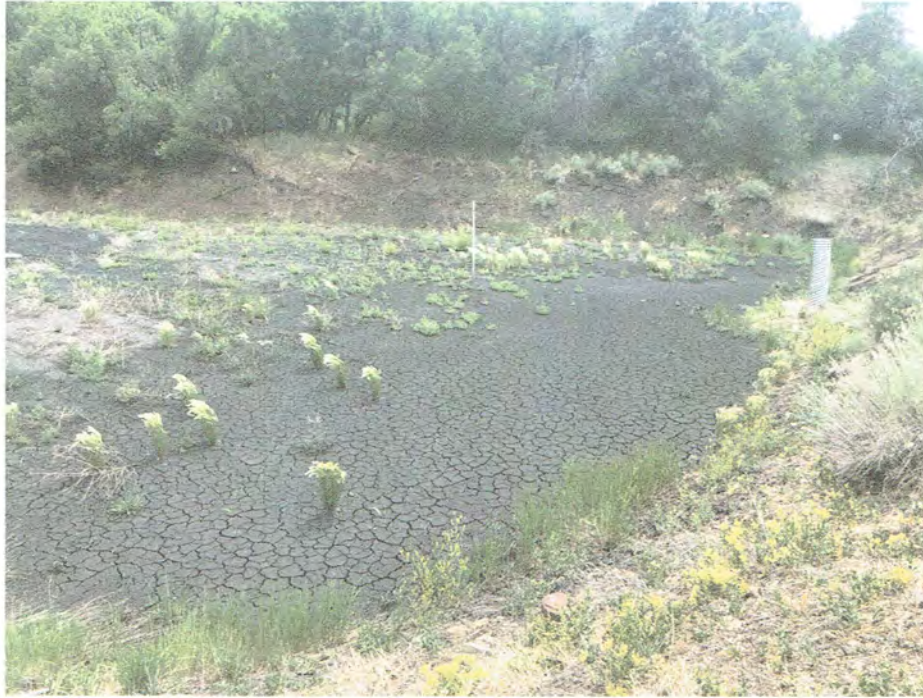
Both ponds were dry at the time of the inspection and appeared to generally be in good condition (see Pic. 1). The sedimentation gages show the ponds are not yet it need of cleaning (see Pic. 2). The ponds should continue to be monitored after storm events to ensure that excess sediment does not reduce the required storage capacity available for storm water runoff.

Pic. 1 – West pond.

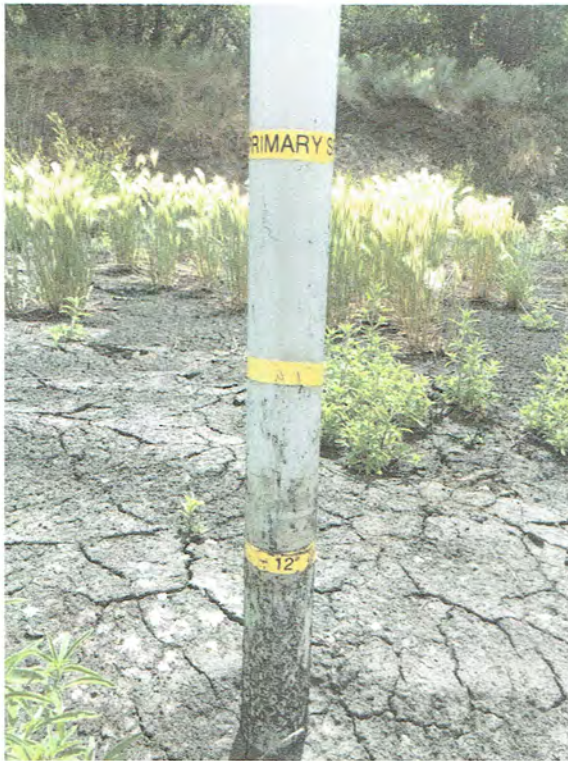
Pic. 2 – West pond sediment gage.

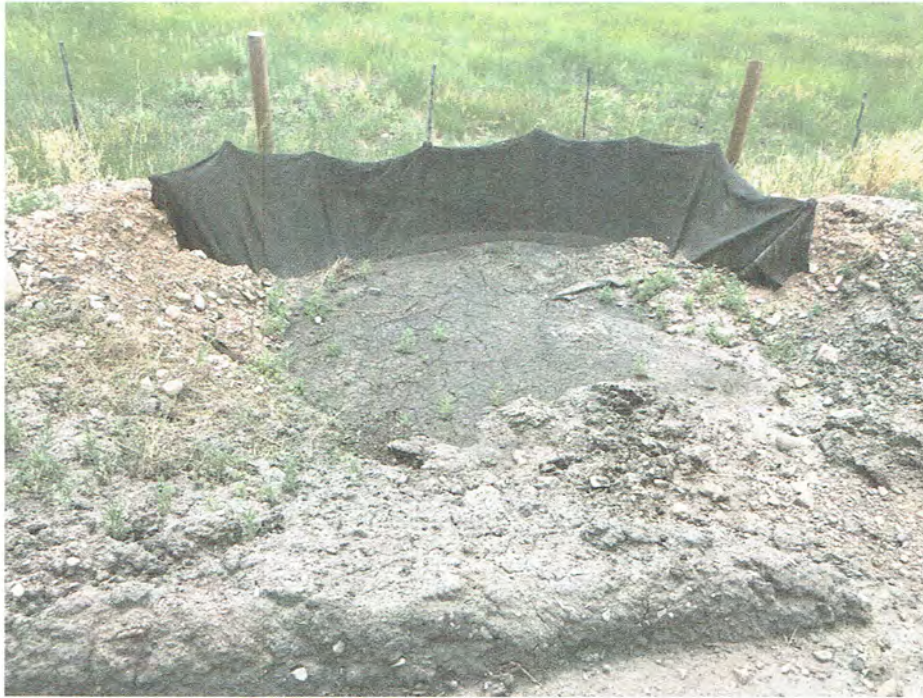
The sedimentation traps at the entrance to the site are generally in good condition and have been repaired (see Pic. 3). Work is ongoing for the new haul road along the west side of the property (see Pic. 4). Waste material continues to be placed at the base of the embankment ple (see Pic. 5), though the rate has decreased from last year. Erosion control measures have again been improved to the inlet for Reach 7 (see Pic. 6). The existing culverts throughout the site were in good condition at the time of the inspection.

Pic. 3 – Sediment trap at driveway.

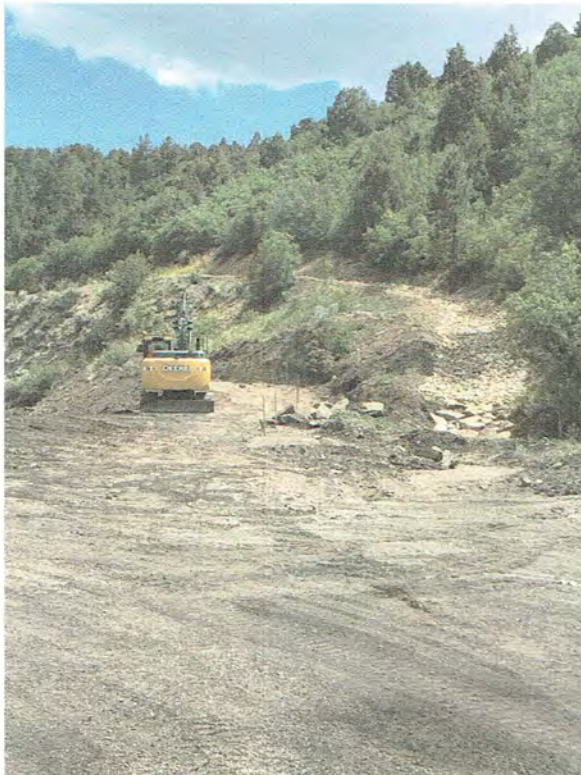
Pic. 4 – Ongoing work for new haul road.

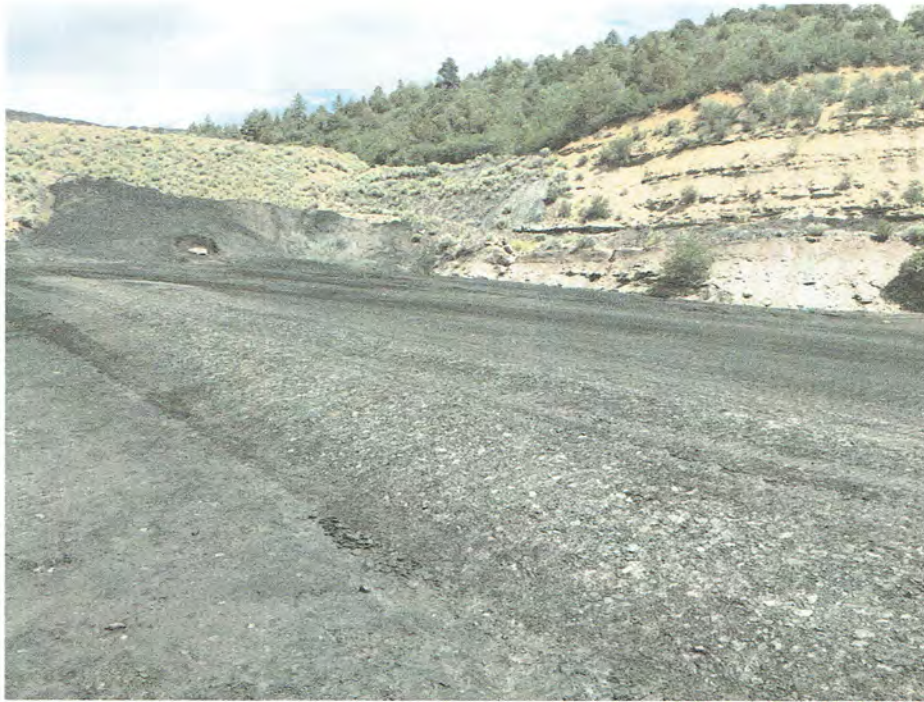
Pic. 5 – Placement of waste material at base of existing embankment pile.

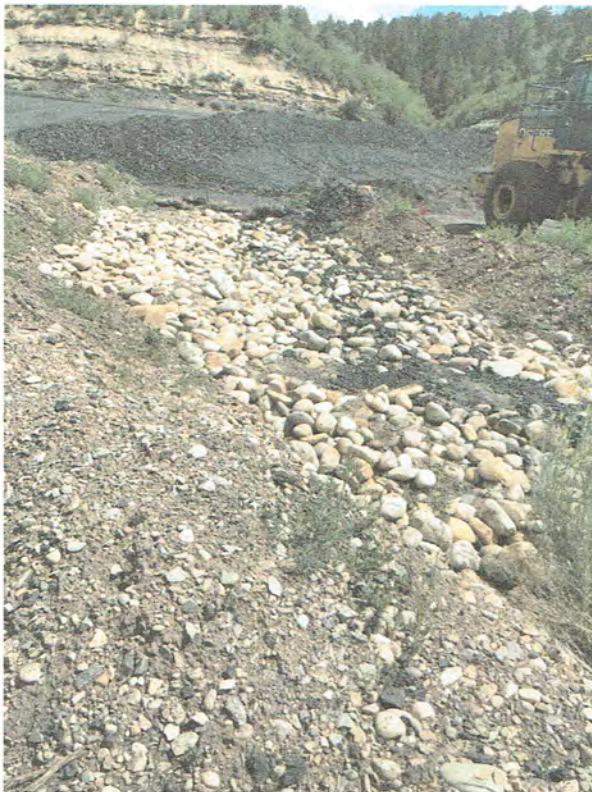
Pic. 6 – Improvements preventing excess sedimentation at Reach 7/foundation drain.
