Re: King I Mine, C-1981-035
Stoner Engineering: Quarterly Inspection: Refuse Pile
2nd Quarter 2020

Re: King Coal I – Quarterly Waste Pile/Embankment Inspection

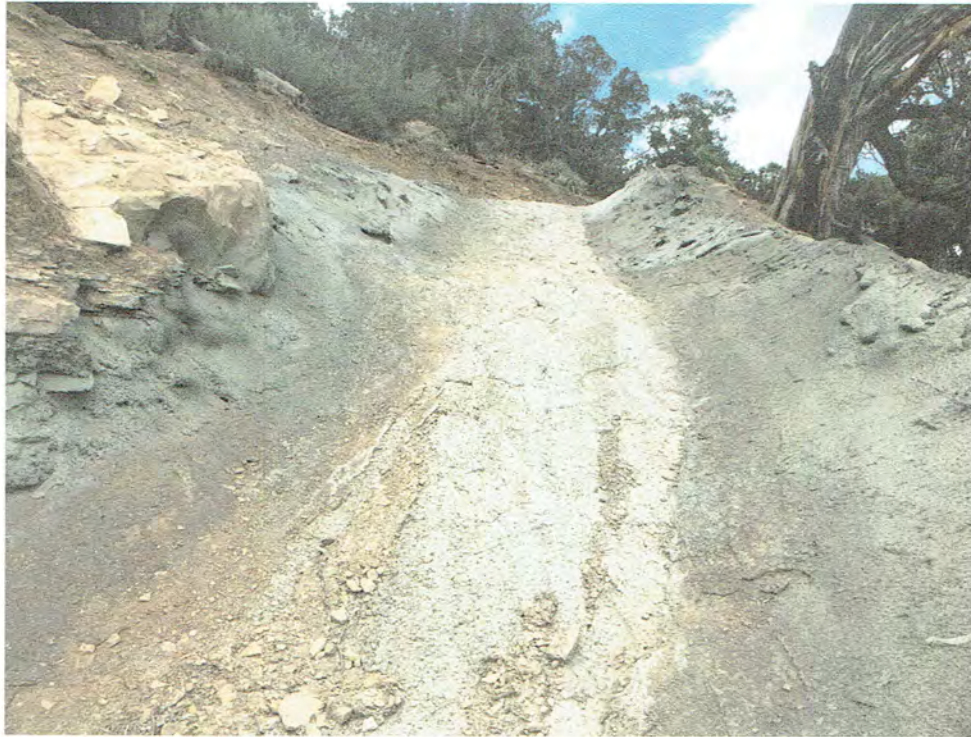
Both the south treated water ditch (Reach 10) and the north clear water ditch (Reach 1) were found to be in generally good condition. There was some additional grouting of the adjacent soils of the grouted section of the upper clear water ditch to minimize erosion potential (see Pic. 1). The face of the embankment appeared to be in good condition as there were no signs of excessive erosion, instability or weakness (see Pic. 2). There has not been any additional waste material placed at the top of the embankment pile since late last year.

Pic. 1 –Reach 1, additional grouting along sides of upper section, grouted channel.

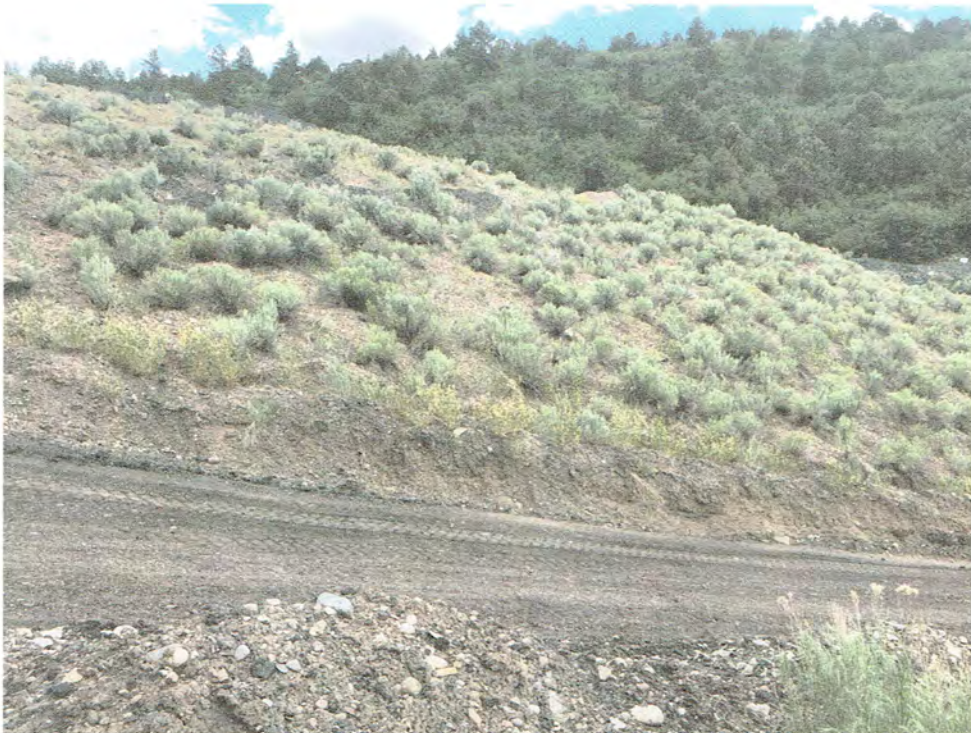
Pic. 2 – Face of waste pile in good condition.

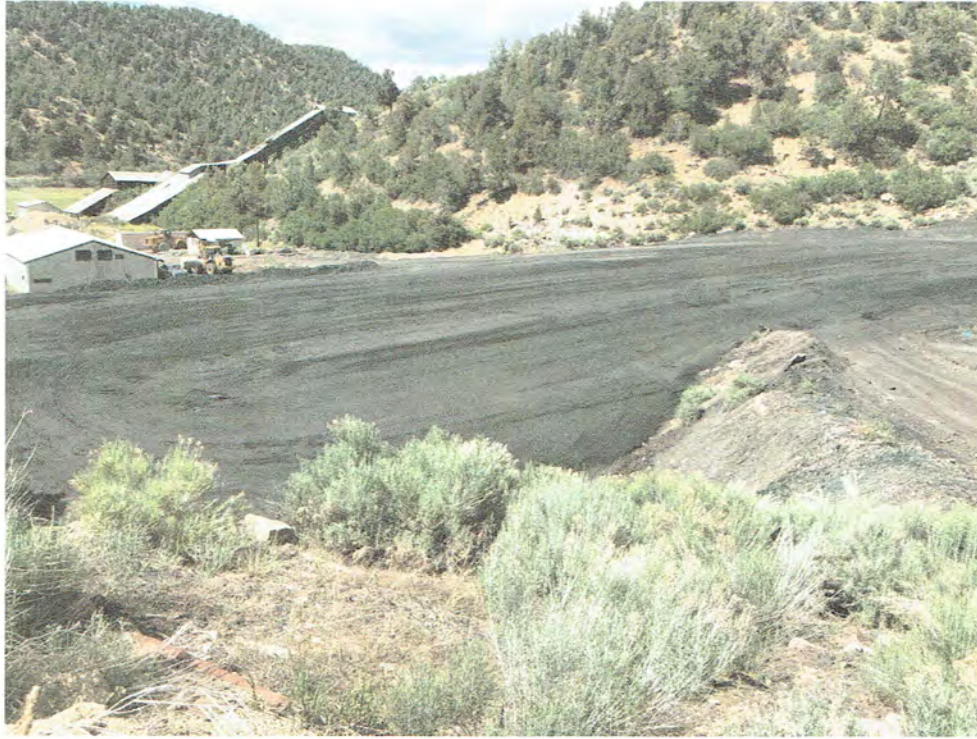
Waste material continues to be hauled to and dumped at the base of the existing waste pile/embankment where it is collected and being placed in accordance with TR-27 (see Pic. 3). The slope of the top of the existing pile is currently in excess of that defined in the Waste Bank Design produced by Don May, 1997. Specifically, the cross slope from north to south across the top of the waste pile embankment. The excess slope does not pose any danger to the stability of the existing waste pile though some localized erosion may occur during/after localized storm events.

Pic. 3 – Waste material being installed placed below existing waste embankment pile.
