MINERALS PROGRAM INSPECTION REPORT
PHONE: (303) 866-3567

MINE NAME: Bootleg Quarry	MINE/PROSPECTING ID#: M-2015-022	MINERAL: Sand and overburden	COUNTY: Adams
INSPECTION TYPE: Monitoring	INSPECTOR(S): Patrick Lennberg	INSP. DATE: June 23, 2020	INSP. TIME: 09:00
OPERATOR: Lazy H Inc	OPERATOR REPRESENTATIVE: Bill and Sandi Havengar	TYPE OF OPERATION: 111 - Construction by Government Agency	
REASON FOR INSPECTION: Normal I&E Program	BOND CALCULATION TYPE: Partial Bond	BOND AMOUNT: \$34,000.00	
DATE OF COMPLAINT: NA	POST INSP. CONTACTS: None	JOINT INSP. AGENCY: County	
WEATHER: Clear	INSPECTOR'S SIGNATURE:

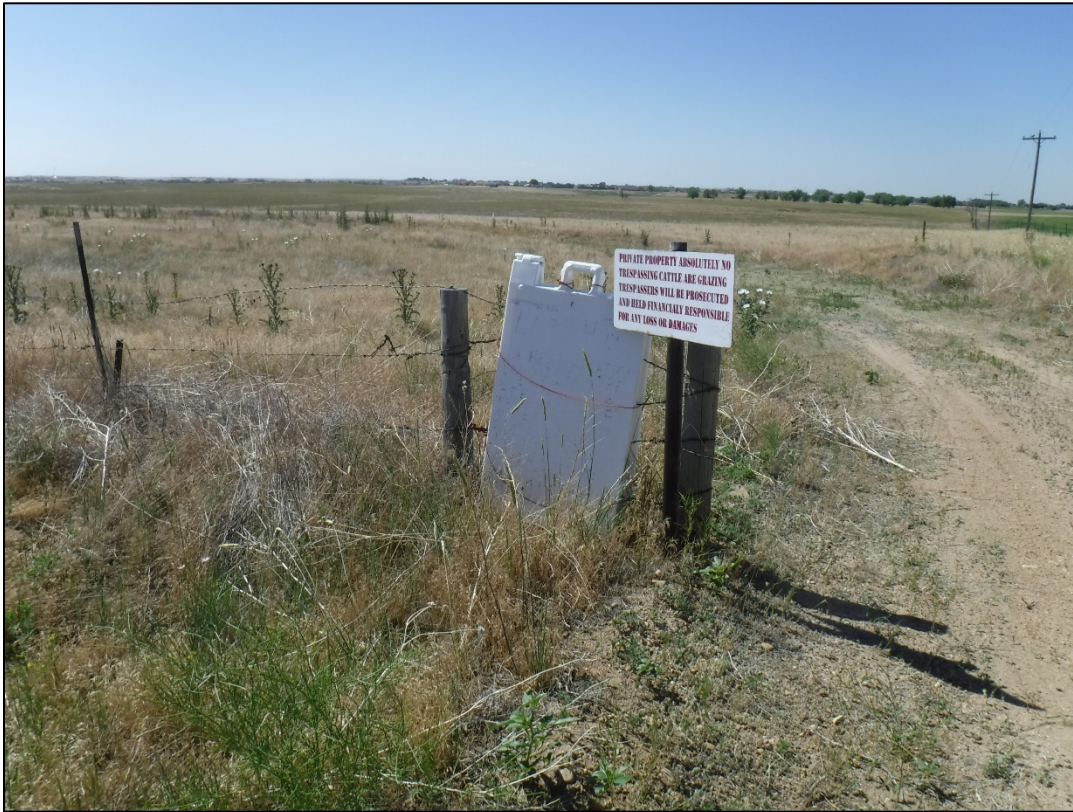
The entrance to the Bootleg Quarry is approximately 1 mile south of the intersection of East 168th avenue and Hudson Mile Road east of Lochbuie, CO in Adams County. The quarry is a 111c permitted site for 13.5 acres. The primary commodity mined is sand. A mine sign was not observed as required by Rule 3.1.12 and the affected area of the site is surrounded by a barbed-wire fence. The Operator was able to get a mine sign posted, and provide photo documentation, before this inspection report was completed so no problem will be cited.

Photo 1: Mine sign at entrance to mine site

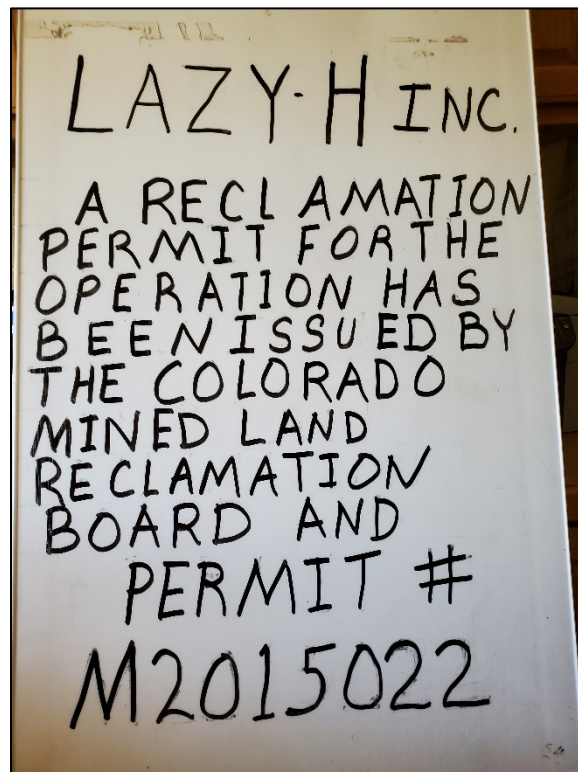
Photo 2: Mine sign replaced at entrance to mine site

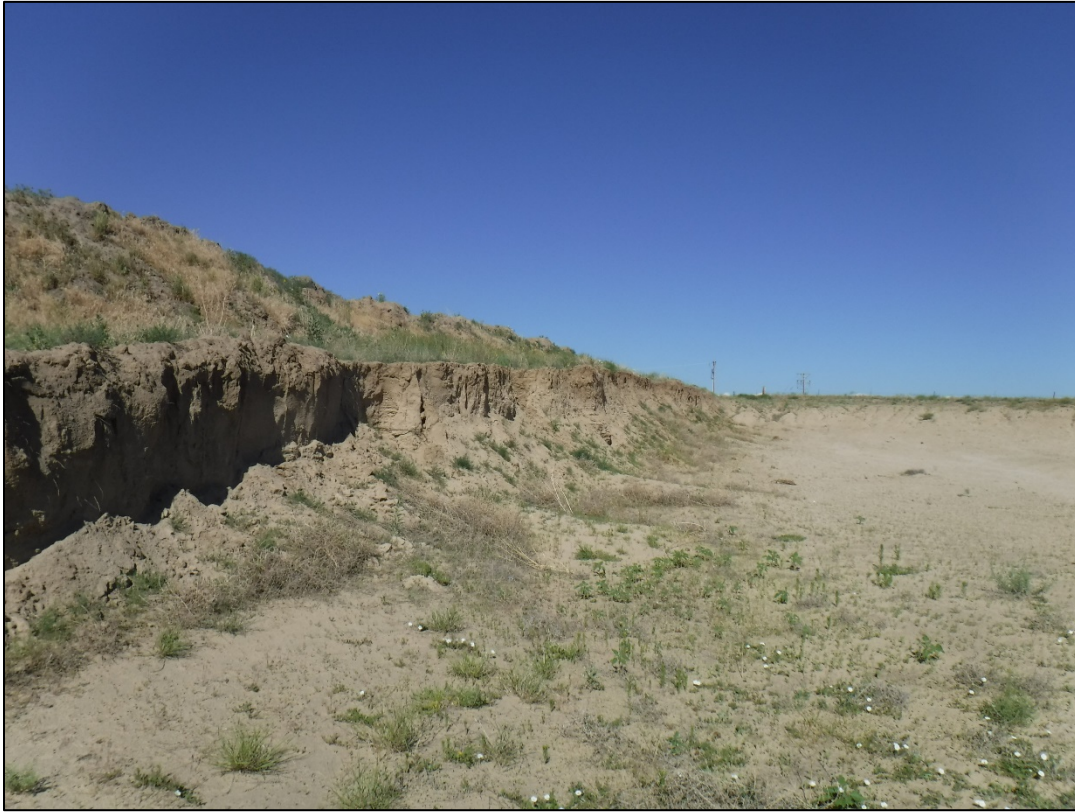
Photo 3: South side of the excavated area looking west

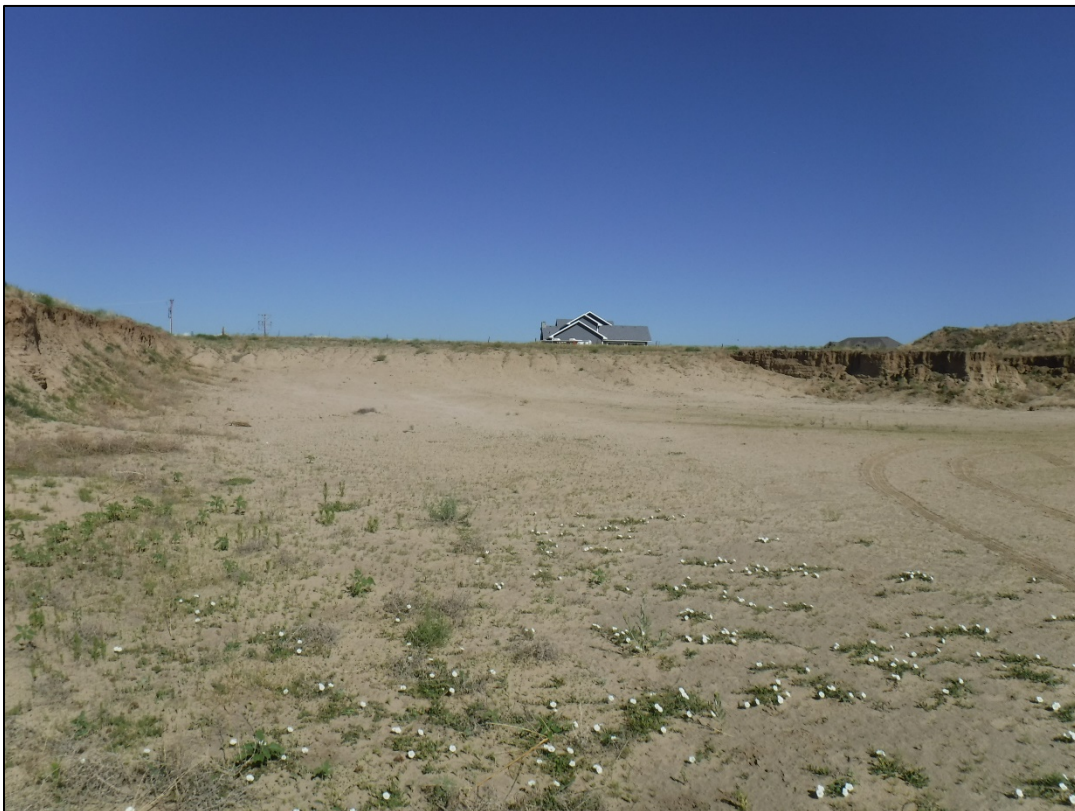
Photo 4: Looking west at the shallow graded west side of excavated area

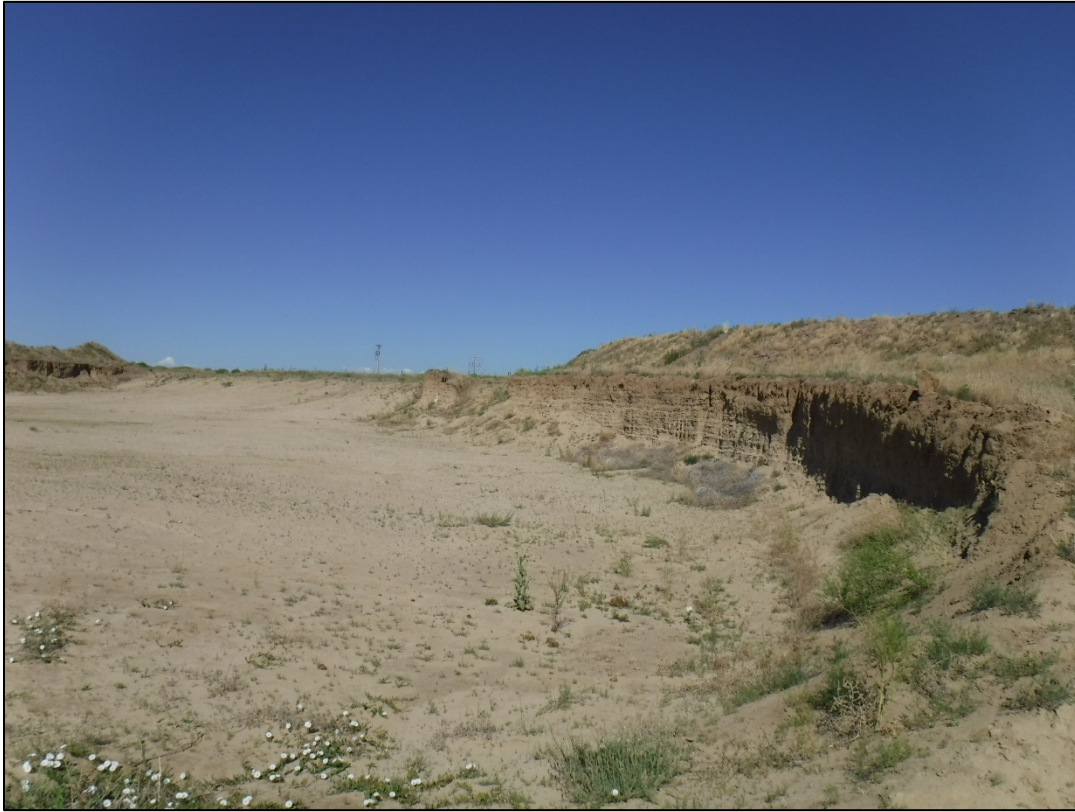
Topsoil stockpiles appeared to be stable. Annual weeds, cheat grass and thistles, were encroaching upon the site. However the site is not acting as a source to the surrounding area. The Operator stated that they would be conducting weed control later this month or early next month.

Photo 5: Looking west along the north highwall, topsoil stockpile on top of wall

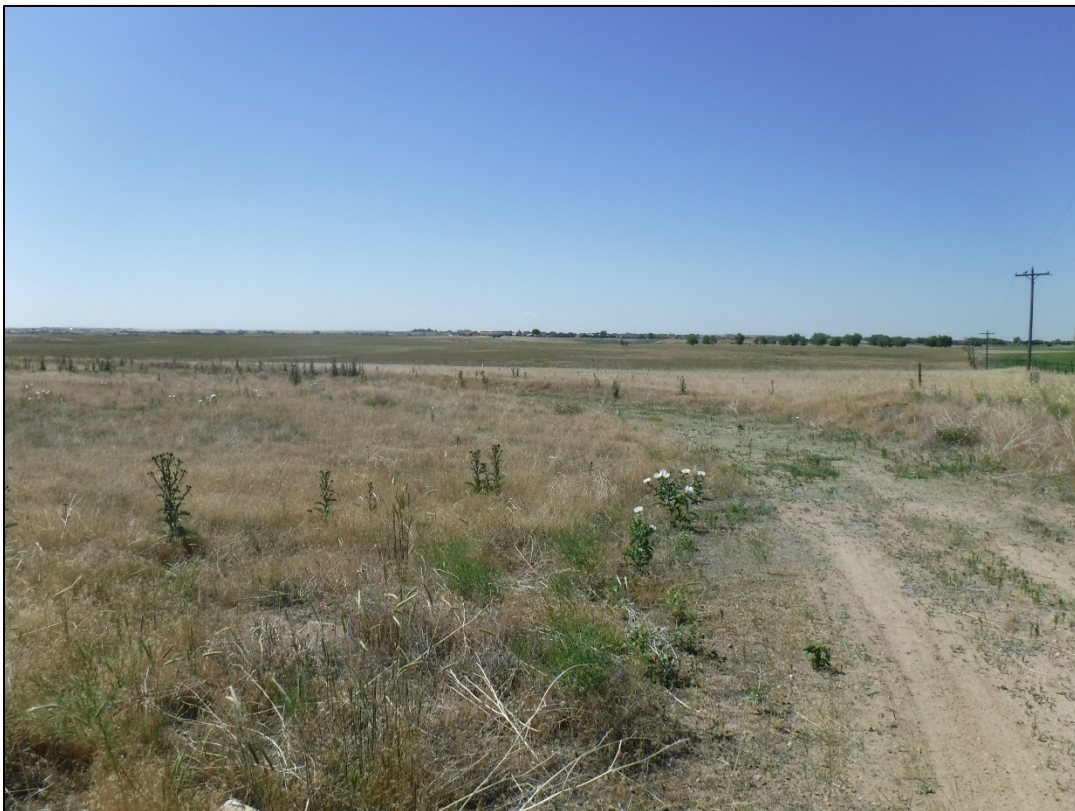
Photo 6: Access road leading to pit
