**MINERALS PROGRAM INSPECTION REPORT**  
**PHONE: (303) 866-3567**

<b>MINE NAME:</b> Orphan View Gravel Pit	<b>MINE/PROSPECTING ID#:</b> M-2013-016	<b>MINERAL:</b> Borrow material	<b>COUNTY:</b> Huerfano
<b>INSPECTION TYPE:</b> Monitoring	<b>INSPECTOR(S):</b> Patrick Lennberg	<b>INSP. DATE:</b> June 24, 2020	<b>INSP. TIME:</b> 09:45
<b>OPERATOR:</b> Huerfano County	<b>OPERATOR REPRESENTATIVE:</b> Dustin Hribar	<b>TYPE OF OPERATION:</b> 112c - Construction Regular Operation	
<b>REASON FOR INSPECTION:</b> Normal I&E Program	<b>BOND CALCULATION TYPE:</b> None	<b>BOND AMOUNT:</b> No Bond Held	
<b>DATE OF COMPLAINT:</b> NA	<b>POST INSP. CONTACTS:</b> None	<b>JOINT INSP. AGENCY:</b> None	
<b>WEATHER:</b> Clear	<b>INSPECTOR'S SIGNATURE:</b>

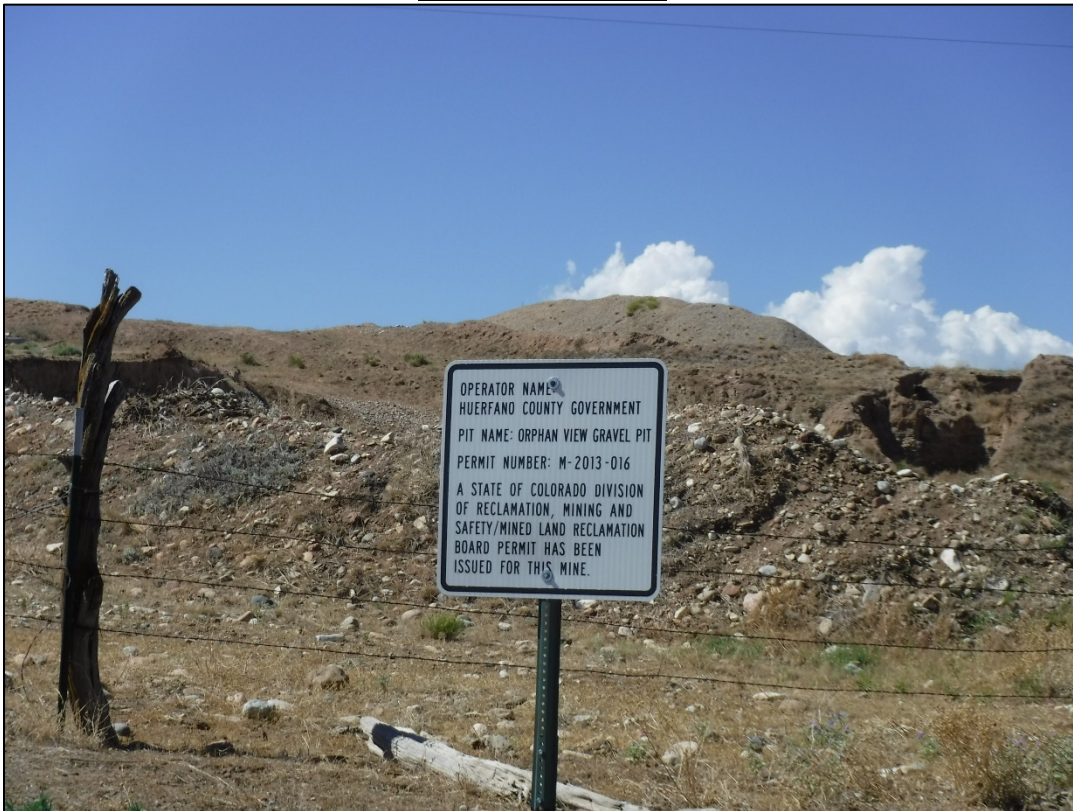
**Photo 1:** Mine sign at entrance off CR 640

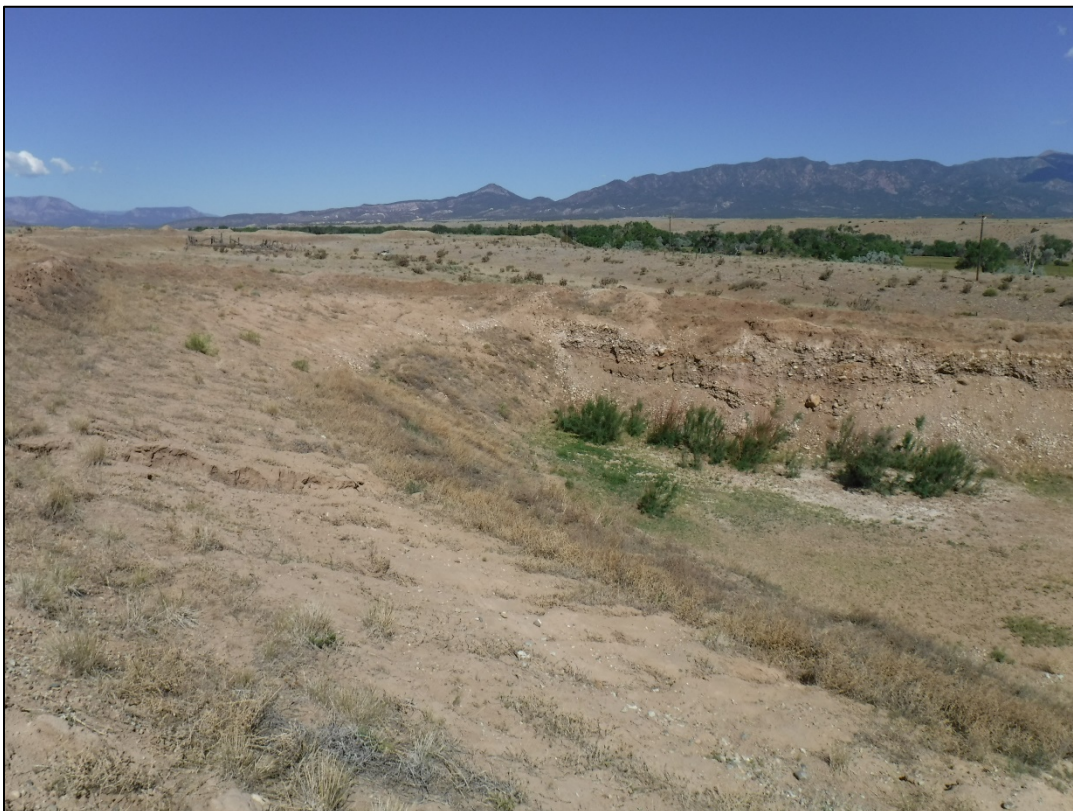
**Photo 2:** Looking NW, western end of pit area

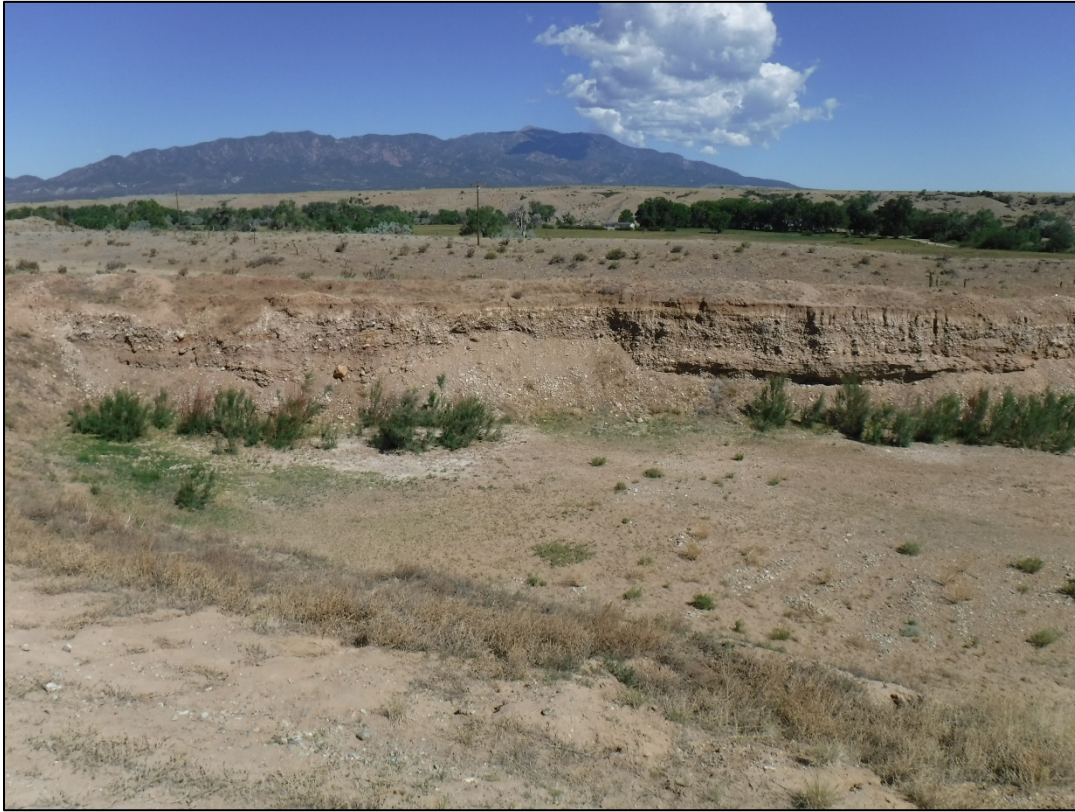
**Photo 3:** Looking north, central portion of pit area

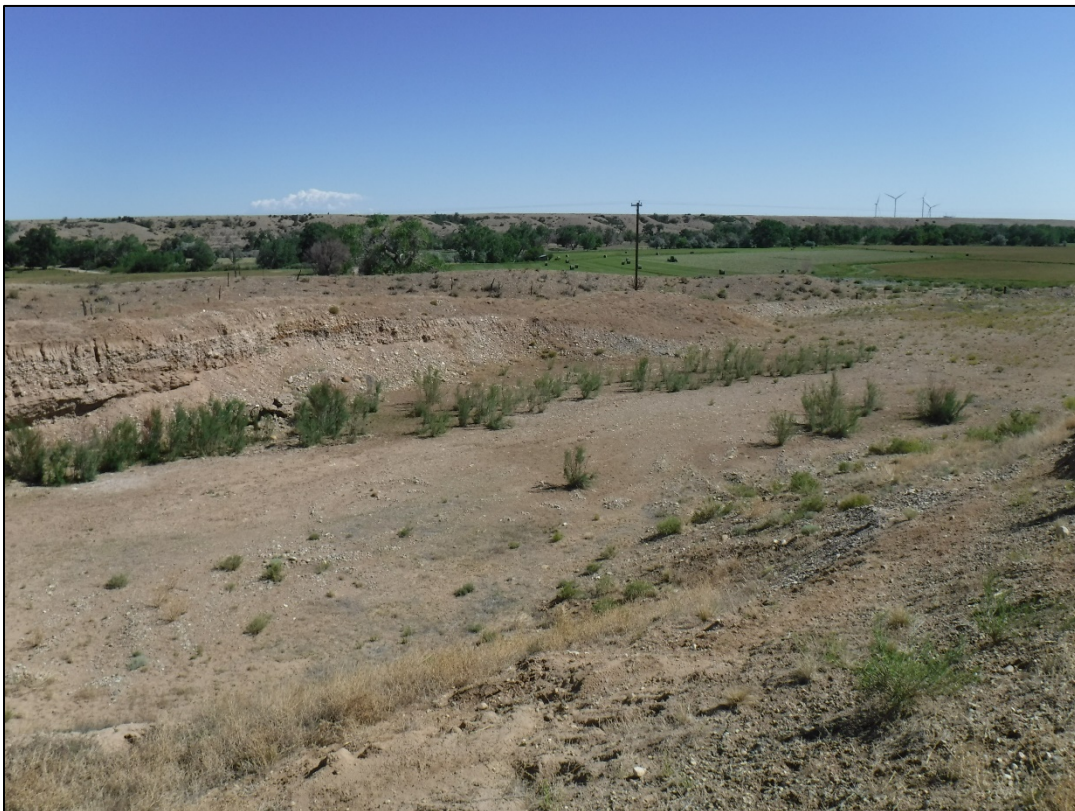
**Photo 4:** Looking NE, eastern portion of pit area

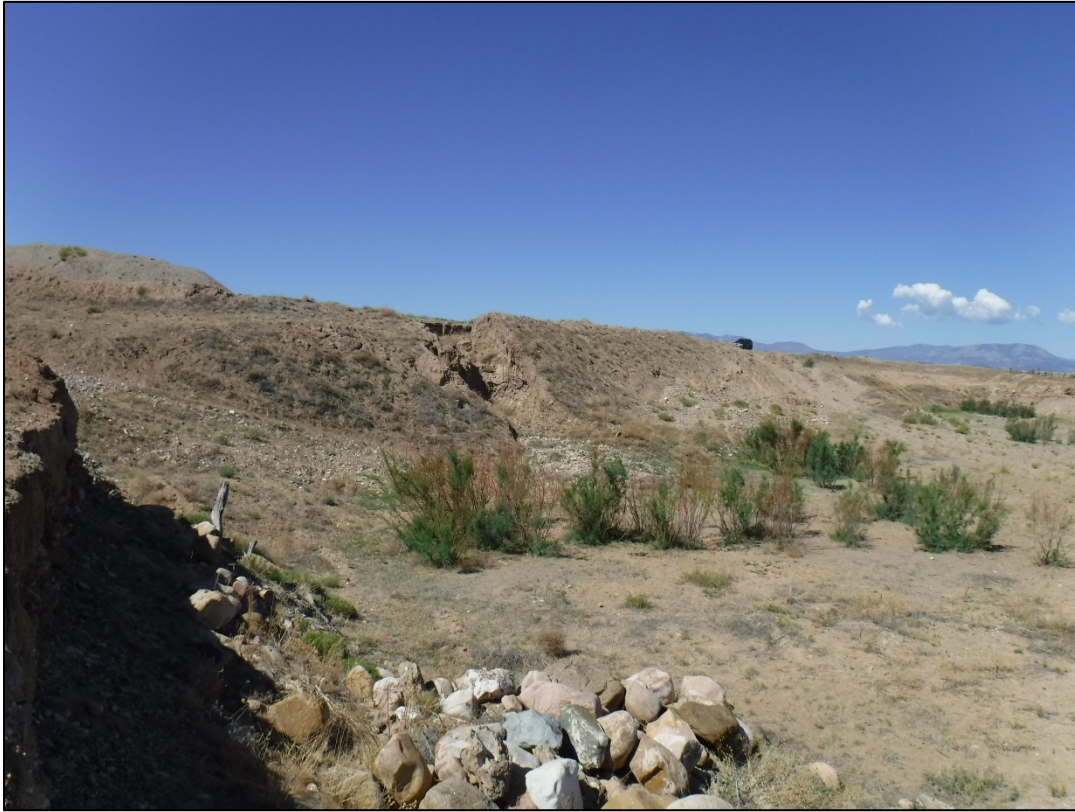
**Photo 5:** Erosion rill near the southeast corner of the pit area

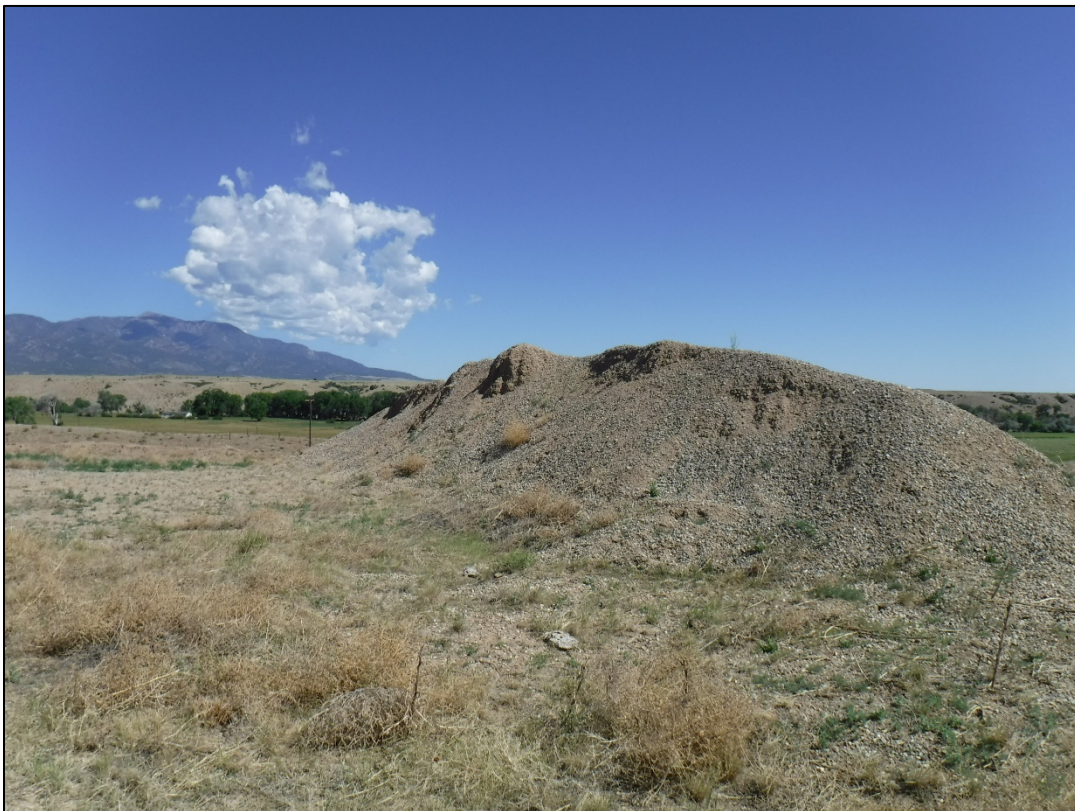
**Photo 6:** Product stockpile remaining at the site

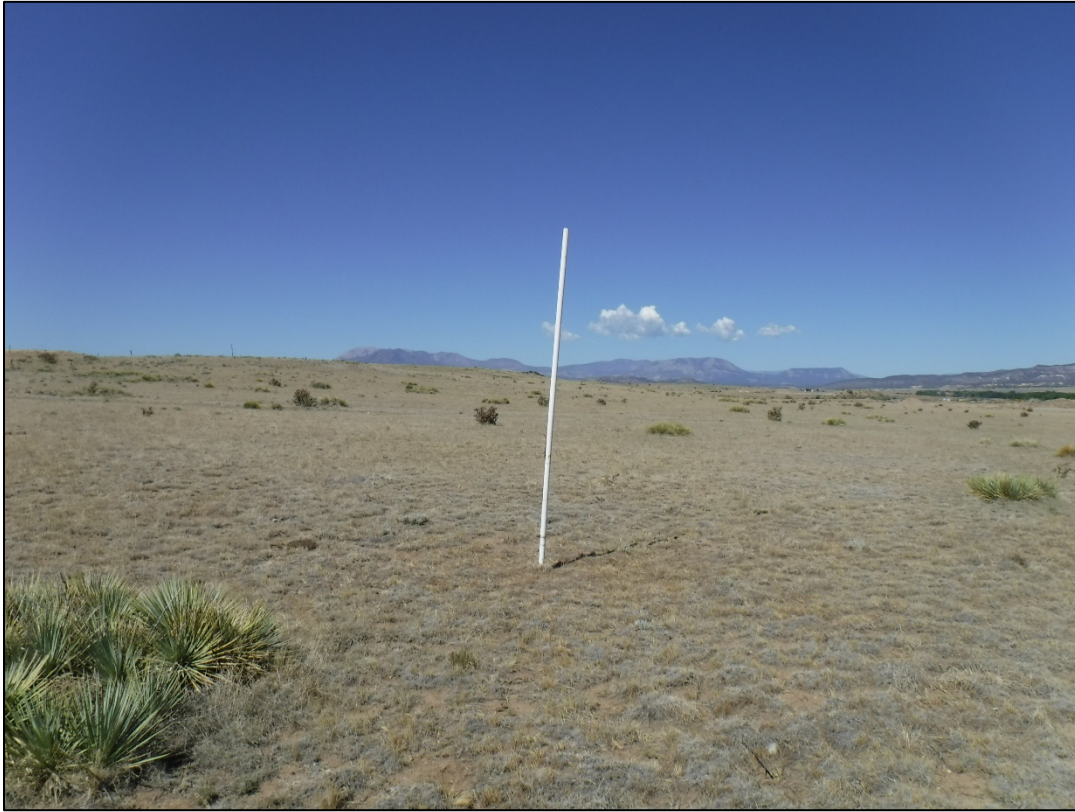
**Photo 7:** Typical boundary marker at the site

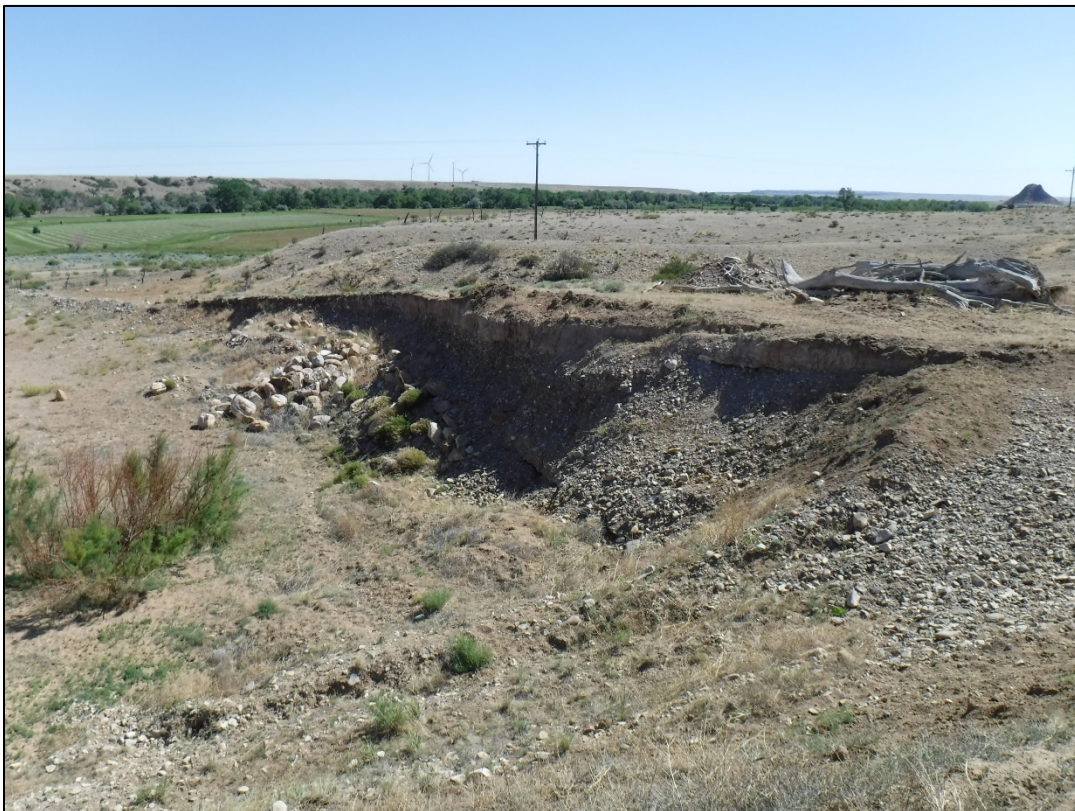
**Photo 8:** Eastern end of the pit area
