PERMIT INFORMATION

Permit Number:	C-1981-014	County:	Fremont

Mine Name: Southfield Mine
Operator: Energy Fuels Coal, Inc.
Operator Address:

INSPECTION INFORMATION

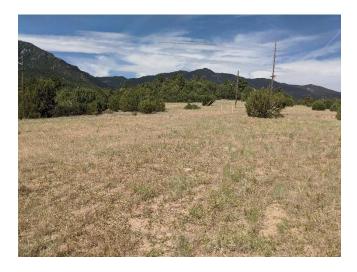
The reclaimed substation pad remains stable and well vegetated. No erosion, noxious weeds or issues were observed.

Substation pad.
