**MINERALS PROGRAM INSPECTION REPORT**  
**PHONE: (303) 866-3567**

<b>MINE NAME:</b> Mineral Mountain Project	<b>MINE/PROSPECTING ID#:</b> M-2014-045	<b>MINERAL:</b> Gold	<b>COUNTY:</b> Teller
<b>INSPECTION TYPE:</b> Monitoring	<b>INSPECTOR(S):</b> Elliott Russell	<b>INSP. DATE:</b> June 2, 2020	<b>INSP. TIME:</b> 10:00
<b>OPERATOR:</b> Mineral Mountain Gold, LLC	<b>OPERATOR REPRESENTATIVE:</b> Lance Barker	<b>TYPE OF OPERATION:</b> 110d - Designated Limited Impact

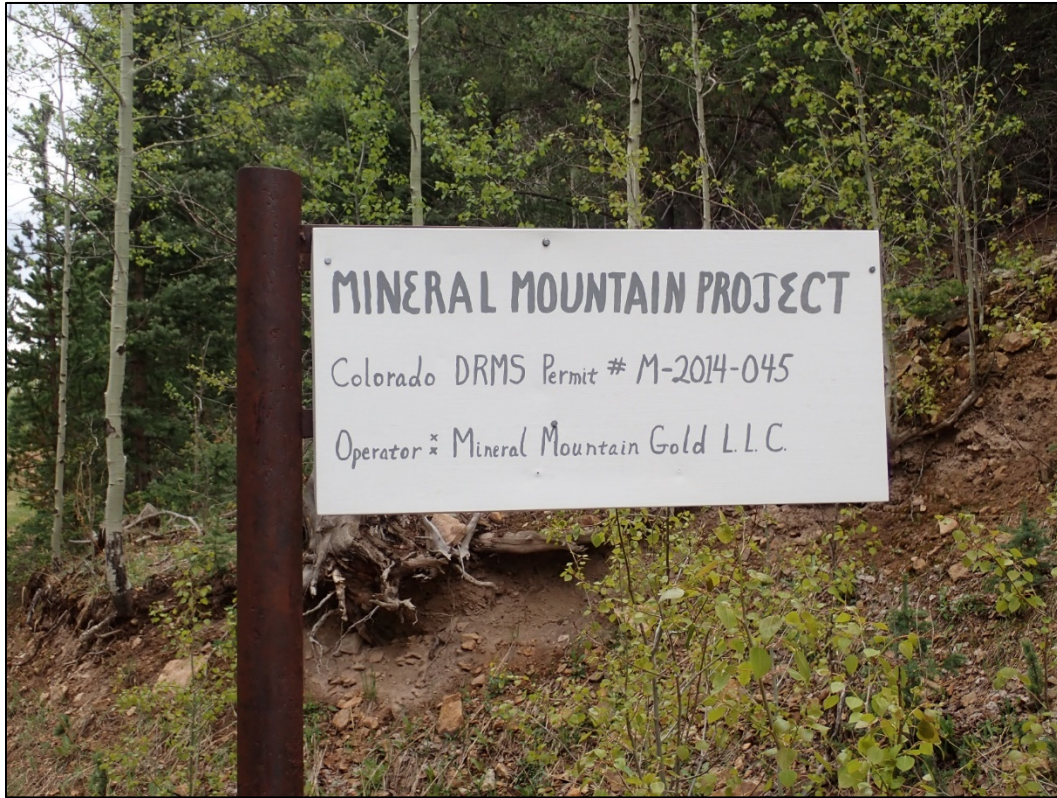
The mine identification sign was posted at the entrance access road along the western permit boundary and was in compliance with Rule 3.1.12(1). The Division observed several red rebar posts around the site delineating the permit boundary. The Operator stated the markers around the area carved out with Acreage Reduction AR-01 were disturbed and were not in the correct locations. The Operator stated since this area is near the two powder magazines, the fire marshal instructed them to clear-cut the trees in this area to reduce the fire hazard. This has been cited as Compliance Problem #1, requiring the Operator to conduct a survey and replace the boundary markers in the correct locations.

**Photo 1.** Mine identification sign along access road and western permit boundary; looking east.

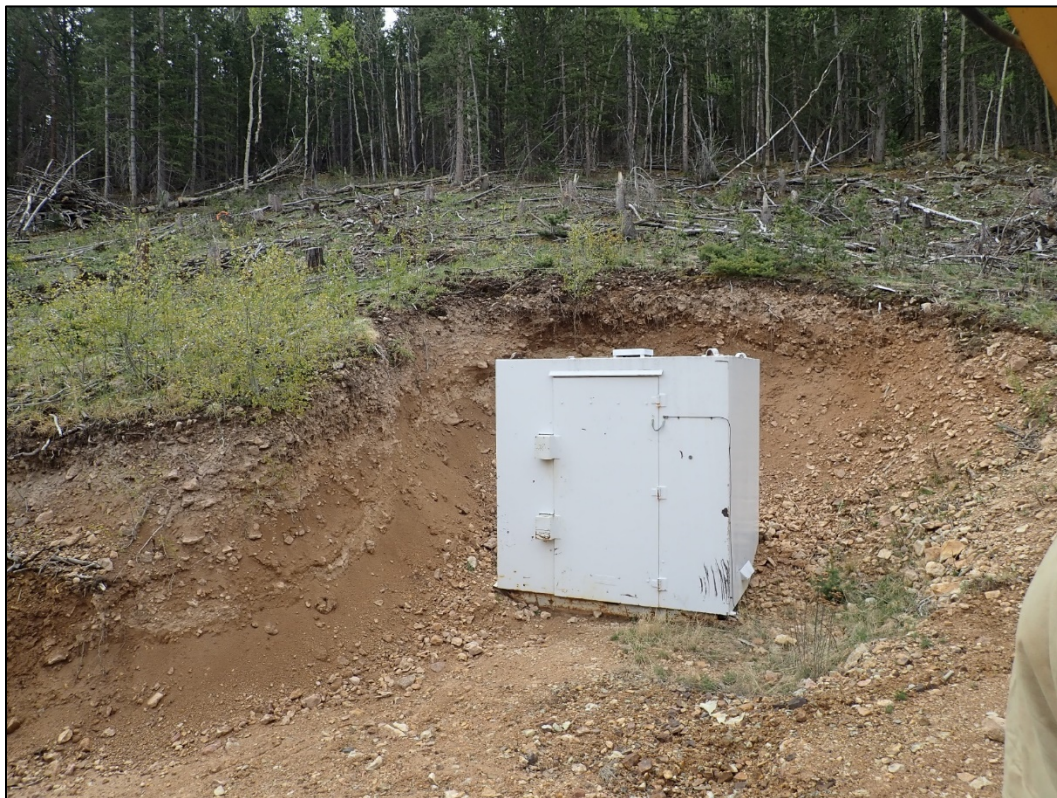
**COMPLIANCE PROBLEM #1:** The affected area boundary markers are missing or incorrectly placed. This is a problem for failure to maintain boundary markers around the affected area as required by Rule 3.1.12(2).

**Photo 2.** Powder magazine area where tree cutting activities disturbed permit boundary markers; looking south.

**CORRECTIVE ACTIONS:** The Operator shall conduct a survey and replace the boundary markers in the correct location(s). The operator shall provide proof to the Division that this has been done by the corrective action date.

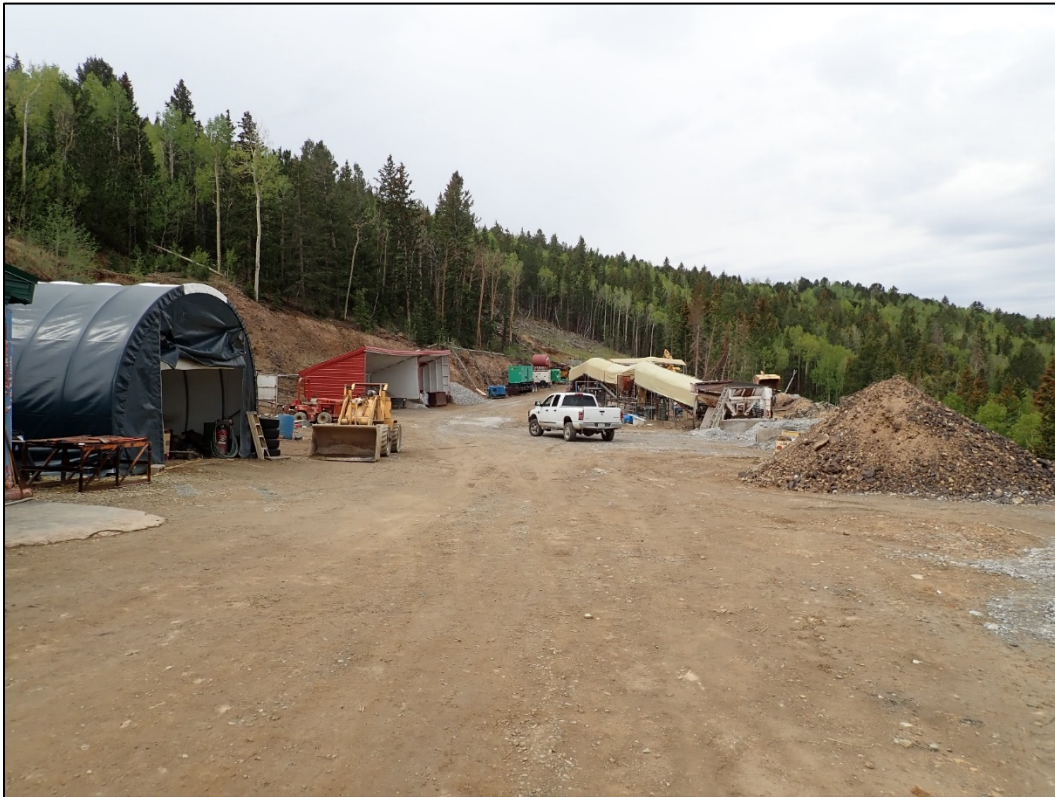
The site consists of a single adit/tunnel and a flattened work area made out of development waste rock identified as the Waste Rock Area on the permit maps. This flat Waste Rock Area was approximately 1 acre in size. The face of the waste rock dump is approximately 50 feet high and is set at the angle of repose. The Waste Rock Area consists of several buildings/structures, generators/compressors, a crusher, underground mining equipment, petroleum storage tanks with secondary containment, and miscellaneous parts, equipment, and scrap metal. The site contained a secondary escape and air vent shafts located 100 feet southeast of the tunnel portal. There were also two conex storage containers located in the southeastern portion of the permit which housed the sampling of drill cuttings with XRF analysis to help determine the advancement of the tunnel.

**Photo 3.** Surface facilities on the Waste Rock Area; looking southwest.

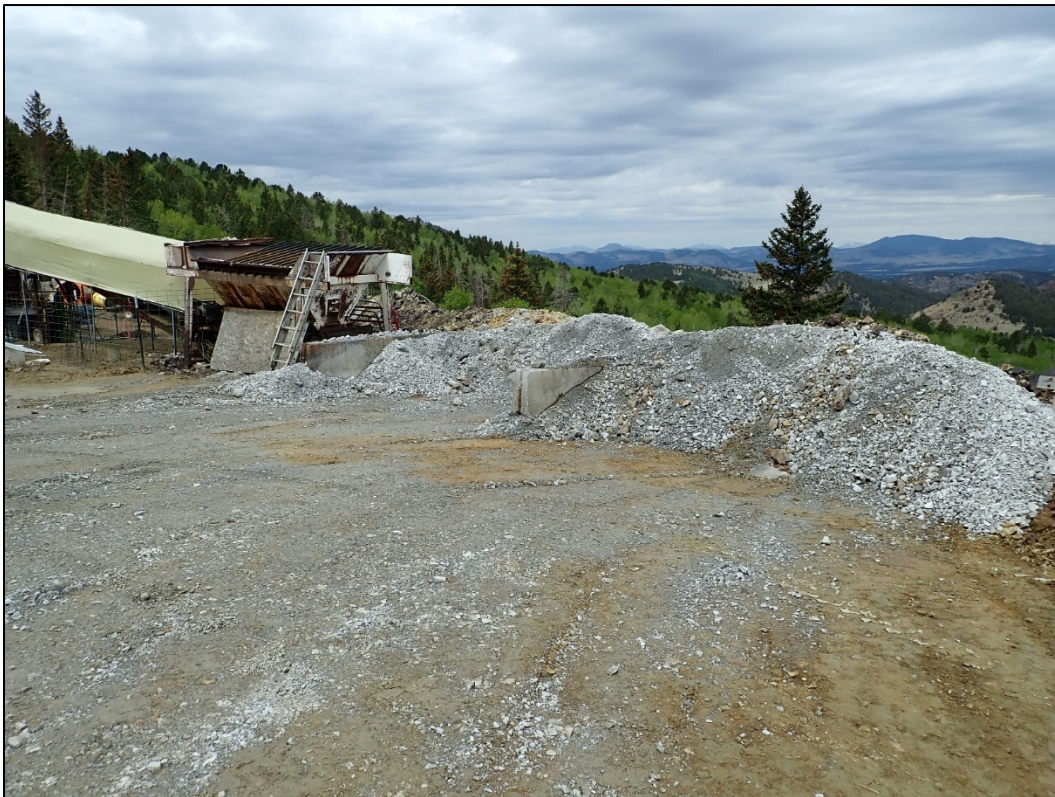
The Operator stated the surface crusher has a capacity of 50 tons per day, but only runs when enough ore is stockpiled. Blasted ore from underground is brought to the surface and stockpiled next to the crusher and is then crushed to 1" minus and stockpiled in the eastern half of an open-sided building next to the tunnel portal. The Operator stated the crushed ore is then hauled back underground and is crushed to 100-mesh with a 1 ton per day ball mill. This material is run across a shaker table to produce a gravity concentrate which is stored in the western half of the open-sided building at the surface. The remaining material is put through a froth-flotation circuit using xanthate to produce a flotation concentrate which is brought to the surface to an enclosed conex storage container where the concentrate is placed in one of three electric

**Photo 4.** Ore stockpile near crusher; looking west.

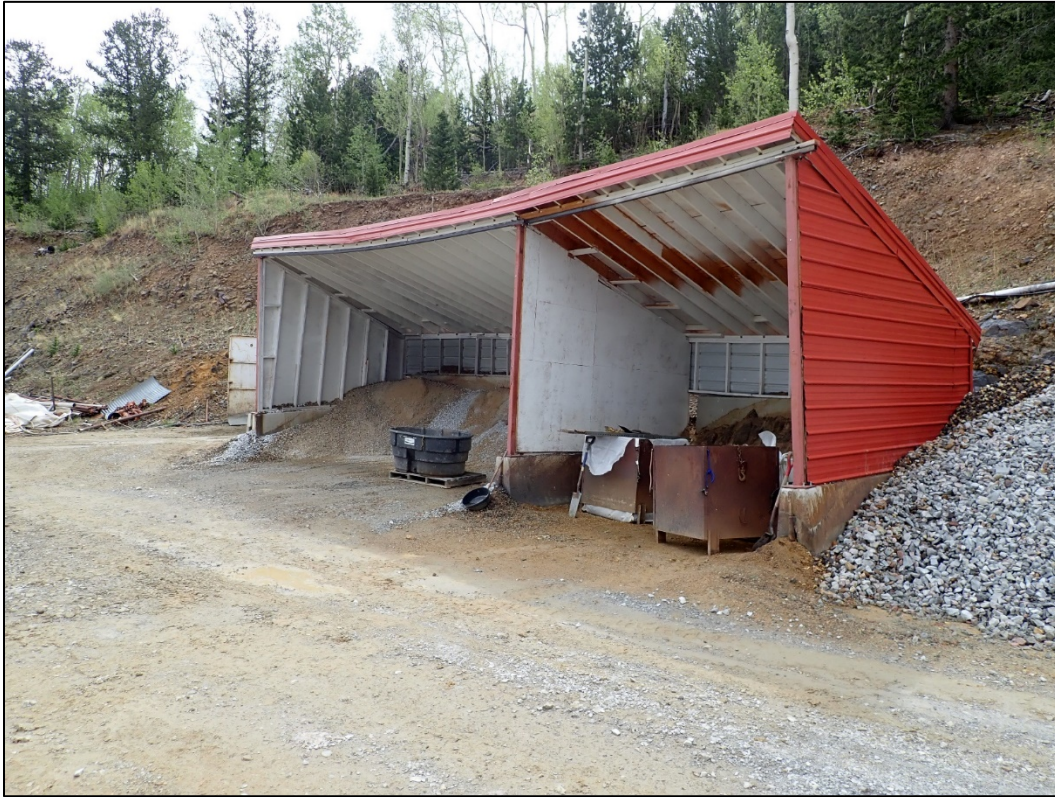
**Photo 5.** Open-sided building containing crushed ore (left) and gravity concentrate (right); looking southeast.

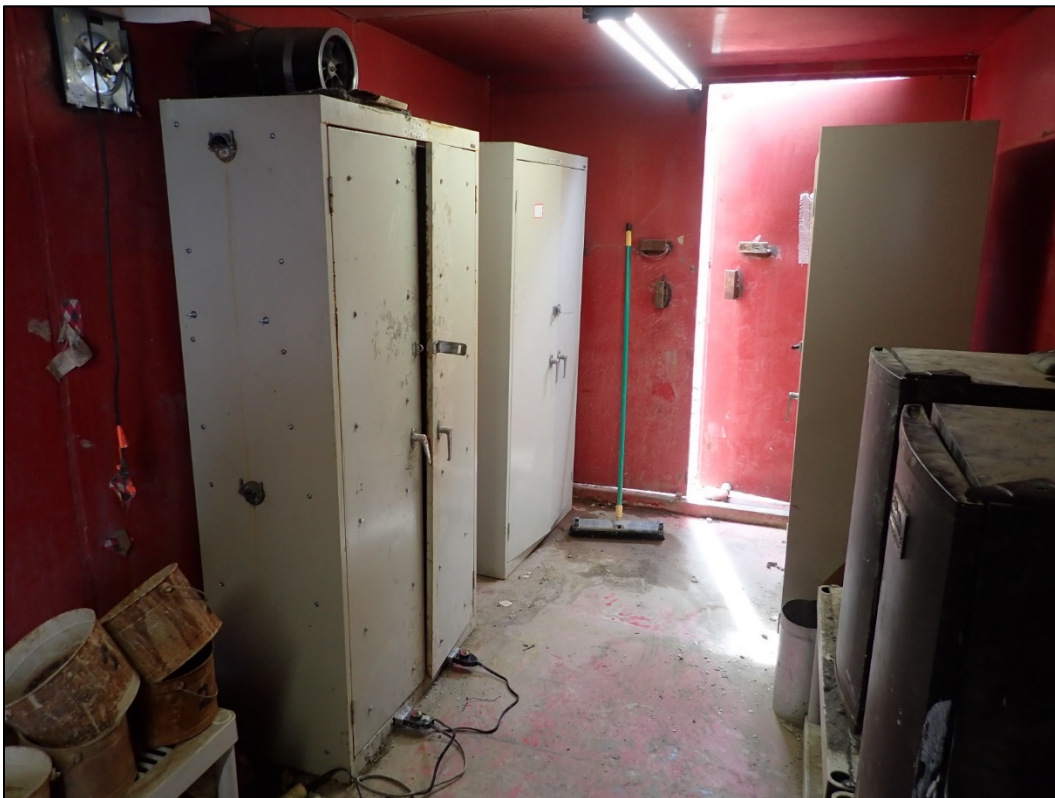
**Photo 6.** Drying lockers for flotation concentrate; looking southeast.

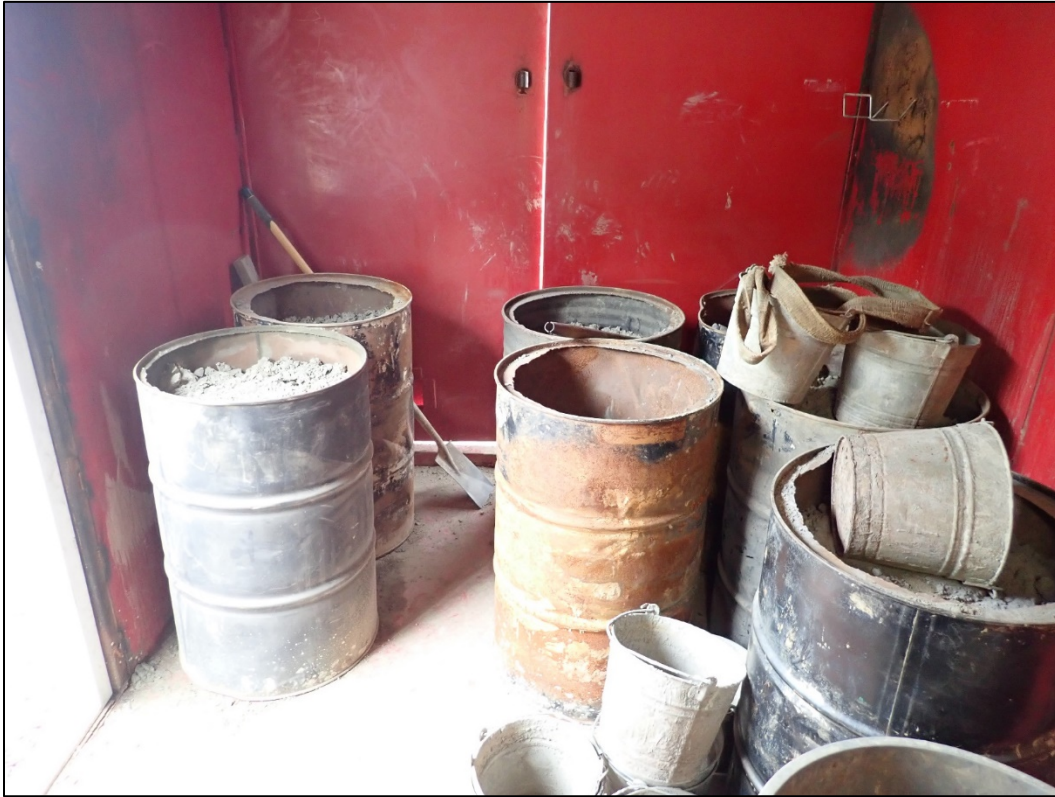
drying locker. The final dried flotation concentrate is stored in open-topped drums inside the same storage container. While inspecting the western portion of the Waste Rock Area, the Division discovered fine grain material on the dump face. The Operator stated this material was the waste from the flotation circuit.

**Photo 7.** Dried flotation concentrate; looking north.

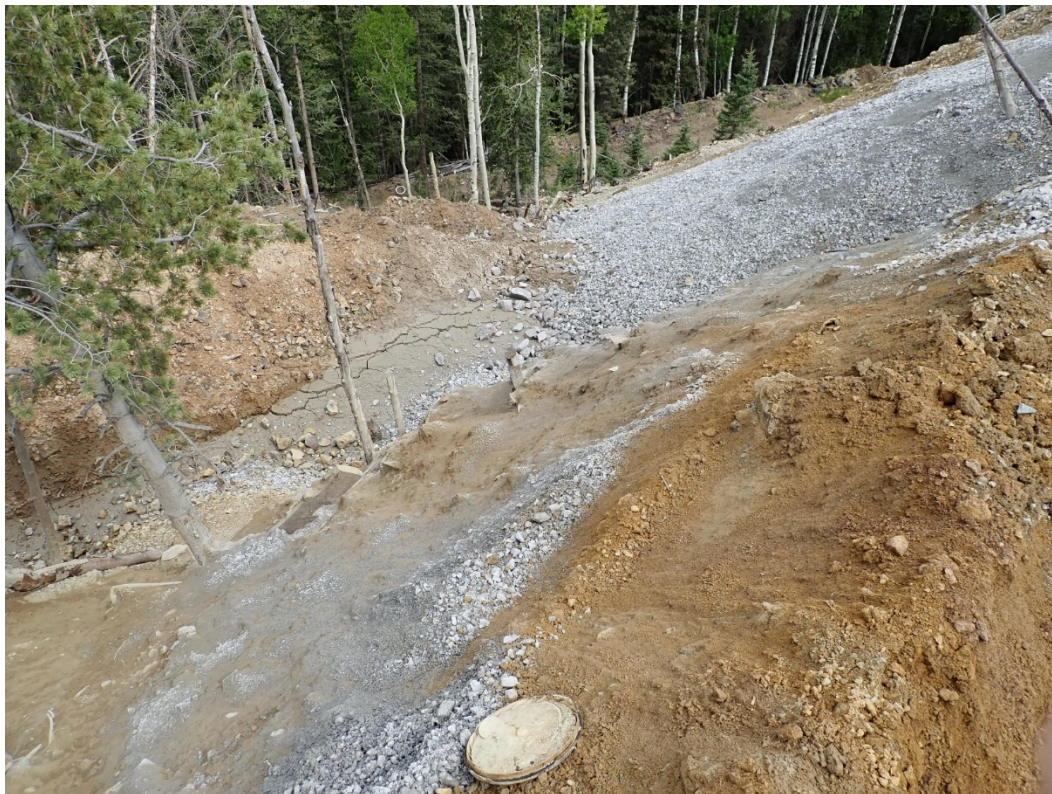
**POSSIBLE VIOLATION:** The Operator is using a gravity and floatation mill which is not authorized by the permit. The Operator is using xanthate in the floatation circuit, a designated chemical, which is not authorized by the permit. The Operator is disposing mill tailings in an unlined repository which is not authorized by the permit. These are possible violations of C.R.S. 34-32.5-124 for failure to follow the conditions of an order, permit or regulation.

After the inspection, upon review of the permit file, the Division has determined the use of gravity and floatation mill, the use of xanthate (a designated chemical), and the disposal of mill tailings in an unlined repository are not authorized by the permit. In general, the permit does not have a mining plan as the original 110(1) permit, applied for in 2014, stated the site was in a prospecting stage and contained little to no information regarding mining and processing of material. The permit stated once more information is collected, a plan could be developed and shared with the Division. The Division has not received a Technical Revision nor Amendment to the permit to define a mine plan nor has the Division received any details regarding processing of ore. Additionally, as required in the stipulated approval of the 110(1) permit, the Operator submitted an application to convert the 110(1) to a 110d in 2015. Within the 110d Environmental Protection Plan, the Operator stated the operation does not use designated chemicals and that the Operator does not anticipate using them, so no plan was submitted nor reviewed for managing designated chemicals. This has been cited as a possible violation for failure to follow the conditions a permit, requiring a hearing before the Mined Land Reclamation Board.

**Photo 8.** Fine grain material (flotation mill tailings) on out-slope of waste rock dump; looking north.

**CORRECTIVE ACTIONS:** These possible violations will require a hearing before the Mined Land Reclamation Board scheduled for the August 19-20, 2020 Board meeting. The schedule and other details for the MLRB hearing has been provided under a separate document, sent via certified mail to the Operator on July 1, 2020.

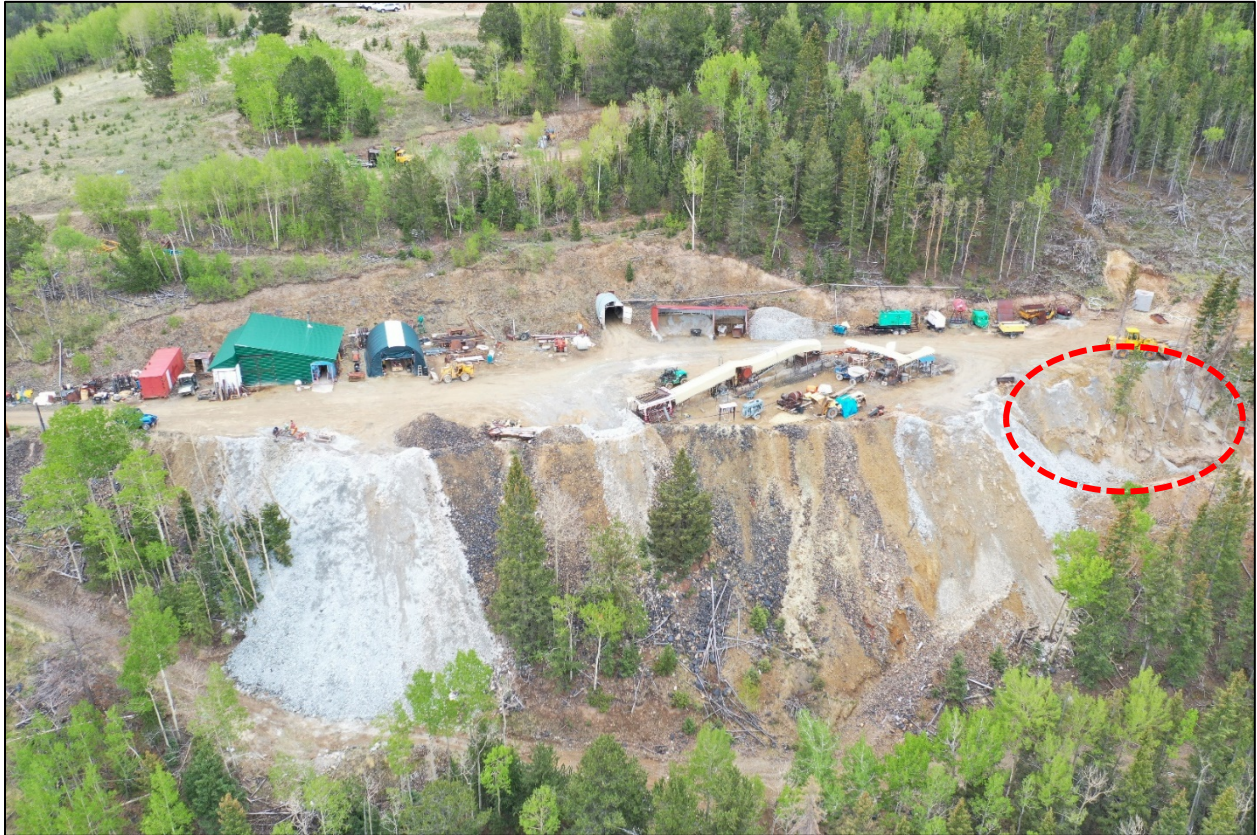
**Photo 9.** Waste Rock Area overview, area where mill tailings were found is circled; looking southeast.

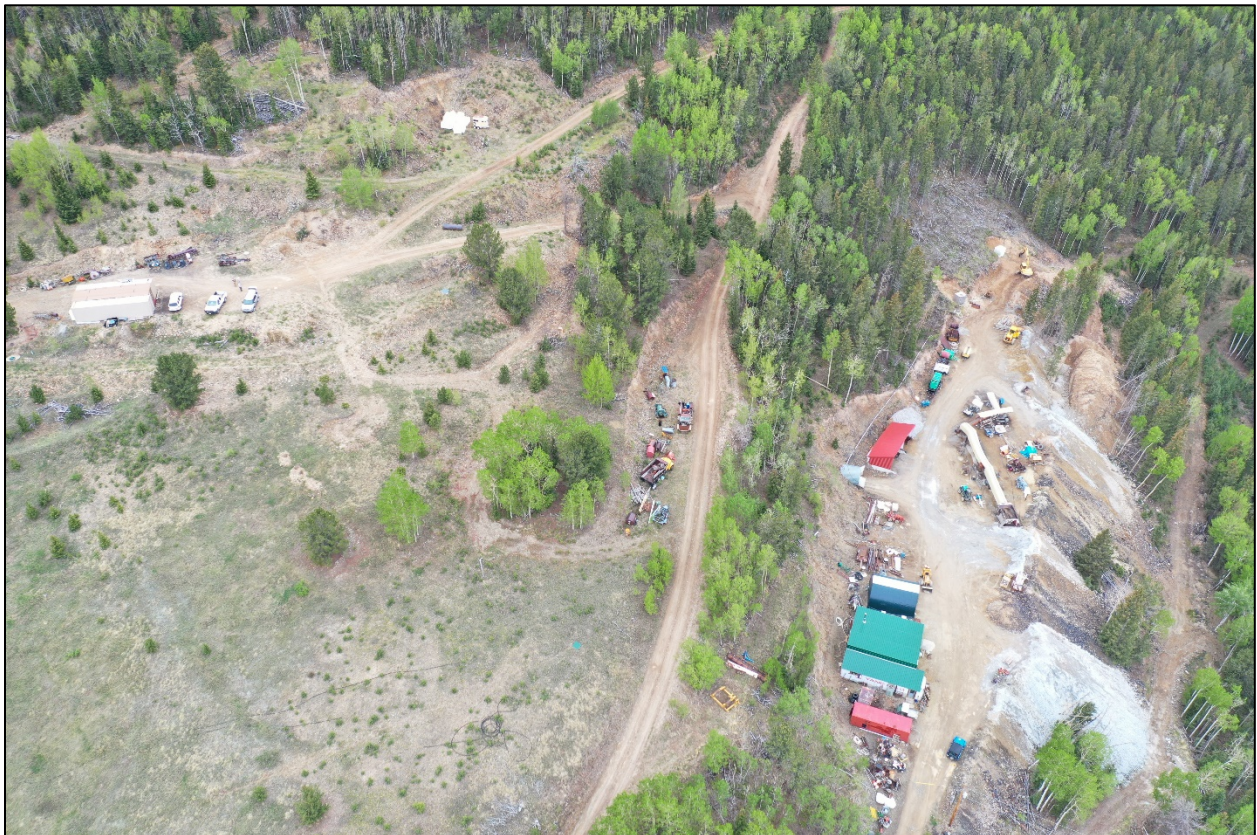
**Photo 8.** Mineral Mountain Project overview; looking southwest.
