**MINERALS PROGRAM INSPECTION REPORT**  
**PHONE: (303) 866-3567**

<b>MINE NAME:</b> Schmidt Site	<b>MINE/PROSPECTING ID#:</b> M-2011-014	<b>MINERAL:</b> Borrow material for	<b>COUNTY:</b> Archuleta
<b>INSPECTION TYPE:</b> Monitoring	<b>INSPECTOR(S):</b> Lucas West	<b>INSP. DATE:</b> June 11, 2020	<b>INSP. TIME:</b> 14:30
<b>OPERATOR:</b> Dale and Ellen Schmidt	<b>OPERATOR REPRESENTATIVE:</b> Dale Schmidt	<b>TYPE OF OPERATION:</b> 110c - Construction Limited Impact	
<b>REASON FOR INSPECTION:</b> Normal I&E Program	<b>BOND CALCULATION TYPE:</b> None	<b>BOND AMOUNT:</b> \$15,140.00	
<b>DATE OF COMPLAINT:</b> NA	<b>POST INSP. CONTACTS:</b> None	<b>JOINT INSP. AGENCY:</b> None	
<b>WEATHER:</b> Clear	<b>INSPECTOR'S SIGNATURE:</b>

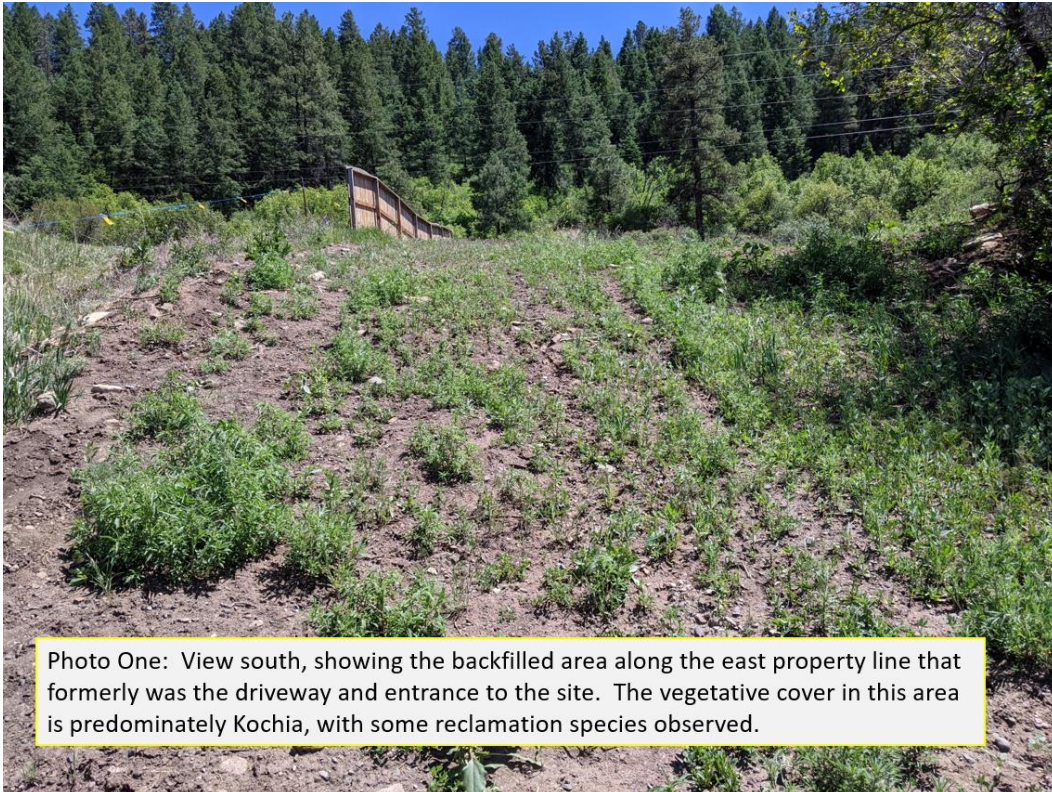
Photo One: View south, showing the backfilled area along the east property line that formerly was the driveway and entrance to the site. The vegetative cover in this area is predominately Kochia, with some reclamation species observed.

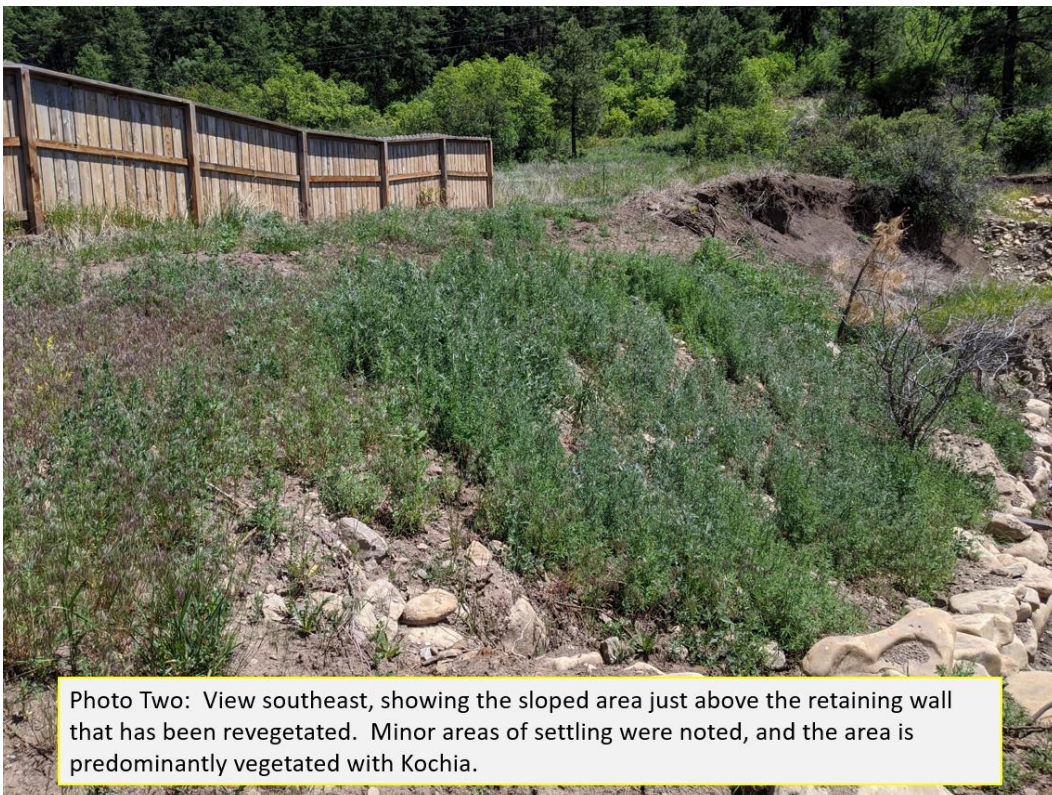
Photo Two: View southeast, showing the sloped area just above the retaining wall that has been revegetated. Minor areas of settling were noted, and the area is predominantly vegetated with Kochia.

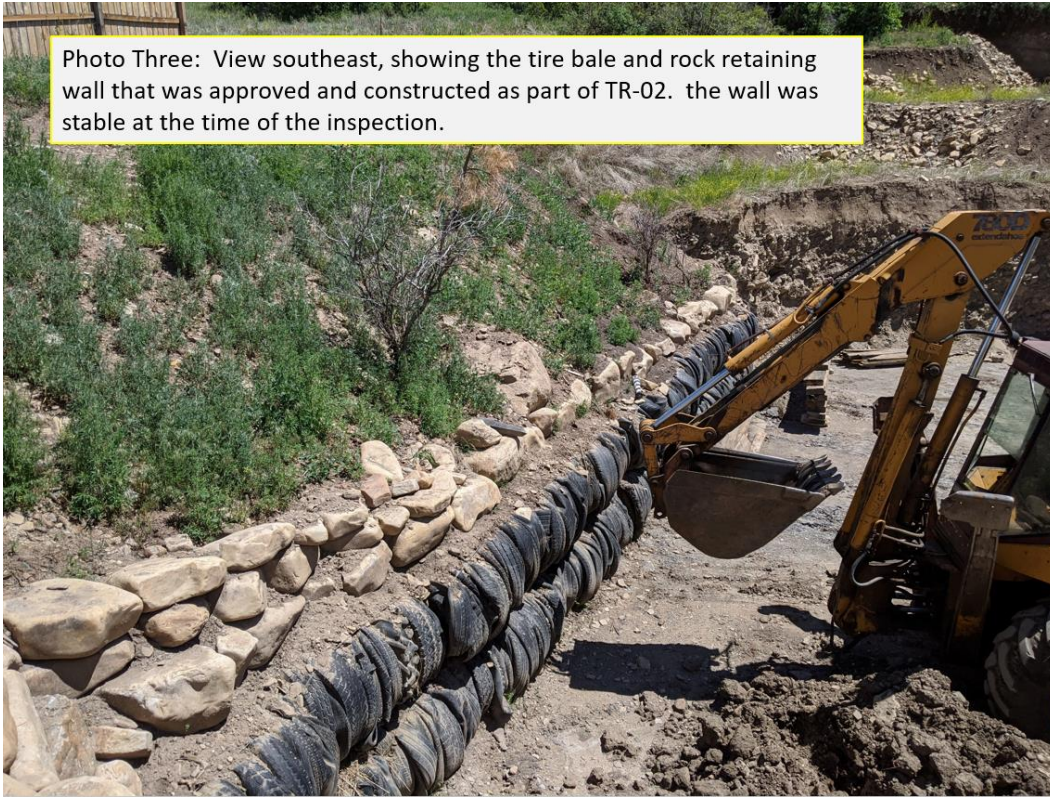
Photo Three: View southeast, showing the tire bale and rock retaining wall that was approved and constructed as part of TR-02. the wall was stable at the time of the inspection.
