MINERALS PROGRAM INSPECTION REPORT
PHONE: (303) 866-3567

MINE NAME: Kattenberg Pit	MINE/PROSPECTING ID#: M-2004-017	MINERAL: Sand and gravel	COUNTY: Grand
INSPECTION TYPE: Monitoring	INSPECTOR(S): Peter Hays	INSP. DATE: June 16, 2020	INSP. TIME: 10:00
OPERATOR: Granby Sand & Gravel, LLC	OPERATOR REPRESENTATIVE: David Marshall	TYPE OF OPERATION: 112c - Construction Regular Operation

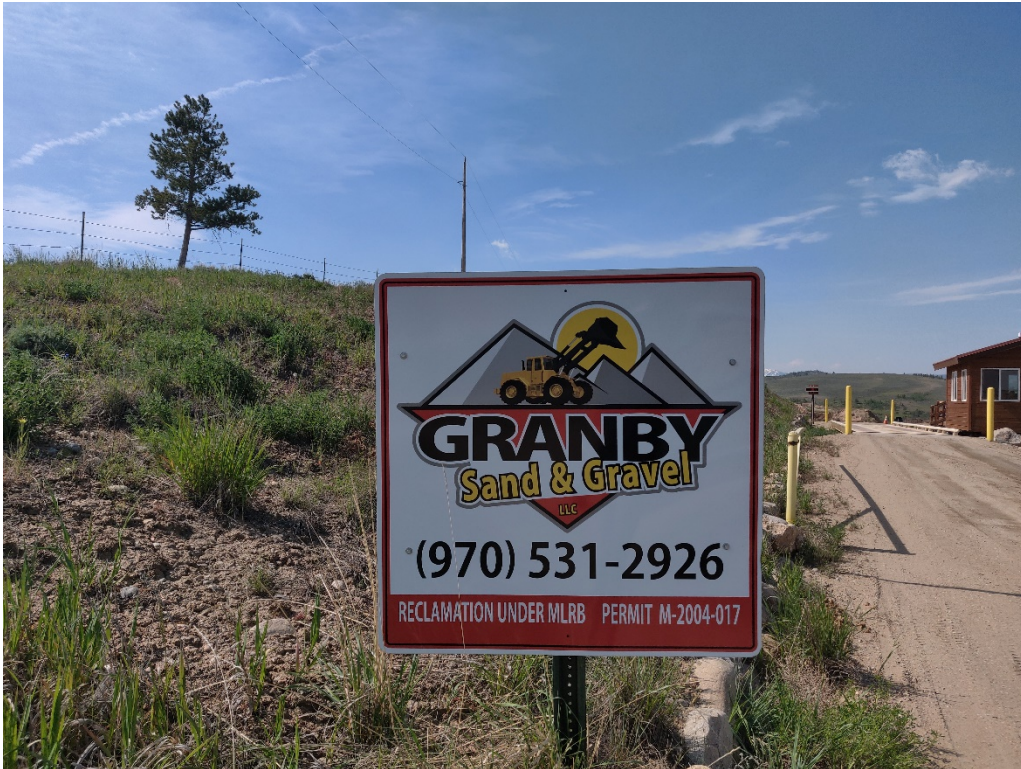
The mine sign was observed as required by Rule 3.1.12. ESCO Construction purchased Granby Sand & Gravel, LLC in January 2020 from the previous Operator, therefore the current sign is acceptable.

Kattenburg Pit mine sign

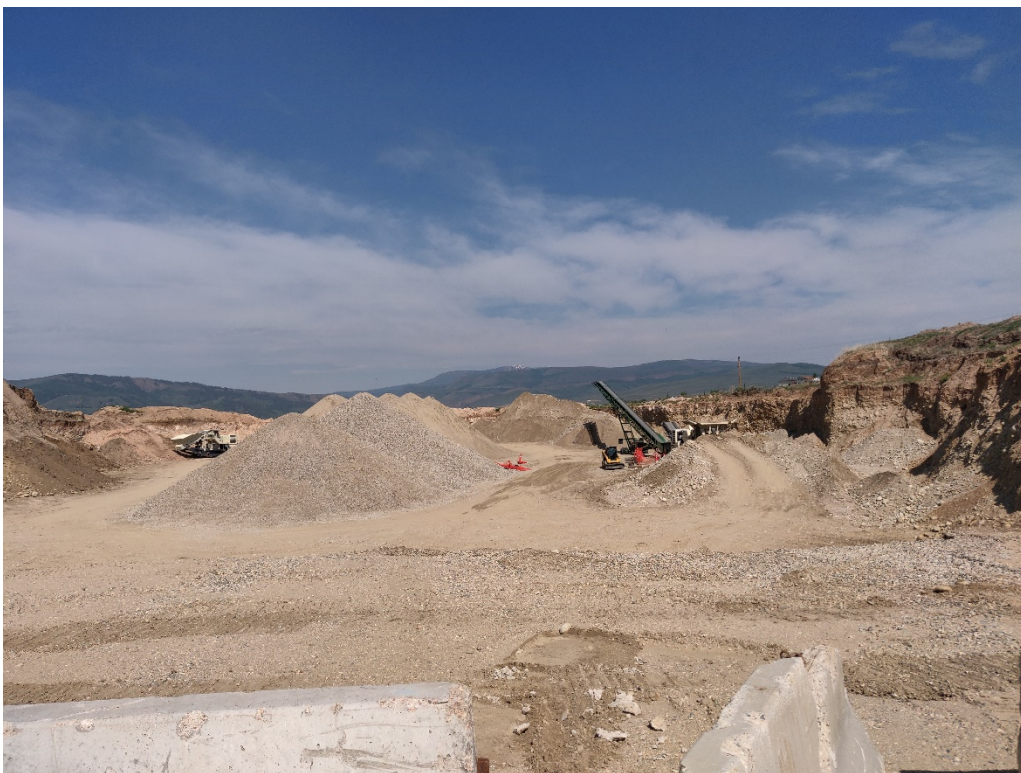
View of the current mining operation in the northwest corner of the site looking east

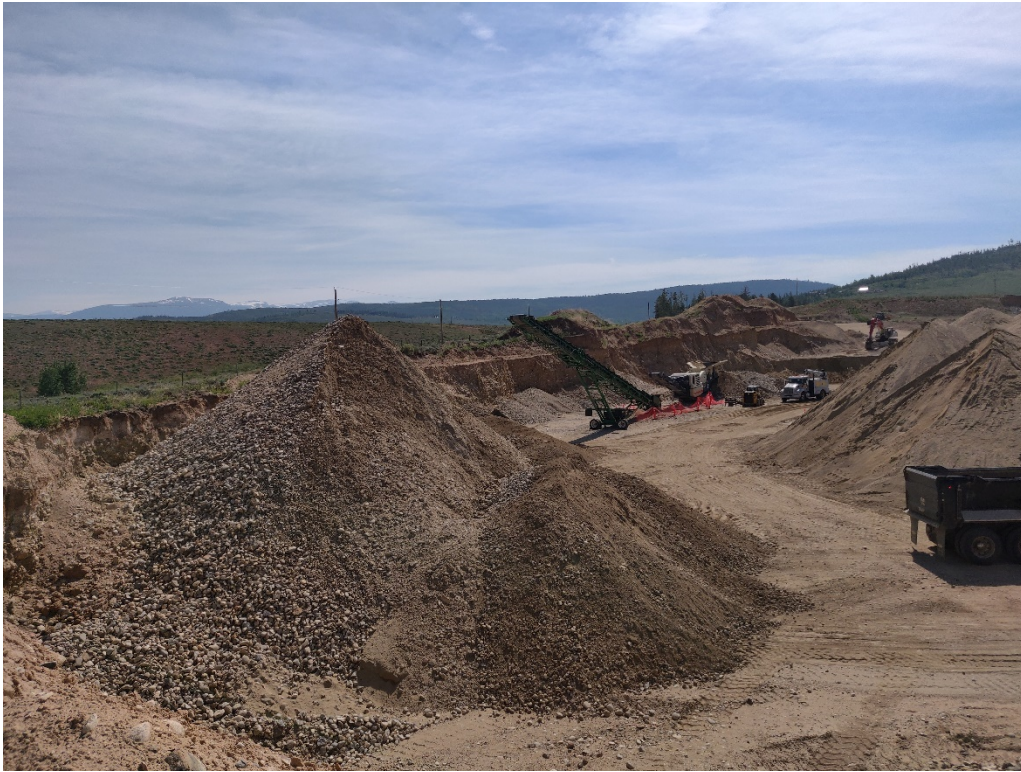
View of the current mining operation from the northwest corner of the site looking northeast

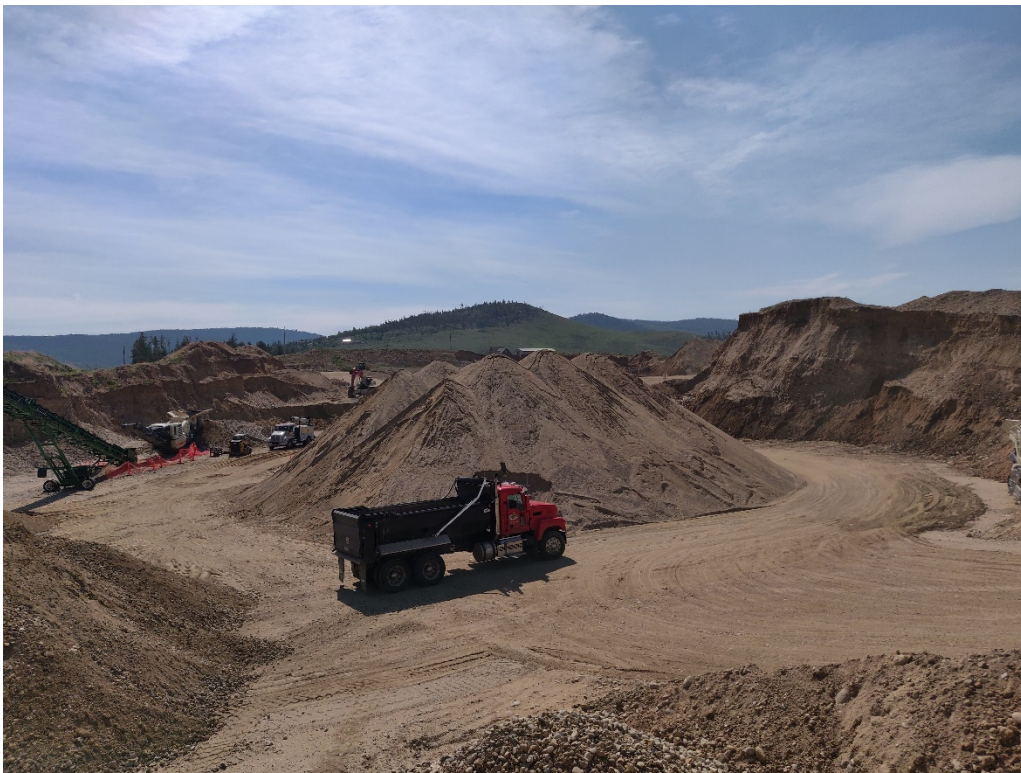
View of the current mining operation from the northwest corner of the site looking east

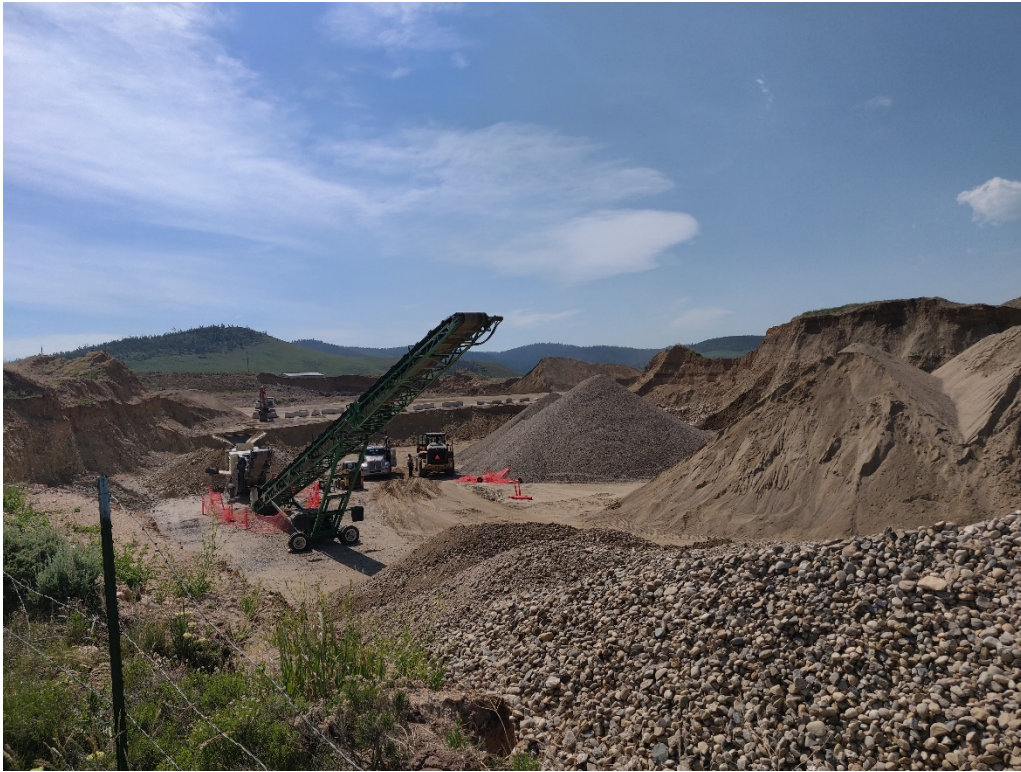
View of the current mining operation from the northwest corner of the site looking southeast

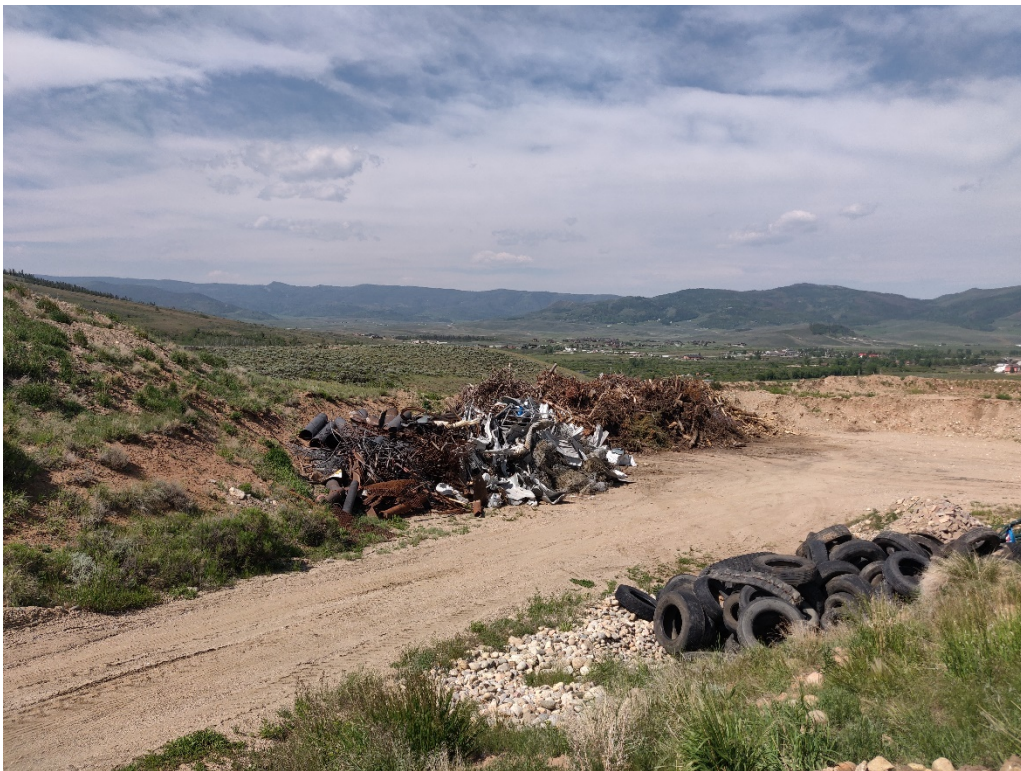
The old mining disturbance area contained scrap metal, trees and old tires. The Operator stated they were aware the material would need to be removed from the site and could not be used as backfill materials.

View of the tires, scrap metal and trees in the old mine pit

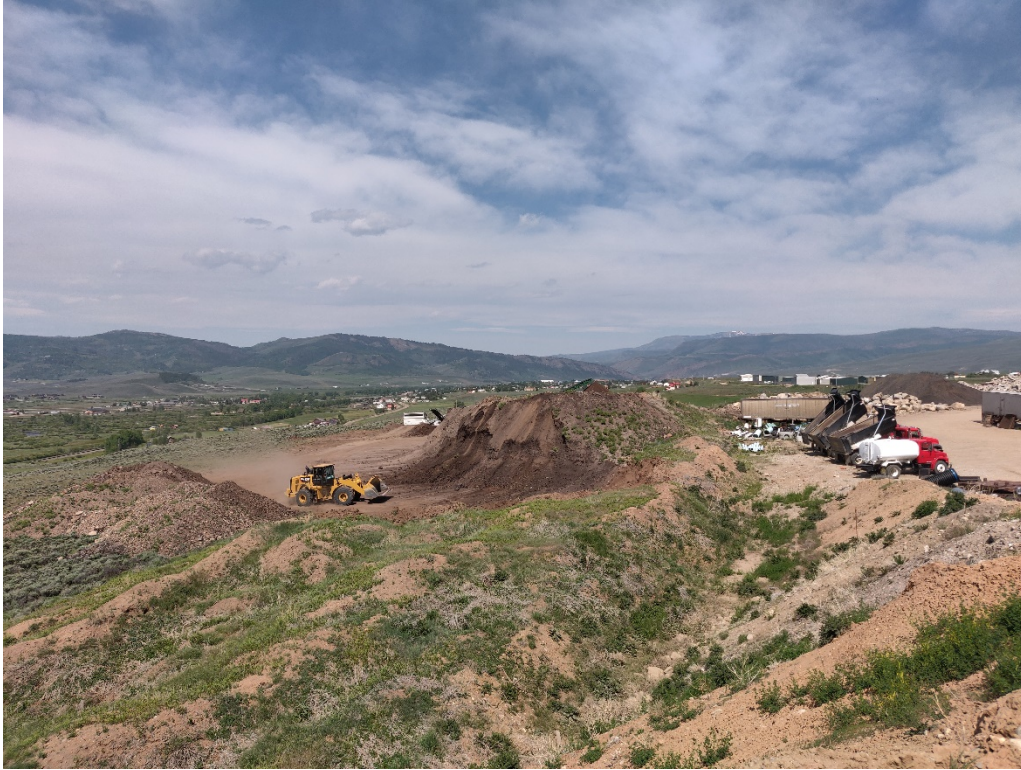
View of the topsoil screening operation

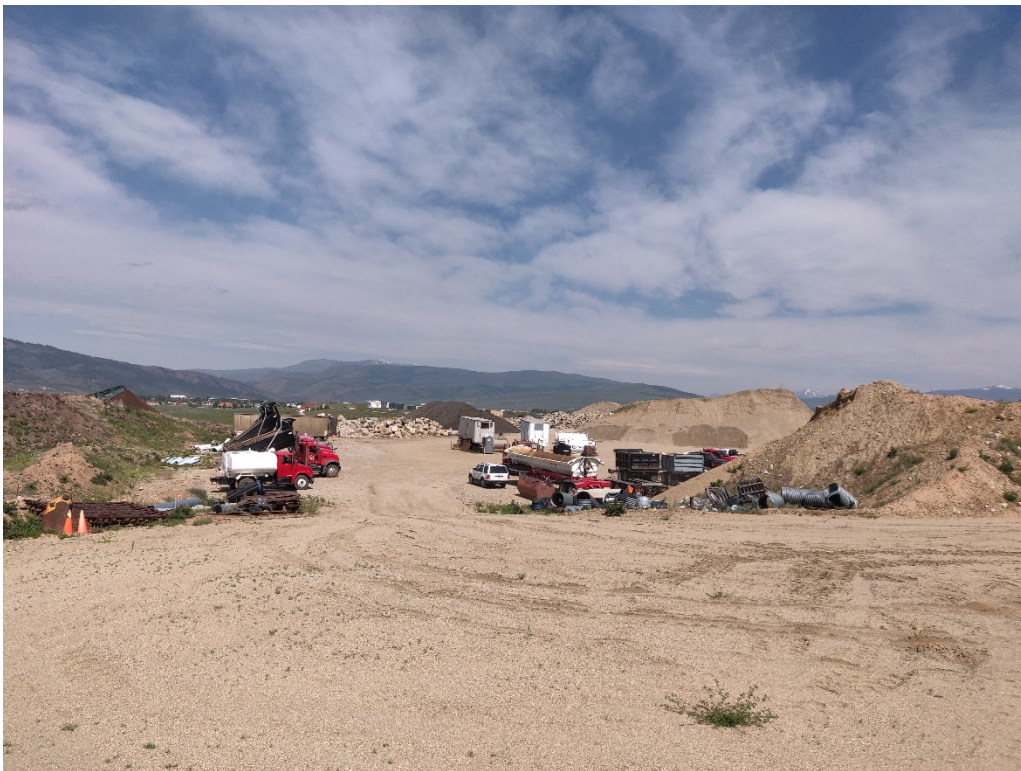
View of the site from the overburden stockpile in the southeast corner of the site looking northwest

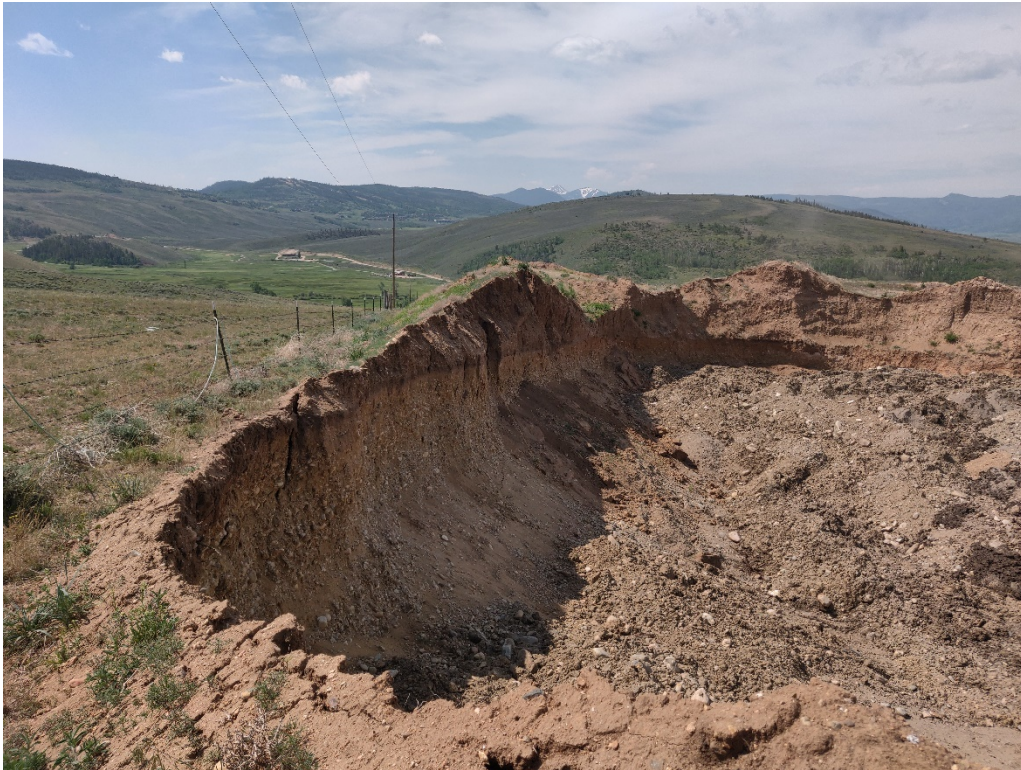
PROBLEM: The approved Mine Plan requires the Operator to maintain a 25 foot offset from the property line and mine the perimeter at the final 3H:1V slope. The northeastern highwall previously repaired by a former Operator has eroded to within 2 feet of the permit boundary and exceeds the approved perimeter mined slope of 3H:1V.

As cited as a problem, the Division will required the Operator to backfill the highwall in the northeast corner of the site to reestablish the required 25 foot offset from the eastern boundary and the required 3H:1V perimeter slope. The slope was backfilled in 2016 by a previous Operator (Willits) to comply with a problem cited by the Division in 2015. The current Operator stated the backfilled highwall eroded over the past winter. Backfill material was stockpiled on the pit floor below the highwall. The Operator stated appropriate equipment would be mobilized soon to backfill the highwall. The Division recommends the highwall is backfilled with moisture conditioned material and compactive effort to prevent the highwall from eroding again.

View of the eroded highwall in the northeast corner of the site looking south

CORRECTIVE ACTIONS: The Division will require the Operator to backfill the highwall to establish the required 25 foot offset from the eastern boundary and the required 3H:1V slope and provide evidence within 30 days of the mailing date of this report.

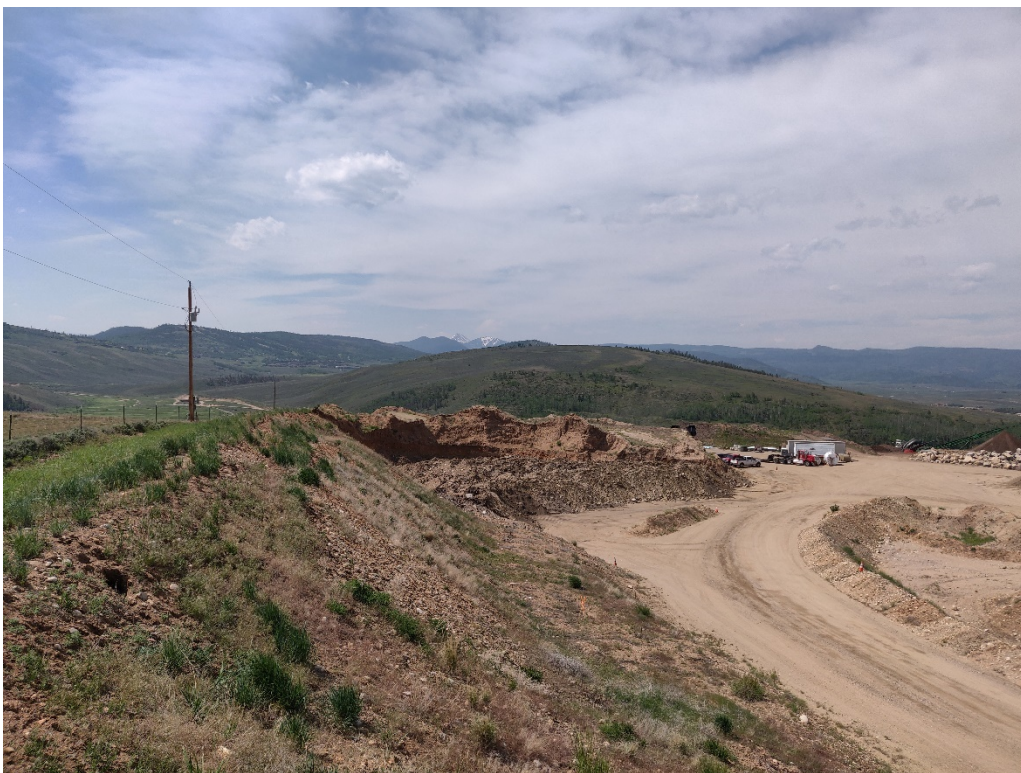
View of the site from the northeast corner looking south

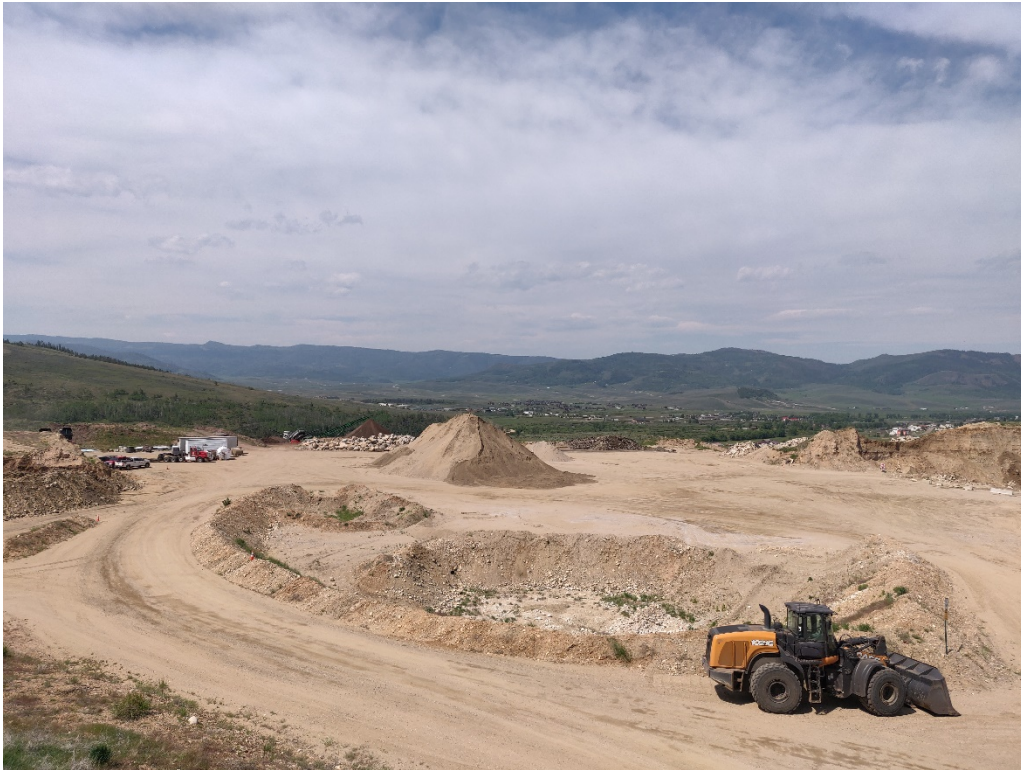
View of the site from the northeast corner looking southwest

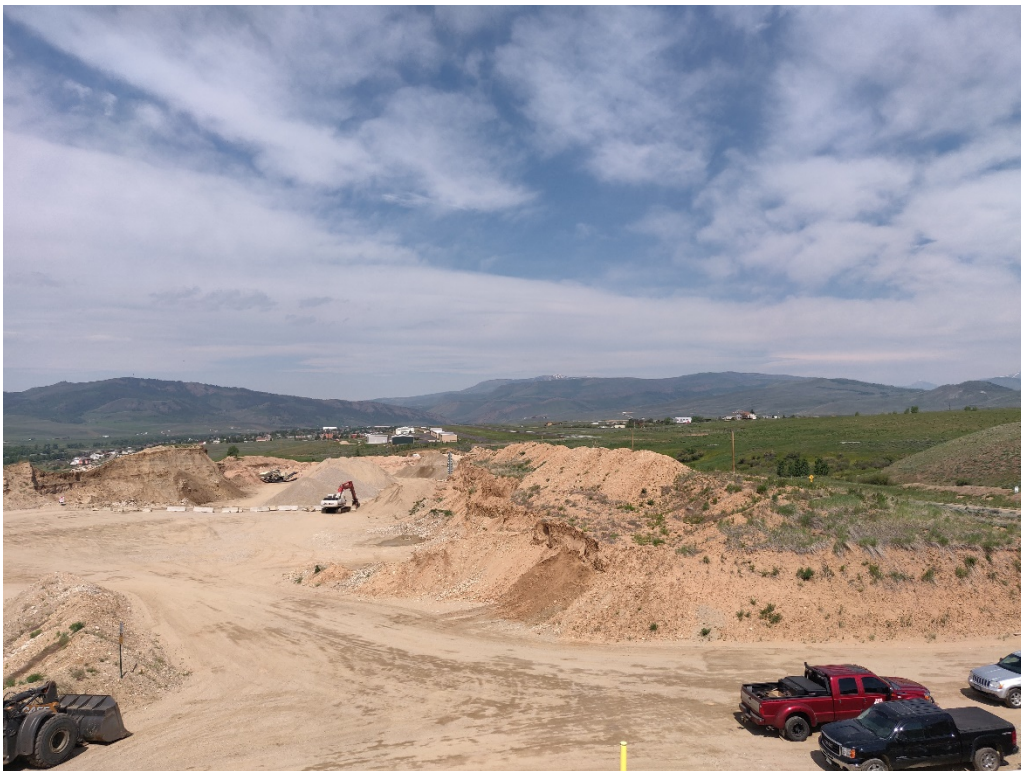
View of the site from the northeast corner looking west
