MINERALS PROGRAM INSPECTION REPORT
PHONE: (303) 866-3567

MINE NAME: Revenue Mine	MINE/PROSPECTING ID#: M-2012-032	MINERAL: Lead, silver and gold	COUNTY: Ouray
INSPECTION TYPE: Multi Person Inspection	INSPECTOR(S): Lucas West	INSP. DATE: June 23, 2020	INSP. TIME: 11:28
OPERATOR: Ouray Silver Mines Inc.	OPERATOR REPRESENTATIVE: Brian Briggs, Kyle Erdmann	TYPE OF OPERATION: 112d-1 - Designated Mining Operation	
REASON FOR INSPECTION: Normal I&E Program	BOND CALCULATION TYPE: None	BOND AMOUNT: \$476,269.41	
DATE OF COMPLAINT: NA	POST INSP. CONTACTS: None	JOINT INSP. AGENCY: None	
WEATHER: Clear	INSPECTOR'S SIGNATURE:

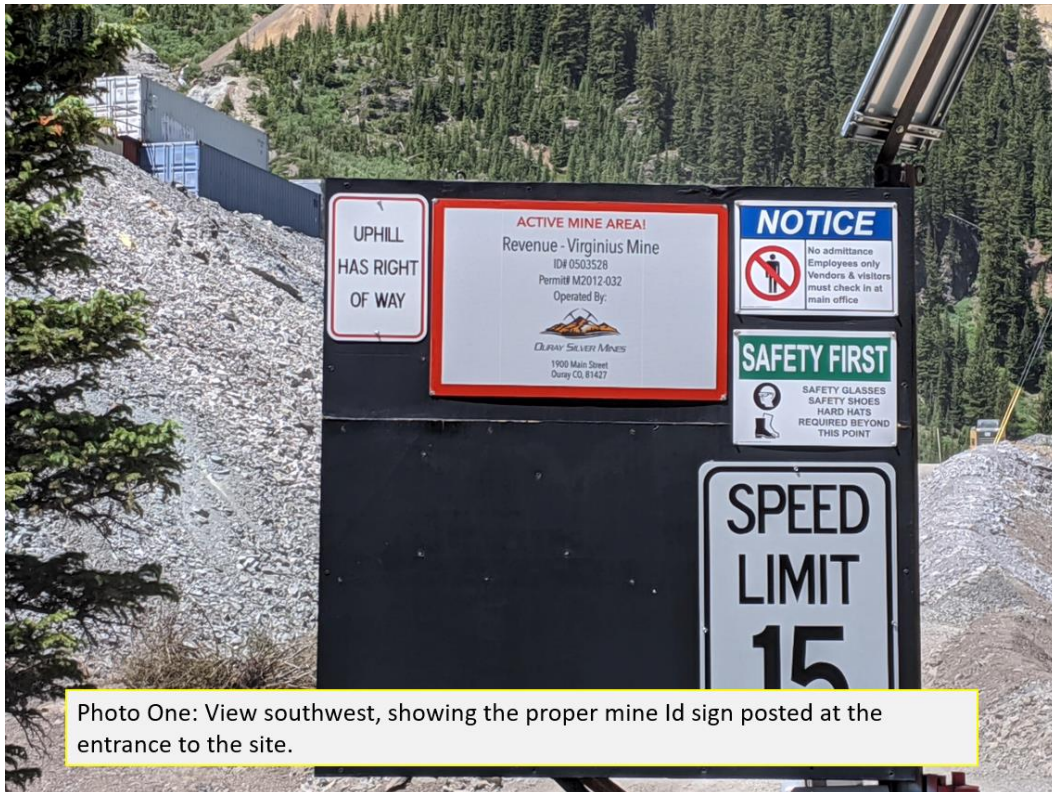
Proper mine identification signage was observed at the entrance to the mine site and can be seen in Photo One. Permit boundary markers in the form of tall white PVC posts were observed around the perimeter of the permitted area. The site was active with various construction and site maintenance activities during the inspection. No mining or milling was taking place at the time of the inspection. Current site activities include cleanup of debris and scrap from around the surface facilities. As well as the installation of the water line to convey water from Pond #2 to Pond #3. A bench was being excavated to install a HDPE pipeline, adjacent to the wetlands area near the center of the permit area. Straw wattles have been placed at the boundary to the wetlands and no fugitive rocks or materials were observed in the wetland area. Photos Two and Three show the work being conducted in this area. The underground facilities were not inspected during this inspection.

Photo One: View southwest, showing the proper mine Id sign posted at the entrance to the site.

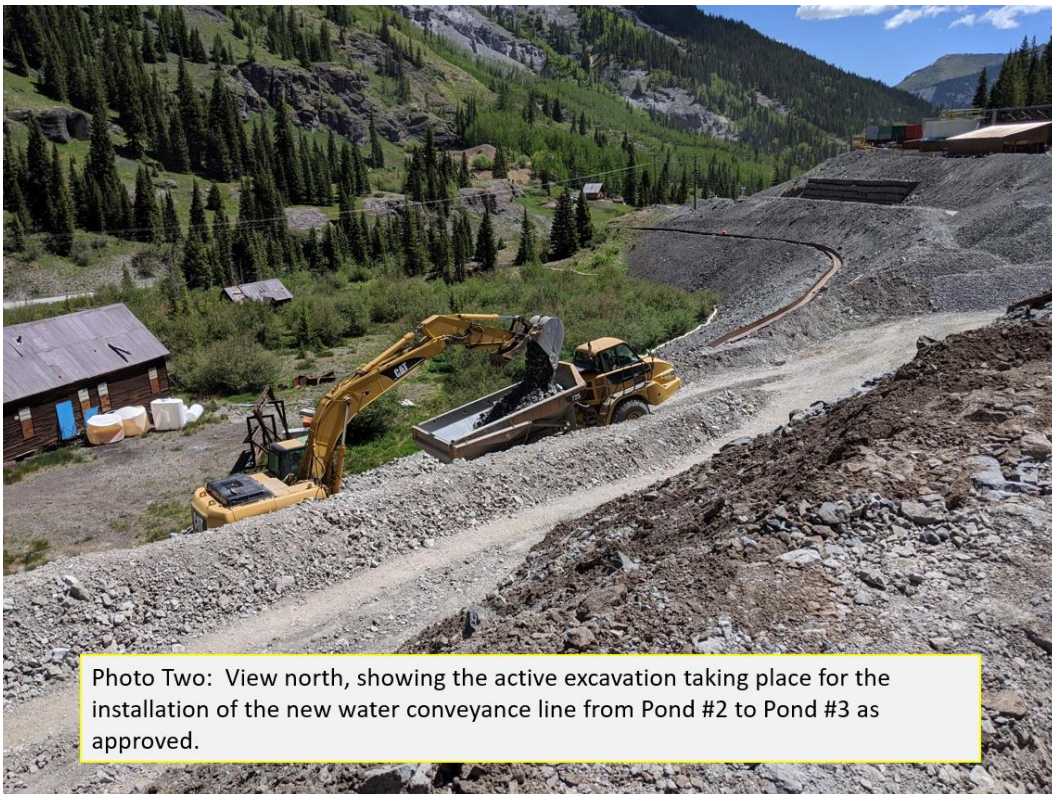
Photo Two: View north, showing the active excavation taking place for the installation of the new water conveyance line from Pond #2 to Pond #3 as approved.

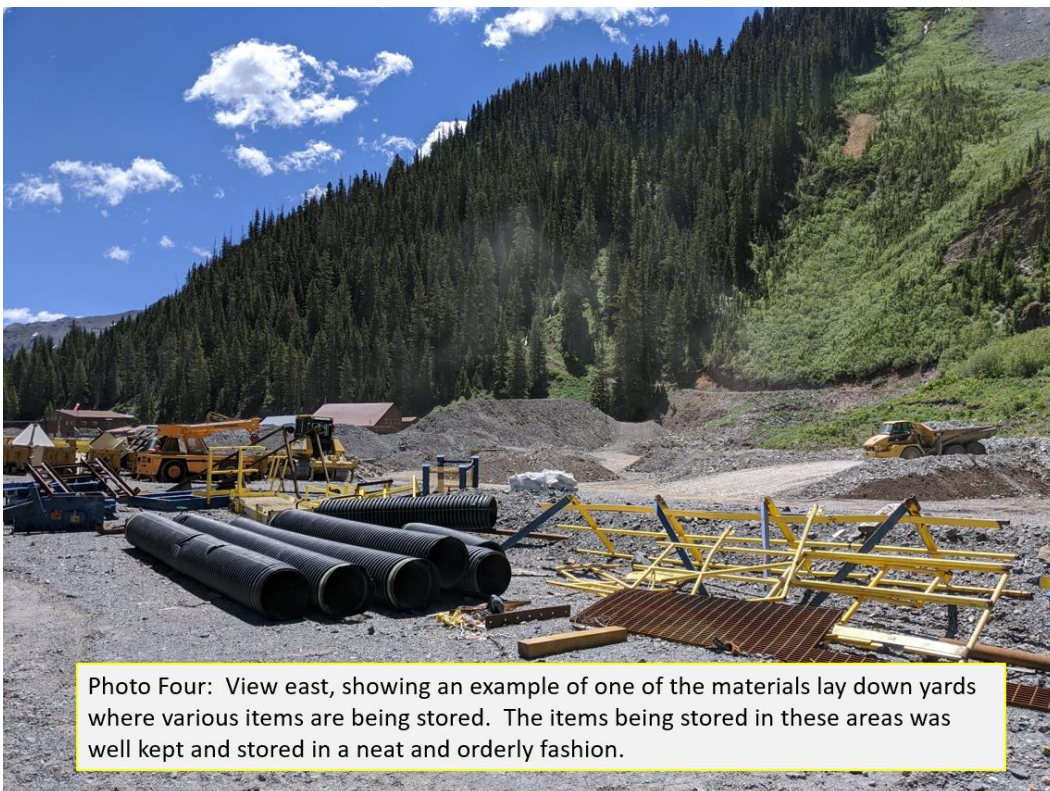
The main portal and its associated structures are in good condition. All storage areas were clean and well kept, all items being stored on site were done so in a neat and orderly fashion. An example of one of the storage facilities can be seen in Photo Four. All fuel and potentially hazardous materials were stored within proper secondary containment structures and were in good condition. Also, under TR-09 the Operator is approved to manufacture road base for sale. Several small stockpiles of the road base material were observed on site and appear to be stable. Crushing operations were actively taking place during the inspection.

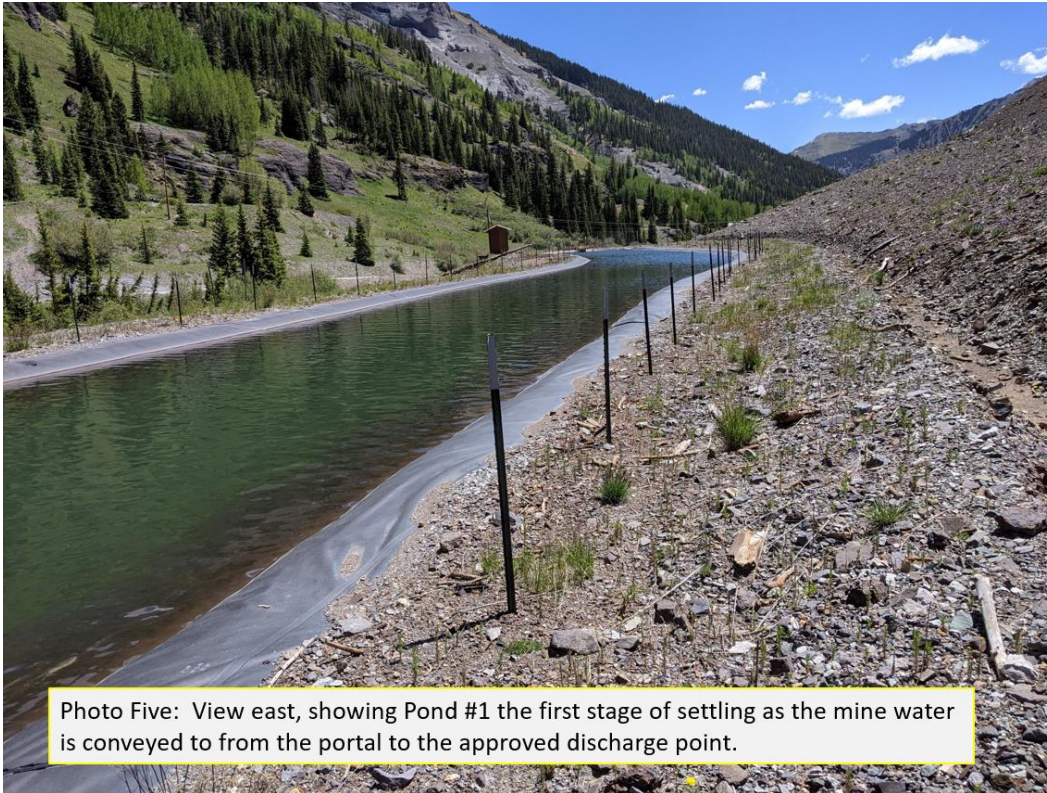
The mine water conveyance and settling system was observed and appears to be functioning as designed and approved. Pond #1 can be seen in Photo Five and Pond #2 in Photo Six. Some of the monitoring well locations were observed and all covers and caps were secured at the time of the inspection. Other surface facilities that were inspected included the fuel and waste storage building, Tailings Thickener Tank, various propane storage sheds and the Materials Storage Connex. The fuel and waste storage building contained various oils, lubricants and fuels all stored in proper secondary containment and in good condition. Photo Seven shows the Waste Storage Building. Also inspected was the materials storage area adjacent to the storage connex. All items stored in that area were in good condition and stored in a neat and orderly fashion. The area can be seen in Photo Eight. Discussions with the Operator indicate that the Materials Storage Connex may be replaced with a more suitable storage structure. Any significant changes to this or other surface facilities would need to be addressed through the Division's Technical Revision or Amendment Process.

Photo Five: View east, showing Pond #1 the first stage of settling as the mine water is conveyed to from the portal to the approved discharge point.

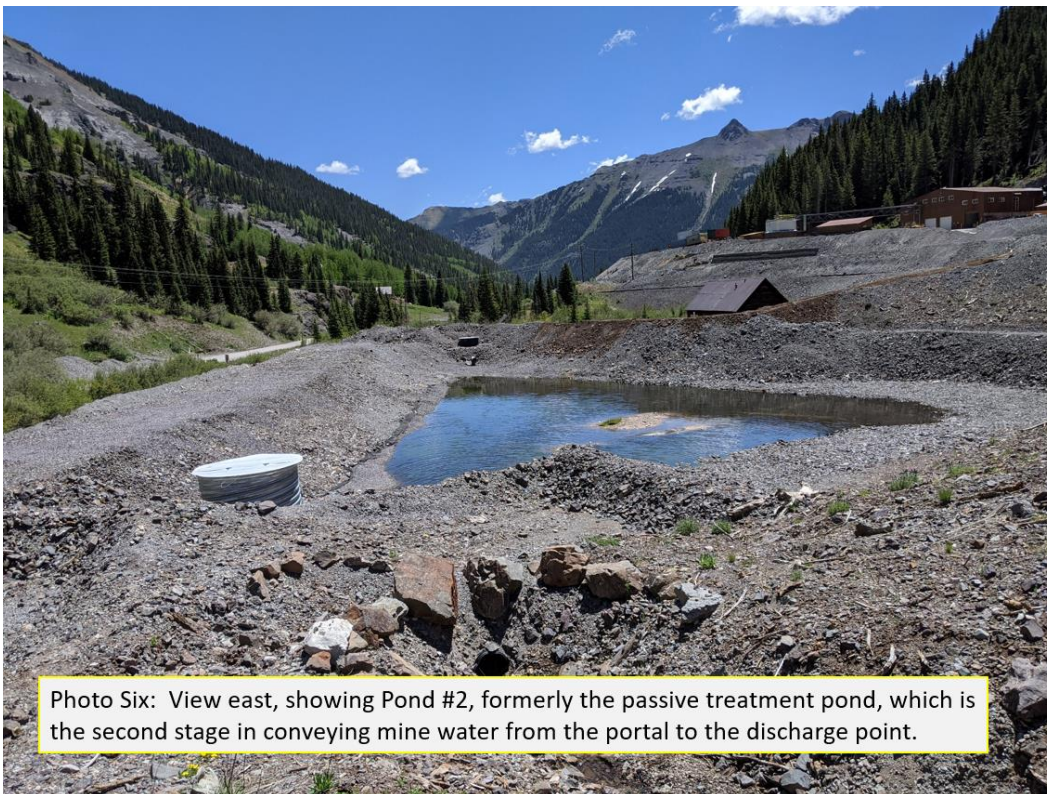
Photo Six: View east, showing Pond #2, formerly the passive treatment pond, which is the second stage in conveying mine water from the portal to the discharge point.

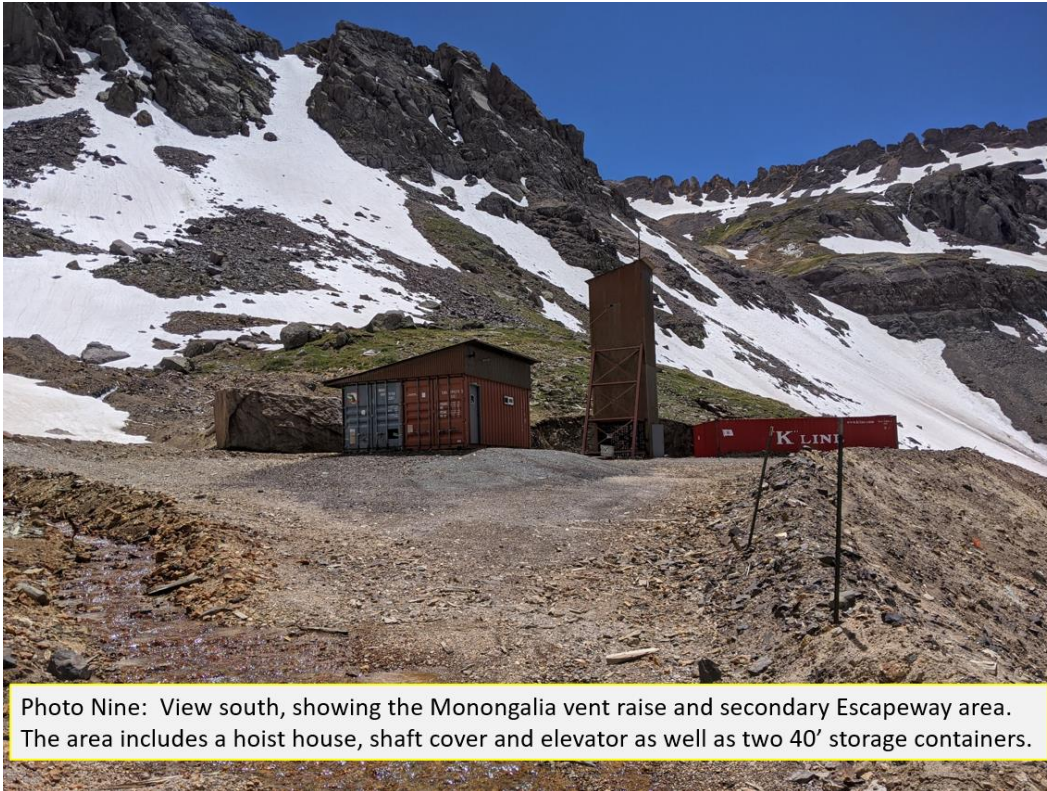
two 40 foot shipping containers used for storage. The area is access by a private road behind a locked gate. There was no evidence of attempted unauthorized entry at the time of the inspection. All structures contained in the area are in good condition and secured. Photos Nine and Ten show the Escapeway facilities. On site discussions with the Operator indicate that prior to beginning production in the underground workings, the surface facilities associated with the Secondary Escapeway will need to be modified. Please note that any changes to the current configuration of the surface facilities and modifications to the reclamation of those facilities will need to be addressed through the Division's Technical Revision or Amendment Process. The overall footprint of the Monongahela Vent Raise and Secondary Escapeway site was in good condition and free from trash and debris.

Photo Nine: View south, showing the Monongalia vent raise and secondary Escapeway area. The area includes a hoist house, shaft cover and elevator as well as two 40' storage containers.

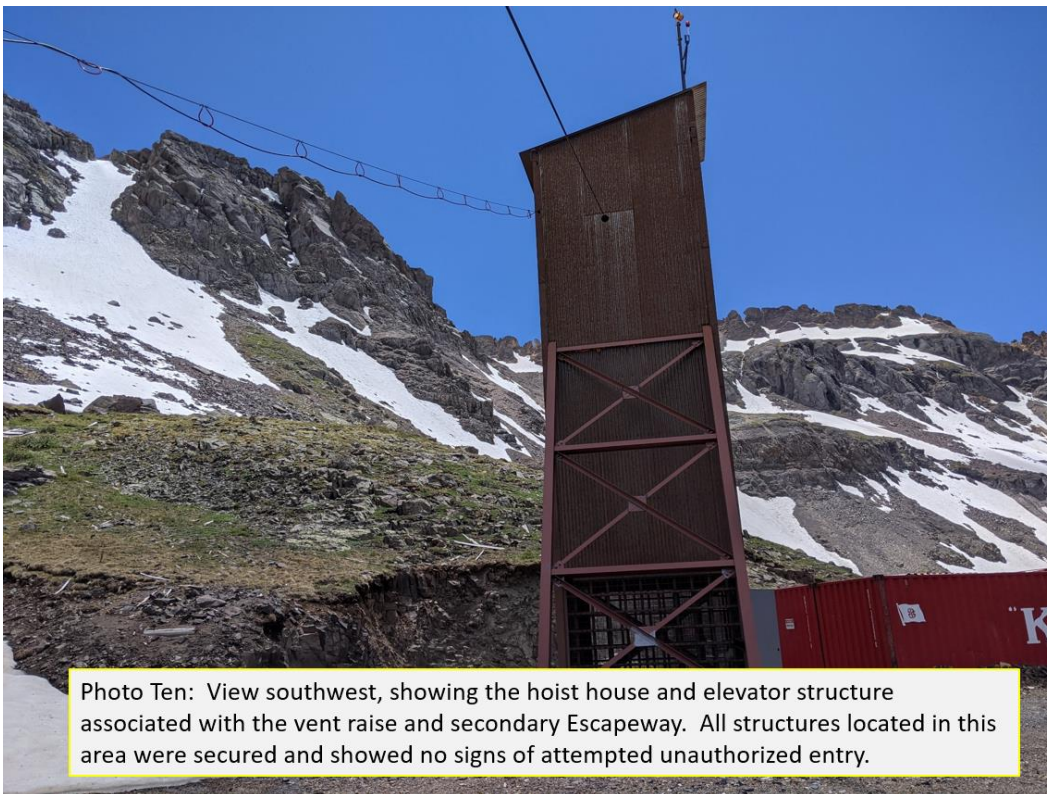
Photo Ten: View southwest, showing the hoist house and elevator structure associated with the vent raise and secondary Escapeway. All structures located in this area were secured and showed no signs of attempted unauthorized entry.
