MINERALS PROGRAM INSPECTION REPORT

MINE NAME: Rother Pit #2	MINE/PROSPECTING ID#: M-2019-036	MINERAL: Sand and gravel	COUNTY: Cheyenne
INSPECTION TYPE: Monitoring	INSPECTOR(S): Timothy Cazier	INSP. DATE: June 11, 2020	INSP. TIME: 10:20
OPERATOR: Cheyenne County	OPERATOR REPRESENTATIVE: Jim Brown	TYPE OF OPERATION: 110c - Construction Limited Impact	
REASON FOR INSPECTION: Normal I&E Program	BOND CALCULATION TYPE: None	BOND AMOUNT: \$0.00	
DATE OF COMPLAINT: NA	POST INSP. CONTACTS: None	JOINT INSP. AGENCY: None	
WEATHER: Clear	INSPECTOR'S SIGNATURE:

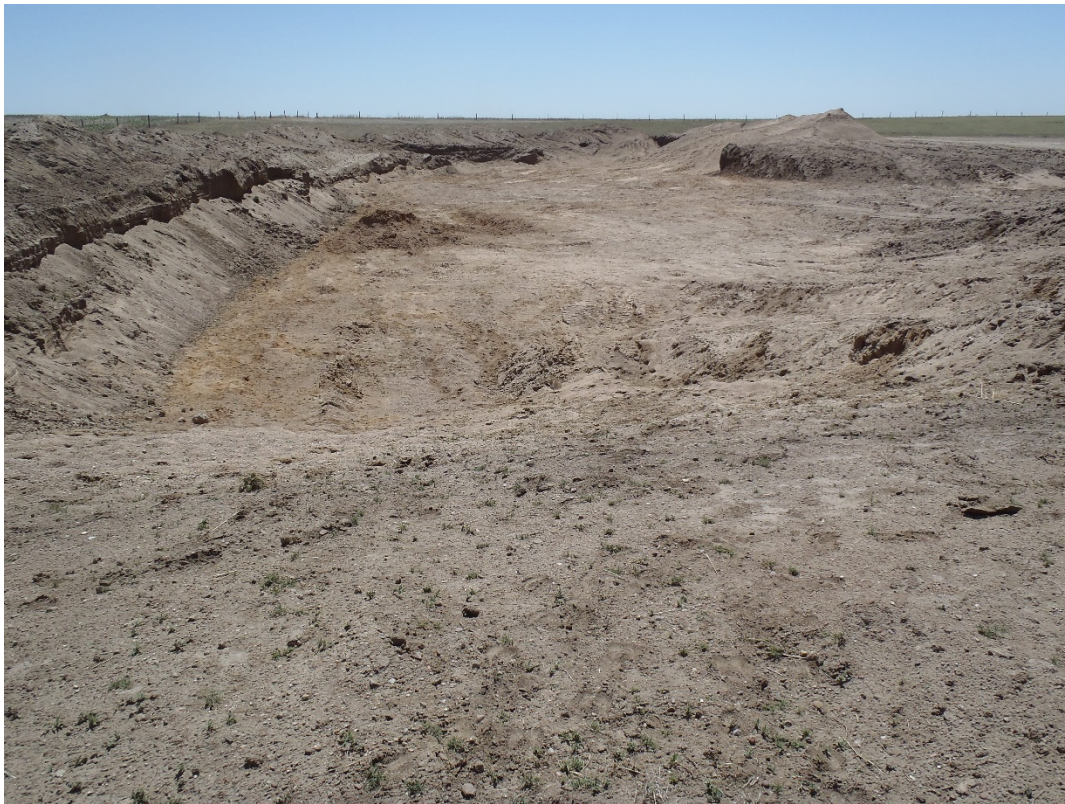
Backfilling and Grading: Sufficient backfill material appeared to be available to push down material from the crest (see **Photo 1**).

Photo 1. Pit (looking SE – topsoil stockpile on left, product stockpile at far side on right).

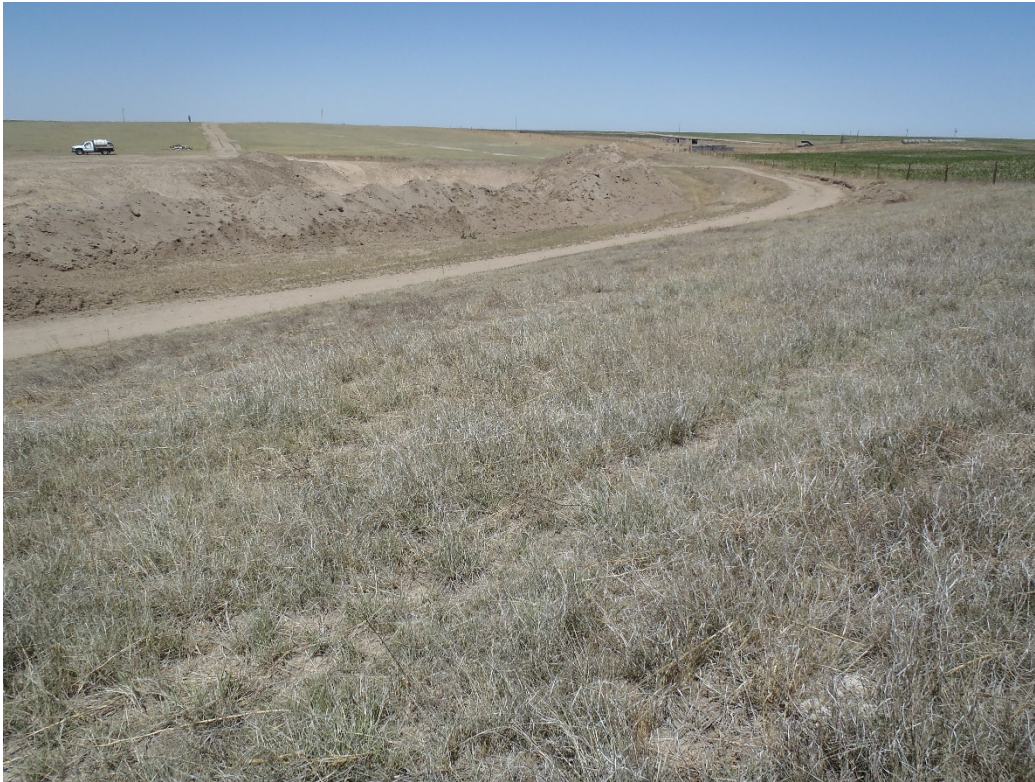
Photo 2. Access road circling pit (east side, looking west).

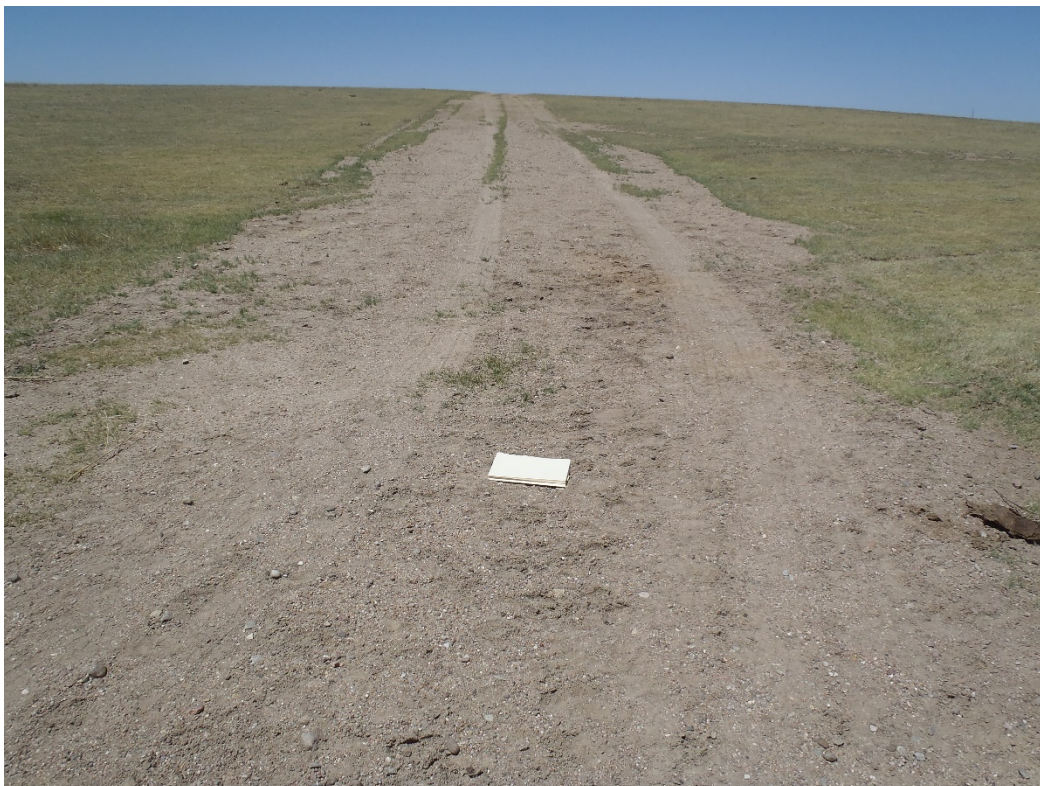
Roads: The roughly 1,200 foot long access road did not appear to be a source of sediment that could be tracked offsite. Road side ditches were clean (see **Photo 3**).

Photo 3. Main haul/access road (looking west from west side of pit).

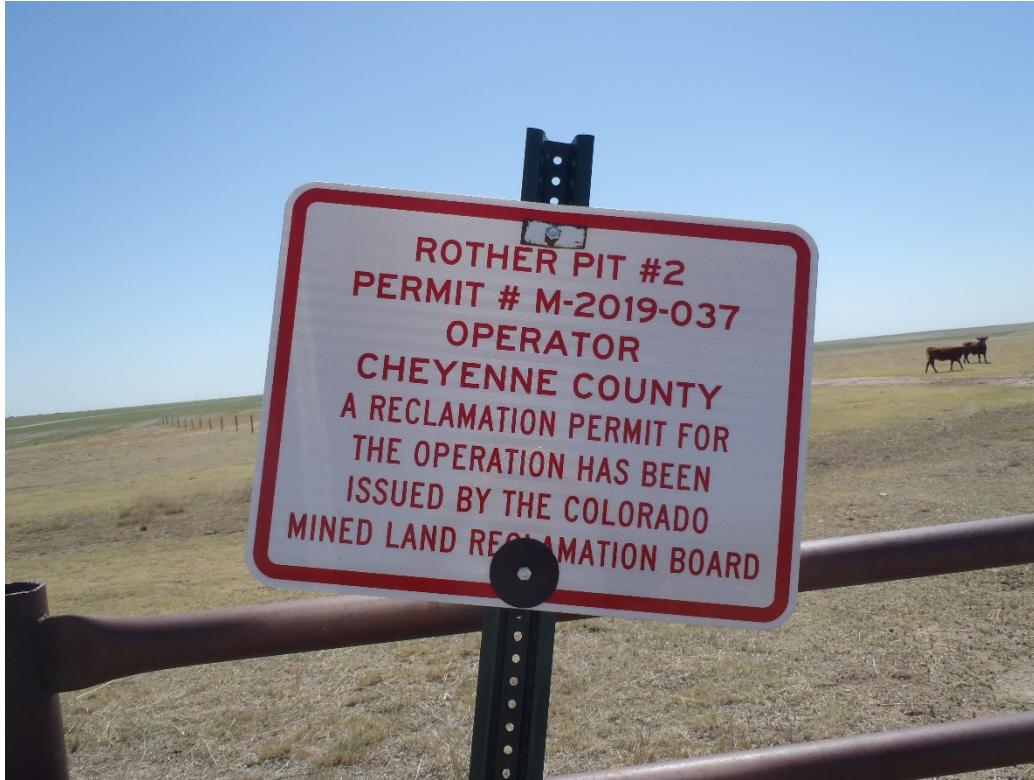
Signs and Markers: The permit sign was properly posted (see **Photo 4**) and boundary markers were observed to delineate the permit boundary (see **Photo 5**).

Photo 4. Permit sign (at entrance off Co Rd 53).

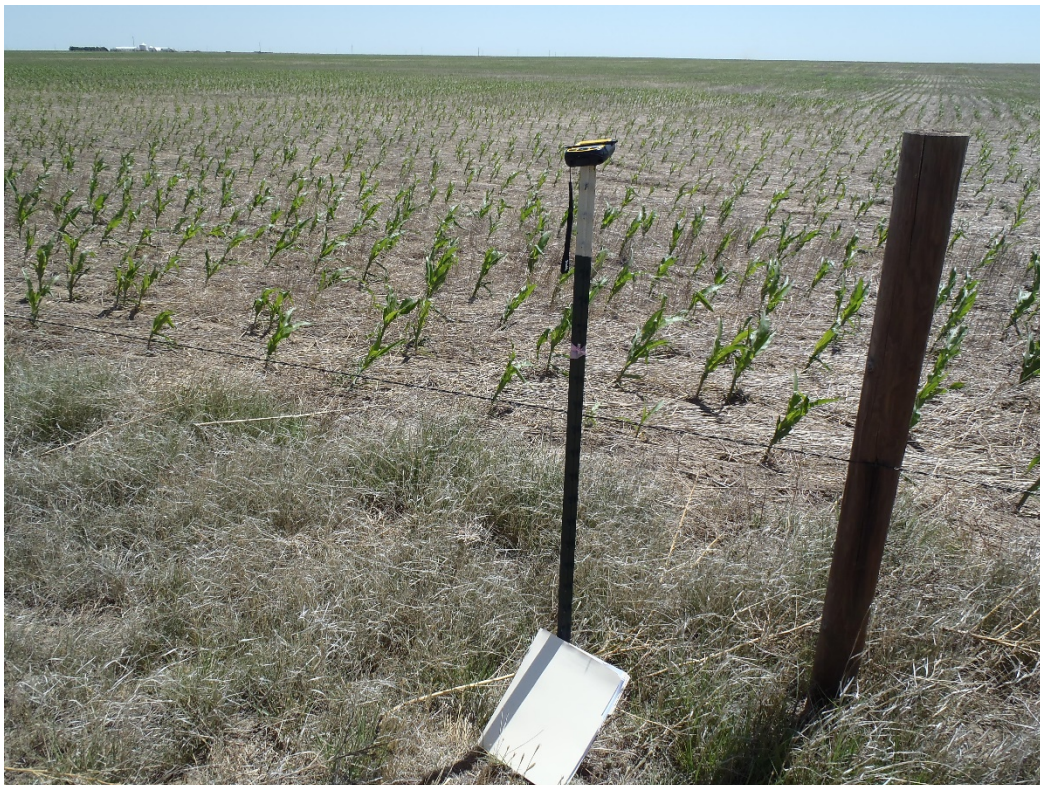
Photo 5. Typical boundary marker (SE corner, looking NE – note GPS unit on T-post).

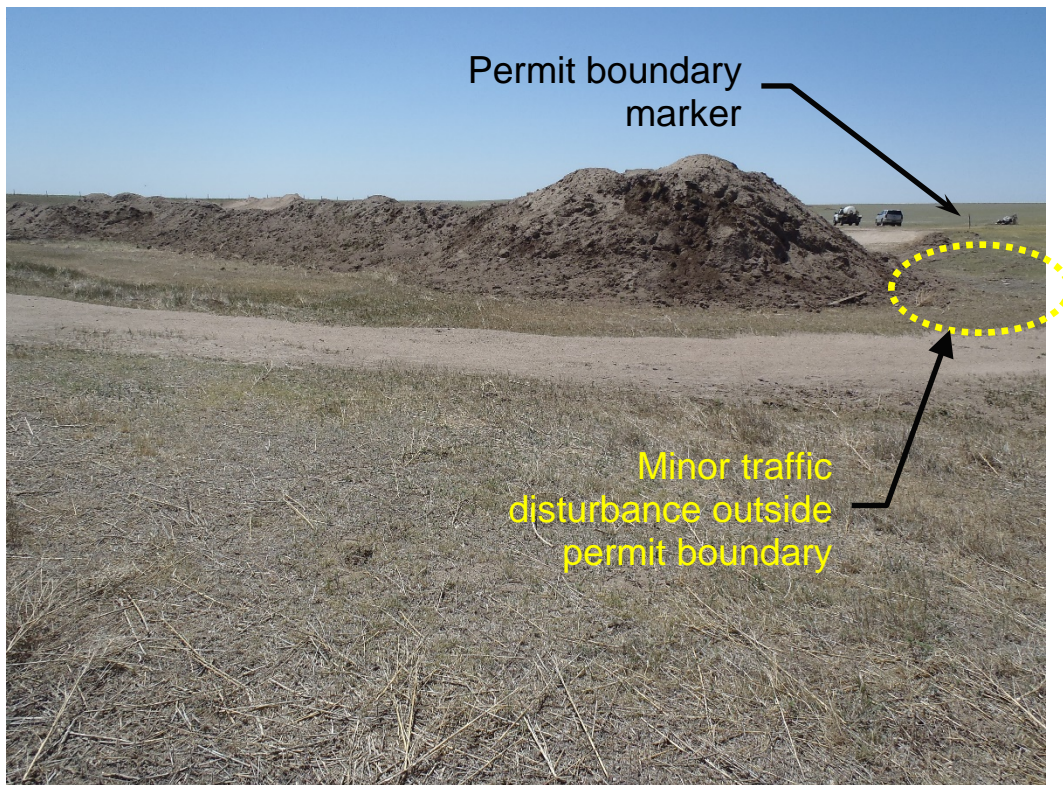
Topsoil: A topsoil stockpile is in the north side of the pit (see **Photo 6**). The slight traffic disturbance outside the permit boundary can also be seen in **Photo 6**.

Photo 6. Topsoil stockpile (looking SW from NW corner).

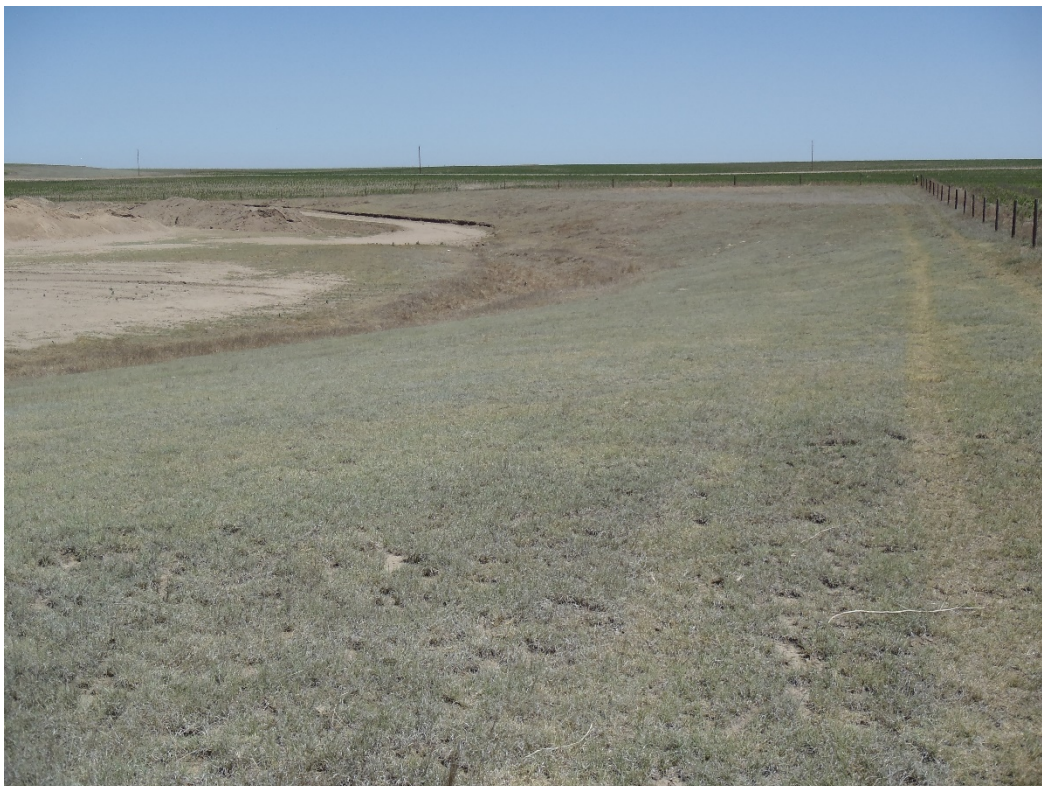
Structures: The only structure observed within 200 feet of the affected area was the barbed wire fence (see **Photo 7**) identified in Exhibit E of the application, on the north and east sides of the site.

Photo 7. Barbed wire fence on east & north sides (looking north).
