MINERALS PROGRAM INSPECTION REPORT
PHONE: (303) 866-3567

MINE NAME: Henderson Mine	MINE/PROSPECTING ID#: M-1977-342	MINERAL: Molybdenum	COUNTY: Clear Creek, Grand
INSPECTION TYPE: Monitoring	INSPECTOR(S): Peter Hays	INSP. DATE: June 17, 2020	INSP. TIME: 09:00
OPERATOR: Climax Molybdenum Company	OPERATOR REPRESENTATIVE: Aaron Hilshorst	TYPE OF OPERATION: 112d-3 - Designated Mining Operation	
REASON FOR INSPECTION: Normal I&E Program	BOND CALCULATION TYPE: None	BOND AMOUNT: \$37,993,785.00	
DATE OF COMPLAINT: NA	POST INSP. CONTACTS: None	JOINT INSP. AGENCY: None	
WEATHER: Clear	INSPECTOR'S SIGNATURE:

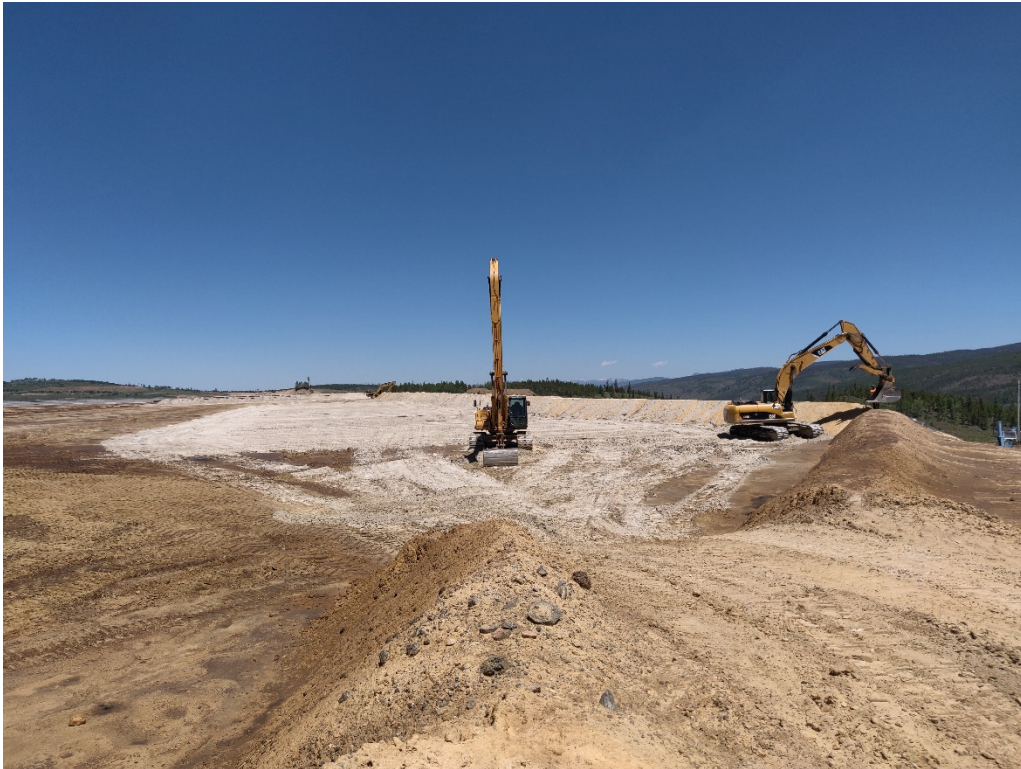
The process of raising the TDF berm was observed during the inspection at the south end of 3 Dam. The berm raise will continue across the crests of 3 Dam and 1 Dam.

View of the 3 Dam berm raise looking north

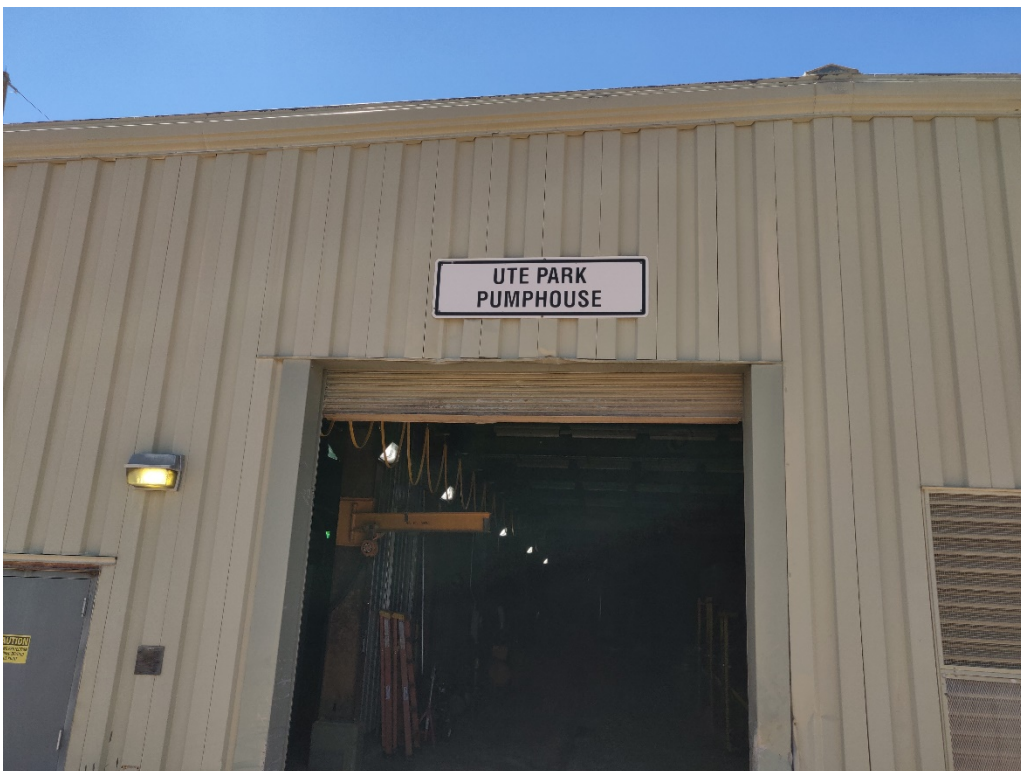
The Ute Park Pumphouse collects seep water and water from the extraction wellfield and returns the water to the tailing storage facility. The extraction well system was improved under technical revisions TR-23, TR-25 and TR-28. The extraction wells, EPF 1.6, were not observed during this inspection.

View of Ute Park Pumphouse

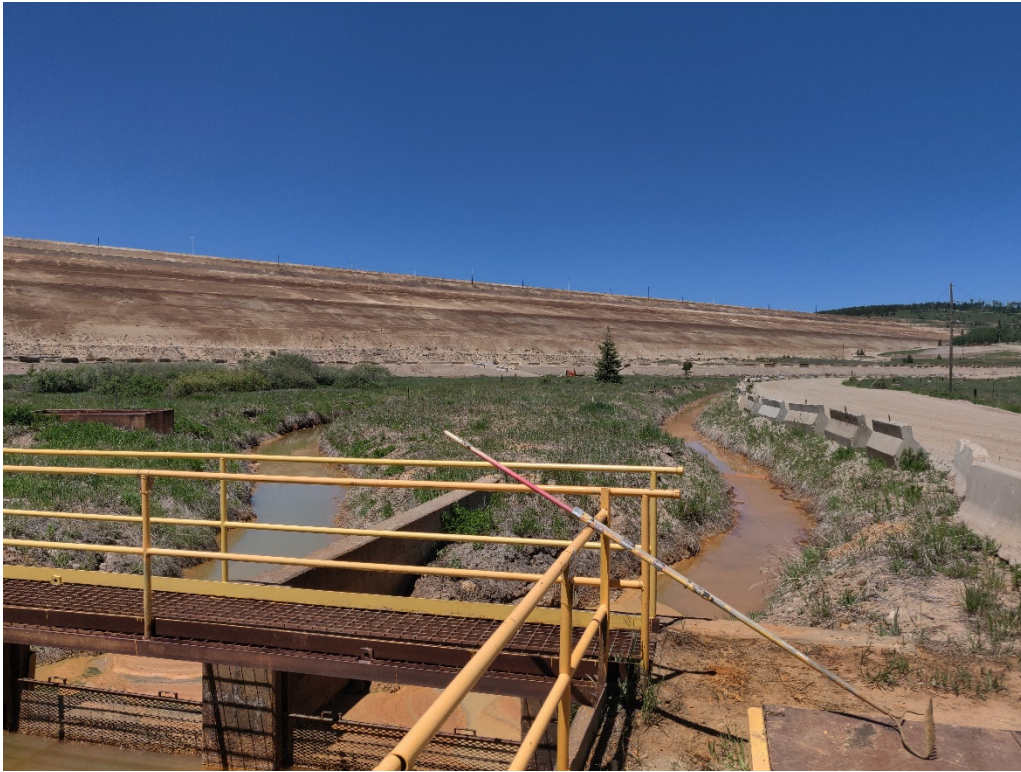
The Seep Water Collection and Return Systems collects water seepage from 1 Dam and 3 Dam to allow the water to be returned to the process water and tailing circuit preventing the potential discharge of the water without treatment. The system is comprised of trenched and piped collection and conveyance structures including foundation drains, horizontal drains, pipelines and ditches which direct seep water to the Ute Park Pump Station. The seep water collection system was recently improved to increase storage capacity under TR-30.

View of the seep water collection trenches from the Ute Park Pump house looking northwest

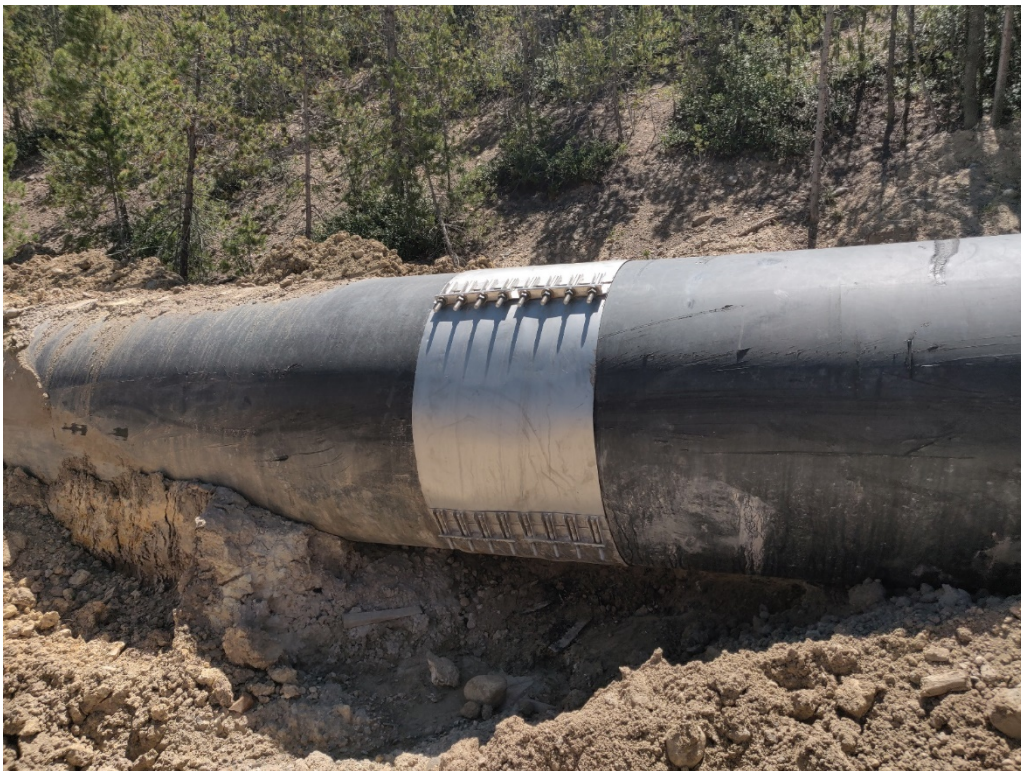
On Friday May 8, 2020, the Operator notified the Division by voicemail of a tailings leak from the TDL on May 7, 2020. The Operator reported a small amount of tailings leaked out of the TDL onto the TSF access road below County Road 3 and from the last drop tower above CR 3. The Operator estimated 55 gallons leaked from the TDL and 150 to 200 gallons from the drop tower. The repaired TDL was observed during the inspection. The repair consisted of a metal band clam being installed around the leak area.

View of a repair section of TDL with a band clamp

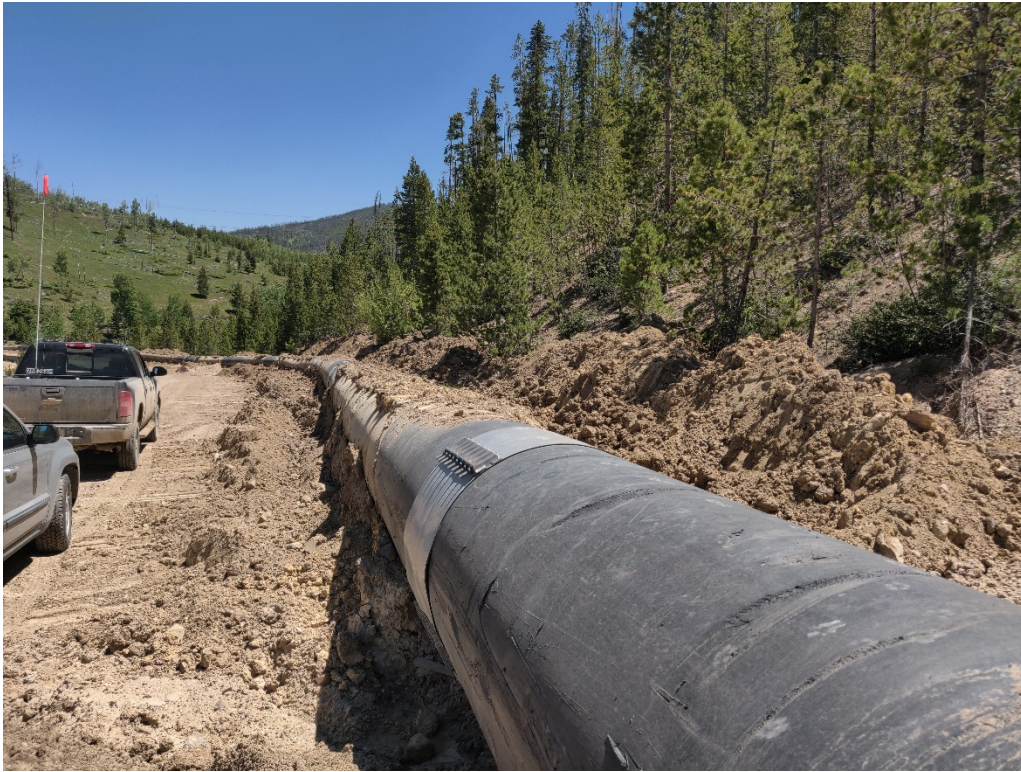
The HDPE section of the TDS was scheduled to be rotated the day after this inspection. The Operator had uncovered the pipeline in preparation for rotating the pipe. The HDPE section of the TDL is scheduled to be replaced in 2 years.

View of the TDL prepared to be rotated

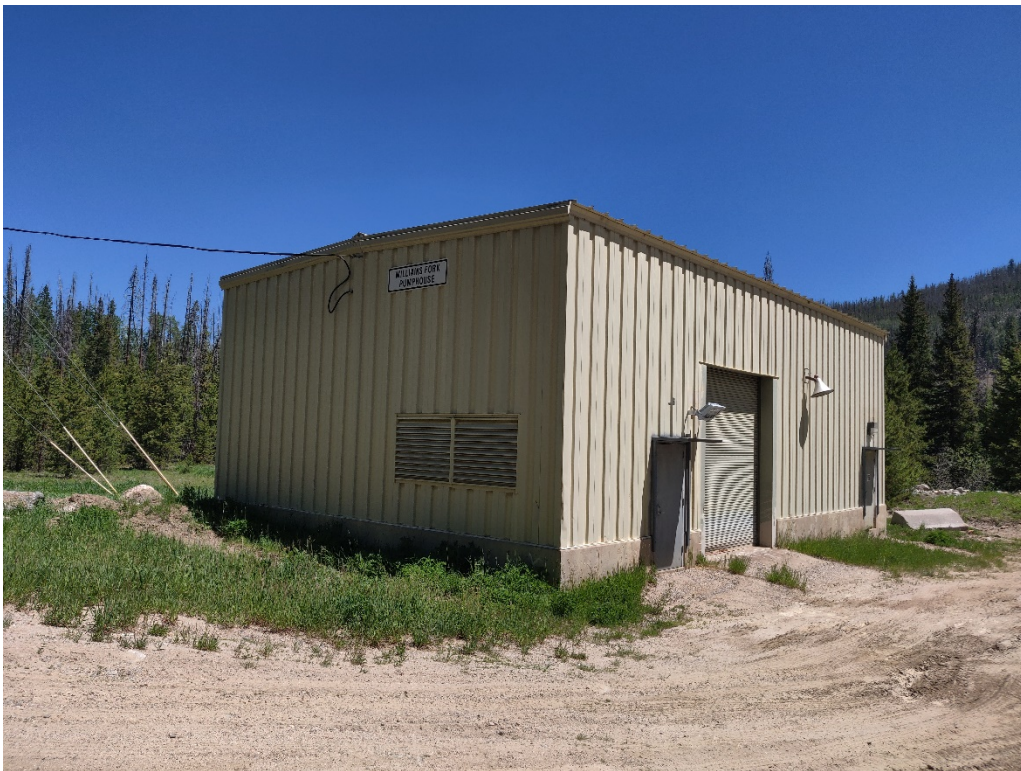
The William Fork Pumphouse pumps water from the Williams Fork River to the 2 potable water storage tanks or to the East Branch Reservoir for make-up water as needed.

View of the Williams Fork Pumphouse

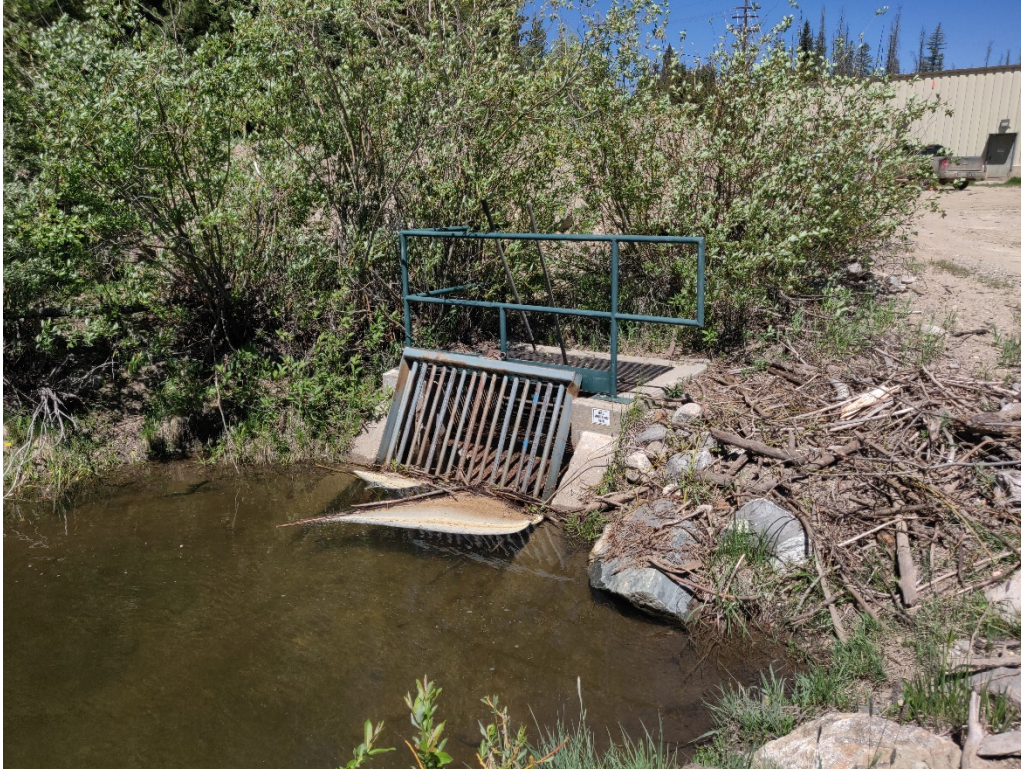
View of surface water sampling point WFR-20 below the William Fork Pumphouse

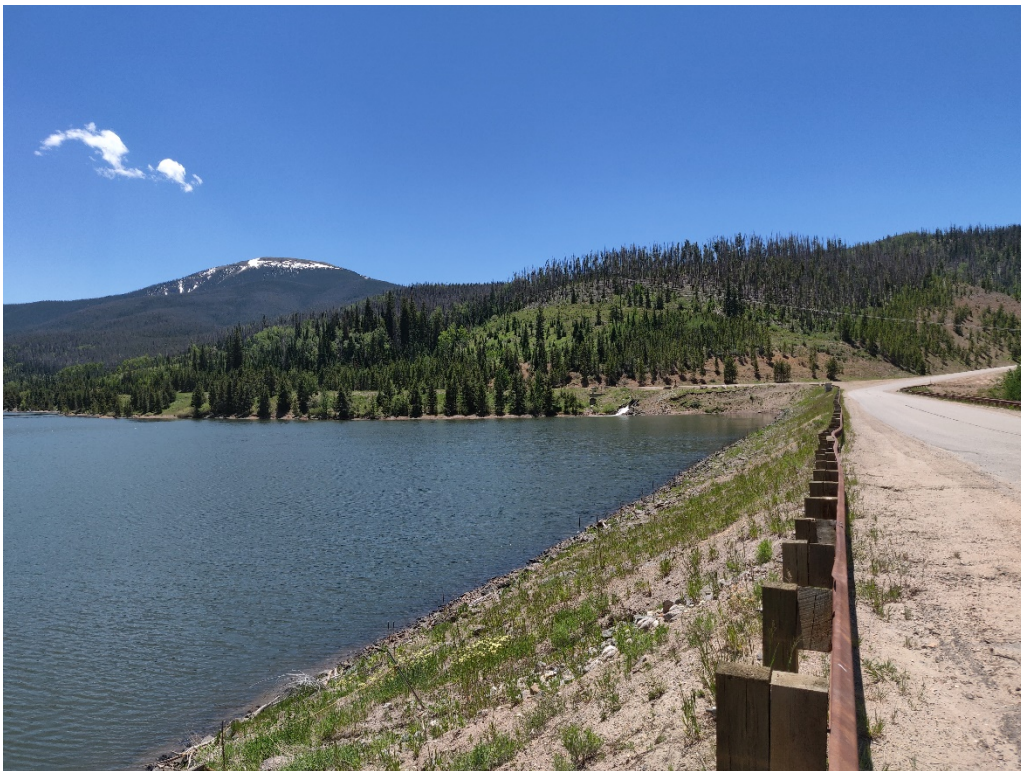
The East Branch Reservoir System includes the reservoir, dam, pump station and process water line. The reservoir is the primary storage area for mill process water. Recycled process water is delivered from the barge pump to the reservoir. An outlet pipe from the reservoir connects to the pump station. The process water is pumped from the East Branch Pumphouse to the process water storage tanks for use in the Mill.

View of the East Branch Reservoir from the east end of the dam looking southwest

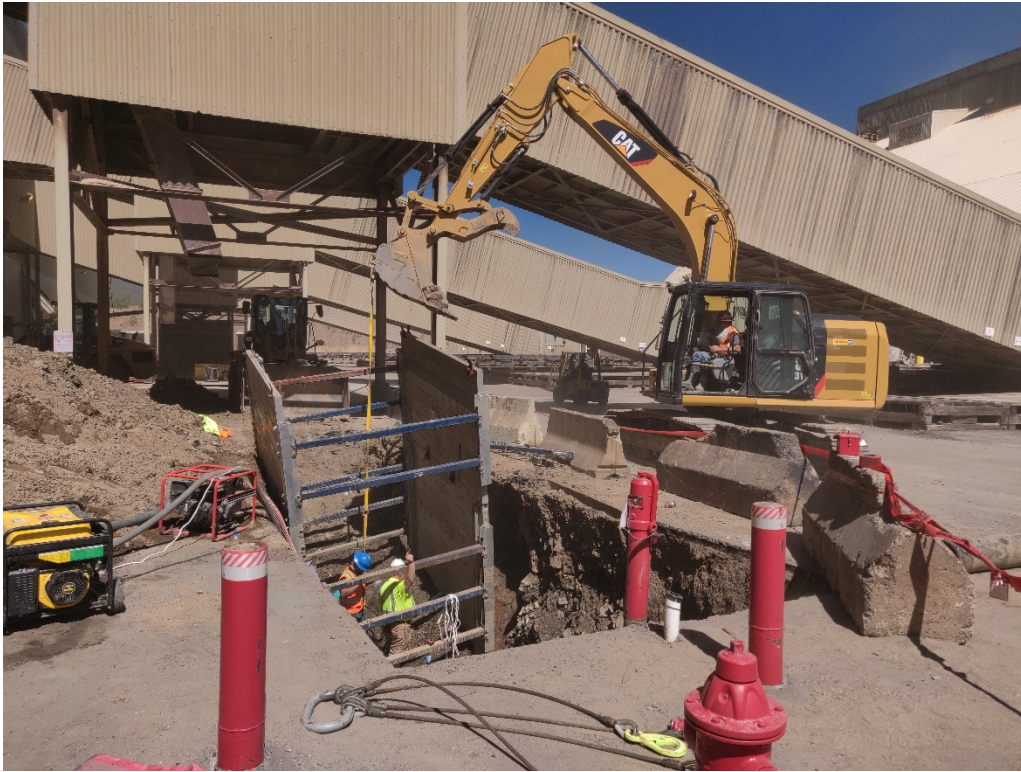
On November 5, 2019, the Division received written follow-up notice of a release of process water from the fire water line from the Mill Process Water Storage Tanks to the sites fire water distribution and suppression systems. The repair of the water line near hydrant 7 was observed during the inspection. During the repair the Operator discovered another possible leak near fire hydrant 6 located west of the first repair area. The second area is planned to be excavated to investigate and repair the source of the leak.

View of the fire line repair near hydrant 7

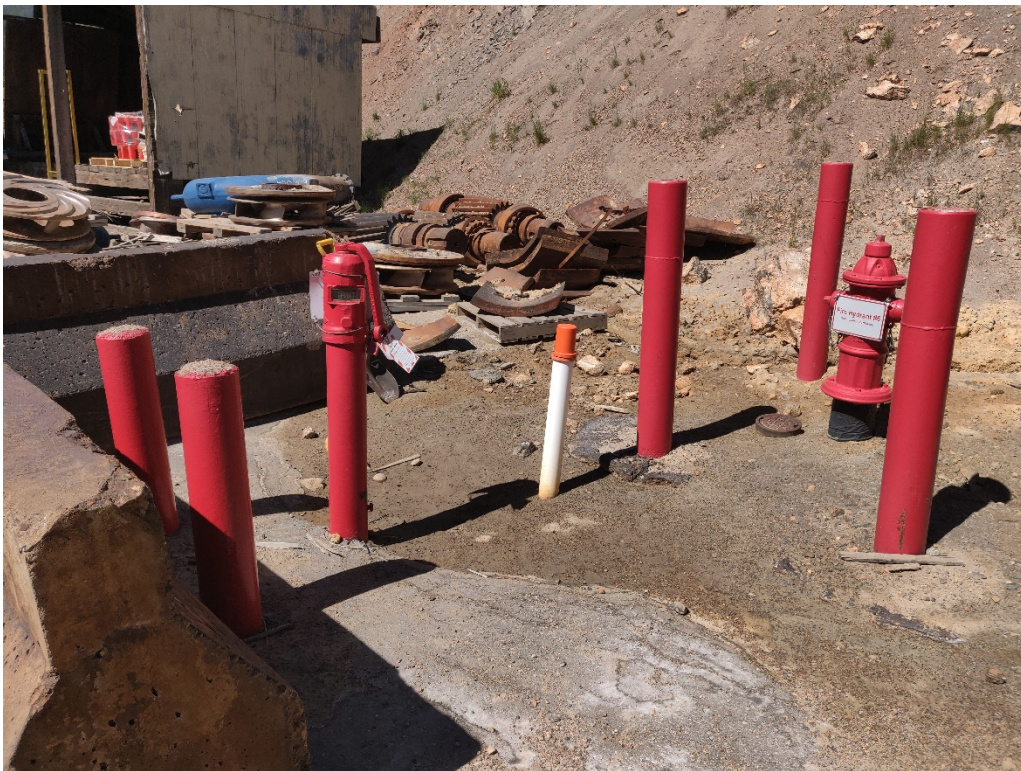
View of possible leak near hydrant 6

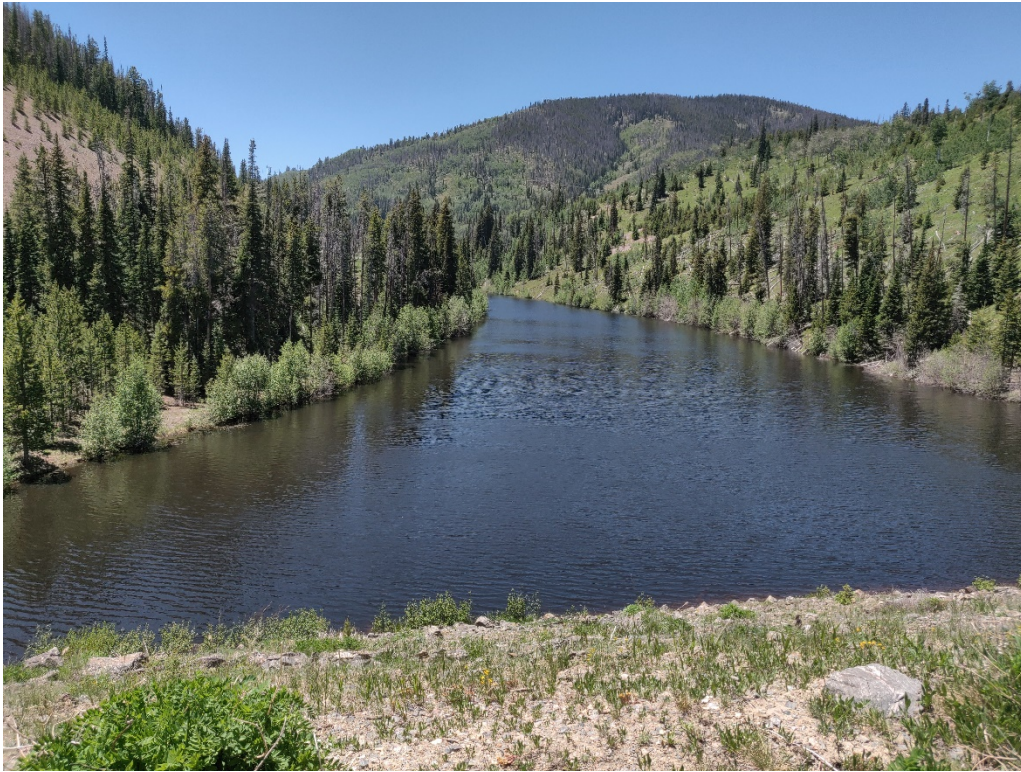
The Ute Reservoir contains fresh (potable) water for the mill facility. The reservoir is the primary source of fresh water at the Mill facility. Two pipelines deliver water from the reservoir to the East Branch Pumphouse.

View of Ute Creek Reservoir

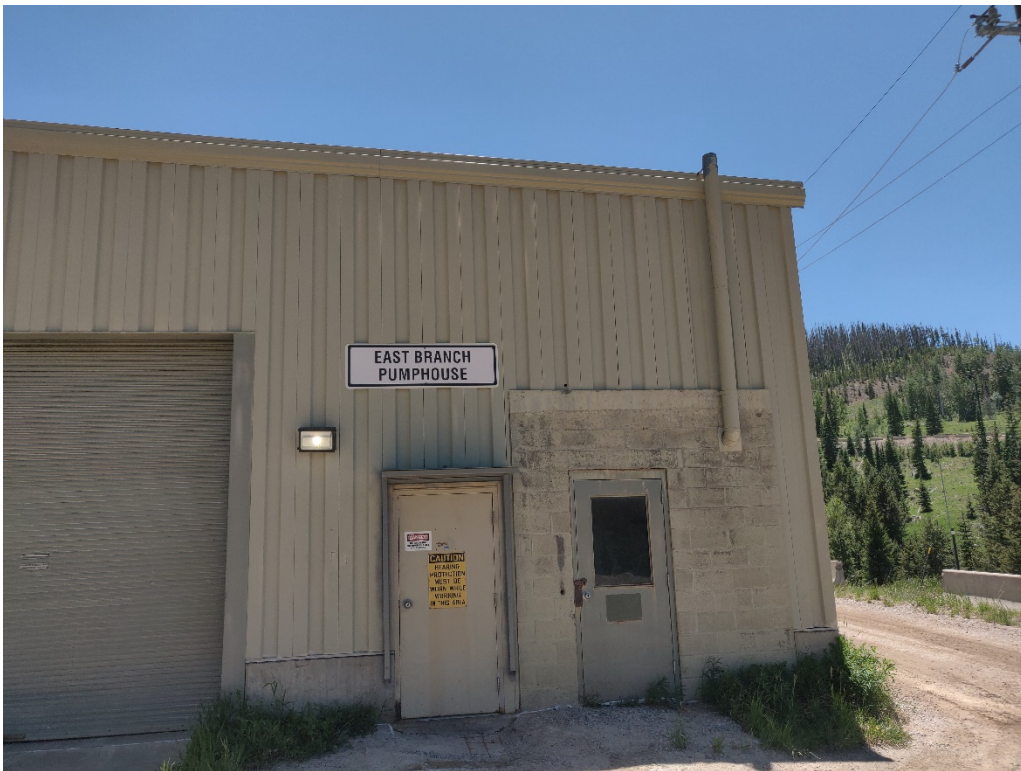
The East Branch Pumphouse also pumps water from the Ute Creek Reservoir to the 2 potable water storage tanks. The water is treated in the plant located in the Mill building prior to use in the facility.

View of the East Branch Pumphouse

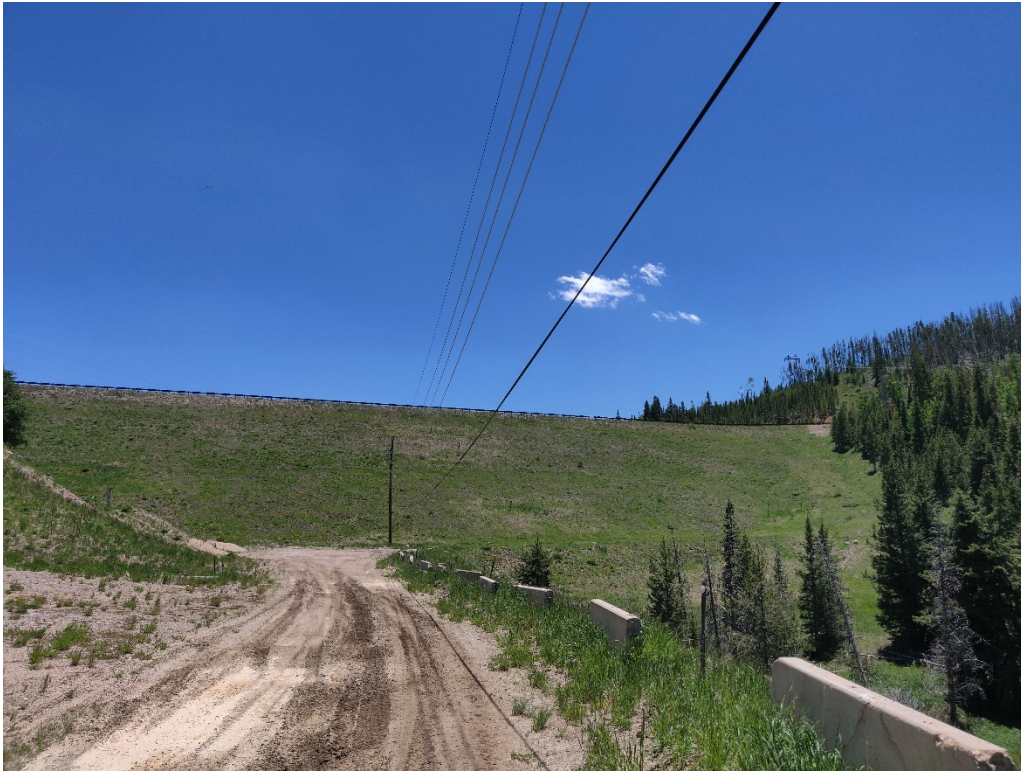
View of the East Branch dam from the East Branch Pumphouse looking south
