**MINERALS PROGRAM INSPECTION REPORT**  
**PHONE: (303) 866-3567**

<b>MINE NAME:</b> Holsinger Gravel Pit	<b>MINE/PROSPECTING ID#:</b> M-1980-052	<b>MINERAL:</b> Sand and gravel	<b>COUNTY:</b> Jackson
<b>INSPECTION TYPE:</b> Monitoring	<b>INSPECTOR(S):</b> Peter Hays	<b>INSP. DATE:</b> June 25, 2020	<b>INSP. TIME:</b> 12:00
<b>OPERATOR:</b> Keith Holsinger	<b>OPERATOR REPRESENTATIVE:</b> Keith Holsinger	<b>TYPE OF OPERATION:</b> 110c - Construction Limited Impact	
<b>REASON FOR INSPECTION:</b> Normal I&E Program		<b>BOND CALCULATION TYPE:</b> Partial Bond	<b>BOND AMOUNT:</b> \$20,000.00
<b>DATE OF COMPLAINT:</b> NA		<b>POST INSP. CONTACTS:</b> None	<b>JOINT INSP. AGENCY:</b> None
<b>WEATHER:</b> Clear	<b>INSPECTOR'S SIGNATURE:</b>

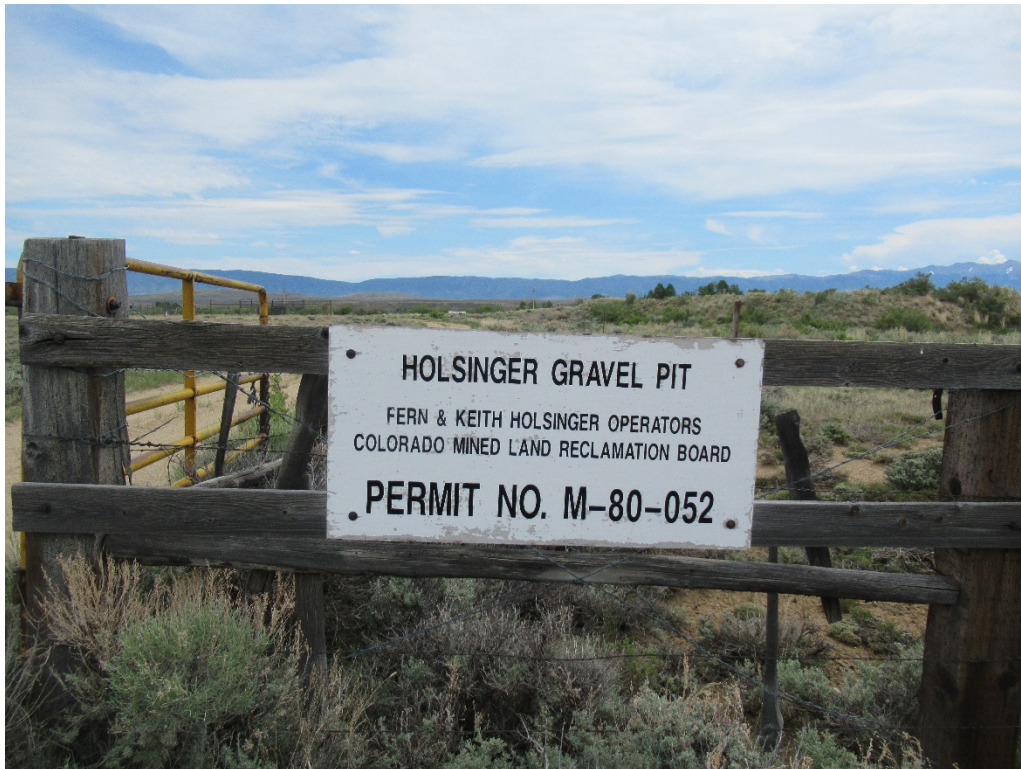
The Division currently holds a financial warranty in the amount of \$20,000.00, which appears adequate to reclaim the site based on the observation from this inspection. An entrance sign was posted as required by Rule 3.1.12.

Holsinger Gravel Pit mine sign

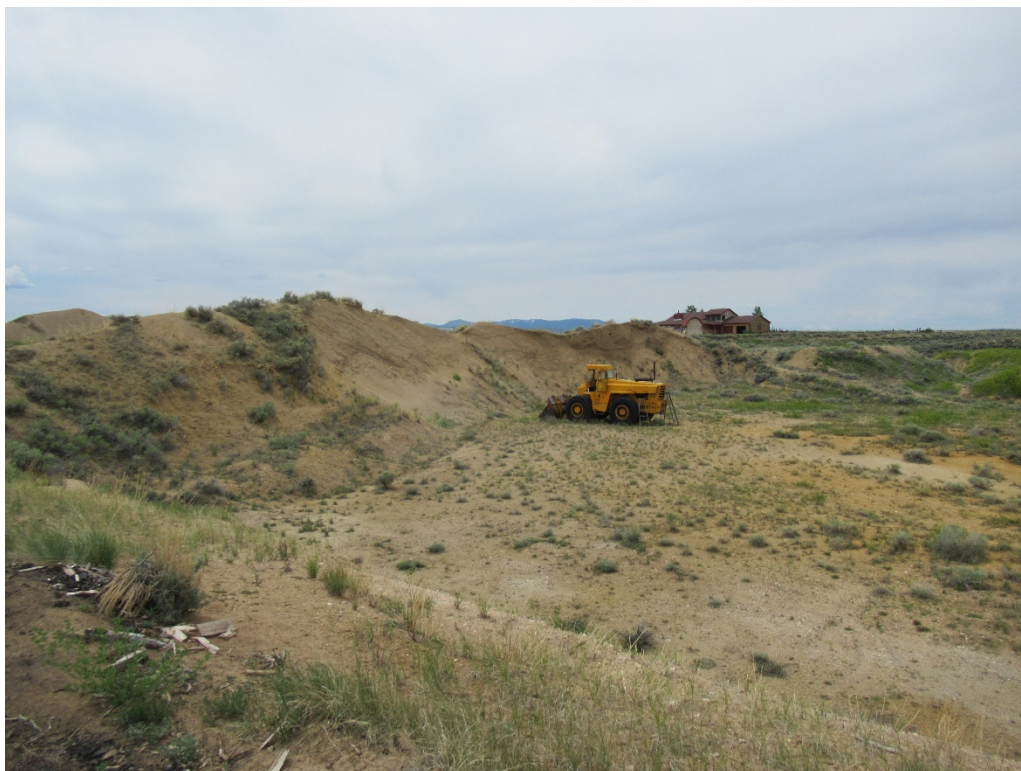
View of the current highwall and pit floor

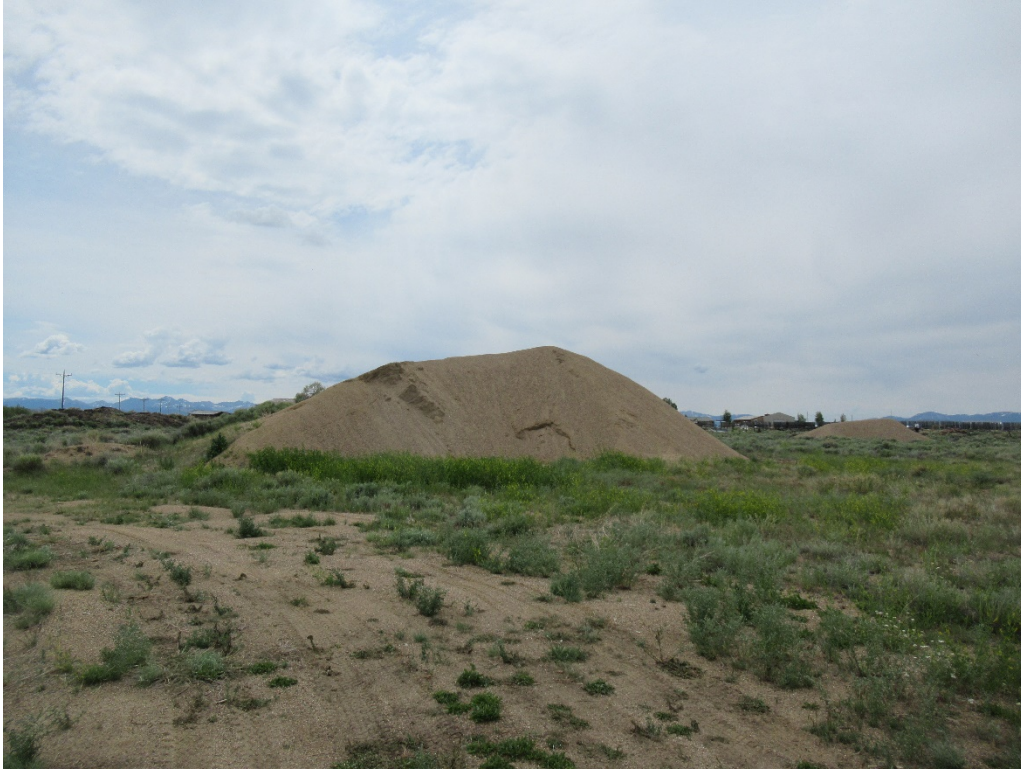
View of the product stockpiles located east of the current highwall

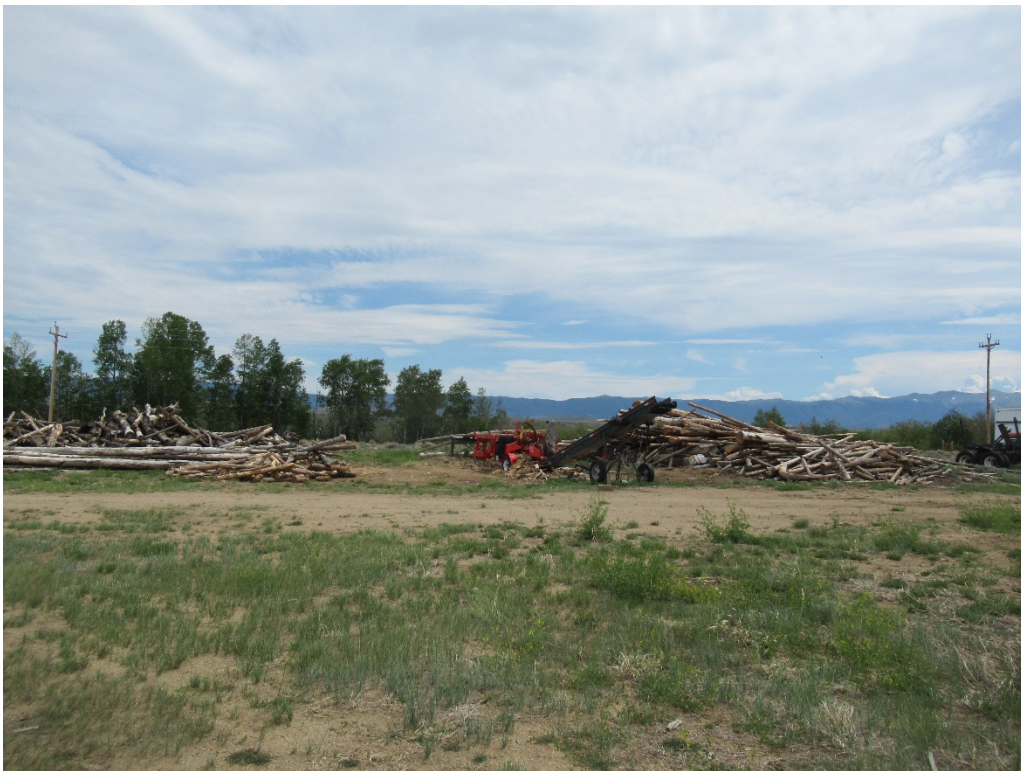
The site is located approximately 3 miles southeast of Walden, CO on State Highway 14. The site is an 110c operation permitted for 9.9 acres. The site was not active during the inspection and appeared unchanged since the last inspection. The Operator reported the last date of excavation, processing or hauling activity occurred on October 15, 2019. Two product stockpiles are located east of the current highwall. A firewood operation including a pile of logs and a wood splitter was located north of the pit floor.

View of the firewood operation in the northern portion of the site

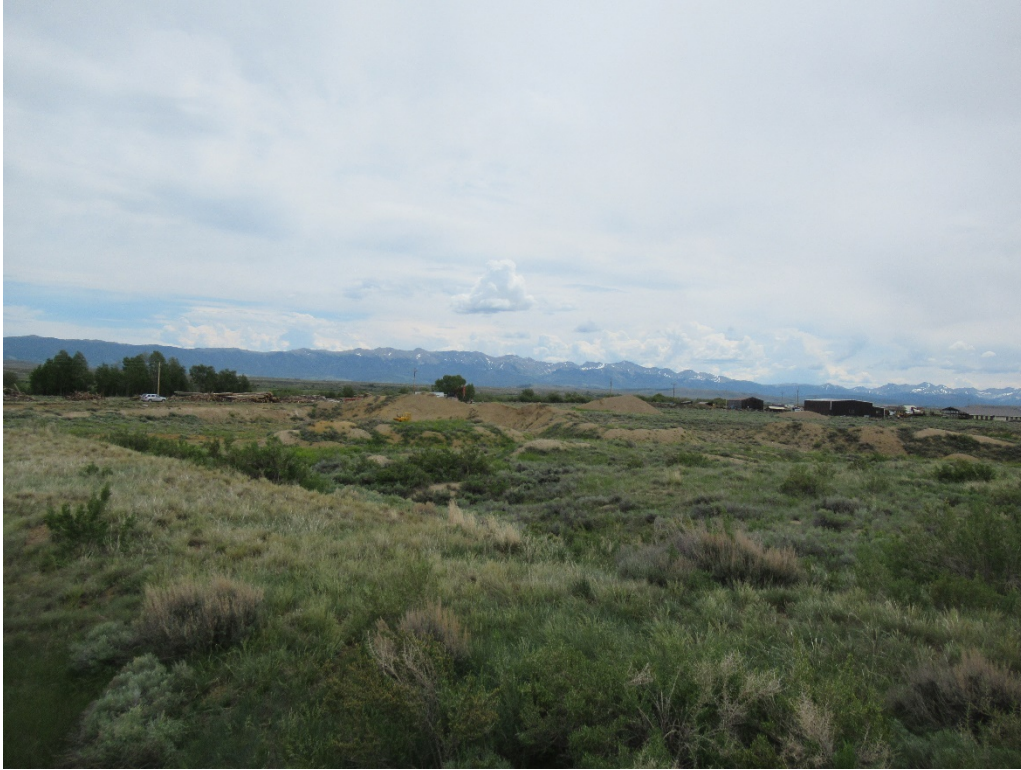
The approved post-mining land use is rangeland. No reclamation was completed since the last inspection. A large well-vegetated topsoil stockpile is located in the southwest corner of the site. The pit floor and pit slopes are covered with volunteered vegetation. The site appeared stable with no erosion features observed during the inspection. No noxious weeds were identified during the inspection.

View of the site from the topsoil stockpile looking northeast
