COLORADO
Division of Reclamation,
Mining and Safety
Department of Natural Resources

Permit Number: C-1981-041 Mine Name: Roadside Portals Operator: Snowcap Coal Company, Inc. Operator Address: MS Tonya Hammond P.O. Box 1430 Palisade, CO 81526	County: Mesa Operation Type: Underground Permit Status: Active Ownership: Private
	Operator Representative Present: NA
Operator Representative Signature: (Field Issuance Only)

Inspection Start Date: July 6, 2020 Inspection Start Time: 09:56 Inspection End Date: July 6, 2020 Inspection End Time: 09:59		Inspection Type: Aerial Inspection Inspection Reason: Normal I&E Program Weather: Clear	
Joint Inspection Agency: None		Joint Inspection Contacts: None	
Post Inspection Agency: None		Post Inspection Contacts: None	
Inspector(s): Clayton Wein Brock Bowles	Inspector's Signature: <i>Clayton Wein</i>		Signature Date: 7/7/2020

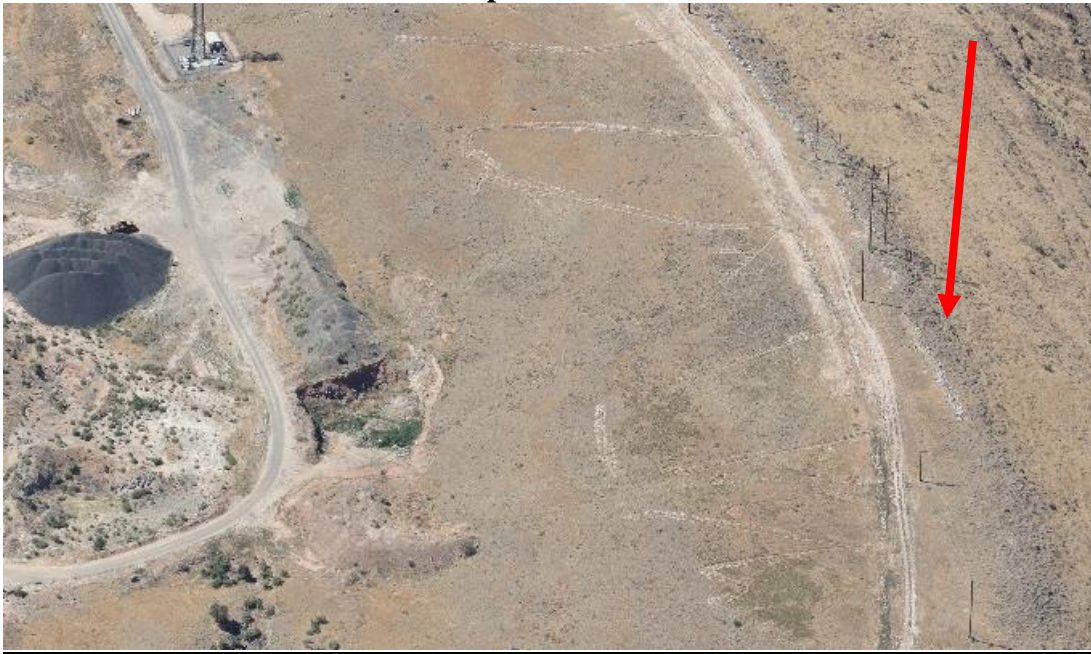
The trenches created by the landowner on top of the Tract 70 were dry during the inspection (Photo 1 and 2). There was no evidence of recent flow in the trenches. Trenches on Tract 71 near the TR-69 repair area were observed to be dry. There was no evidence of recent flow in the trenches.

Photo 1: The north end of the Tract 70 Mesa. The landowner's trenches were dry

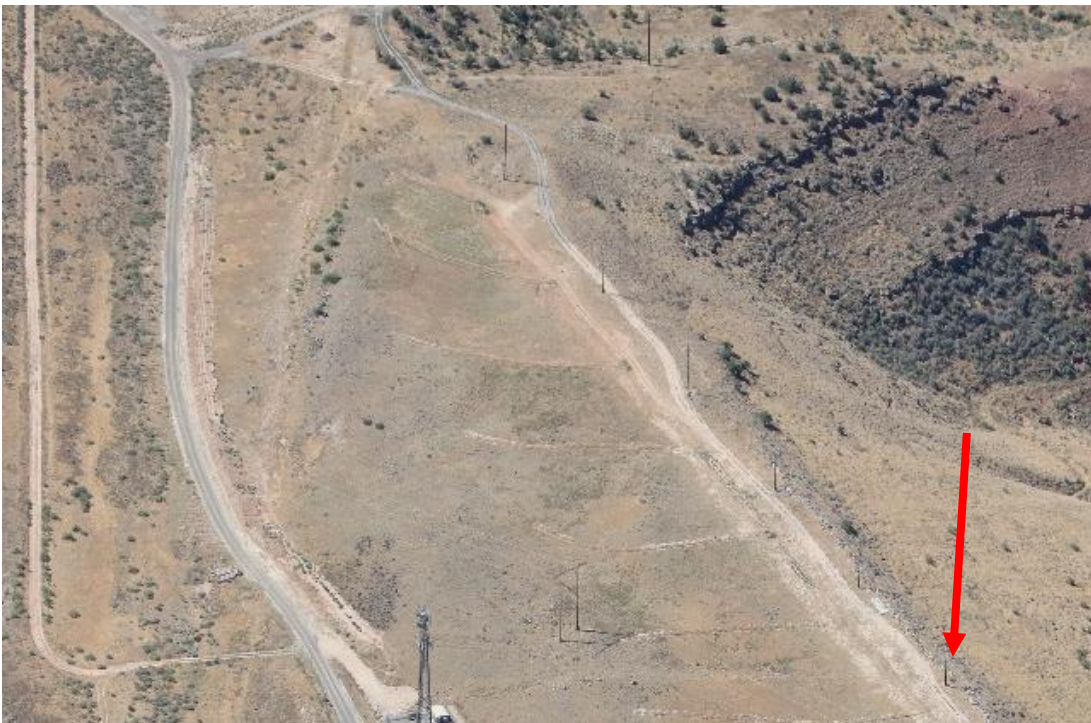
Photo 2: The south end of the Tract 70 Mesa. The landowner's trenches in this section were dry.

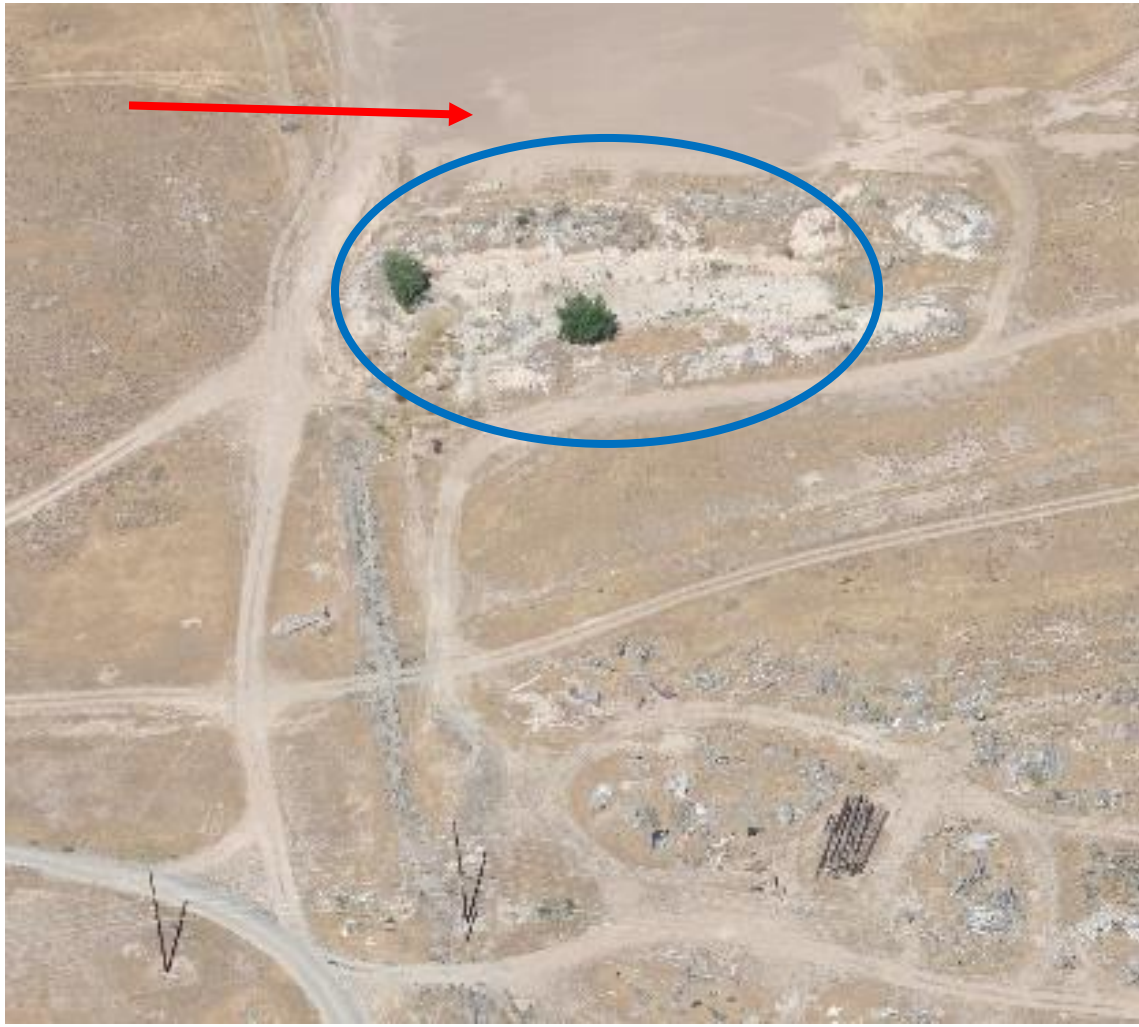
The Carey Pond, located to the south of the TR-69 repair area was dry (Photo 3). There was no evidence of recent water impoundment in the pond.

Photo 3: The Carey Pond is outlined in the blue circle in the photo. The pond was dry.

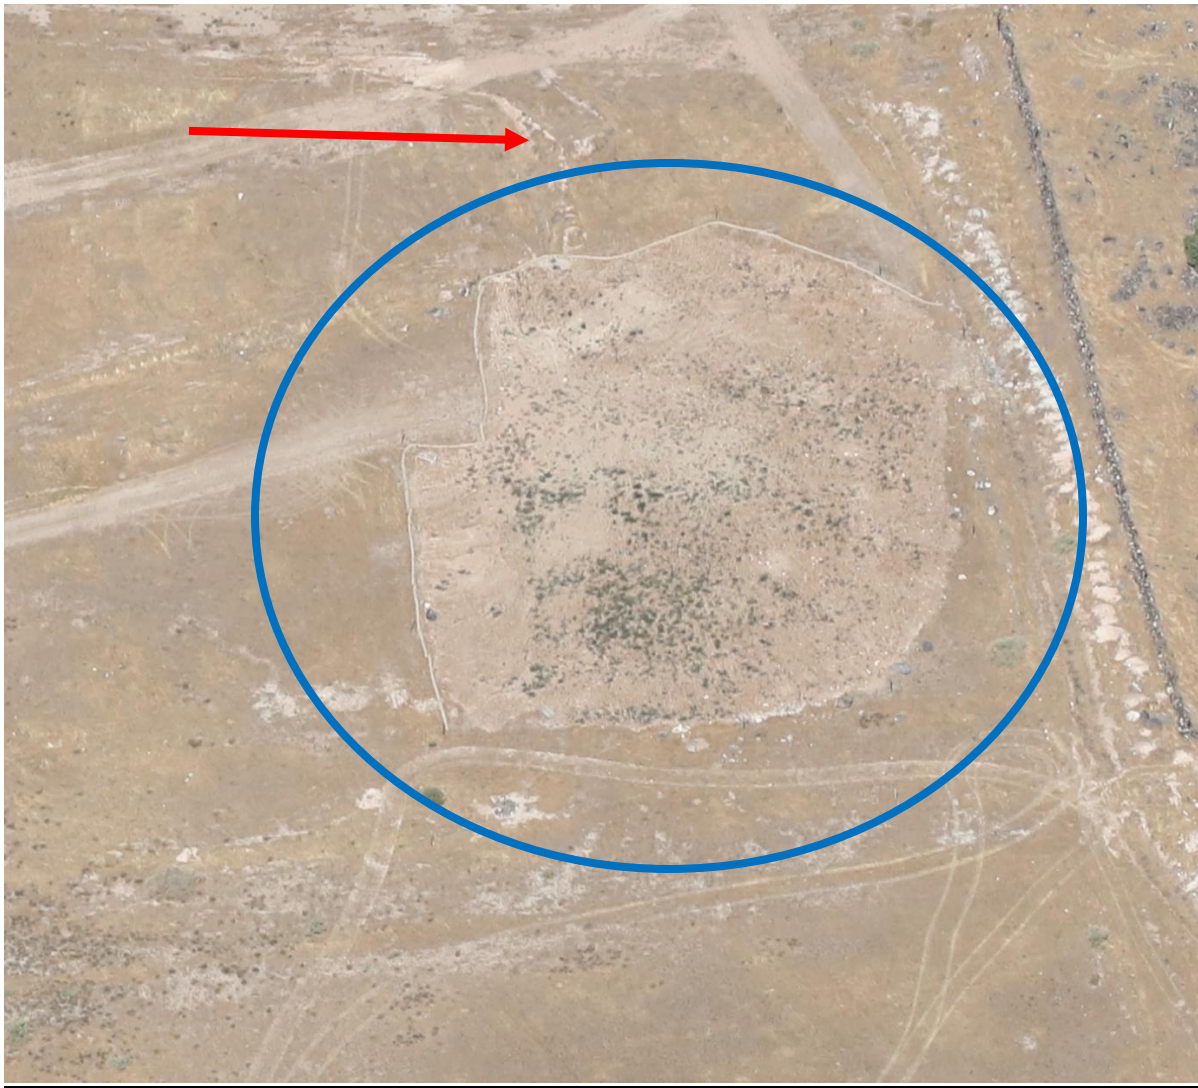
The TR-69 repair area is the only permitted disturbance at the mine site (Photo 4). The area is just under ½ an acre in size. The boundary of the disturbance was marked by T-posts. The sediment logs placed on the down-gradient portion of the area were intact and in good condition. There were no indications of off-site impacts. The site was stable and no indications of surface settling were identified. Vegetation at the site had

begun to grow in and appeared to be helping stabilize the site.

Photo 4: The TR-69 repair area. The site is outlined in the blue circle.
