MINERALS PROGRAM INSPECTION REPORT
PHONE: (303) 866-3567

MINE NAME: Colorado Red Rose Stone Resource	MINE/PROSPECTING ID#: M-2013-068	MINERAL: Granite, granite gneiss	COUNTY: Larimer
INSPECTION TYPE: Surety Release Inspection	INSPECTOR(S): Brock Bowles	INSP. DATE: June 25, 2020	INSP. TIME: 13:00
OPERATOR: Colorado Rose Red Inc.	OPERATOR REPRESENTATIVE: None	TYPE OF OPERATION: 111 - Construction by Government Agency	
REASON FOR INSPECTION: Surety Release Requested	BOND CALCULATION TYPE: None	BOND AMOUNT: \$7,500.00	
DATE OF COMPLAINT: NA	POST INSP. CONTACTS: None	JOINT INSP. AGENCY: None	
WEATHER: Cloudy	INSPECTOR'S SIGNATURE:

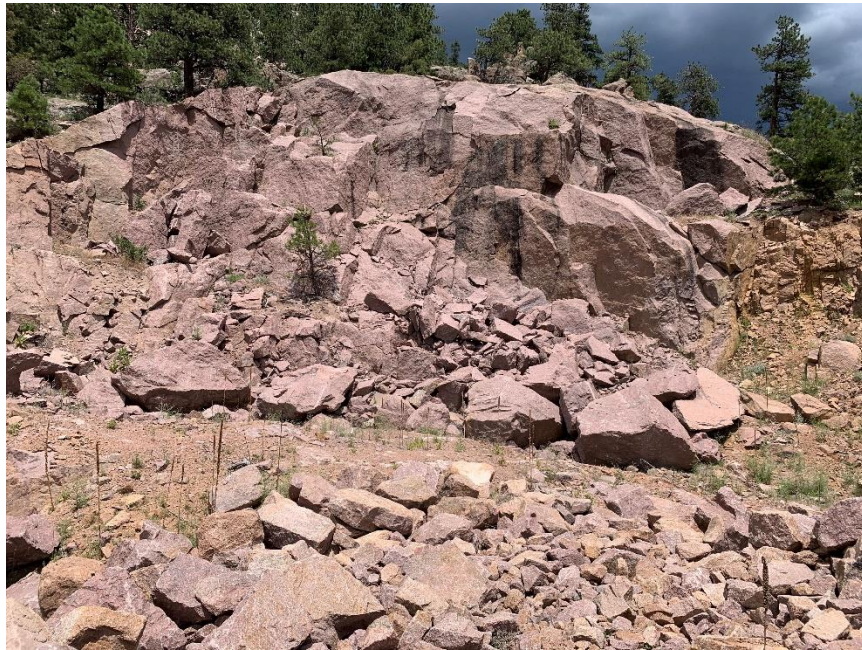
A small highwall (approximately 100' long x 30' high) was noted on the east side of the pit area. Below the highwall is rather large bench area. The highwall and loose material on the bench area appear to be stable. No hydrological issues were noted.

Highwall in pit area, picture looking east.

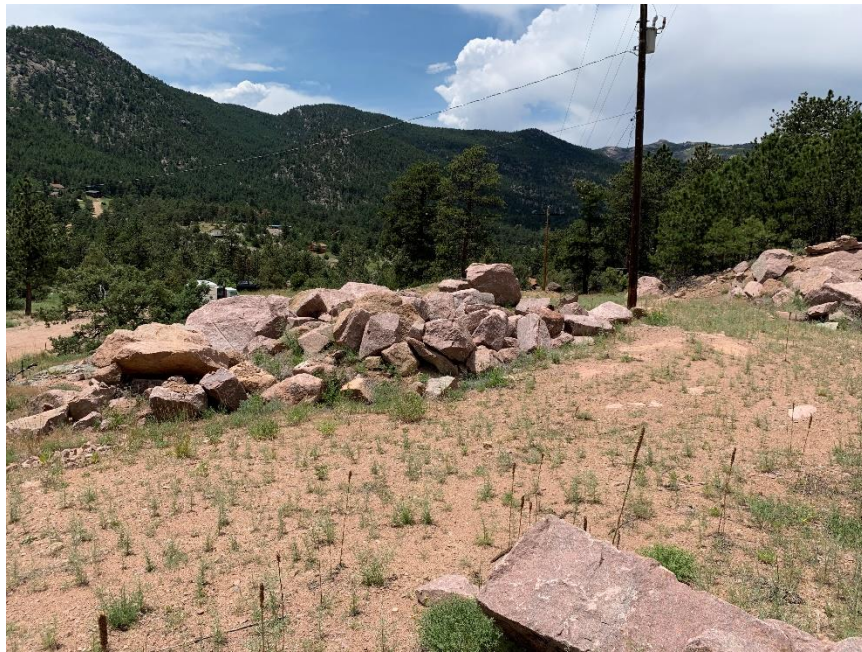
Bench area below highwall, picture looking northwest
