MINERALS PROGRAM INSPECTION REPORT
PHONE: (303) 866-3567

MINE NAME: SerFer Pit	MINE/PROSPECTING ID#: M-2008-006	MINERAL: Gravel and sand	COUNTY: Larimer
INSPECTION TYPE: Surety Release Inspection	INSPECTOR(S): Brock Bowles	INSP. DATE: June 25, 2020	INSP. TIME: 10:00
OPERATOR: Connell Resources, Inc.	OPERATOR REPRESENTATIVE: Kevin Anderson	TYPE OF OPERATION: 112c - Construction Regular Operation	
REASON FOR INSPECTION: Surety Release Requested	BOND CALCULATION TYPE:	BOND AMOUNT: \$21,115.00	
DATE OF COMPLAINT: NA	POST INSP. CONTACTS: None	JOINT INSP. AGENCY: None	
WEATHER: Clear	INSPECTOR'S SIGNATURE:

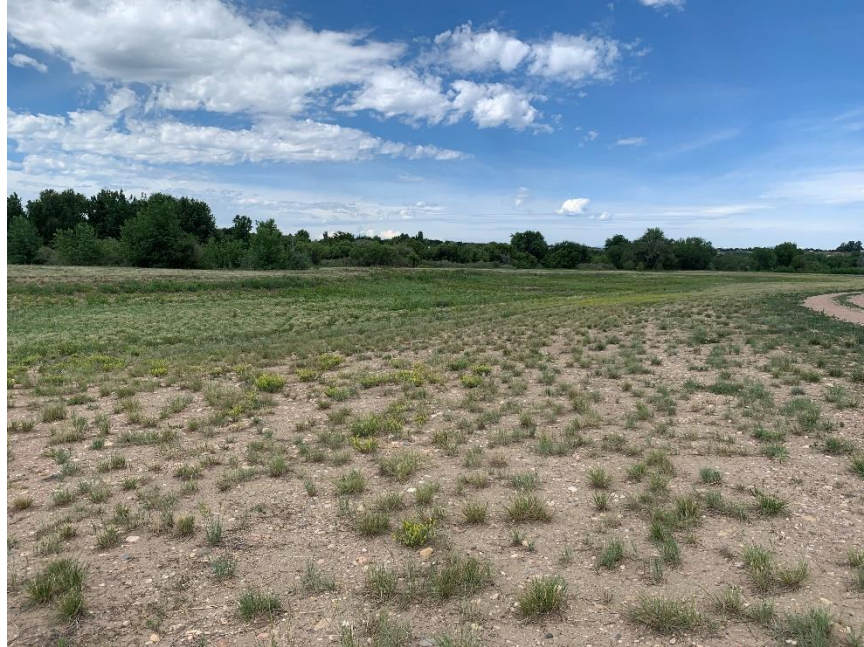
The small depression south of the main reservoir was graded at 3h:1v slopes or less. The northern bank of the depression area had some Canada thistle and had recently been mowed. Mowing is an effective method of control that must be done several times per year. It does appear that this area is frequently mowed because there are many cottonwood sprouts in the bottom area but there are no cottonwood trees in the area.

The depression area on the south side between the reservoir and Poudre River.

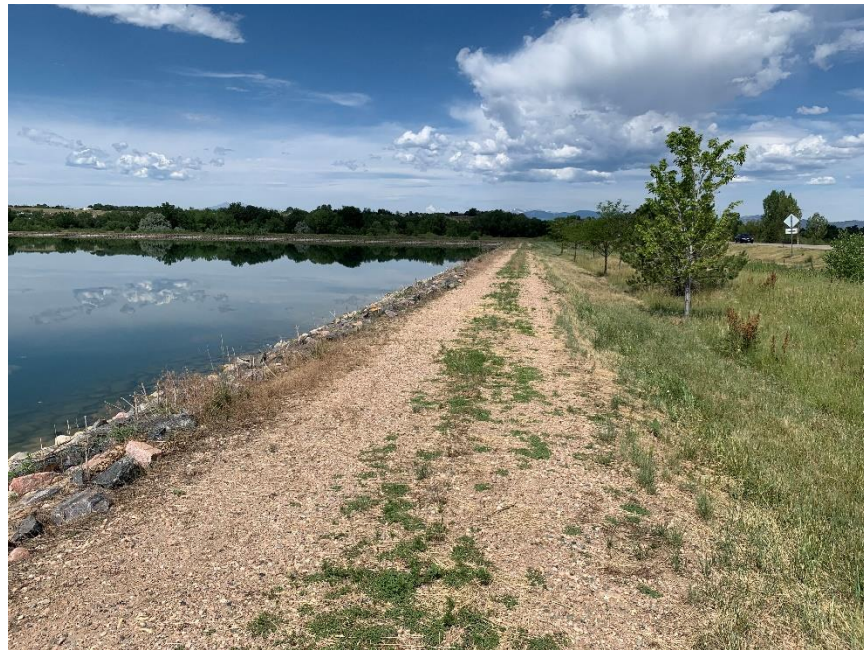
The site was graded in accordance with the reclamation plan and topography map approved in Technical Revision 1. The entire embankment of the reservoir was walked and appeared to be stable. The embankment was rock lined on the inside and there were no signs of erosion.

The north embankment looking west

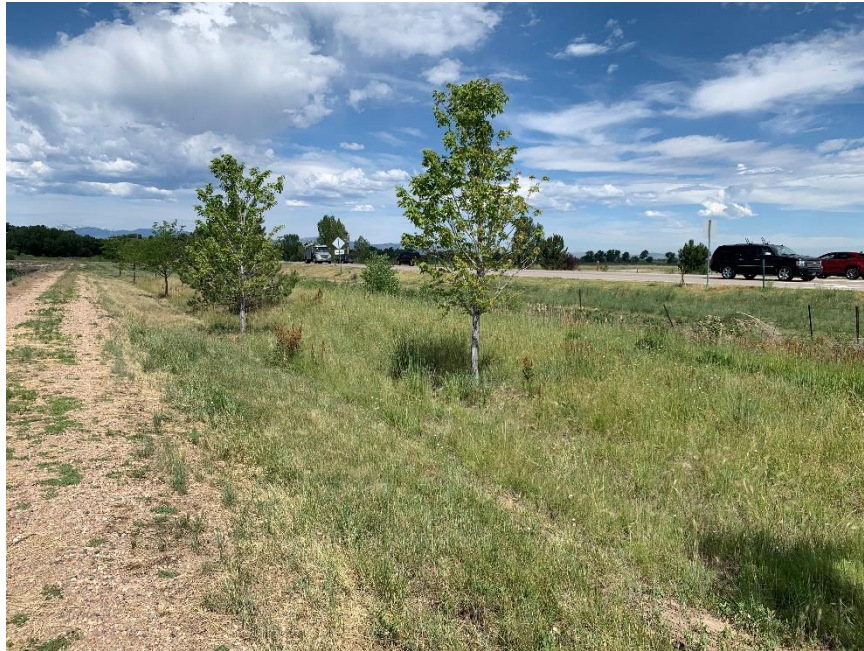
The vegetation on the upland dry areas was a little sparse, but overall looked healthy and well established. Most of the species seen were desirable. There were no signs of erosion. Several thistle plants around the reservoir were dead indicating recent treatment. The vegetation on the north and east side of the reservoir was dense, diverse and well established. A few thistle plants were noted in this area and should be treated while the population is small. This area was not mowed.

The vegetation on the northern boundary along Hwy 392 looking northwest.

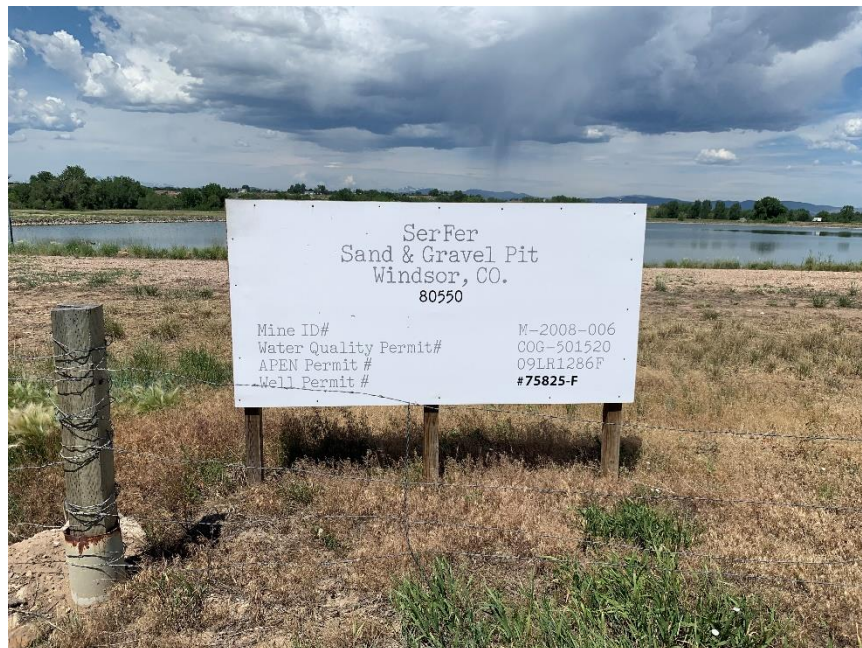
The mine entrance sign was in place. The permit boundary on the east and north sides were marked by a fenceline. The gate was locked upon arrival. The boundary markers on the south and west sides were not verified because they were in dense vegetation along the Poudre River and a ditch.

Mine entrance sign facing County Line Road, Hwy 13.
