PERMIT INFORMATION

Permit Number: C-1982-056 Mine Name: Foidel Creek Mine Operator: Twentymile Coal, LLC Operator Address: Ms Miranda Kawcak 29515 Routt County Road No. 27 Oak Creek, CO 80467	County: Routt Operation Type: Underground Permit Status: Active Ownership: Private
	Operator Representative Present: None
Operator Representative Signature: (Field Issuance Only)

Inspection Start Date: July 6, 2020 Inspection Start Time: 08:45 Inspection End Date: July 6, 2020 Inspection End Time: 09:00		Inspection Type: Aerial Inspection Inspection Reason: Normal I&E Program Weather: Clear	
Joint Inspection Agency: None		Joint Inspection Contacts: 	
Post Inspection Agency: None		Post Inspection Contacts: 	
Inspector(s): Tabetha Lynch Brock Bowles	Inspector's Signature:  		Signature Date: 7/9/2020

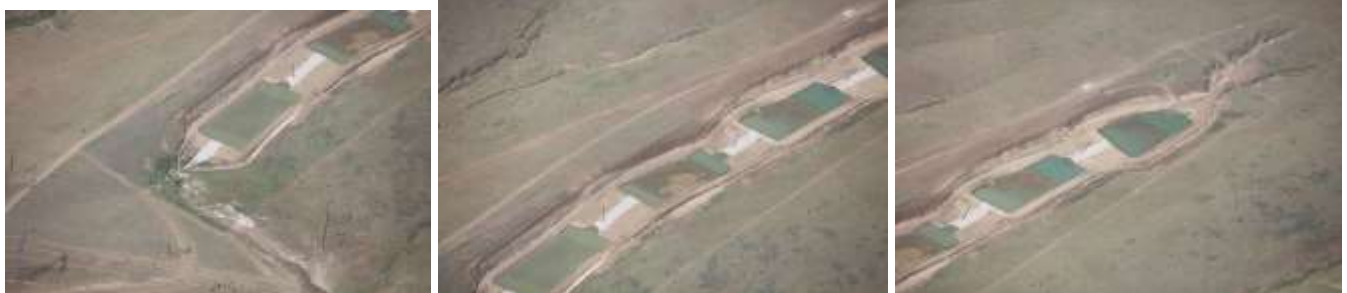
Most ponds appear to be holding water. Check dams have been placed along the diversions ditches of the passive treatment ponds. Passive treatments ponds shown below.

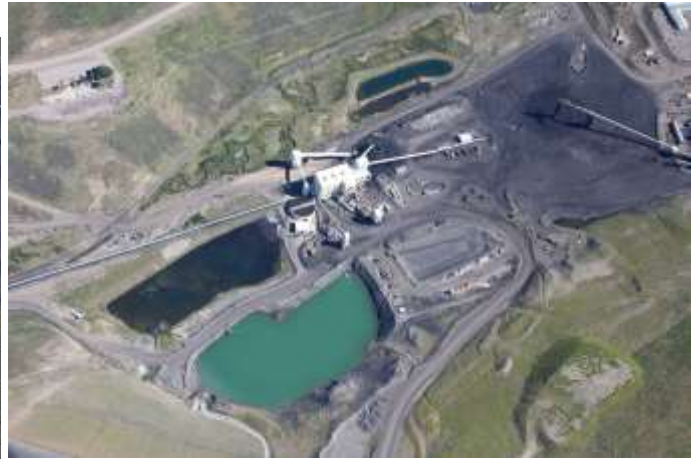
Ponds D, E with deltas to be cleaned

- Clear Sump to Pond B
- Ditches need to be cleaned of debris and reestablished on the warehouse pad
- Clear Delta at inlet of ponds D and E

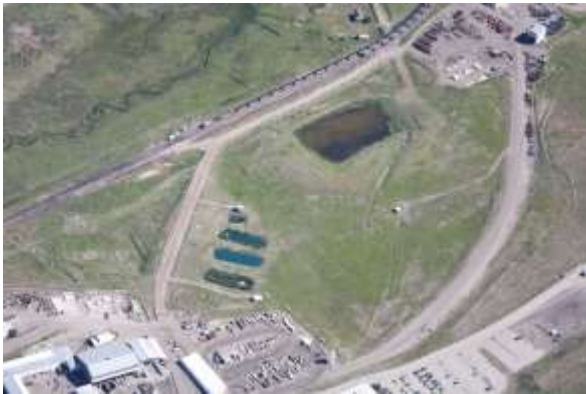
Ditch behind warehouse appears to have lumber to be cleared, culvert F-4 appears to still be damaged (noted during last complete)

- Repair Culvert F-4(A)

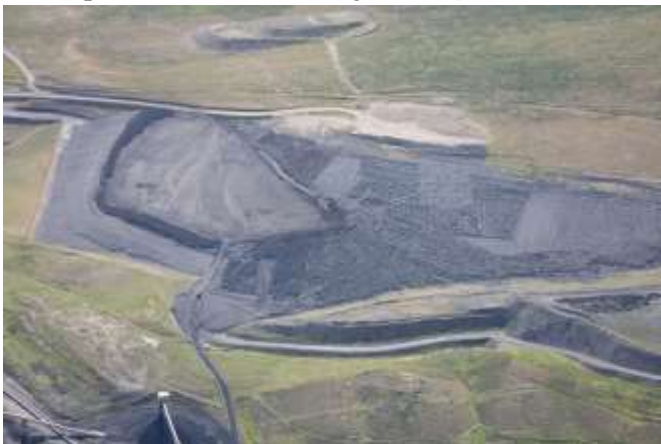
Waste pile, below, is receiving waste, **please submit Revision to the Division with the Waste pile as-built.**
