PERMIT INFORMATION

Permit Number: C-1992-081 Mine Name: Hayden Gulch Loadout Operator: Hayden Gulch Terminal, LLC Operator Address: Ms Miranda Kawcak P.O. Box 670 Hayden, CO 81639	County: Routt Operation Type: Loadout Permit Status: Active Ownership: Private Operator Representative Present: none
Operator Representative Signature: (Field Issuance Only)

INSPECTION INFORMATION

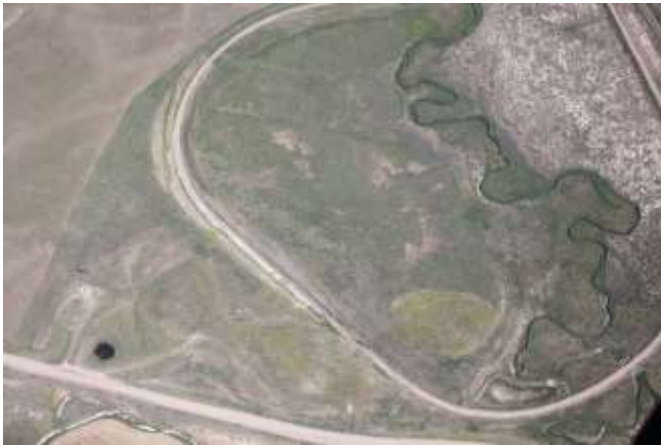
Ponds appear mostly dry and not discharging. Dry Creek appears to have lower flow. Culverts appear to be functional.

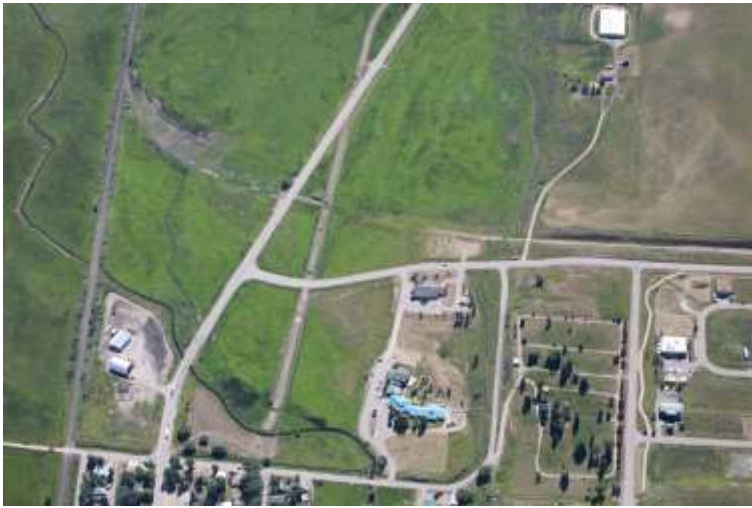
Tracks across Hwy 40 are in place. It does not appear any equipment is on site. Hay field on north side of Hwy 40 still has some flooding.
