**MINERALS PROGRAM INSPECTION REPORT**  
**PHONE: (303) 866-3567**

<b>MINE NAME:</b> #2 Verhoeff Pit	<b>MINE/PROSPECTING ID#:</b> M-2008-013	<b>MINERAL:</b> Sand and gravel	<b>COUNTY:</b> Bent
<b>INSPECTION TYPE:</b> Surety-Related Inspection	<b>INSPECTOR(S):</b> Daniel Cunningham	<b>INSP. DATE:</b> July 2, 2020	<b>INSP. TIME:</b> 13:30
<b>OPERATOR:</b> Riverside Aggregates, LLC	<b>OPERATOR REPRESENTATIVE:</b> None	<b>TYPE OF OPERATION:</b> 110c - Construction Limited Impact	
<b>REASON FOR INSPECTION:</b> Surety Related	<b>BOND CALCULATION TYPE:</b> Complete Bond	<b>BOND AMOUNT:</b> \$10,254.00	
<b>DATE OF COMPLAINT:</b> NA	<b>POST INSP. CONTACTS:</b> None	<b>JOINT INSP. AGENCY:</b> None	
<b>WEATHER:</b> Clear	<b>INSPECTOR'S SIGNATURE:</b>

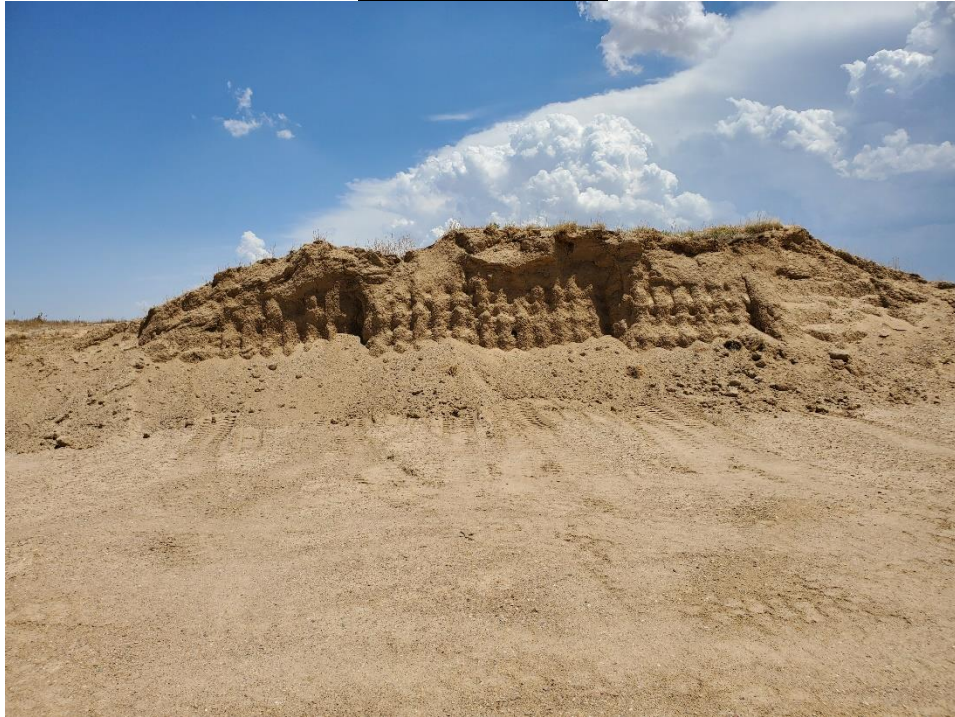
Remaining highwall

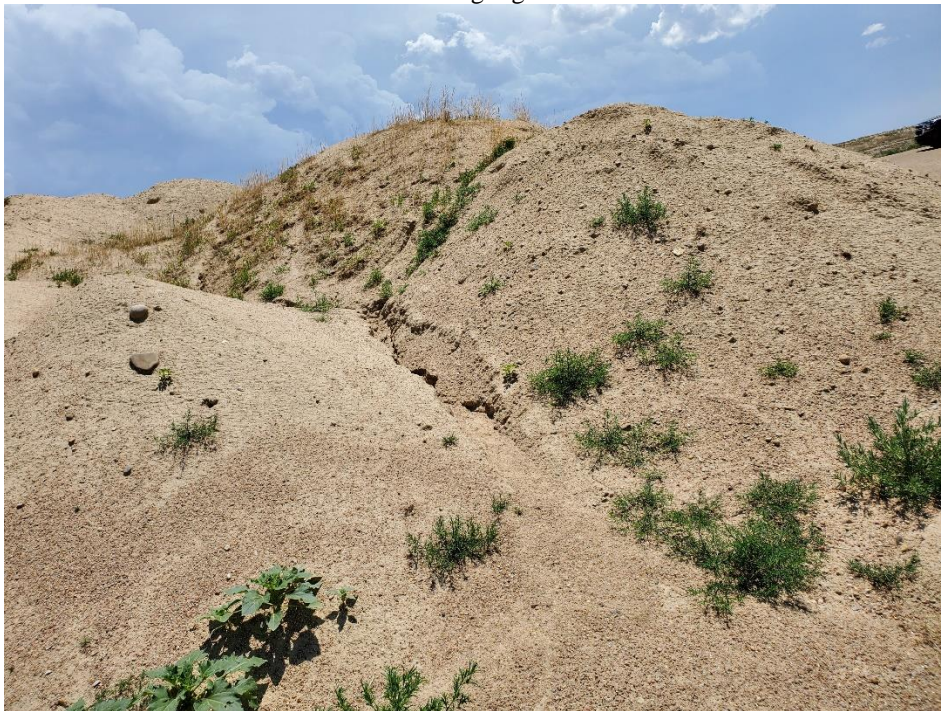
Stockpile

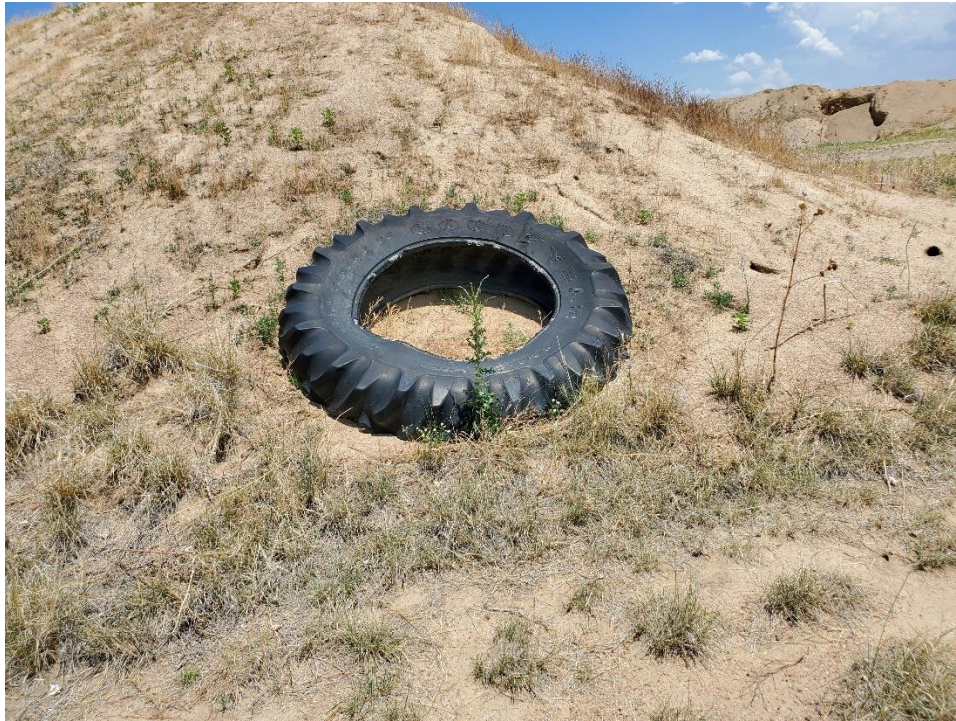
Tire buried in stockpile

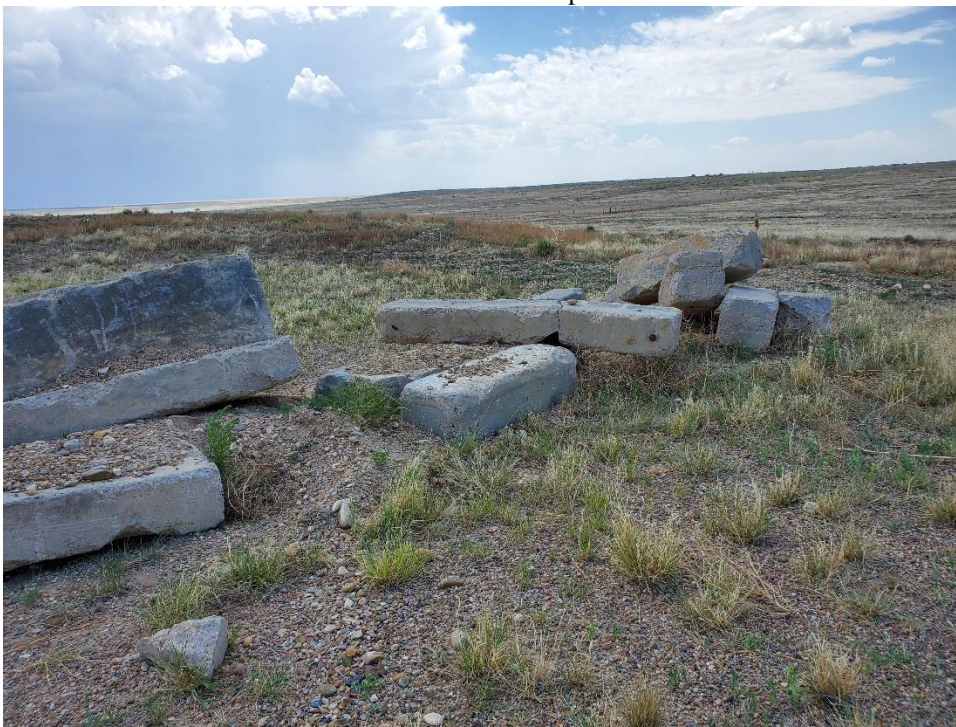
The amount of reclamation work that has been completed by the Operator since the inspection in March was minimal, with much of the area not changed at all. An estimation of 700 cubic yards has been moved since the March 2020 inspection. There are still several large stockpiles on site, and the highwall has had minor work done to it. Several large piles of concrete were stockpiled on site and a large tire was partially buried in one of the stockpiles. The sites is currently not approved for inert fill per Rule 3.1.5(9), so this material will need to be removed during reclamation.

Concrete left onsite
